# technical brief

## Pool Shocking—"Fun in the Sun" Can Be a Shocking Event

*Power Quality Information Services and Support Target*

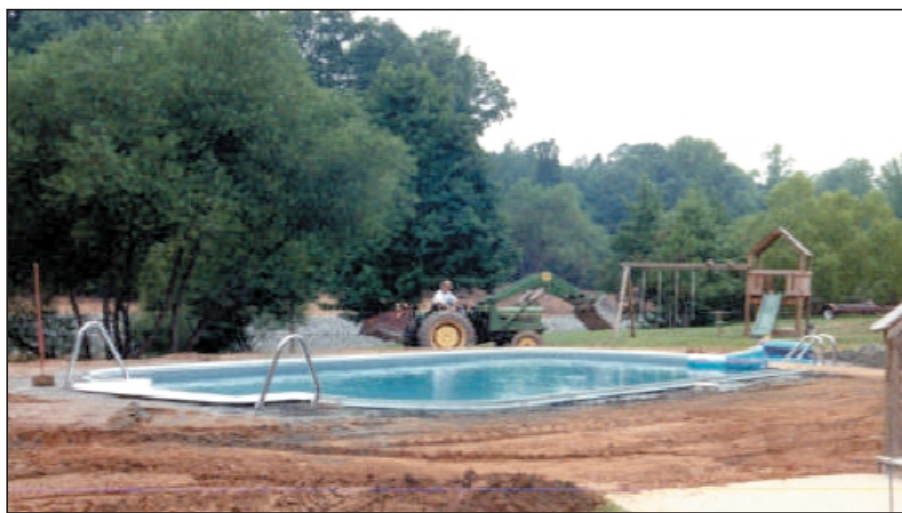
Figure 1. Swimming pool still under construction.

The customer was in the construction stage of a swimming pool, shown in Figure 1, and had experienced several incidents of shocking while working around the pool. The swimming pool cavity in the ground was 4" to 6" larger than the fiberglass pool shell. The 4" to 6" gap between the shell and the surrounding earth had to be back-filled with dirt before the concrete deck was poured. The customer indicated he was getting shocked while standing in the pool water and reaching out to pull dirt into the gap. Every time he came in contact with the earth, he experienced a shocking sensation.

The shocking voltage was measured to be  $3.1V_{ne}$  ac from the pool's water to the soil around the pool. The potential difference was created by the pool's water being held at the elevated system neutral level (via the pool's grounded ladder and submerged light fixture) while the sur-

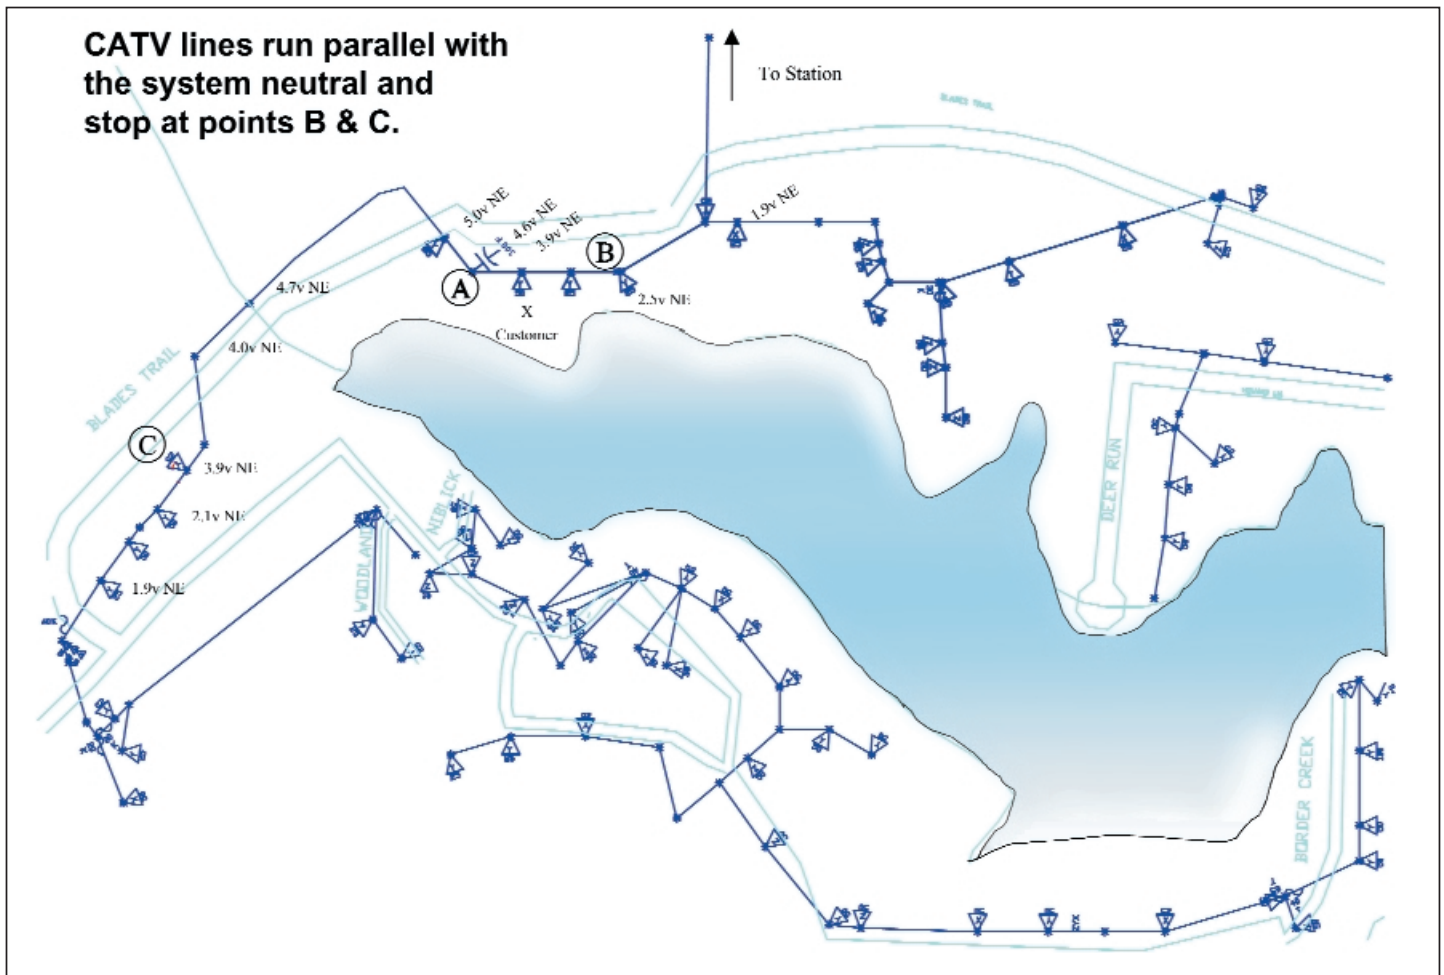
Figure 2. Distribution circuits and geographics in the area of inquiring customer.

- Faulty wiring on the customer side
- Open current-limited fuse on the capacitor bank, point A in Figure 2
- Open or damaged system neutral on either of the two circuits.

The next step in the investigation was to take amp readings and neutral-to-earth voltage measurements on the circuit in the vicinity of the inquiring customer. The circuit construction was three-phase with 1/0 ACSR primary and 2 ACSR neutral. The values measured are indicated in Figure 2. There was no appreciable current on the grounding conductors along the circuit, therefore no current values are offered. This is an indication that the system neutral is intact having no open points in this area.

The increasing and decreasing magnitude of the neutral-to-earth voltages between points B and C is an indication that there is a relative increase in the neutral impedance in that region. A close inspection of the circuitry in this area reveals the culprit. The local cable company has installed CATV conductors in all regions around this part of the lake, with the exception of the circuitry between points B and C. The elevated neutral-to-earth voltages measured in this area are related to the increased neutral

impedance resulting from the absence of CATV cables.

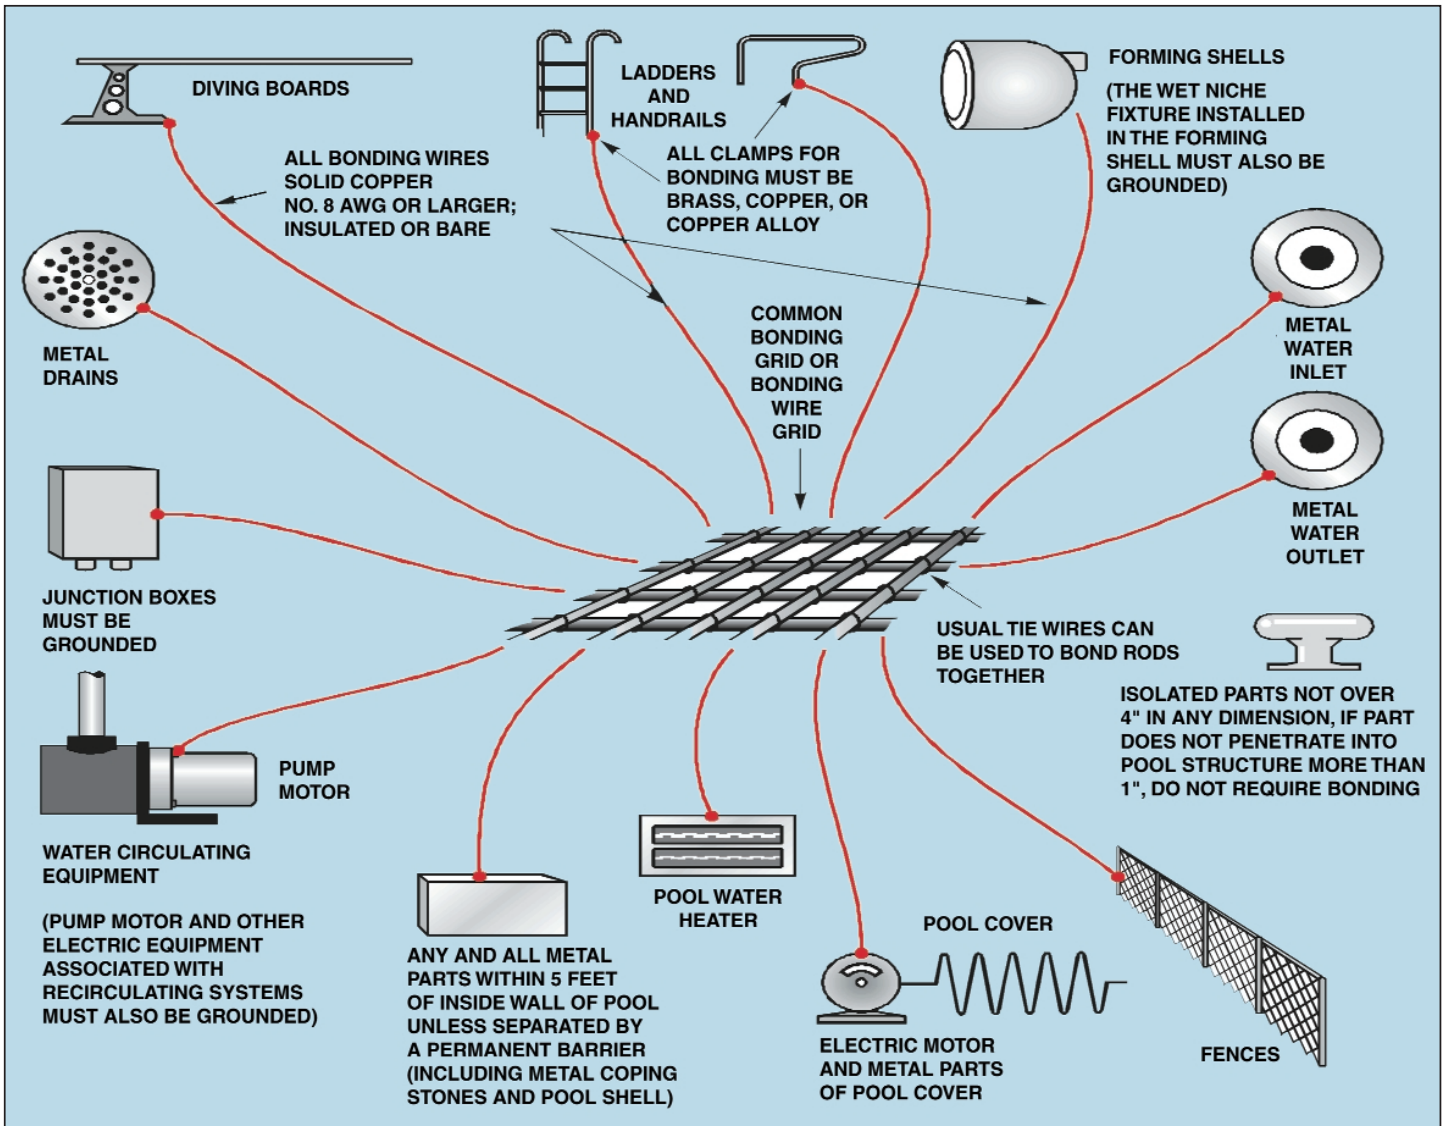
Figure 4. Bonding and grounding requirements of a swimming pool.

**Pool Bonding per the NEC.** The effect of bonding all metallic parts of a pool is to eliminate the potential difference between any two adjacent objects or areas of the pool. The result is that shocking sensations around the pool are eliminated. Typically, No. 8 or larger solid copper wire is used to bond together the pool equipment, such as ladders, handrails, coping stones, etc. This bonding is normally completed

before the concrete deck is poured. For other safety reasons, **the swimming pool shall be bonded per Article 680-22 of the National Electrical Code (NEC).** Figure 4 illustrates the various components to be bonded together.

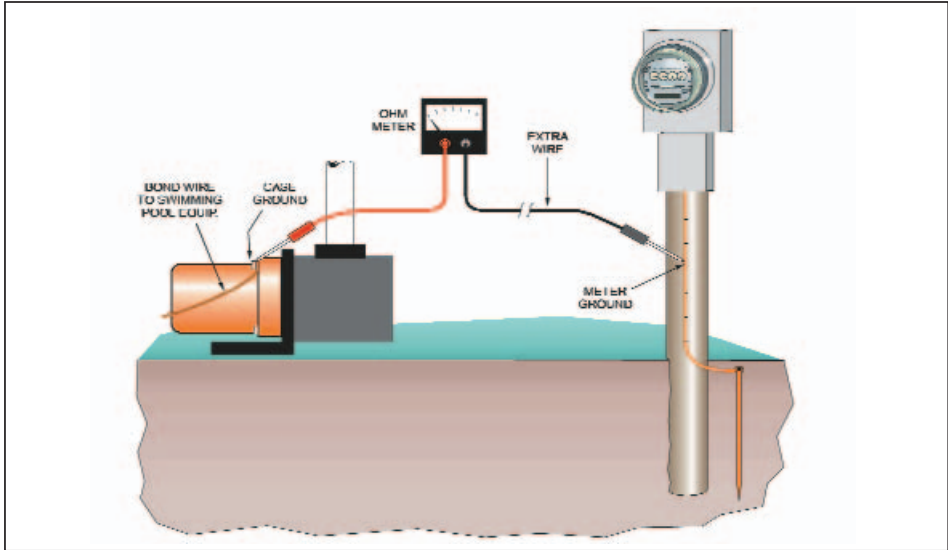
**What Happens When All Is Not Bonded?** Without proper bonding, a difference of potential can exist between the metal parts of the pool and the pool water or any wet surfaces around the pool. The result can be a slight, yet painful shock. All pool shocking investigations should evaluate the bonding between the pool's metallic components. A good way to do this is with the use of an ohmmeter, see Figure 5. Typical bonding ohm values are listed in Table 5.

Figure 5. Ohm measurements taken between the grounding electrode conductor at the meter and the pool pump motor.

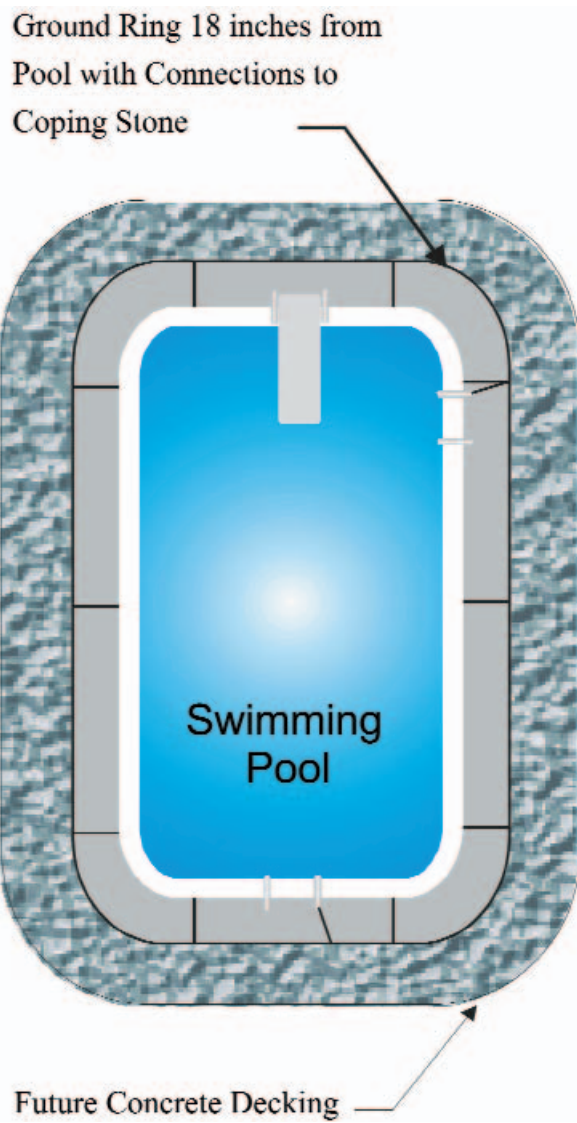
Figure 6. Swimming pool with ground ring installed.

In this case study, there was an additional option because the construction of the concrete decking had not been completed. Although the contractor refused to install rebar in the concrete decking to be used as a grounding grid system, the customer was persuaded to employ a single conductor ground ring around the pool structure. The ground ring was installed approximately 18 inches away from the pool's edge and was bonded back to the coping stones, the ladder, and hand rail, as shown in Figure 6. The ground ring effectively becomes a single conductor grounding-grid around the pool structure.

The ground ring held the concrete decking immediately above it at the neutral/grounding system potential. The 18-inch gradient to the pool's edge was minimal such that there was very little potential difference between the pool water and the surface at the pool's edge. The customer has not experienced any incidence of pool shocking since the pool's completion.
