# **Dry Cask Storage Characterization Project**

*Interim Progress Report – June 2000*

**1000157**

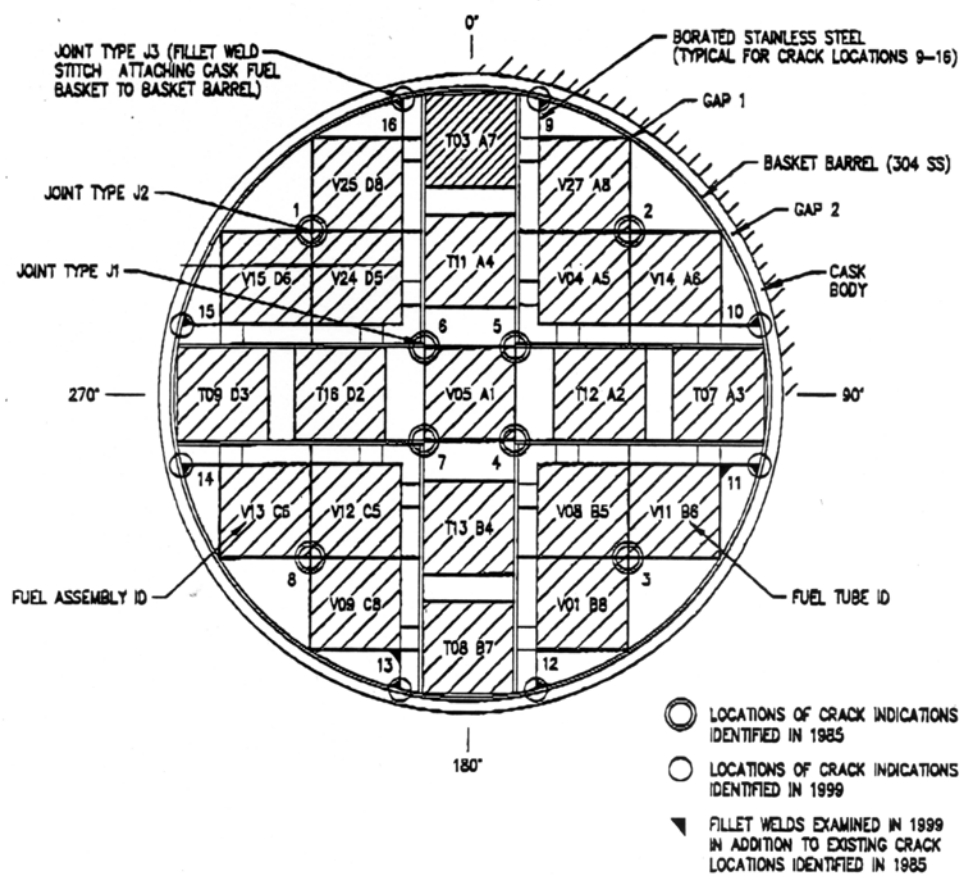
Figure 2-1. Castor-V/21 Basket Crack Indication Locations

The 1985 inspection of the basket after the completion of the heat transfer performance tests identified eight broken welds in the top of the basket (EPRI 4887). The affected welds are identified in Figure 2-1. The welds cracked as a consequence of the stresses created by the differential thermal expansion of the tightly-fitting basket within the cask during the tests. An objective of the 1999 inspections was to re-examine the affected welds for any changes in configuration, and to examine other accessible welds in the basket structure for cracks or corrosion. Unfortunately, the stitch welds of the structure are located in the flux trap and spacer channels, not inside the 21 fuel tubes. Therefore, the only accessible welds were the welds visible at the top of the basket and a few others.

The eight known broken welds appeared to be the same as in the 1985 inspection. The four welds in the corners of the central fuel tube All involved welds of stainless steel to borated stainless steel, whereas the four welds joining the fuel tubes in clusters A8/A5/A6, B6/B5/B8, C8/C5/C6, and D6/D5/D8 involved only stainless steel. The 1999 inspection confirmed that five welds were broken clear through, and three had substantial cracks that propagated partially through the top stitch weld. The narrowness of the flux traps and the supports within blocked the views of the stitch welds below the top welds from the top-side video cameras, and prevented the insertion of the pencil camera assembly. Therefore, the condition of those welds could not be determined.

The inspections found that all eight of the top stitch welds were cracked, and seven of the eight bottom welds. The intermediate welds did not appear to be cracked.

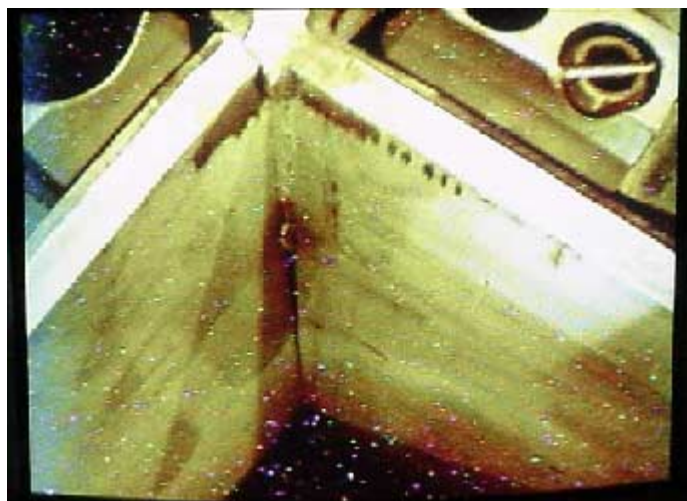
Figure 2-2. Cracks in basket welds

Additional cracks in basket welds (as shown in Figure 2-2.) were associated with stainless/borated steel junctions welds in fuel tubes.

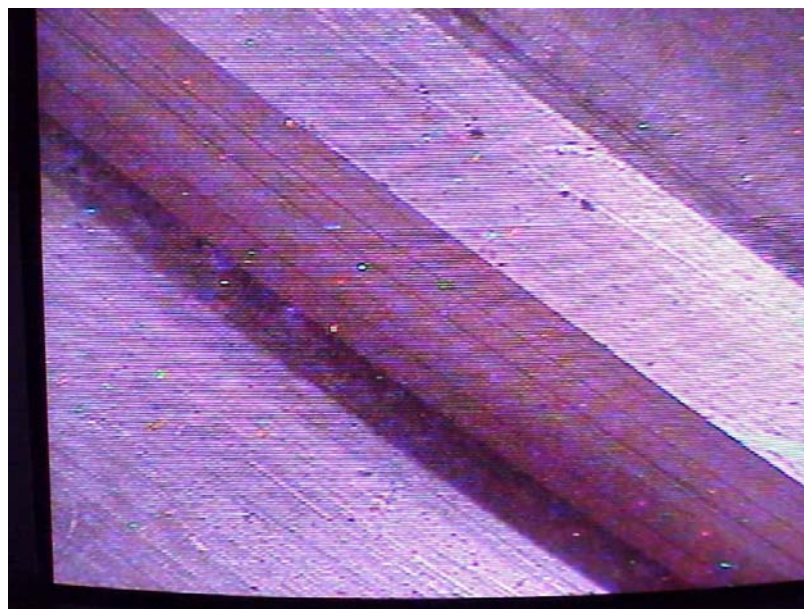
**Fig 2-4. Close-up of rods via video.**

The assemblies were in a generally good condition, which had not changed since the 1985 inspection. The general visual survey revealed a dark gray oxide layer under ambient cell lights, and light tan by video. The inspection found no increase in the oxide layer thickness. There was no formation of a loose oxide scale or particles between the fuel rods of the grid spacers or on the bottom nozzles.

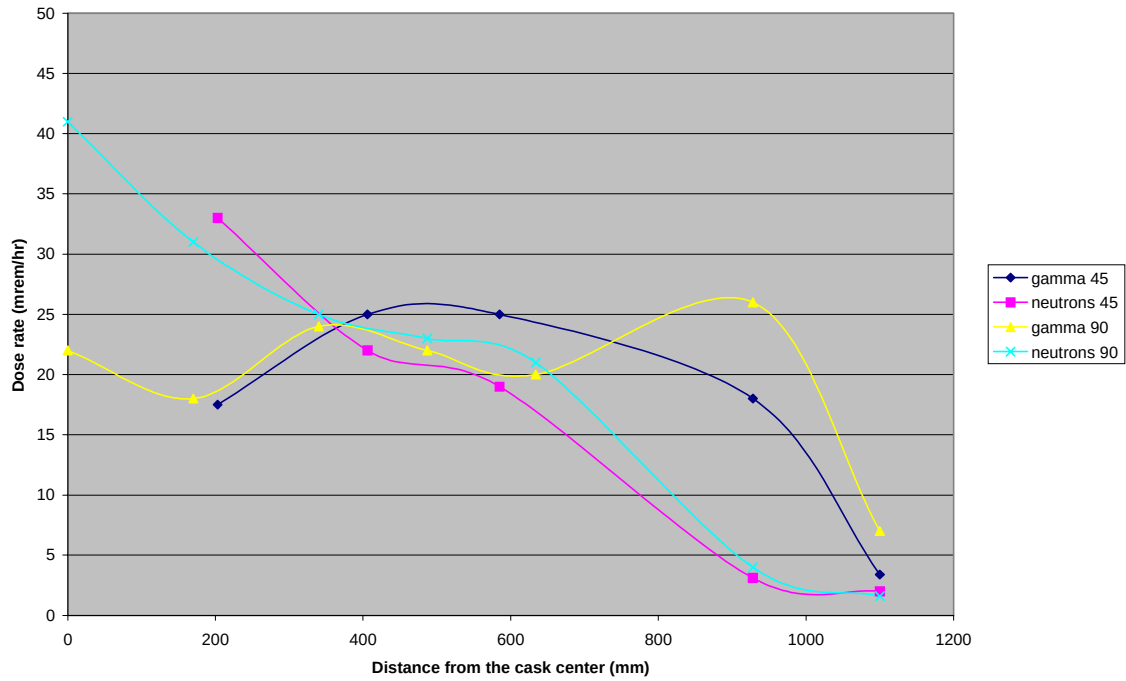
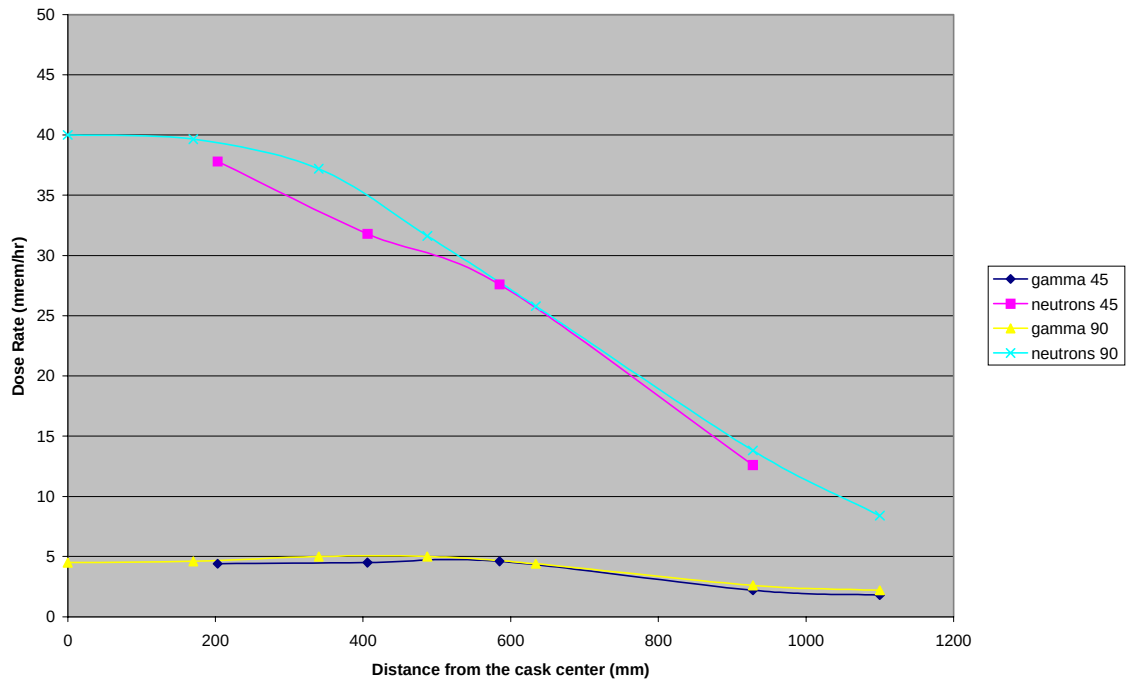
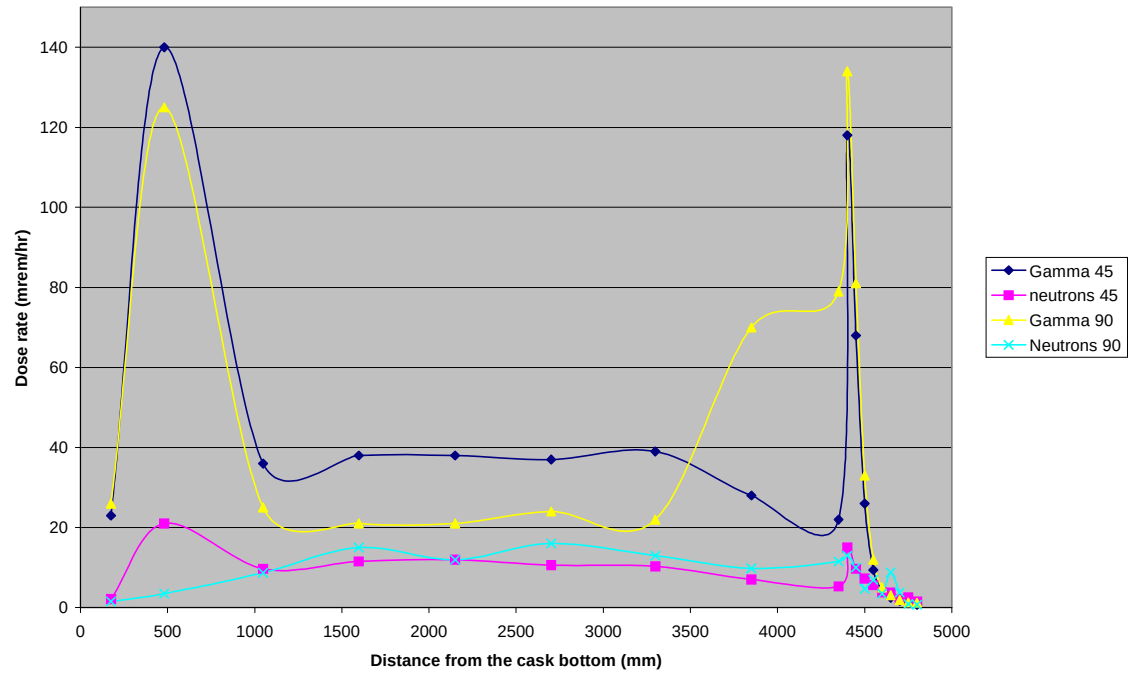
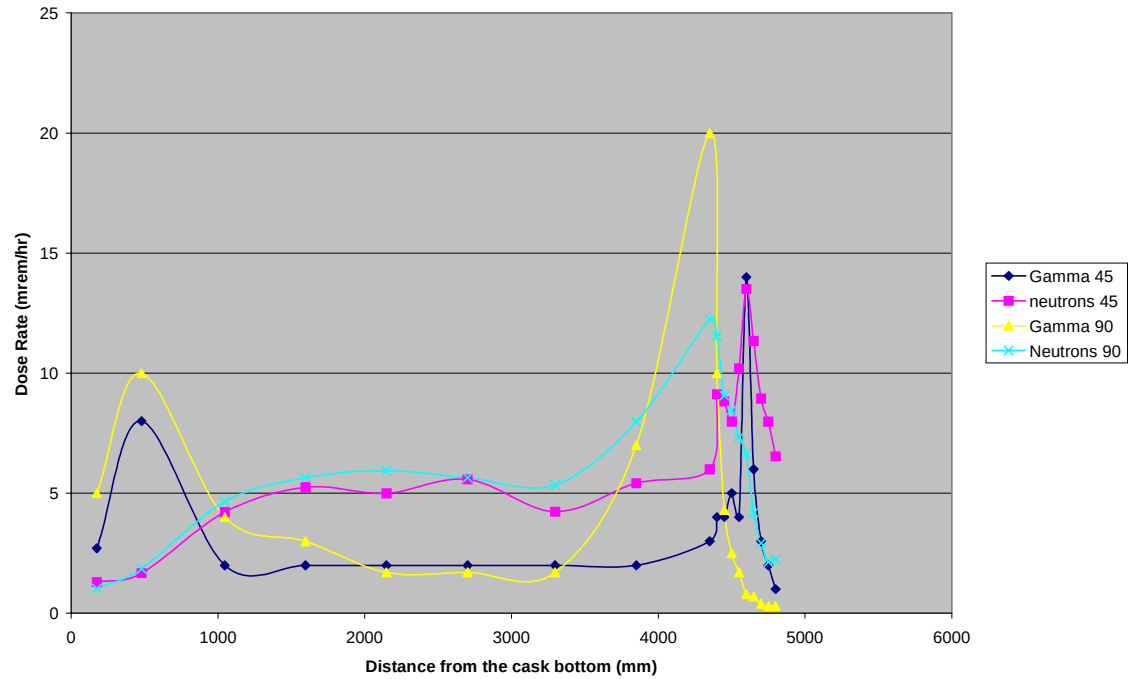
Comparing these results with those from 1999, we notice that the data follow more obvious trends (radioactive decay has eliminated the side-effects). Gamma dose rates were attenuated from an average 20 mrem/hr to less than 5 mrem/hr, which means an average factor 4 decay in 15 years.

The 1999 data show a general decay. The gamma profile was reduced by an average factor 15: from 140 to 8 mrem/hr near the bottom, from 120 to 14 mrem/hr near the top of the cask, and from 30 to 2 mrem/hr on the remainder of the side of the cask.

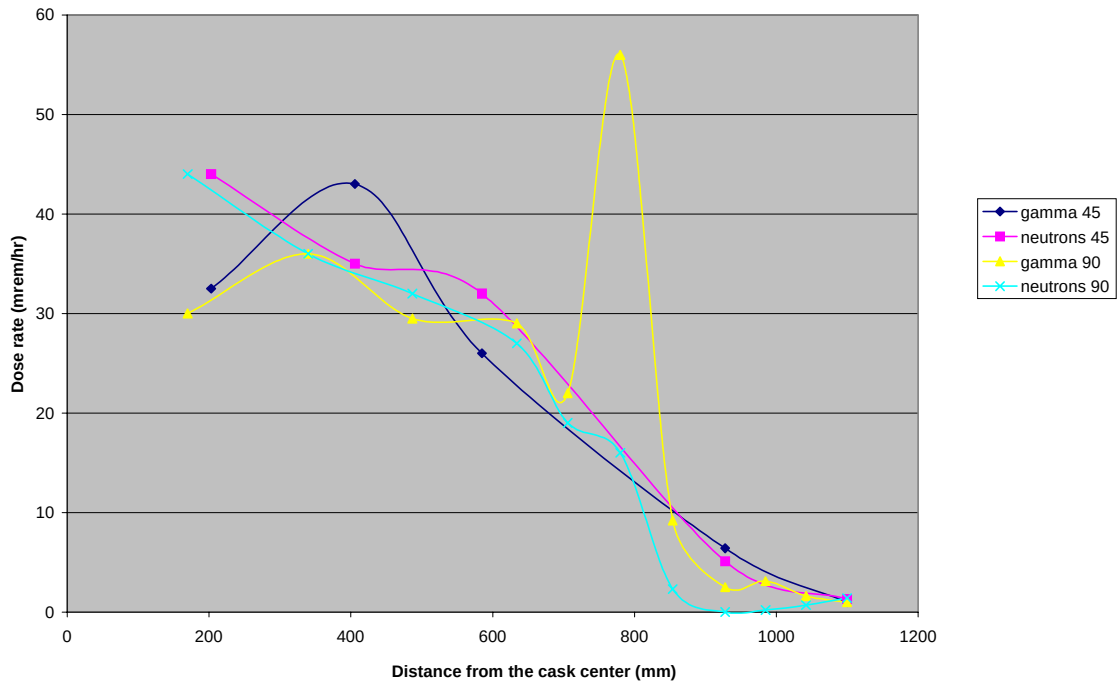
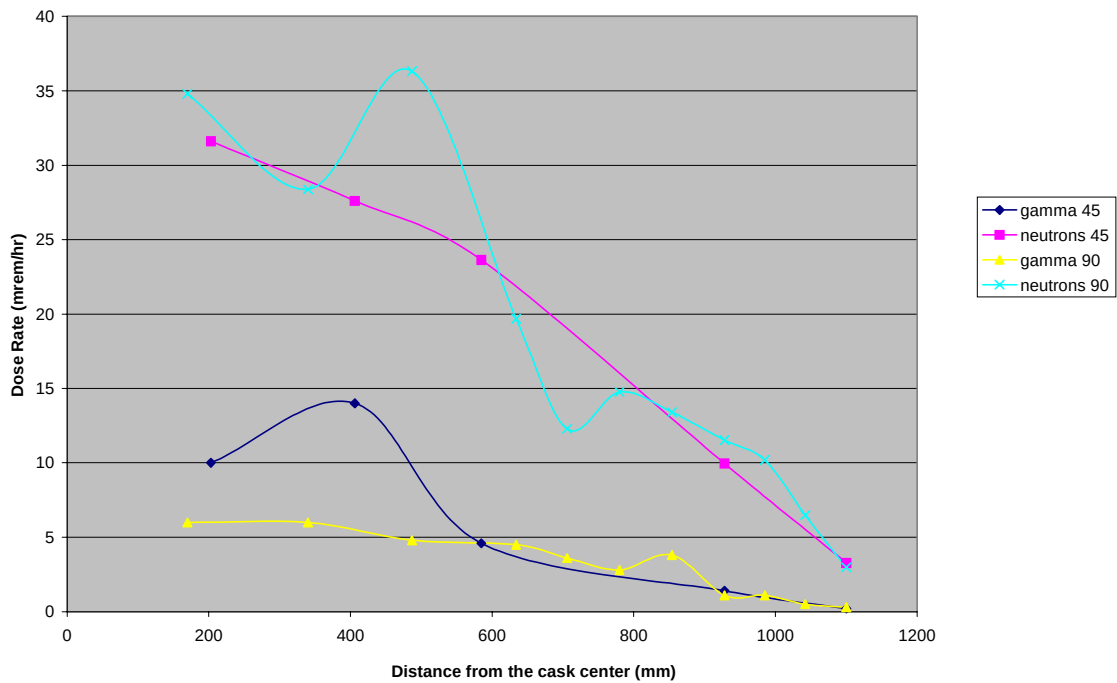
Figure 3-5 and 3-6 show the dose rates measured on the top of the cask in 1985 and in 1999, depending on the distance to the center of the cask.
