# Non-intrusive Predictive Distribution Maintenance

Radio Frequency Interference/Ultrasonic Surveys of  
Distribution Lines

**1000194**

Final Report, July 2000

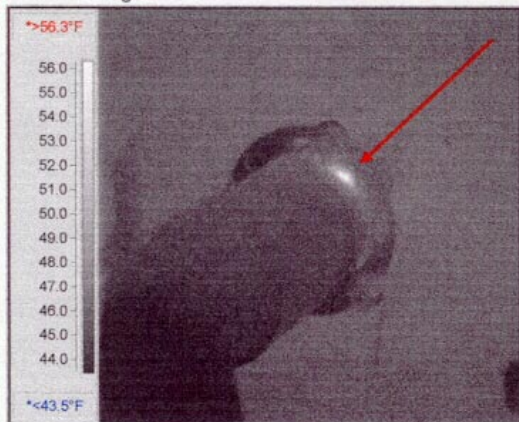
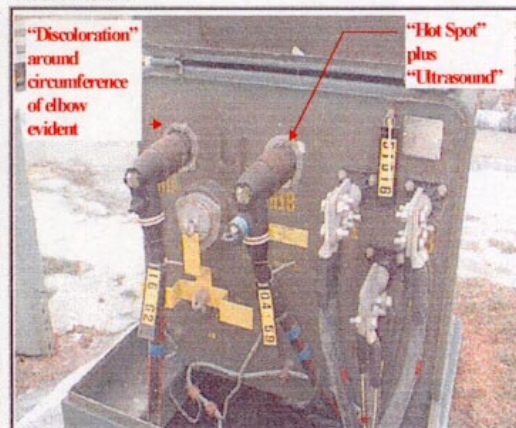
Remarks: No "Bleed-off" wires for both primary bushings. Also, discoloration evident around H1A bushing, although No I.R. or U.S. problems detected. U.S. Instrument Sensitivity= 6.4 @ 50% Measured Reading. Humidity= 26%. Ambient= 2 deg. Celsius. D. to D.= 2 Met.

Repair: **3 Months**

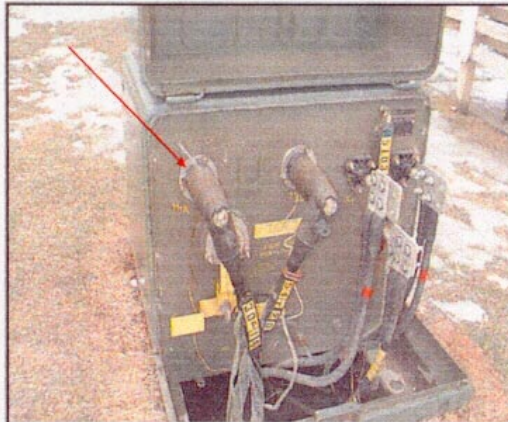
Remarks: Ultrasound Instrument Sensitivity= 6.9 @ 50% Measured Reading. Humidity= 26 %. Ambient= 2 deg. Celsius. Distance to Device= 1 Meter.

Repair: **Monitor Regularly**
