Heat Recovery Steam Generator (HRSG) Chemical Cleaning Guidelines Case Studies

Heat Recovery Steam Generator (HRSG) Chemical Cleaning Case Studies

1012756

Final Report, November 2006

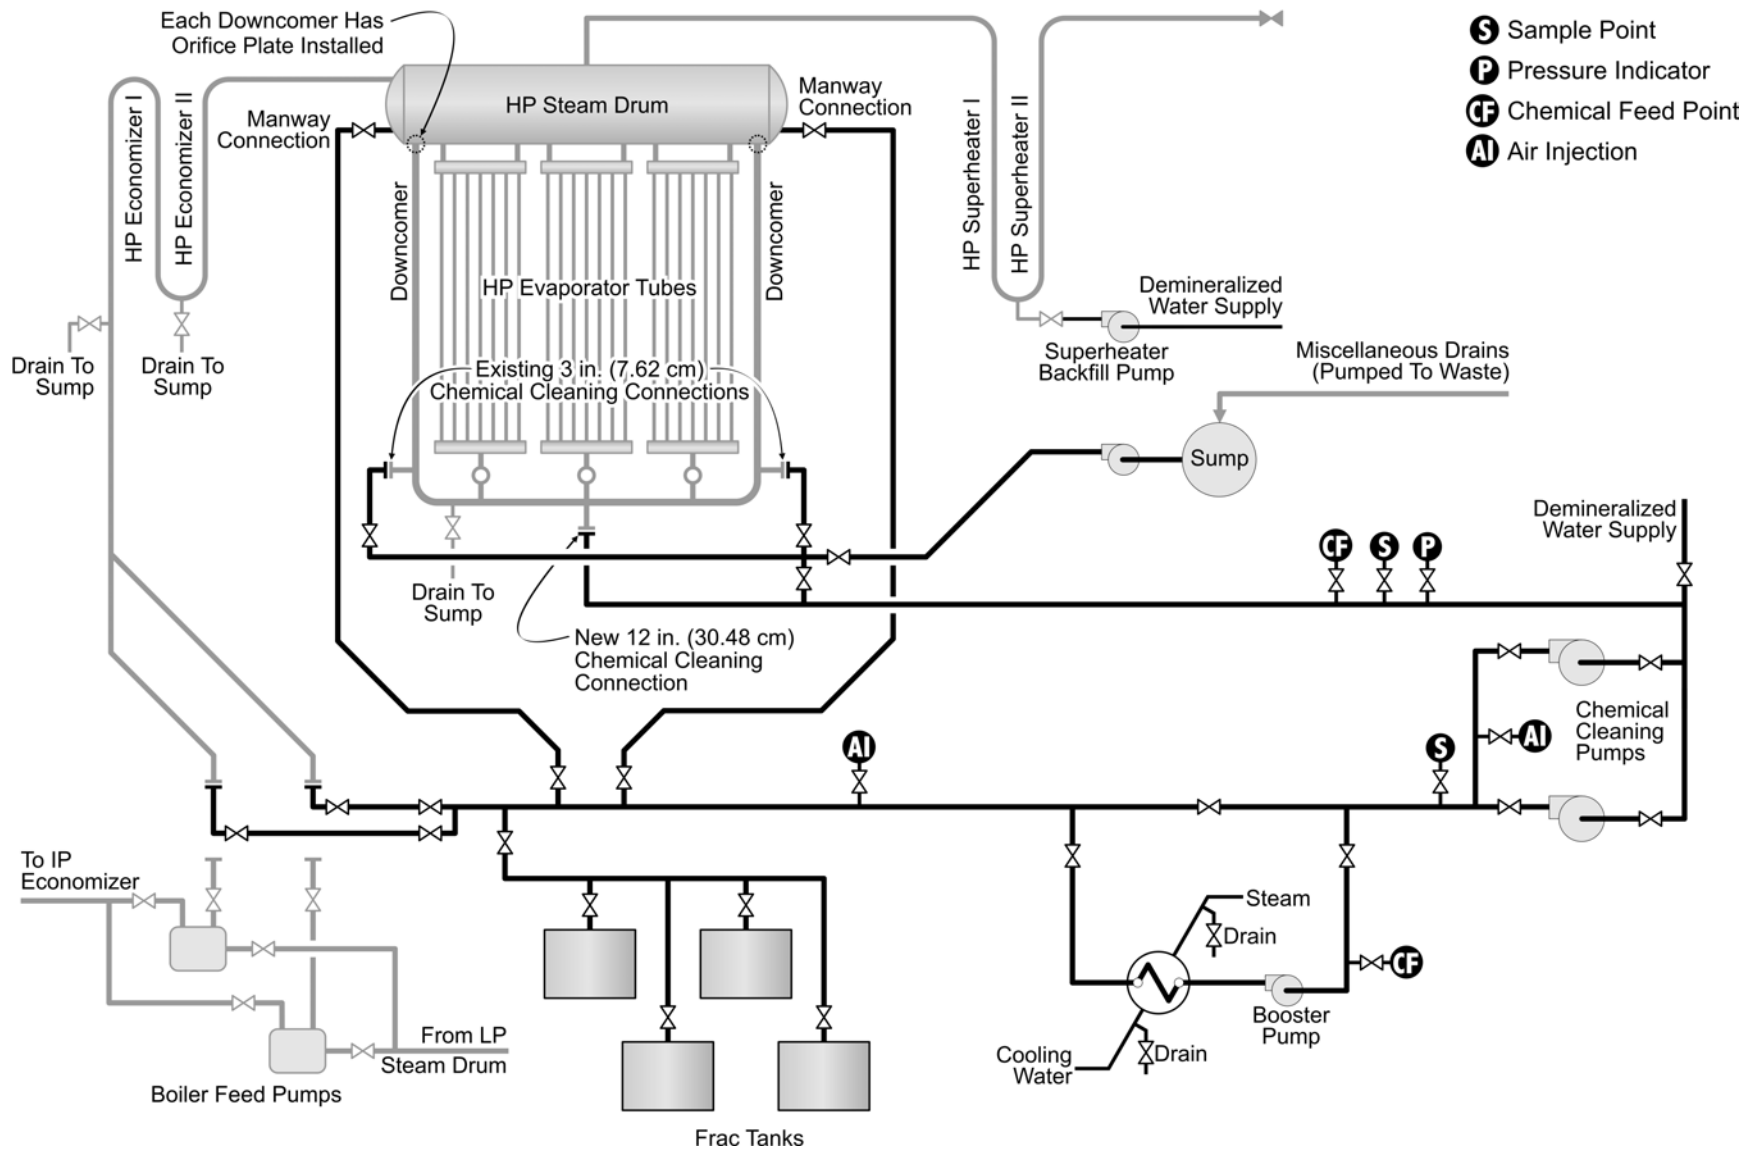
Figure 2-1
Case Study 1: HP Evaporator-Economizer Cleaning

Figure 2-1 presents the cleaning system design used for the HP evaporator section. Orifice plates were installed in the two main downcomers to minimize the amount of flow bypassing the evaporator tubes by passing through the downcomer pipes. The two downcomers run down the sides of the HRSG and then under the HRSG where they connect to form a combined horizontal downcomer. This is referred to as the common lower header herein. Three longitudinal headers are fed from the common lower header. Each longitudinal header feeds five harps of tubes provided by separate feeder pipes of varying diameter.

In addition to the two existing (3-inch or ~8 cm diameter) connections, a 12-inch (~30 cm) diameter connection was installed on the common lower header for the three suction connections from the HP evaporator. This new 12-inch (30 cm) diameter connection to the common lower header was fabricated to be a permanent HP flange fitting for ease of use on future chemical cleanings. An 8-inch (20 cm) diameter connection also was installed to the manways at each end of the steam drum. Figure 2-2 shows an example of this type of connection. These drum adapters worked very well. Also, two 4-inch (10 cm) diameter lines were installed on the HP feedwater lines at the existing boiler feed pump outlet flanges.

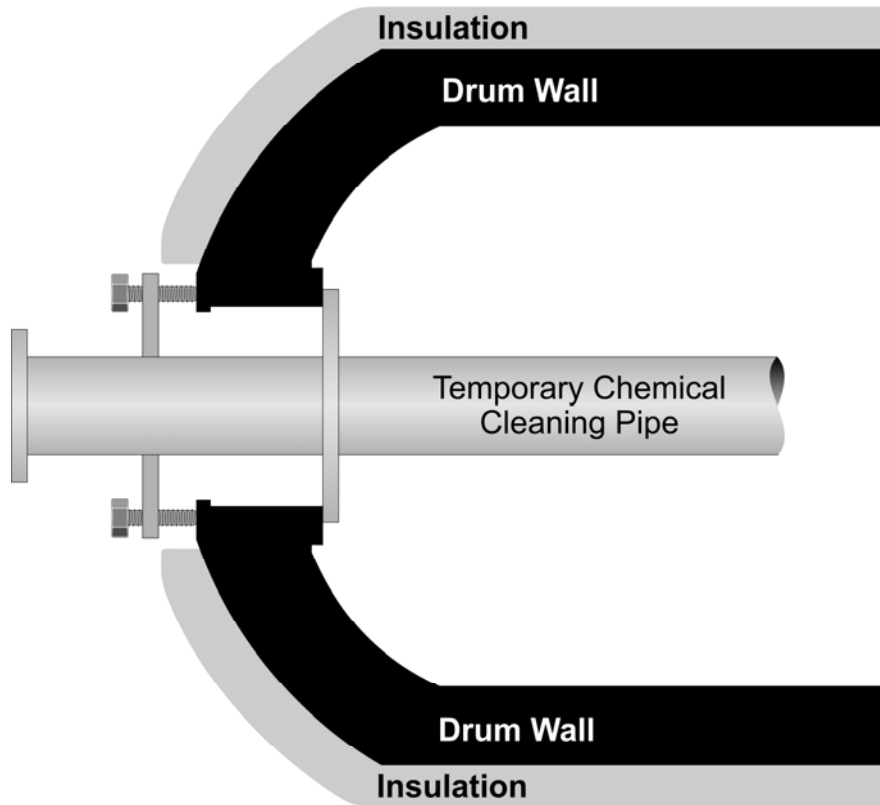
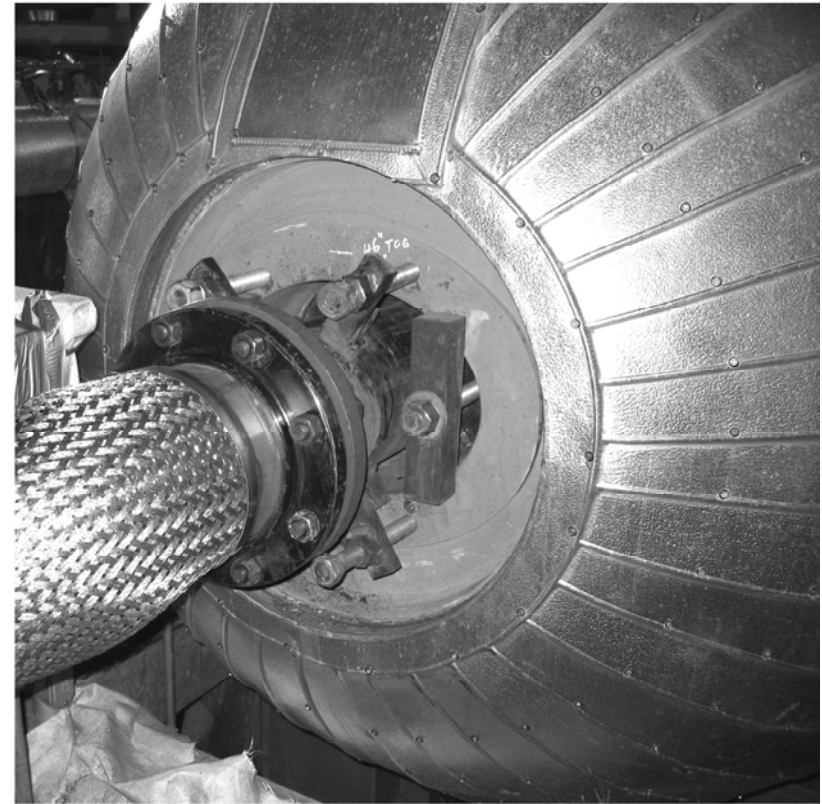
Figure 2-2
Case Study 1: Steam Drum Manway Connection for Temporary Chemical Cleaning Piping

While not shown in Figure 2-1, a temporary sightglass was provided on the steam drum for level control. To avoid aeration, a nitrogen pad was maintained on the steam drum (via the normal nitrogen layup system connection) during the iron oxide removal phase of the cleaning. No buildup of hydrogen pressure was noted in the drum during the cleaning. Also, bleed vents were installed on the economizer upper headers to void noncondensable gases during the evaporator fill and the subsequent cleaning process. As is common on HRSG units, the economizers include downflow sections which can become bound with noncondensable gases if not properly vented.

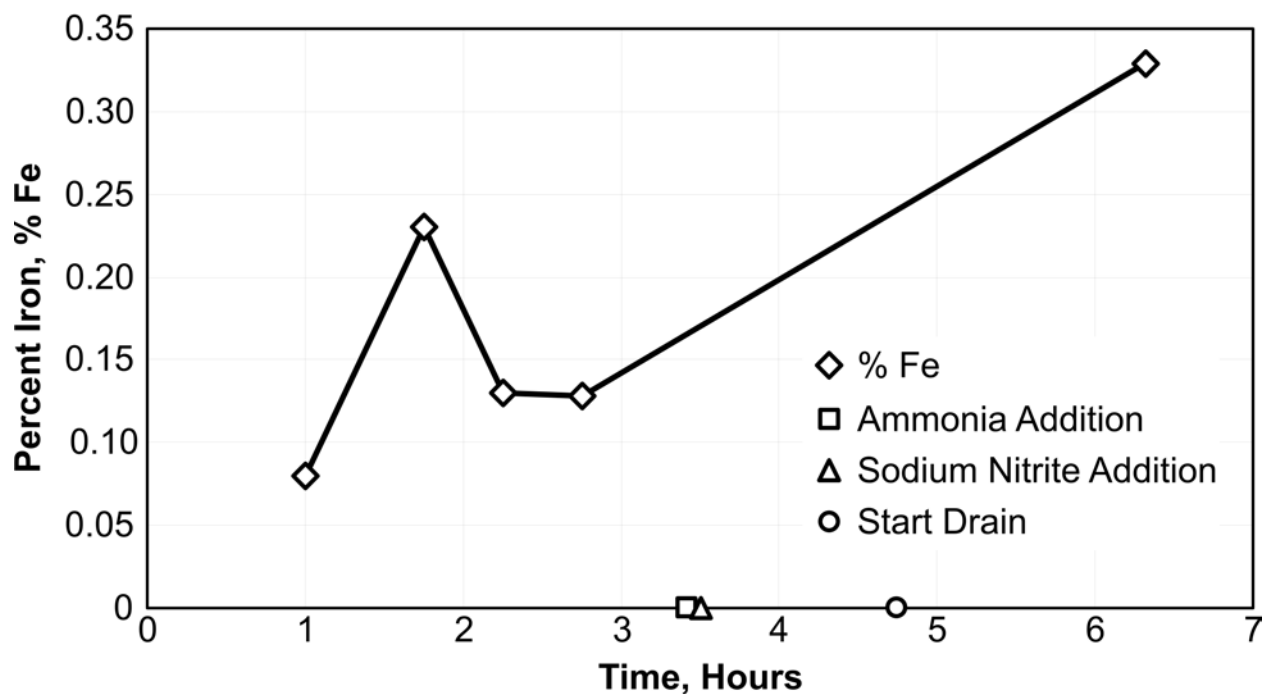
Figure 2-13
Case Study 6: Ammoniated Citric Acid Cleaning Iron Concentration Data

As shown in Figure 2-13, insufficient iron testing was performed to obtain a meaningful concentration plateau. Only two similar iron concentrations, determined after approximately 2.5 hours of total contact time, were used to indicate that stable chemistry conditions been obtained. However, once the two similar readings were obtained, the iron oxide removal stage was considered complete and subsequently terminated. This termination was very likely premature. At least three consecutive similar readings collected with acceptable process conditions are needed to indicate a stable concentration plateau and longer contact times (3-12 hours) usually are required to ensure cleaning completion with ammoniated citric acid.

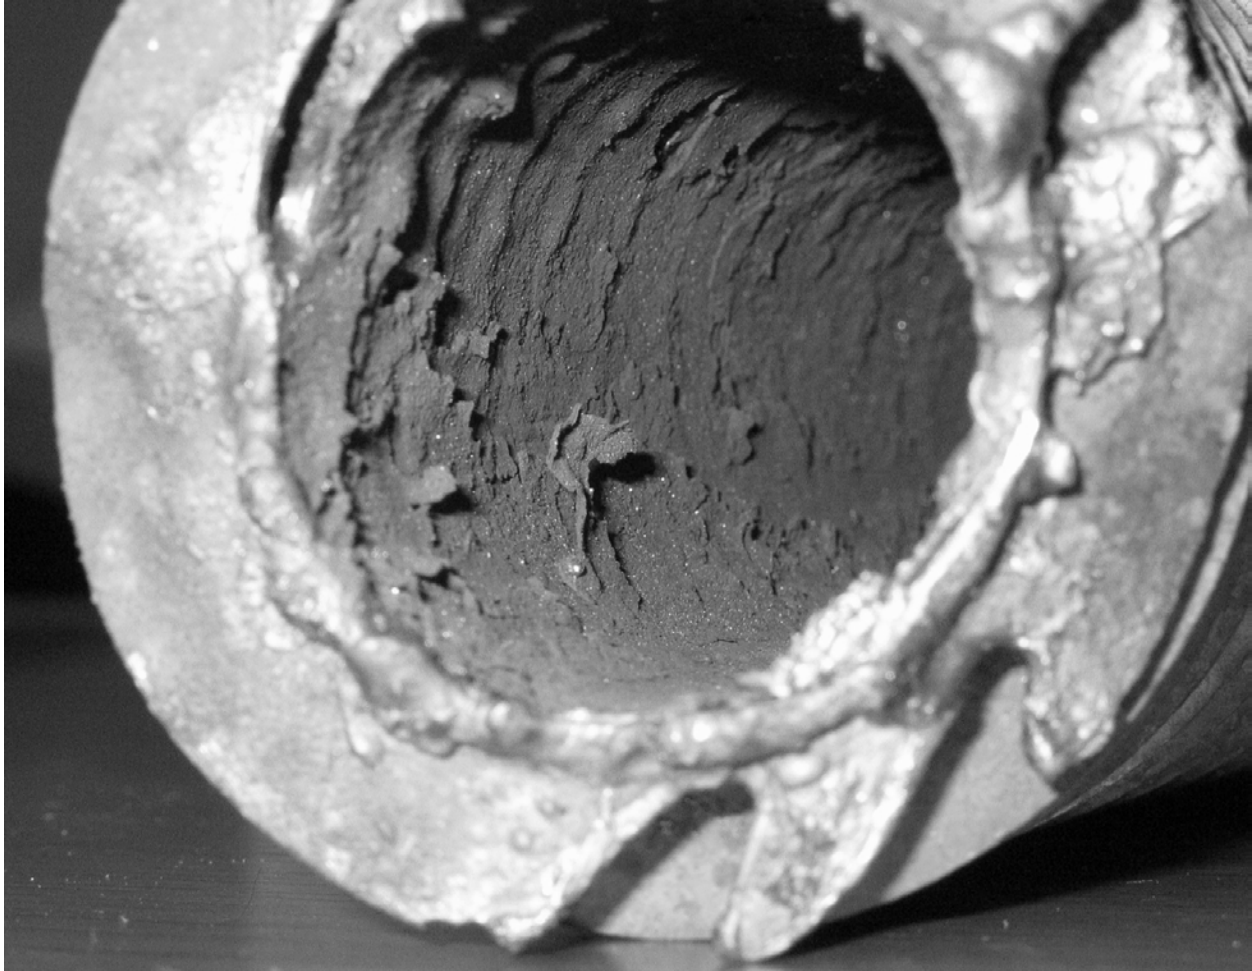
Figure 3-2
Case Study 15, Typical Evaporator Tube Before Hydrojetting

The facility is currently managing tube deposit accumulations and the frequency of evaporator tube failures by hydrojetting the tubes on an annual basis. The hydrojet pressure used is 5,000-10,000 psig (~34-69 MPa) for these cleanings. Figure 3-2 shows a typical evaporator tube before hydrojetting.

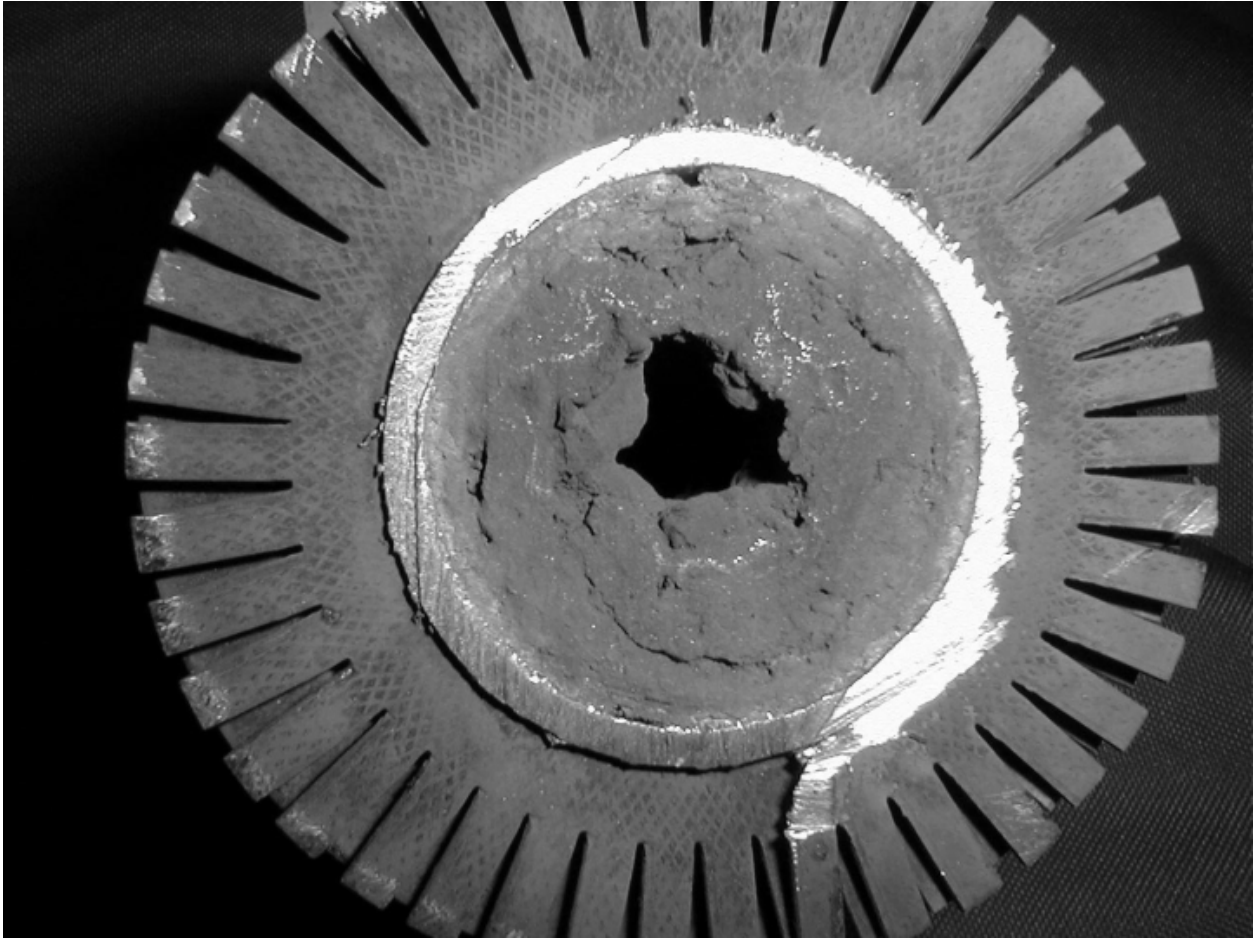
Figure 3-3
Case Study 16: Evaporator Tube before Hydrojetting

Figure 3-3 presents a view of one of the evaporator tubes with excessive waterside deposits. This evaporator tube was removed from the HRSG following an evaporator tube failure. In response to the tube failure, a videoscopic inspection was performed of the evaporator tubes. This required cutting into the upper evaporator headers to run the videoscope probe down the tubes. Based on the videoscopic survey, it was determined that roughly 80% of the evaporator tubes were essentially clean and that heavy deposits were restricted to a very small number of tubes along the outside lanes of the evaporator sections. Because of the high cost of chemical cleaning, it was instead elected to use hydrojetting to remove internal deposits from tubes in the outer lanes of the evaporators. Access for hydrojetting was facilitated by cutting into the headers for the evaporators. It was reported that the thicknesses of waterside deposits in these tubes were significantly reduced by the hydrojetting. The effectiveness of mechanical removal of waterside deposits was determined visually, based on videoscopic inspections made following hydrojetting operations. No further evaporator tube failures have occurred since implementing the program of annual hydrojetting almost 10 years ago. To avoid high dissolved oxygen levels during startups, mechanical vacuum pumps were installed to maintain condenser vacuum during nightly off-load cycles of the HRSG units. This reduced condensate dissolved oxygen levels substantially, after which feed of the reducing agent was eliminated.

In some cases, such extreme deposit thicknesses may require the combination of mechanical and chemical cleaning methods to obtain reasonable cleaning effectiveness. Cleaning effectiveness can be evaluated in trials on tube samples removed from the unit or via on-site videoscopic inspection during hydrojetting operations.
