Heat Recovery Steam Generator (HRSG) Chemical Cleaning Guidelines Case Studies

Heat Recovery Steam Generator (HRSG) Chemical Cleaning Case Studies

1012756

Final Report, November 2006

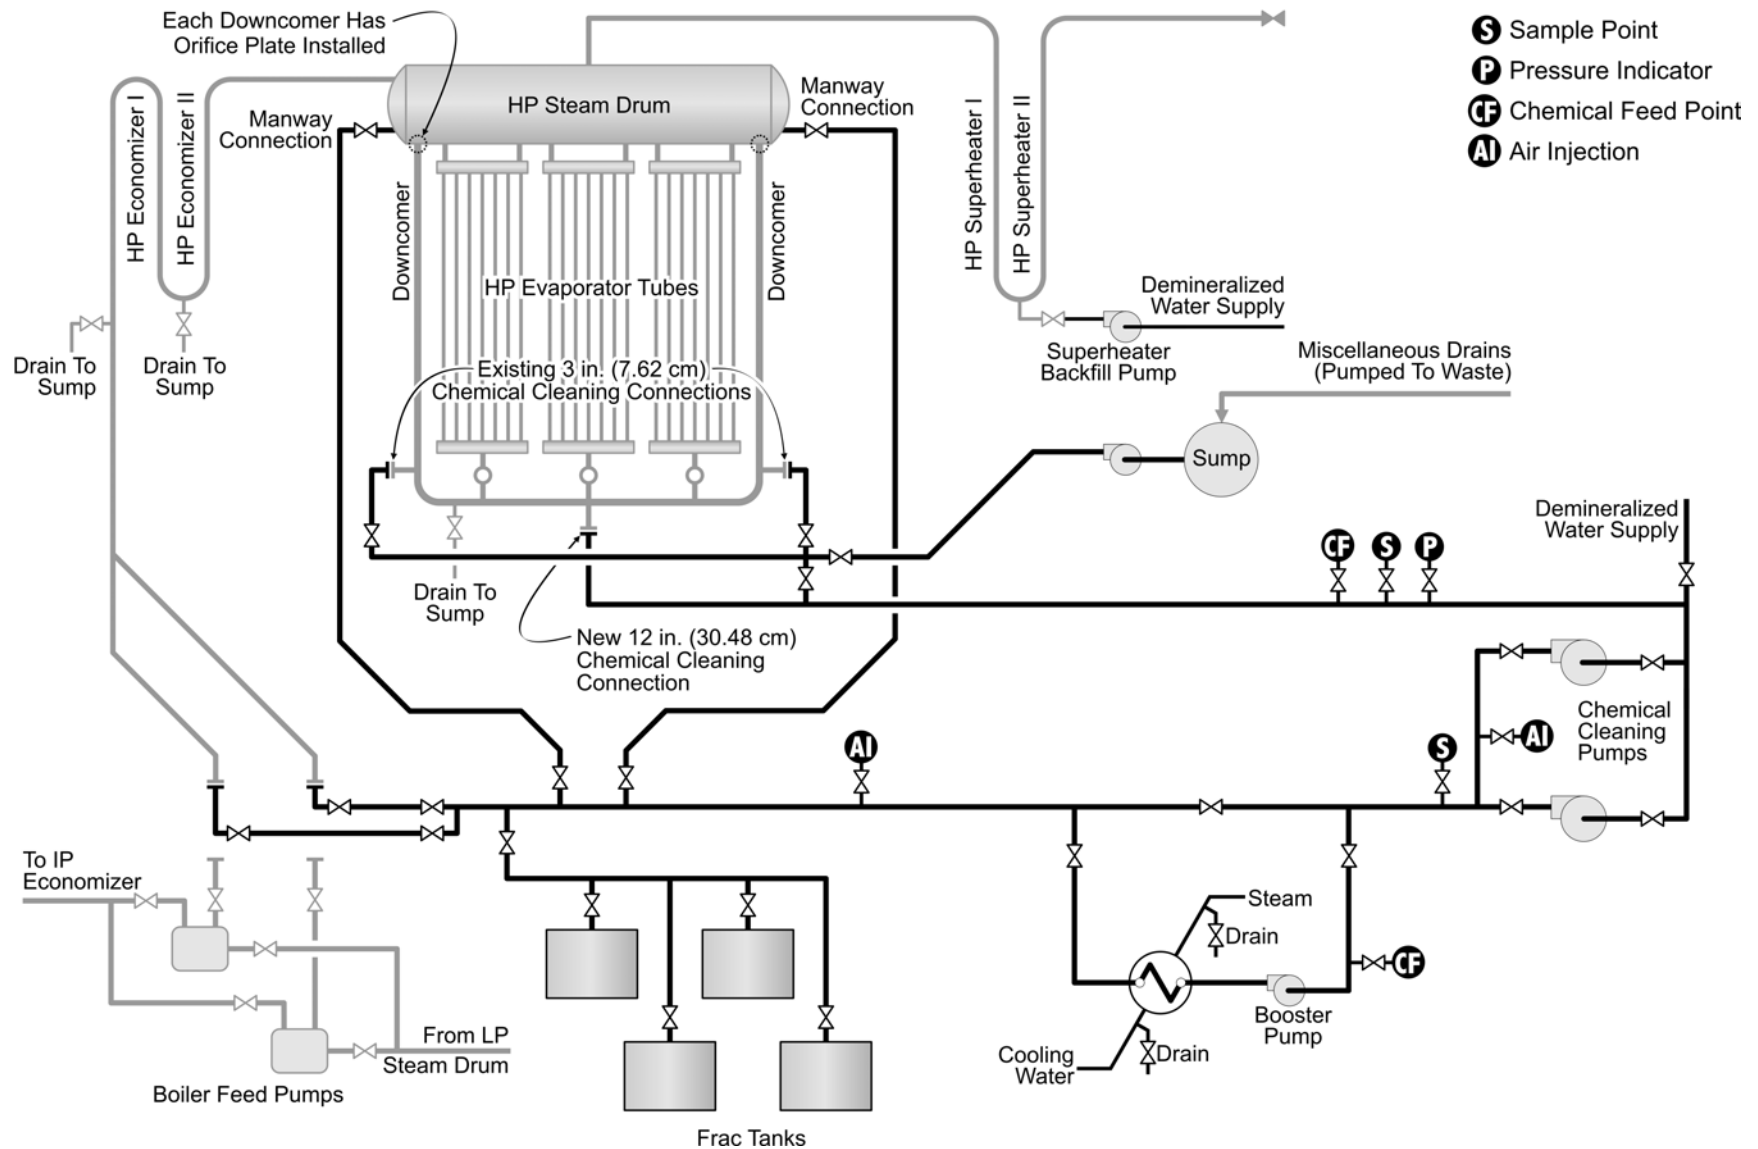
Figure 2-1
Case Study 1: HP Evaporator-Economizer Cleaning

Figure 2-1 presents the cleaning system design used for the HP evaporator section. Orifice plates were installed in the two main downcomers to minimize the amount of flow bypassing the evaporator tubes by passing through the downcomer pipes. The two downcomers run down the sides of the HRSG and then under the HRSG where they connect to form a combined horizontal downcomer. This is referred to as the common lower header herein. Three longitudinal headers are fed from the common lower header. Each longitudinal header feeds five harps of tubes provided by separate feeder pipes of varying diameter.

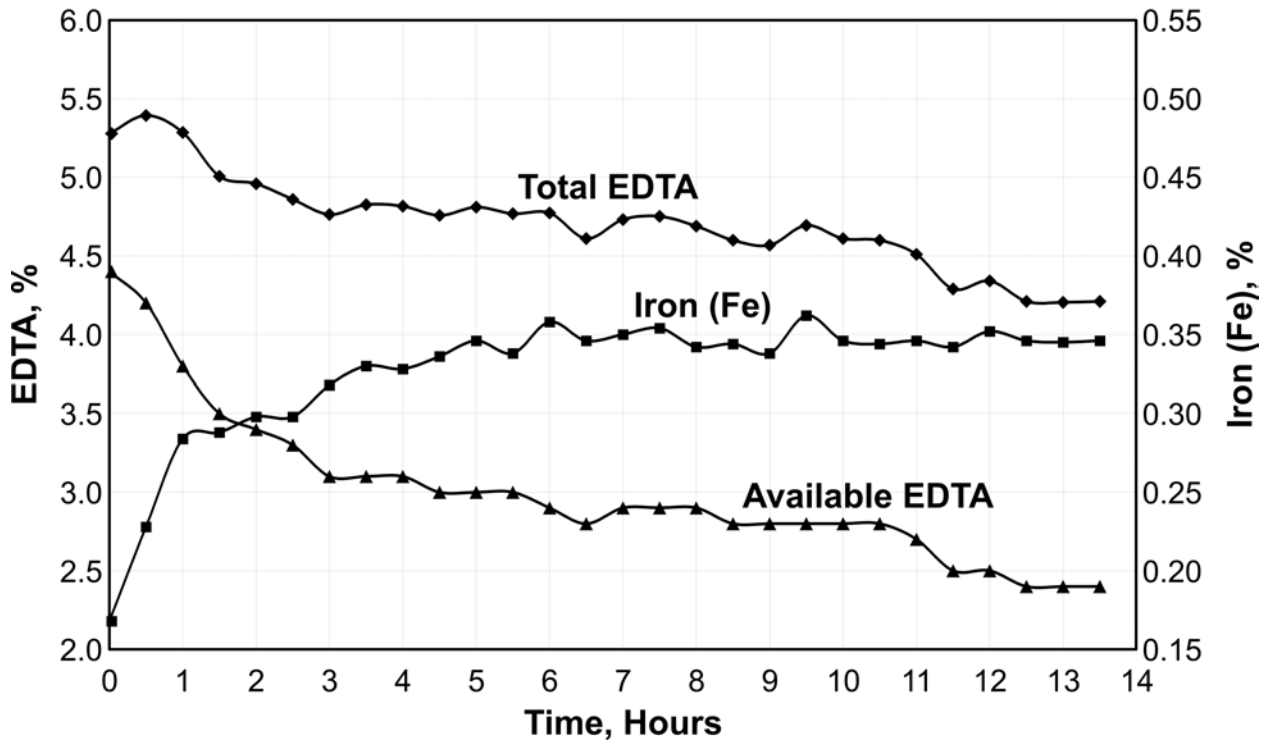
Figure 2-6
Case Study 2: Iron Oxide Removal

As shown in Figure 2-6, the trends for both the percent available EDTA and percent total EDTA indicate that the EDTA was not completely distributed throughout the HP and LP evaporators. It is hypothesized that this trend may have been due to insufficient dispersion of EDTA in the system. Figure 2-7 shows the amount of system volume which would have contained EDTA, assuming the EDTA and iron concentration data were correct. It is possible that portions of the HRSG did not contain an equivalent amount of EDTA until the last one to two hours of the iron oxide removal stage. The other possible problem with the EDTA data could have been the test procedure for available EDTA concentration. After the solvent pH was elevated above 9.1 with ammonia for the passivation stage, the available EDTA concentration value was 1.5%. Using an iron concentration of 0.35% at the completion of the iron stage and 1.5% available EDTA, the total EDTA concentration would be 3.33% - which would correspond to the expected original concentration of EDTA added to the system. The high free and total EDTA concentrations may have been due to an error in EDTA readings during the iron oxide removal stage. It is also possible that the lower EDTA concentration represents more uniform dispersion of the EDTA by the end of the passivation stage. This case study was a demonstration of the potential benefits of calculating and tracking the total EDTA concentration during the cleaning, assessing solvent distribution, and determining the end of the cleaning process.

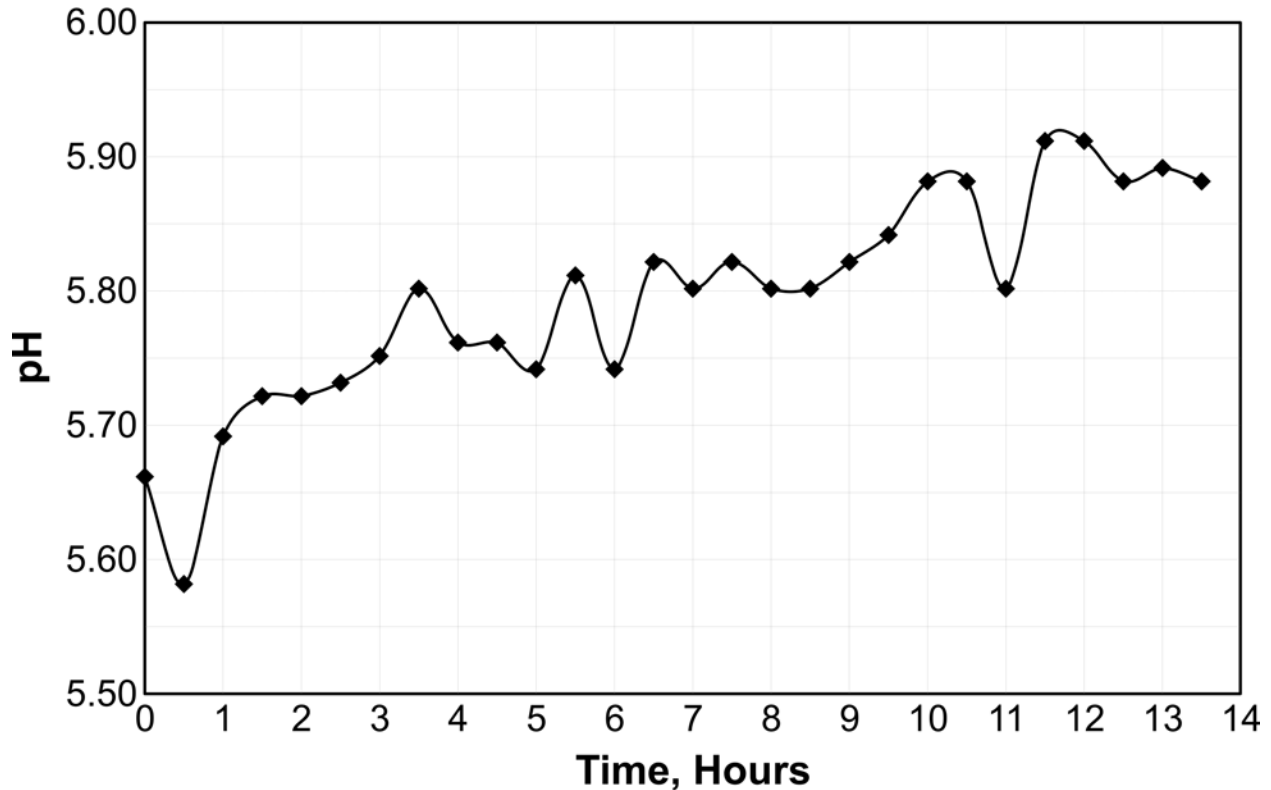
Figure 2-8
Case Study 2: Solvent pH During Iron Oxide Removal

For diammonium EDTA chemical cleanings, it is advised to maintain solvent pH nearer to the acidic level (5.0 to 5.5) for optimal scale and deposit removal. Figure 2-8 shows solvent pH data during the iron oxide removal stage of the cleaning. Solvent pH gradually increased from 5.6 to 5.9 during the iron oxide removal stage. To maintain the same rate of iron oxide removal, formic acid should have been injected into the cleaning solvent to reduce the solvent pH back to a range of 5.5 to 5.6. Alternatively, longer contact times may have been required to ensure that chemistry had stabilized and the cleaning stage was complete. This case study is considered to be a clear demonstration of the need to ensure that a supply of formic acid is on hand to reduce the pH if required.

- **Calculate and Track Total EDTA.** Tracking the total EDTA (based on free EDTA and metals dissolved) is recommended for all EDTA cleanings to evaluate when the solvent is properly distributed and consumption has ceased (see Figures 2-6 and 2-7).
- **Diammonium EDTA pH Control.** The rate of iron oxide removal decreases as the pH rises. With this solvent it is desirable to maintain pH values of 5.0-5.5 for optimal iron oxide removal.

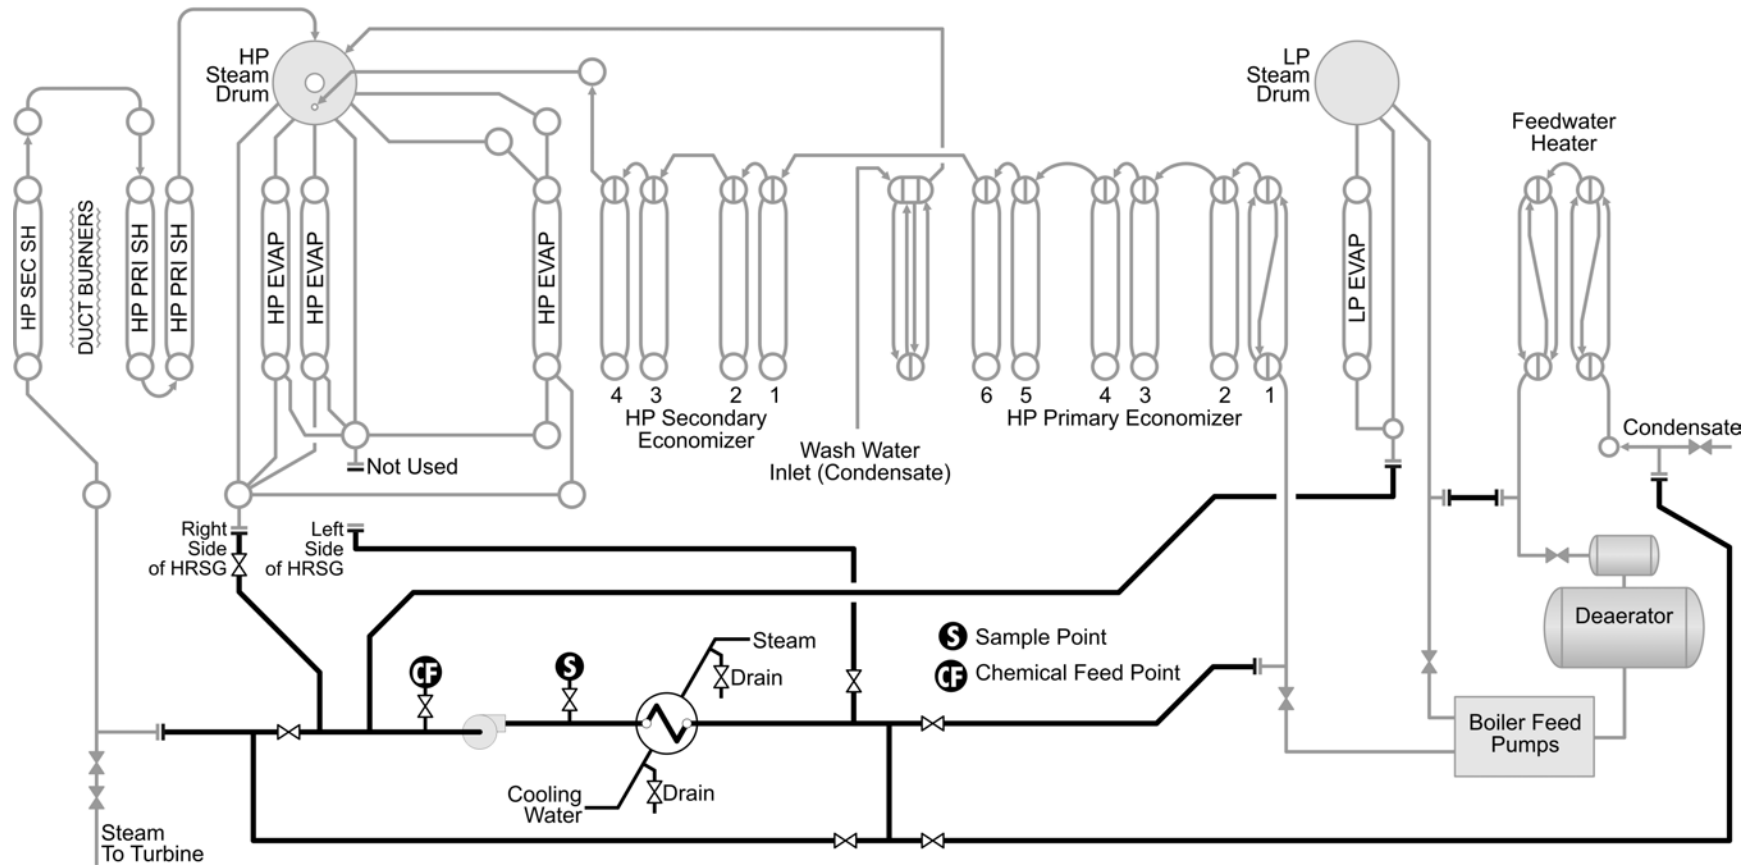
Figure 2-9
Case Study 3: Simplified Drawing of HRSG Cleaning System

While not involved in the planning process, a consultant was contacted by one of the parties involved to view the chemical cleaning. The cleaning solution was a proprietary blend of citric acid, phosphoric acid and inhibitor. After dilution to the concentration recommended in the product literature, the pH should have been 0.6-1.0. The material safety data sheet (MSDS) indicated that the applied solvent contained 0.14-0.19% citric acid, 0.05-0.09% phosphoric acid, and 0.01-0.02% inhibitor. This blend of solvent provided minimal iron removal capability. No iron concentration testing was performed (the cleaning contractor tested only for pH and acid content). The temperature desired and maintained during the cleaning was not noted. However, the solvent was so dilute that the cleaning could not have been effective.

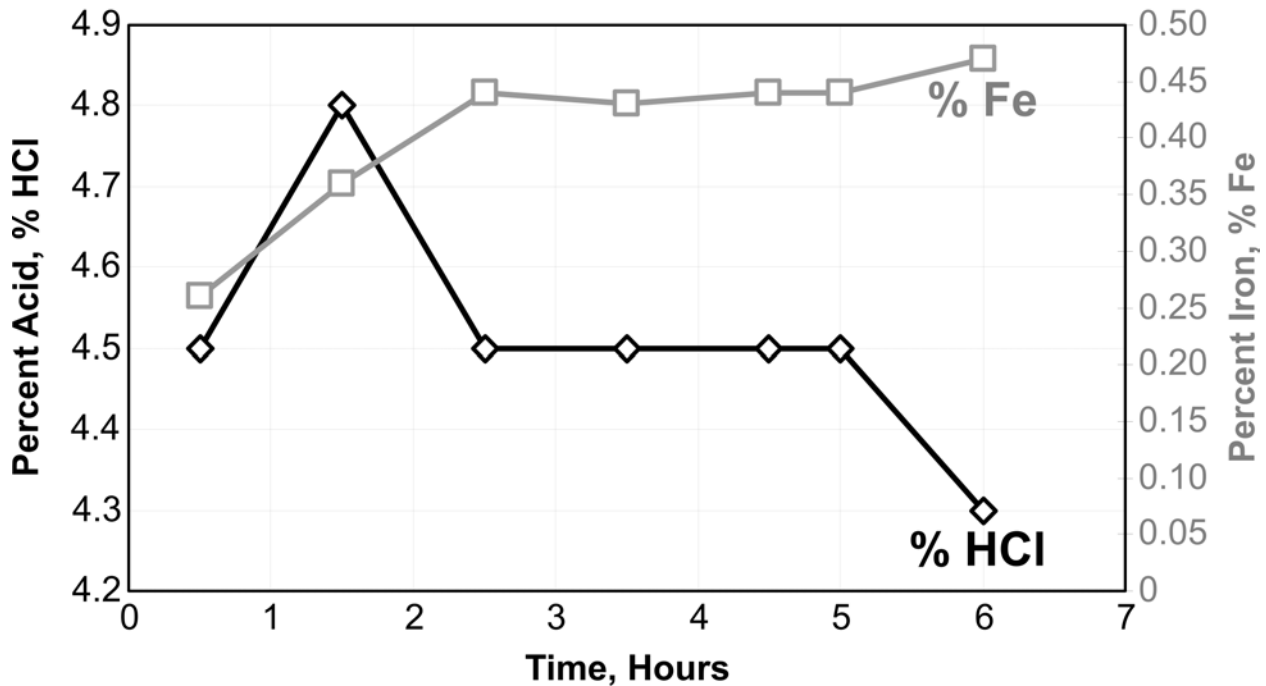
Figure 2-12
Case Study 6, Hydrochloric Acid Stage Chemistry Data

exposed to solvent for the full contact period. A blend fill with inhibited hydrochloric acid was included in the initial specification. In the absence of any known errors in collection of the composite drain sample, it seems likely that solvent addition for this cleaning was not performed in the intended manner and that subsequent circulation did not result in thorough mixing and distribution of the solvent throughout the system.

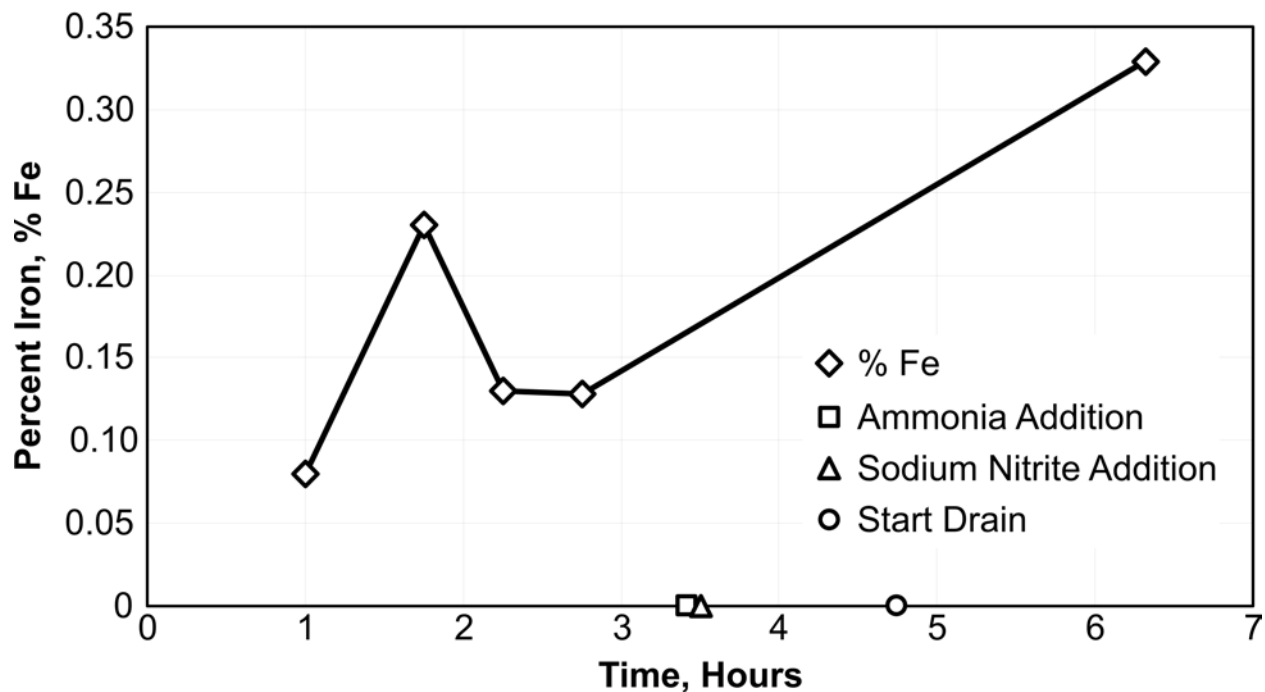
Figure 2-13
Case Study 6: Ammoniated Citric Acid Cleaning Iron Concentration Data

As shown in Figure 2-13, insufficient iron testing was performed to obtain a meaningful concentration plateau. Only two similar iron concentrations, determined after approximately 2.5 hours of total contact time, were used to indicate that stable chemistry conditions been obtained. However, once the two similar readings were obtained, the iron oxide removal stage was considered complete and subsequently terminated. This termination was very likely premature. At least three consecutive similar readings collected with acceptable process conditions are needed to indicate a stable concentration plateau and longer contact times (3-12 hours) usually are required to ensure cleaning completion with ammoniated citric acid.

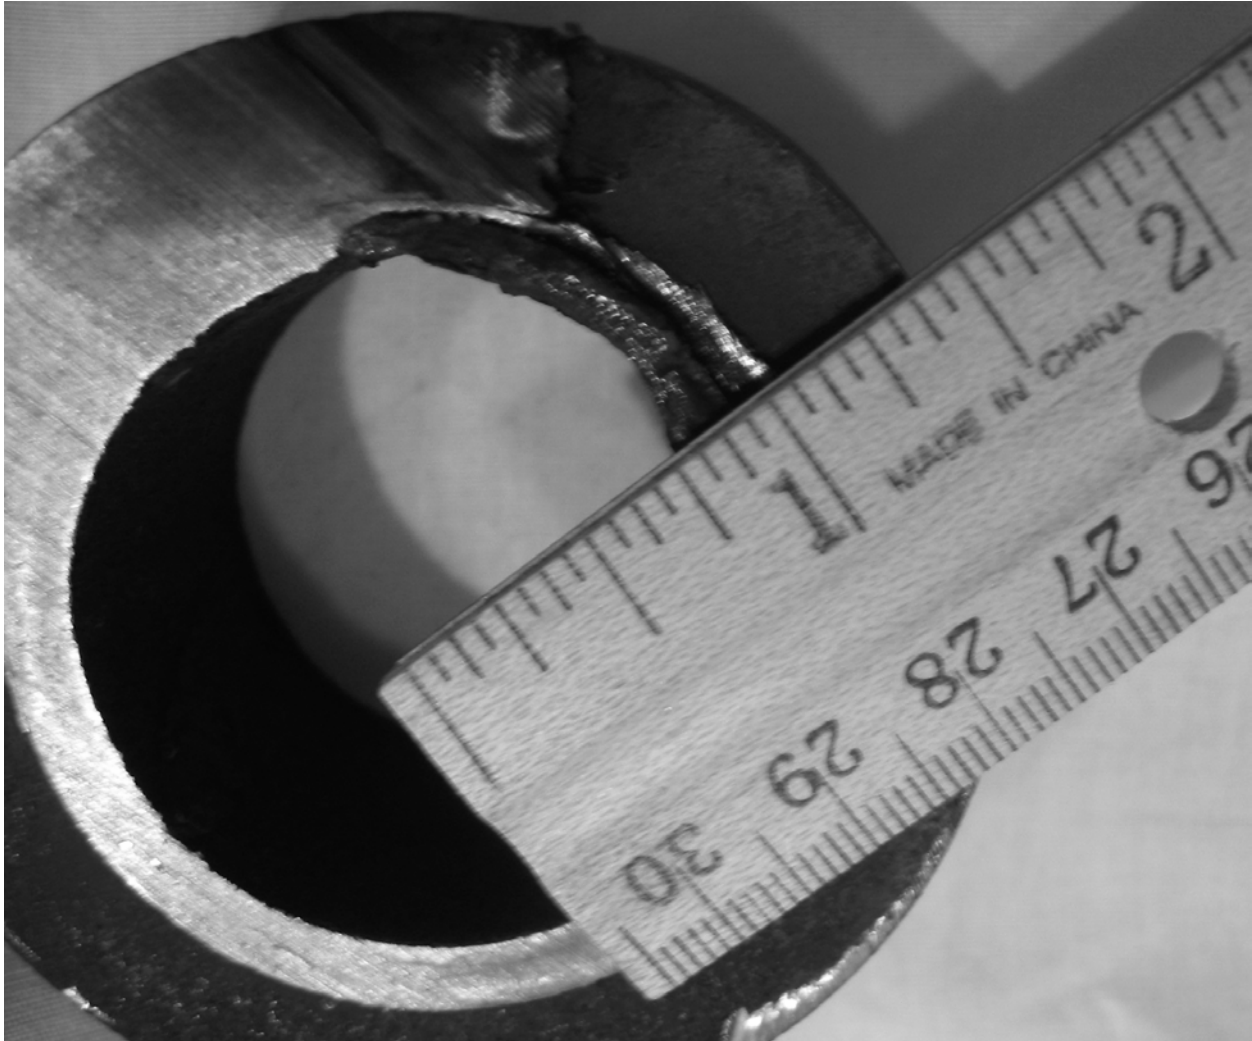
Figure 3-1
Case Study 13 Tube Sample

The deposit was about 0.25 inch (~0.63 cm) thick, and the deposit weight was determined to be 822.6 g/ft² (~885 mg/cm²) by a mechanical method of deposit removal (slightly different than Method A of ASTM D-3483). Deposit weight removal methods are discussed in Reference 2. ⁽²⁾

The scale consisted primarily of the base metal oxide (~99% iron oxide and ~1% manganese oxide). A full investigation into the mechanisms and root causes of the corrosion and deposit accumulations was not performed.

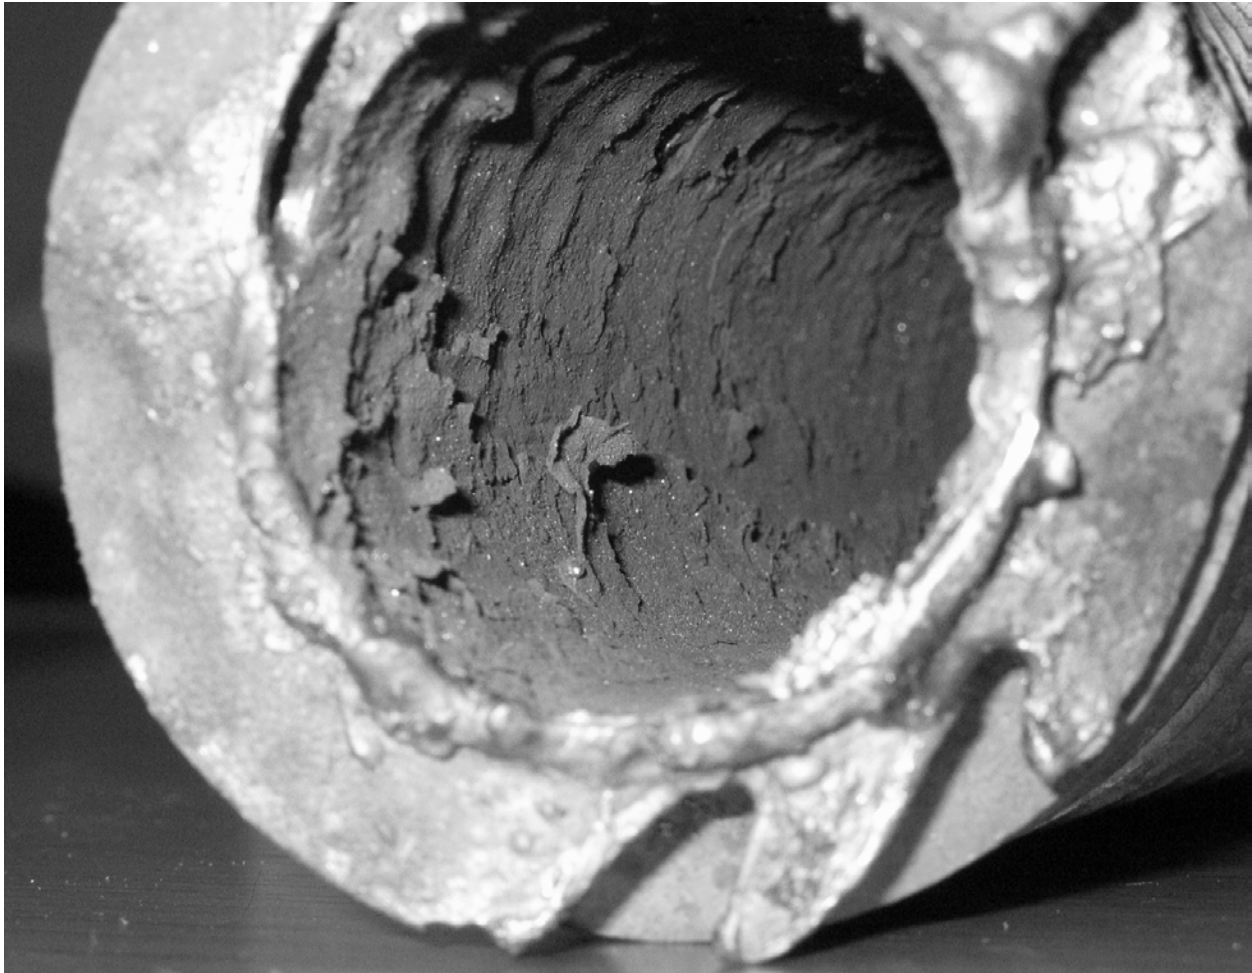
Figure 3-2
Case Study 15, Typical Evaporator Tube Before Hydrojetting

The facility is currently managing tube deposit accumulations and the frequency of evaporator tube failures by hydrojetting the tubes on an annual basis. The hydrojet pressure used is 5,000-10,000 psig (~34-69 MPa) for these cleanings. Figure 3-2 shows a typical evaporator tube before hydrojetting.

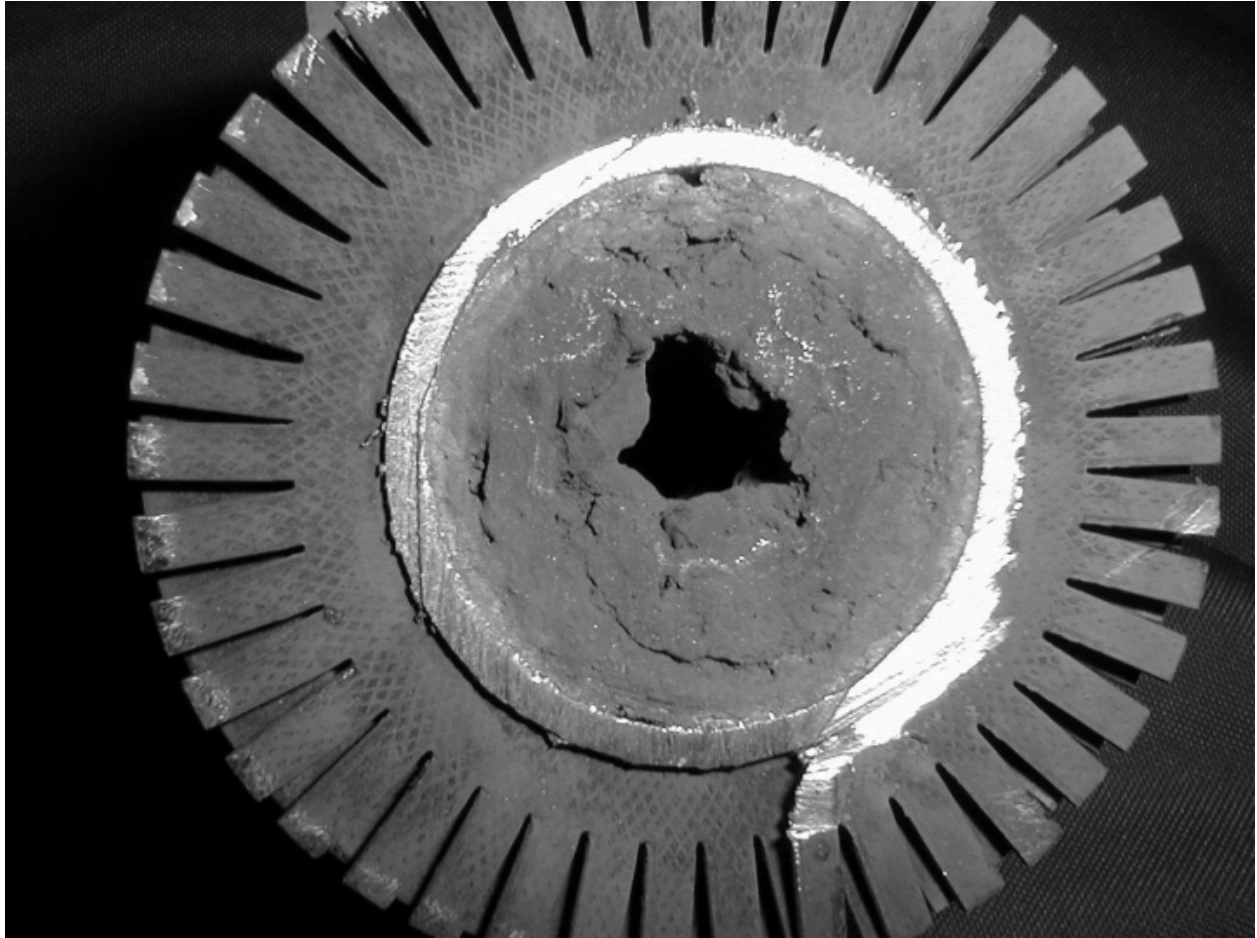
Figure 3-3
Case Study 16: Evaporator Tube before Hydrojetting

Figure 3-3 presents a view of one of the evaporator tubes with excessive waterside deposits. This evaporator tube was removed from the HRSG following an evaporator tube failure. In response to the tube failure, a videoscopic inspection was performed of the evaporator tubes. This required cutting into the upper evaporator headers to run the videoscope probe down the tubes. Based on the videoscopic survey, it was determined that roughly 80% of the evaporator tubes were essentially clean and that heavy deposits were restricted to a very small number of tubes along the outside lanes of the evaporator sections. Because of the high cost of chemical cleaning, it was instead elected to use hydrojetting to remove internal deposits from tubes in the outer lanes of the evaporators. Access for hydrojetting was facilitated by cutting into the headers for the evaporators. It was reported that the thicknesses of waterside deposits in these tubes were significantly reduced by the hydrojetting. The effectiveness of mechanical removal of waterside deposits was determined visually, based on videoscopic inspections made following hydrojetting operations. No further evaporator tube failures have occurred since implementing the program of annual hydrojetting almost 10 years ago. To avoid high dissolved oxygen levels during startups, mechanical vacuum pumps were installed to maintain condenser vacuum during nightly off-load cycles of the HRSG units. This reduced condensate dissolved oxygen levels substantially, after which feed of the reducing agent was eliminated.

In some cases, such extreme deposit thicknesses may require the combination of mechanical and chemical cleaning methods to obtain reasonable cleaning effectiveness. Cleaning effectiveness can be evaluated in trials on tube samples removed from the unit or via on-site videoscopic inspection during hydrojetting operations.
