# Examination of Heat Recovery Steam Generator Plants

*Case Studies of Remote Visual Inspection Techniques*

1014197

Technical Update, March 2008

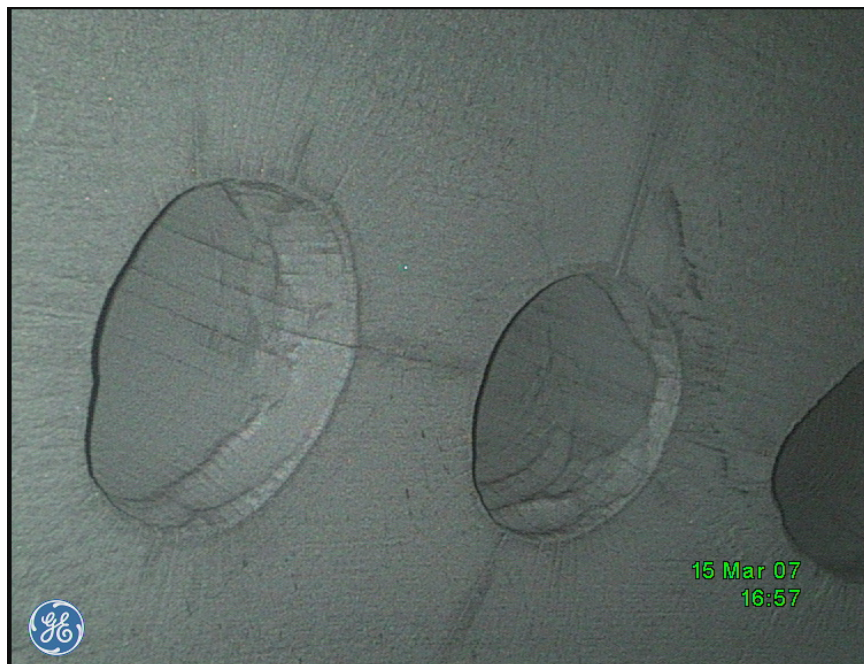
**Figure 3-2**  
**Cracks on Surface of Tubes and Header Ligaments**  
(Ligament cracks initiate on tube bore holes and are parallel with the tube axis.)

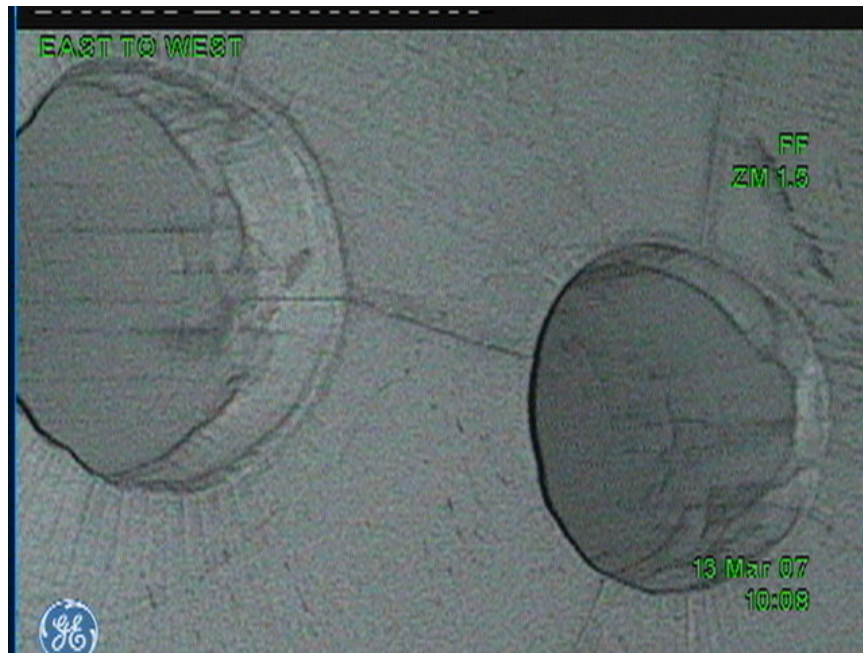
**Figure 3-3**  
**More Direct View of the Image from Figure 3-2 Showing the Indications in More Detail**

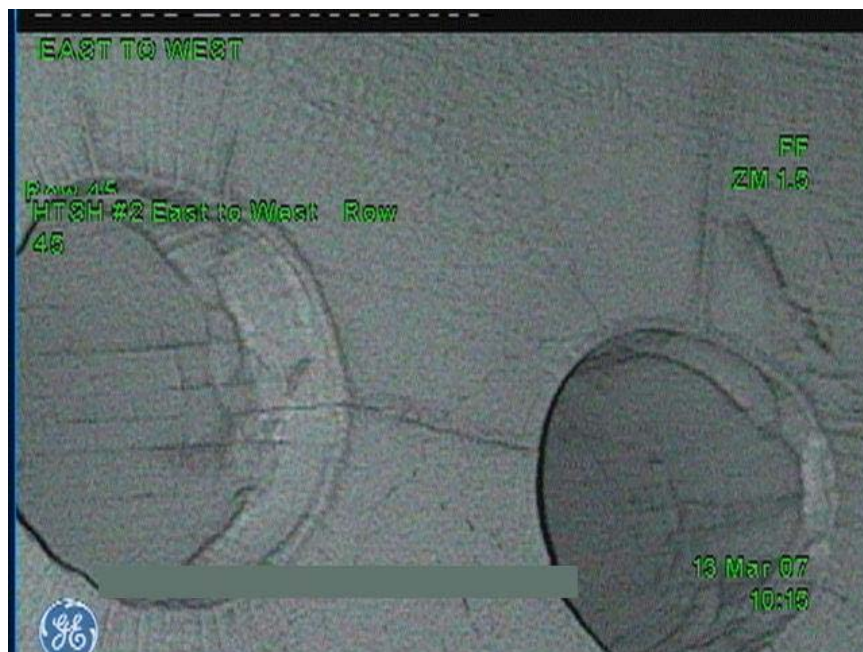
**Figure 3-4**  
**Close-Up of the Image from Figure 3-3**

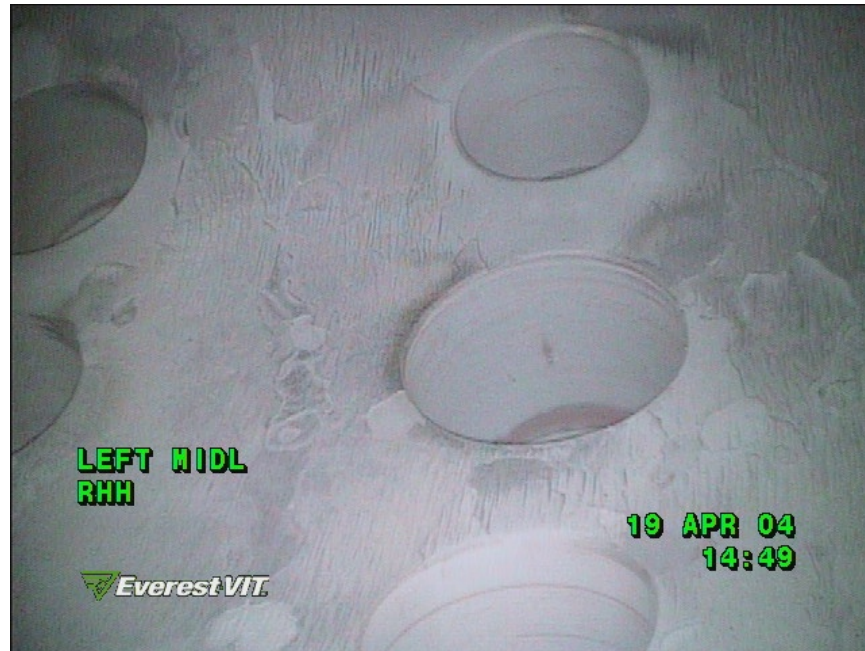
**Figure 3-5**  
Oxide Layer on the Header Wall Is Indicative of High-Temperature Service

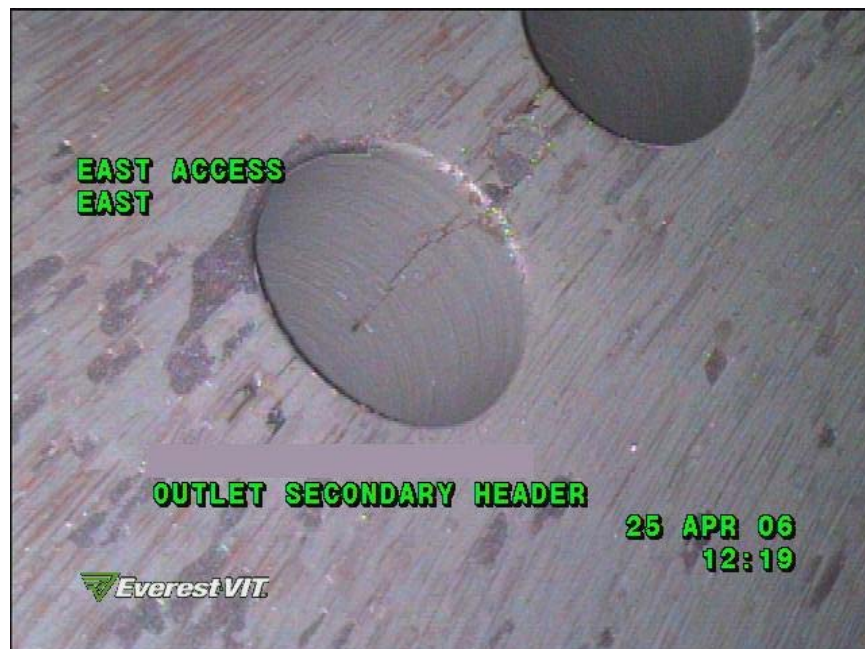
**Figure 3-6**  
Oxide Layer on the Header Wall, with Some Isolated Spalling, Is Indicative of High-Temperature Service

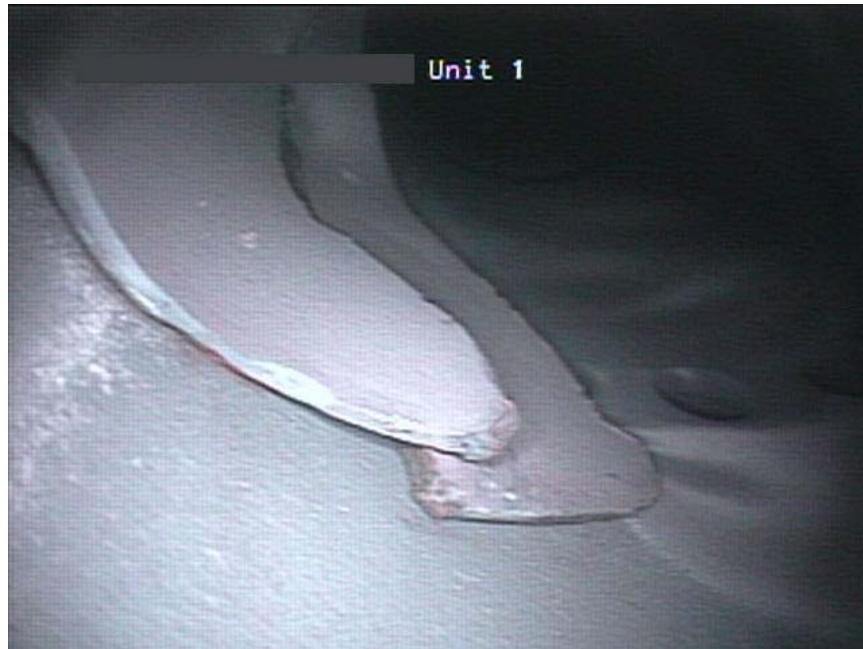
**Figure 3-8**  
Debris in a Header May Lead to Localized Flow Disruption in the Tube and Subsequent Overheating

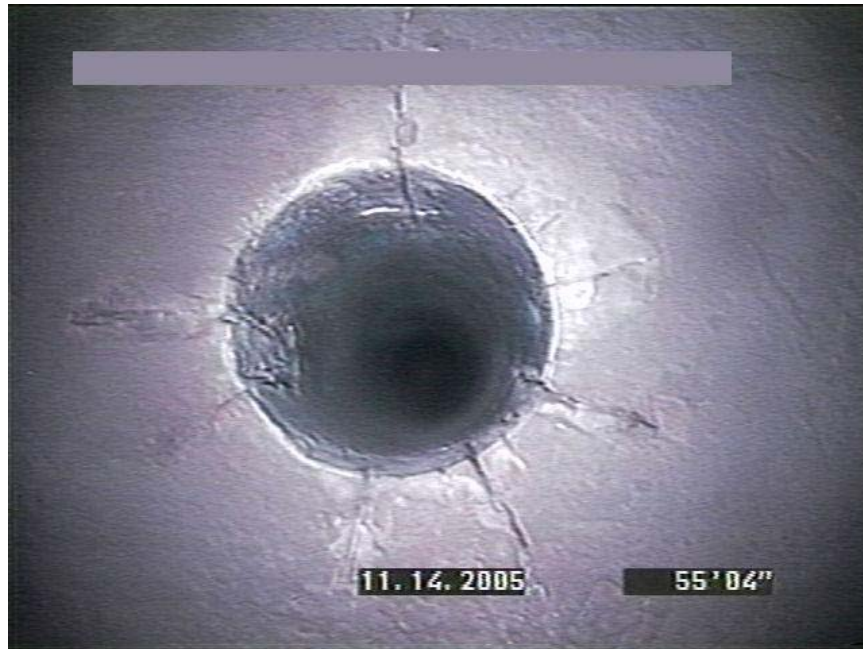
**Figure 3-10**  
**Starburst Pattern Can Be Seen with Increased Definition**

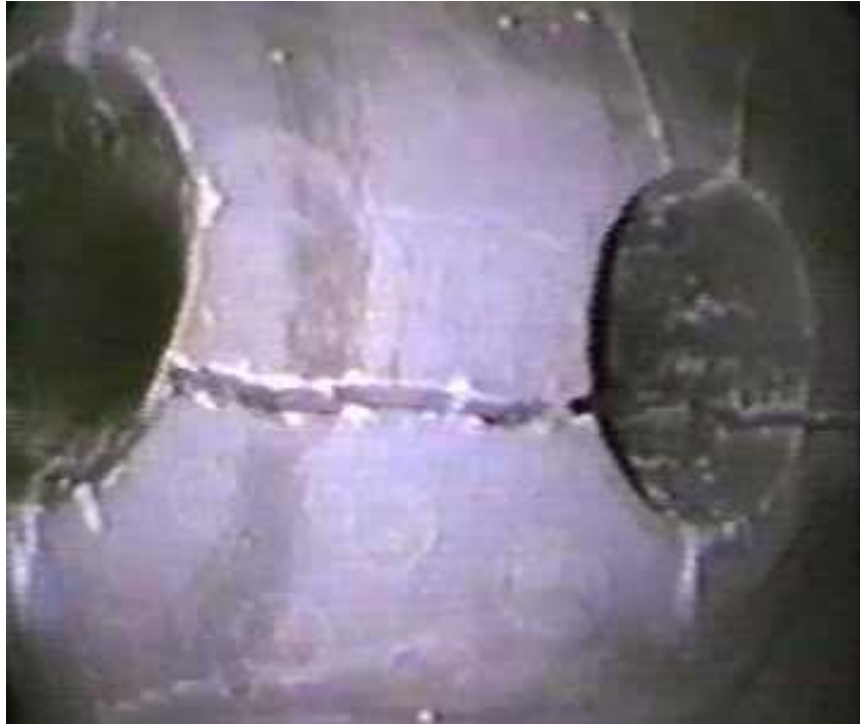
**Figure 3-11**  
**Circumferential Crack Running Through the Tube Penetration in the Header**  
**(The relative width of the crack can be used to prioritize crack severity.)**

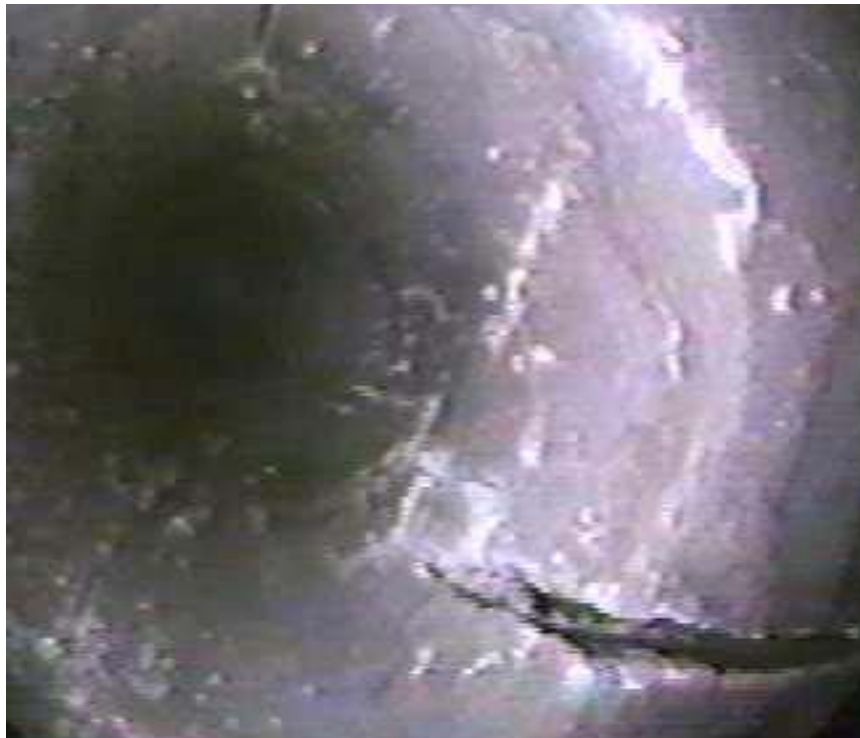
**Figure 3-12**  
**Crack in the Tube Wall as Documented with RVI**

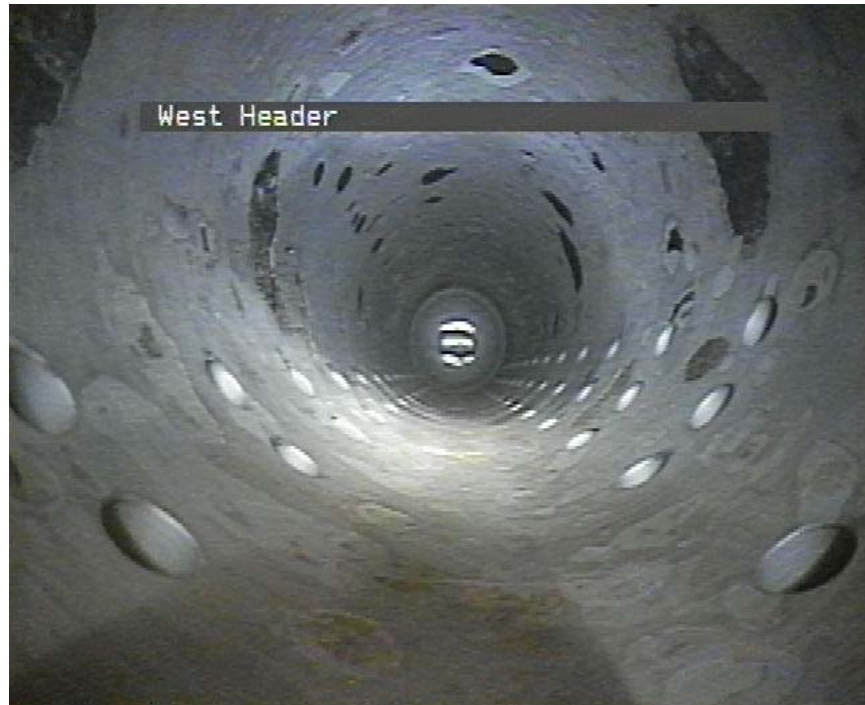
**Figure 3-13**  
**Overview of Header Penetrations with Some Spalling of High-Temperature Oxide**

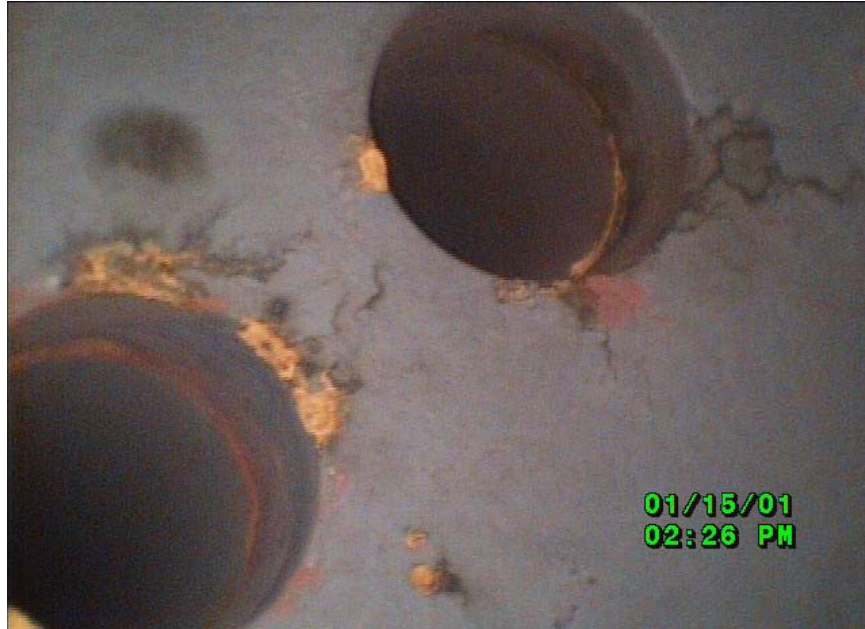
**Figure 3-15**  
**Lower Temperature Rust on Potential Cracks Can Be Identified by a Characteristic Reddish Color Using RVI**

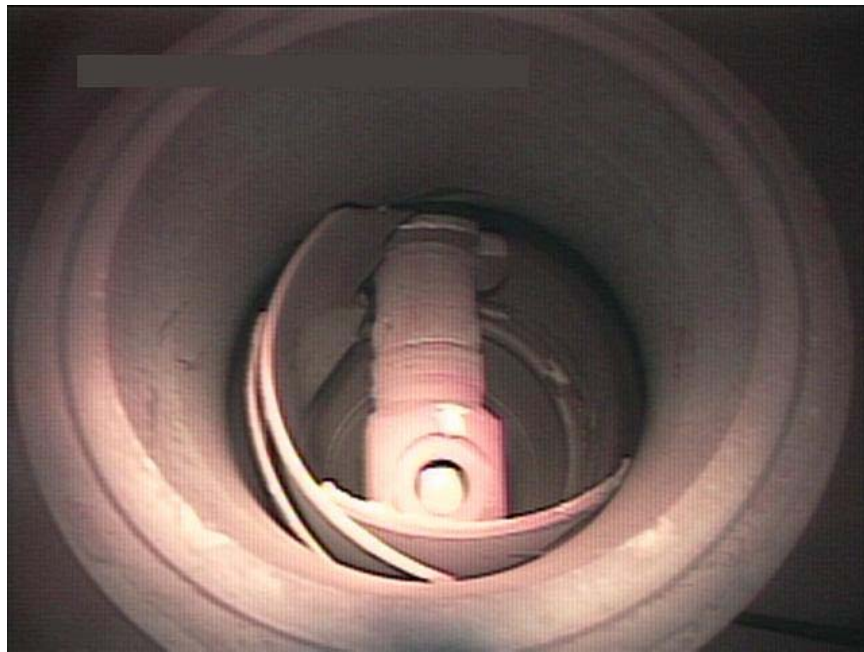
**Figure 4-1**  
**Desuperheater Nozzle with a Damaged Liner as Seen by RVI**

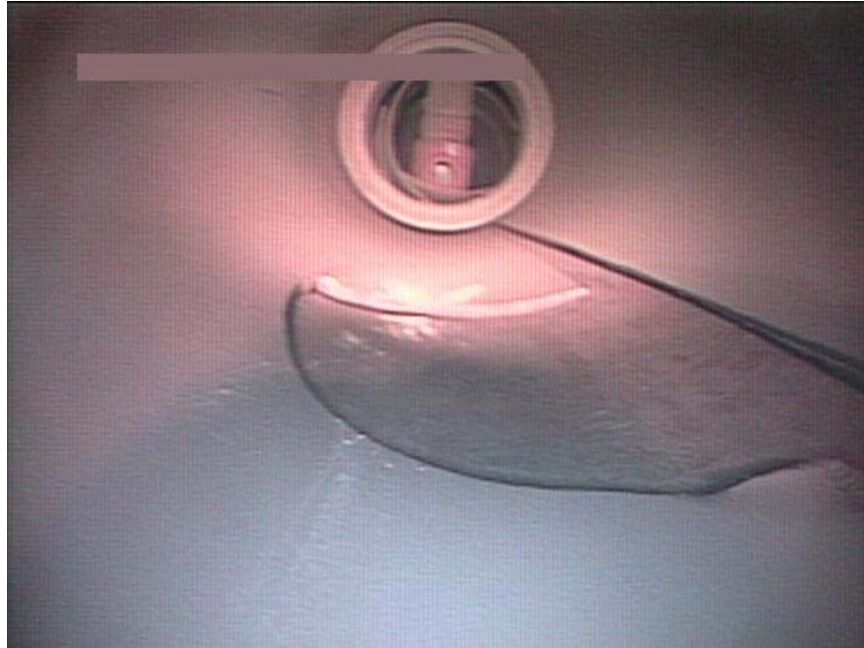
**Figure 4-2**  
**Missing Liner Section in a Desuperheater**  
**(Fragments from this liner can be seen in Figure 4-1.)**

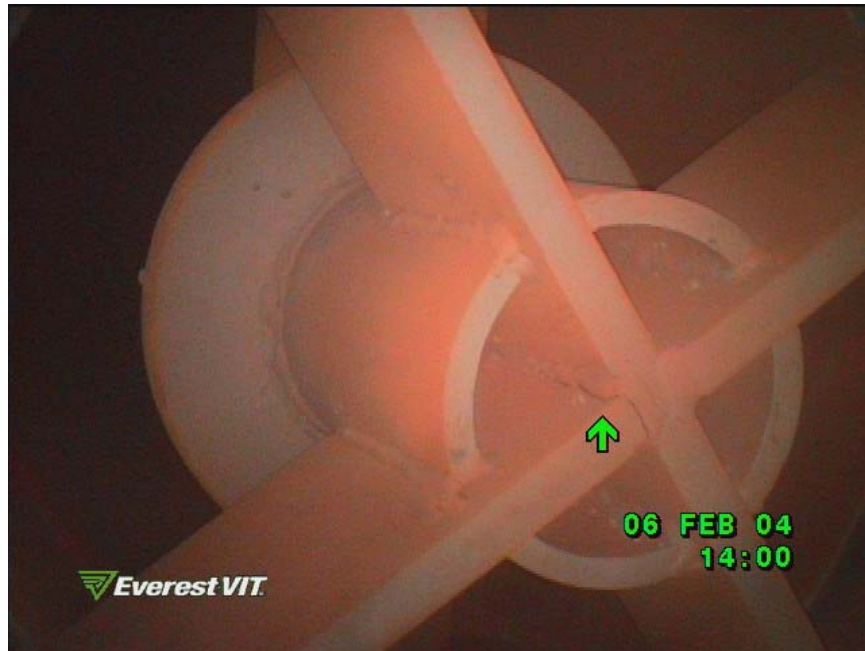
**Figure 4-3**  
**RVI Image of Cracking in an Attenuator Nozzle**  
(Cracking may progress and lead to failure of the nozzle.)

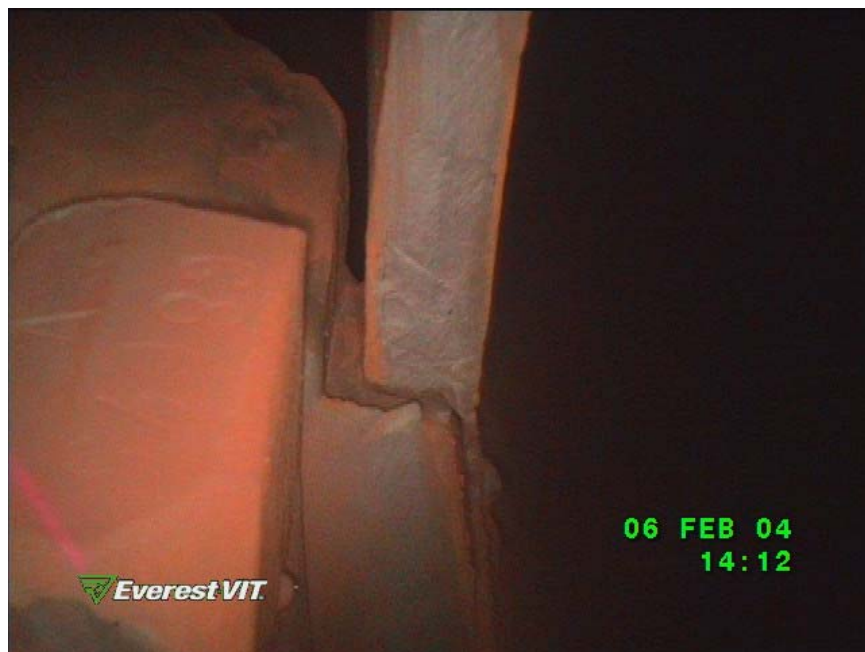
**Figure 4-4**  
**Crack in a Liner Attachment near the Stop Block**  
(Cracks may progress and cause additional damage.)

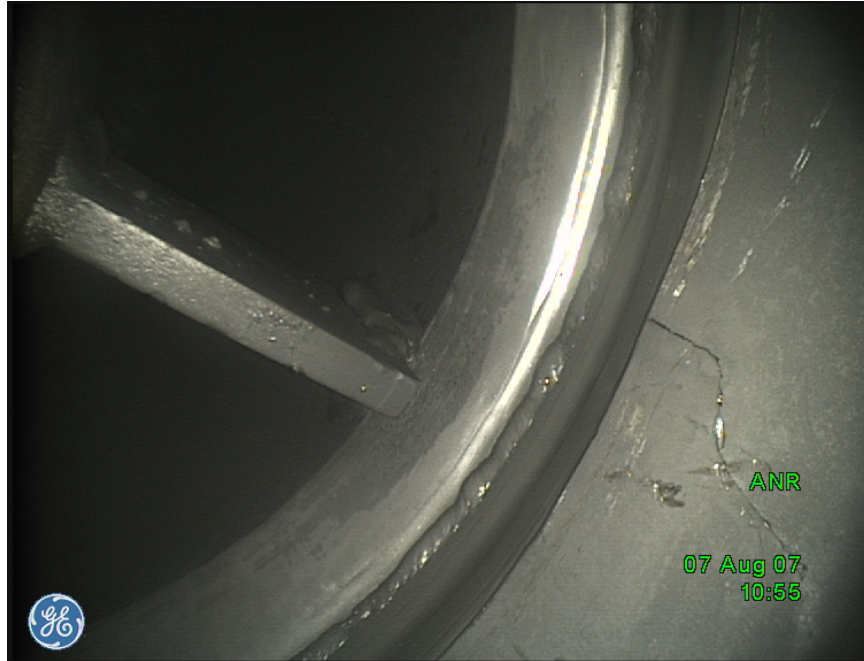
**Figure 4-5**  
**Crack in a Liner near the Nozzle**  
**(Cracks may progress by vibration and cause additional damage downstream.)**

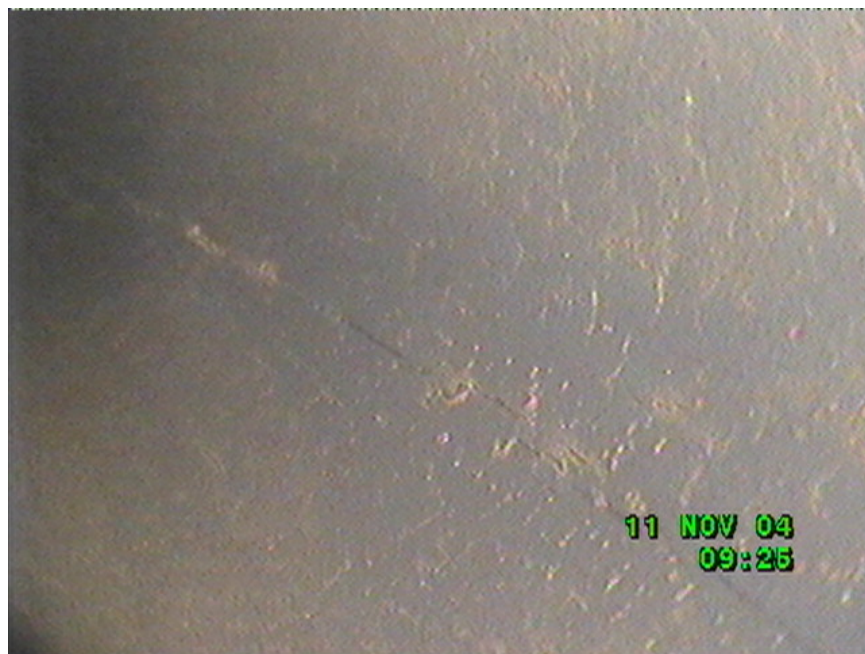
**Figure 5-2**  
**Longitudinal Crack in an Economizer Tube**  
**(Cracks are noted by dark linear indications on the remote visual inspection image.)**

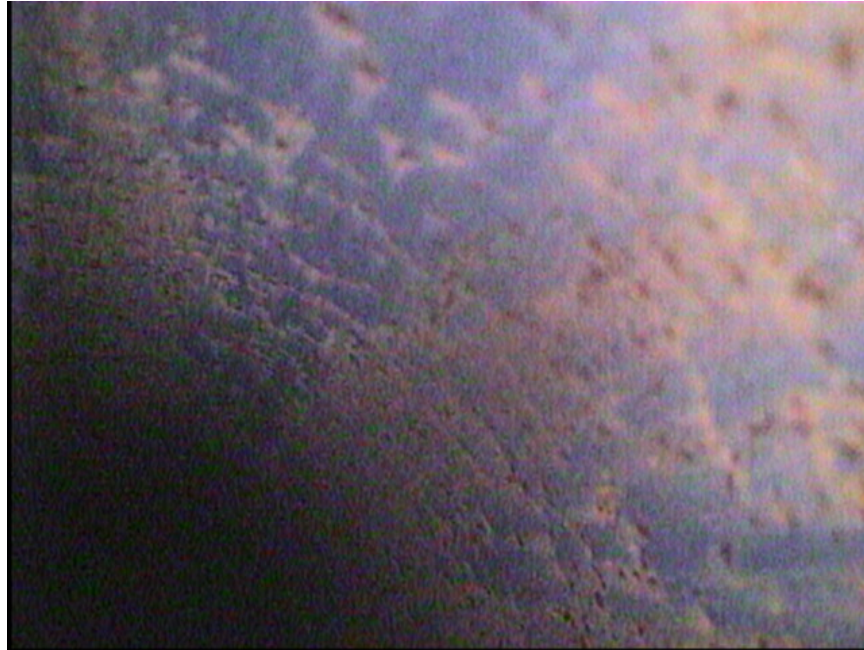
**Figure 5-3**  
**Crazed “Mud-Cracking” Type of Damage Found on the Inner Surface of an Economizer Tube**

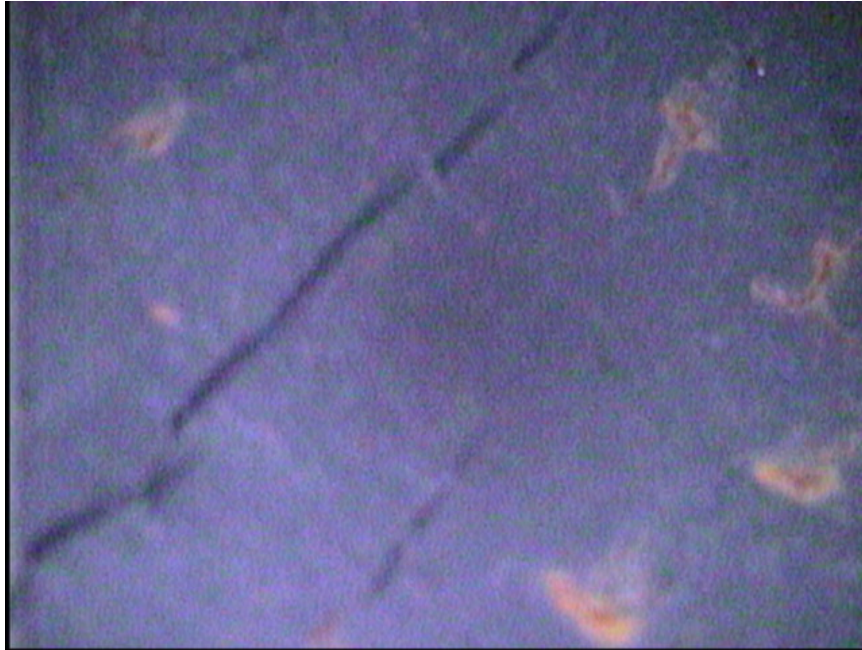
**Figure 5-4**  
**Reddish Color Rust “Blooms” of Hematite in the Magnetite Scale**  
**(Longitudinal cracks are also present in the image.)**

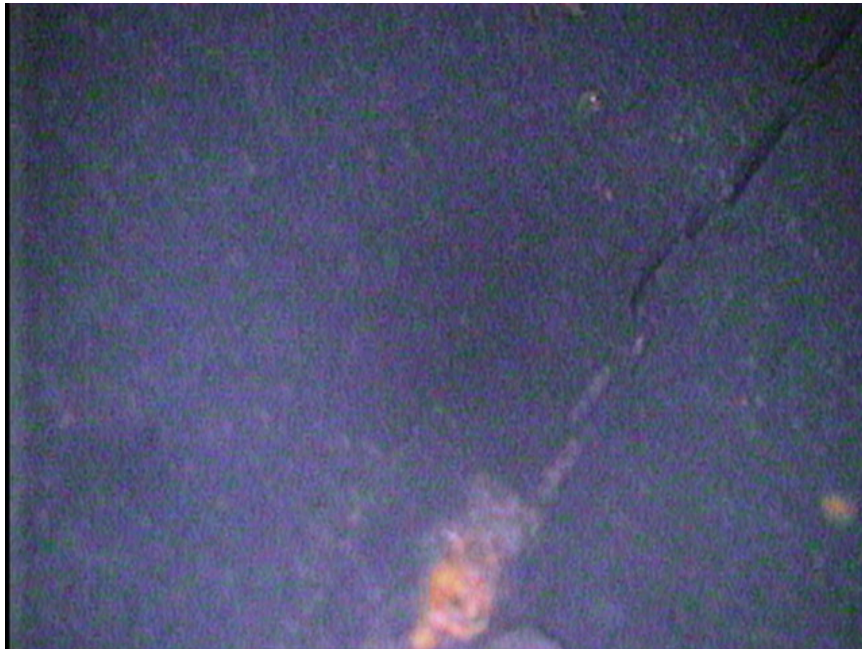
**Figure 5-5**  
**Close-Up Image of Red Rust from a Longitudinal Crack Found in the Tube**  
**(Cracks may have been present or opened more during a recent shutdown.)**

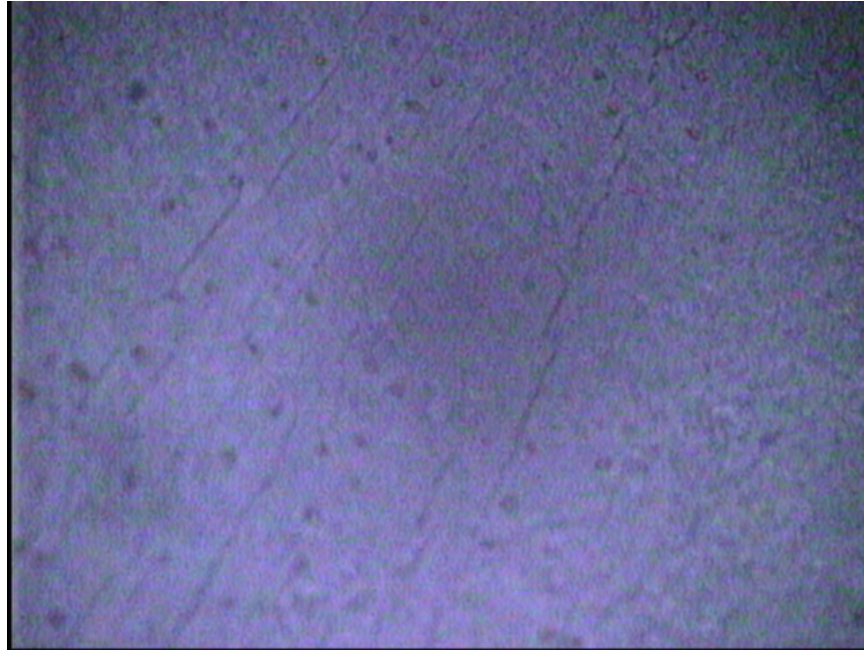
**Figure 5-6**  
**Multiple Longitudinal Cracks Found in an Economizer Tube**  
(This type of cracking is indicative of thermal fatigue from hot/cool or wet/dry cycles.)

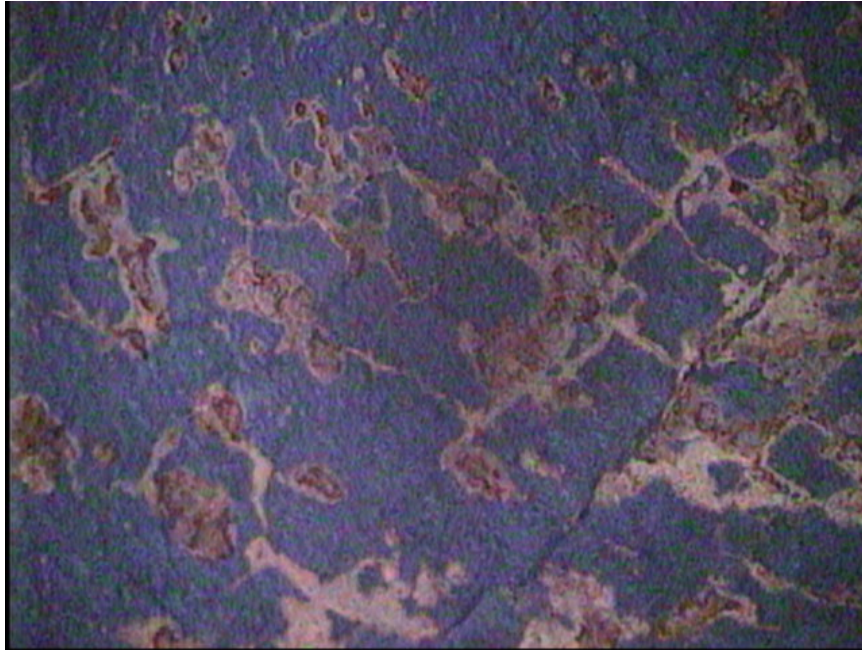
**Figure 5-7**  
**More Severe Crazed Cracking Than That Seen in Figure 5-3**  
**(Some of the oxide layer has spalled in this region.)**

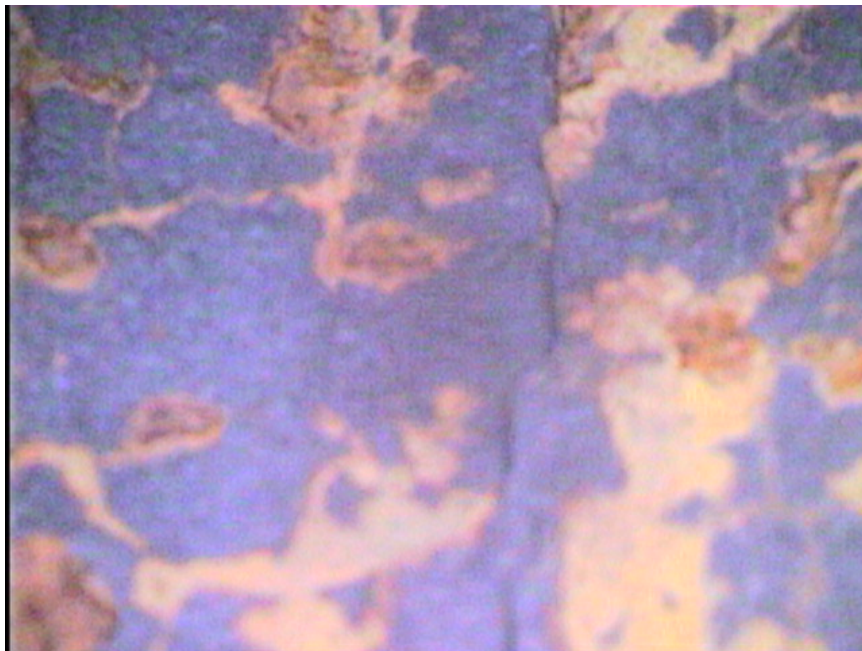
**Figure 5-8**  
**Close-Up of the Area with the Spalled High-Temperature Black Magnetite Oxide Layer and Cracks**  
**in the Tube Surface**

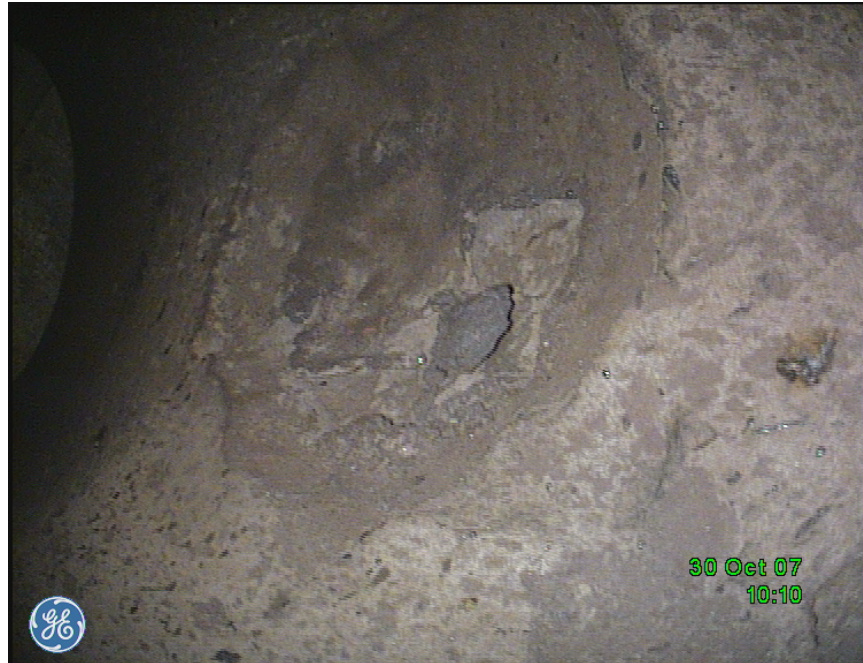
**Figure 6-1**  
**Inner Surface Deposit with a Pit as Found by RVI**  
(This type of deposit and subsequent pitting may be indicative of hydrogen damage in waterwall tubes.)

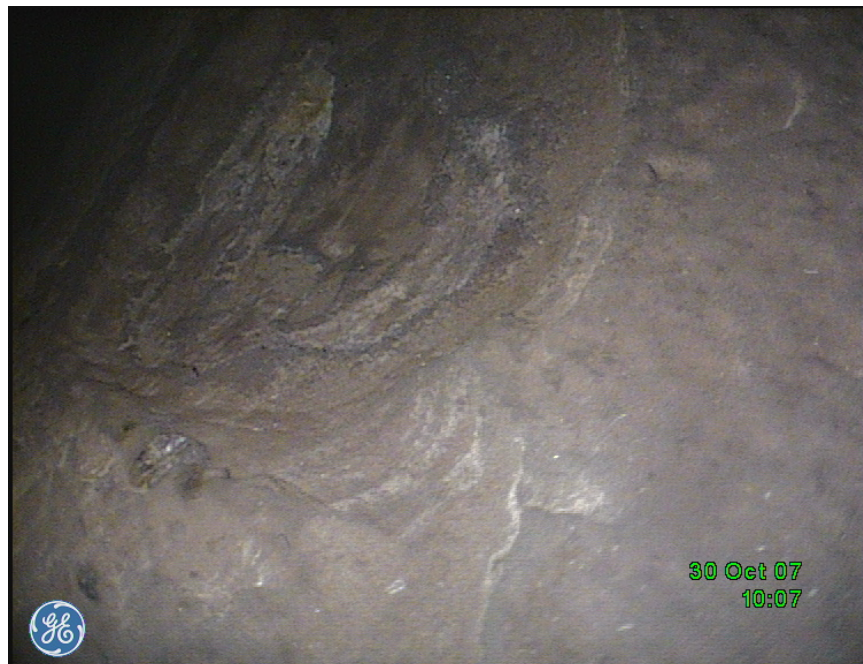
**Figure 6-2**  
**Layered Deposit on a Pitted Area in a Waterwall Tube as Seen in Figure 6-1**

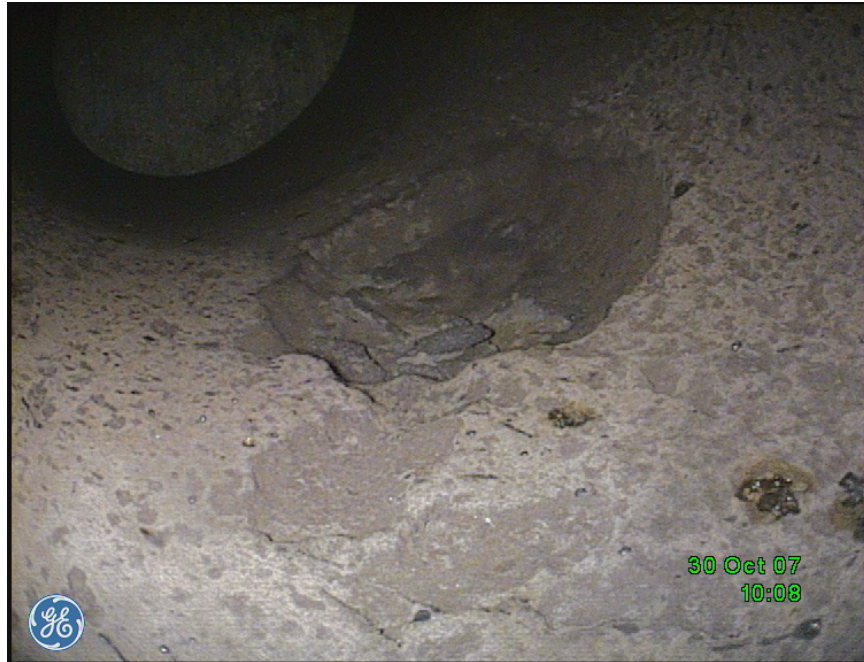
**Figure 6-3**  
**Localized Wall Loss in the Pit Seen in Figure 6-1**  
**(Removal of the tube section would confirm the presence of hydrogen damage.)**

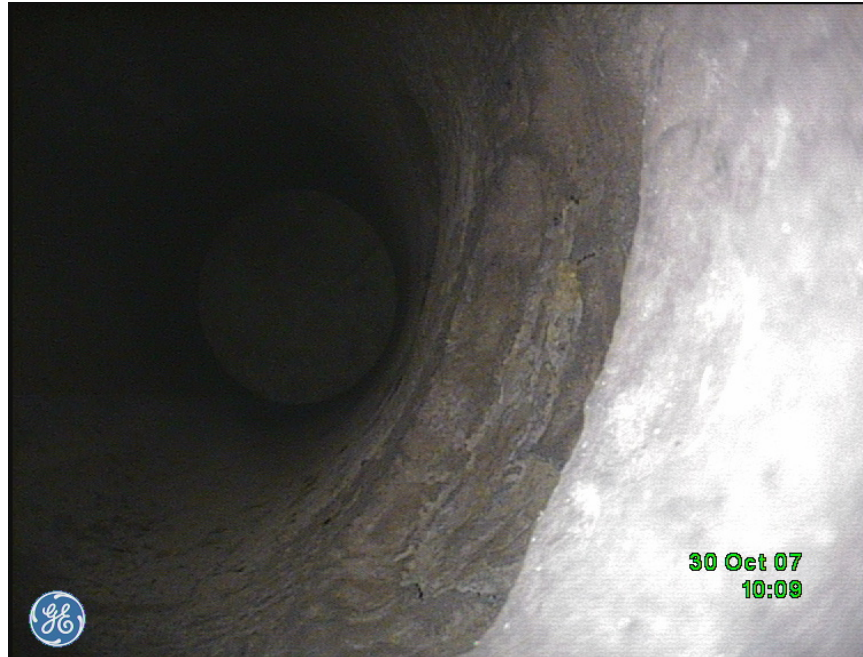
**Figure 6-4**  
**Additional RVI Image of the Pitted Region Seen in Figure 6-1**  
**(Actual penetration depth can be confirmed by ultrasonic examination.)**

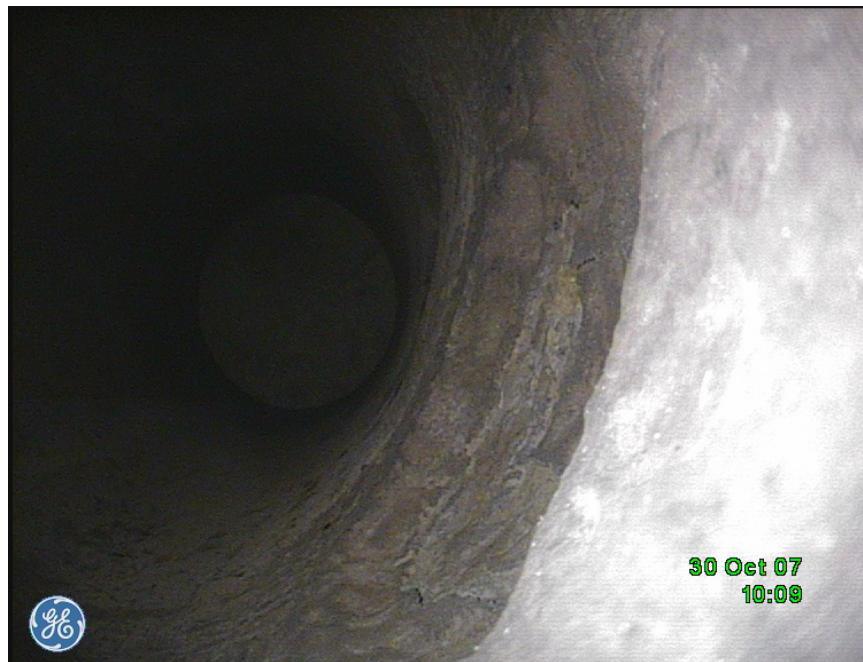
**Figure 6-5**  
**Layered Deposit on a Pitted Region**  
**(Such deposit may confirm external ultrasonic examination or identify areas for external ultrasonic examination.)**

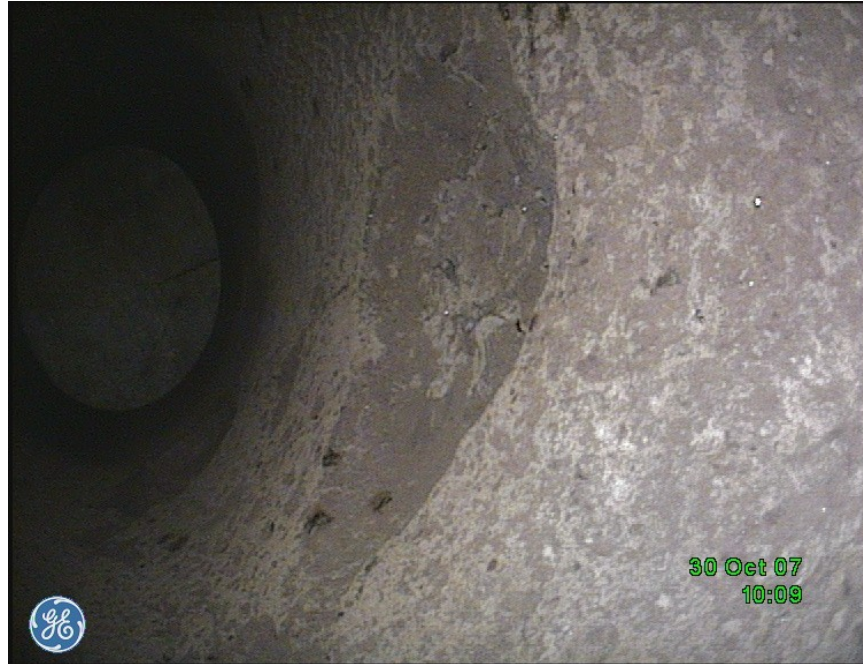
**Figure 6-6**  
**RVI Image of a Pitted Region with Hydrogen Damage**  
(This region was subsequently removed for laboratory examination.)

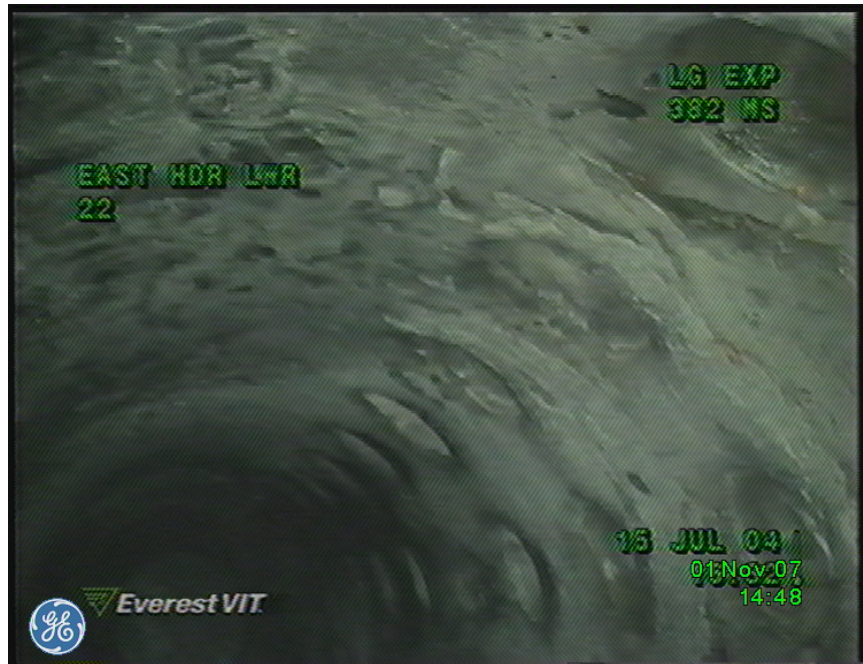
**Figure 7-1**  
Upper Economizer Header with Significant Surface Deposit as Identified by RVI

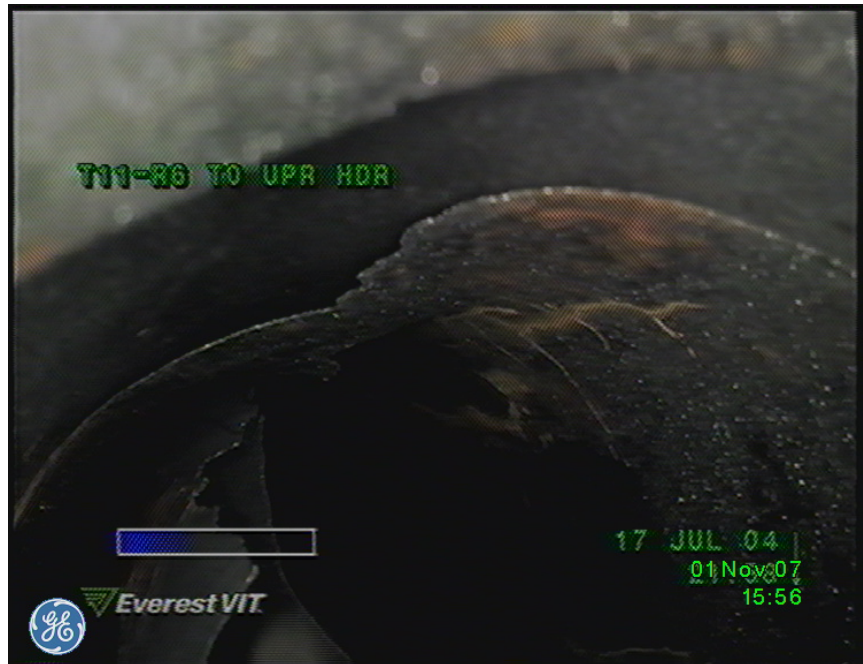
**Figure 7-3**  
**Close-Up Image of the Upper Economizer with Significant Surface Deposit**  
 (RVI should be reviewed with a water treatment specialist for additional evaluation.)

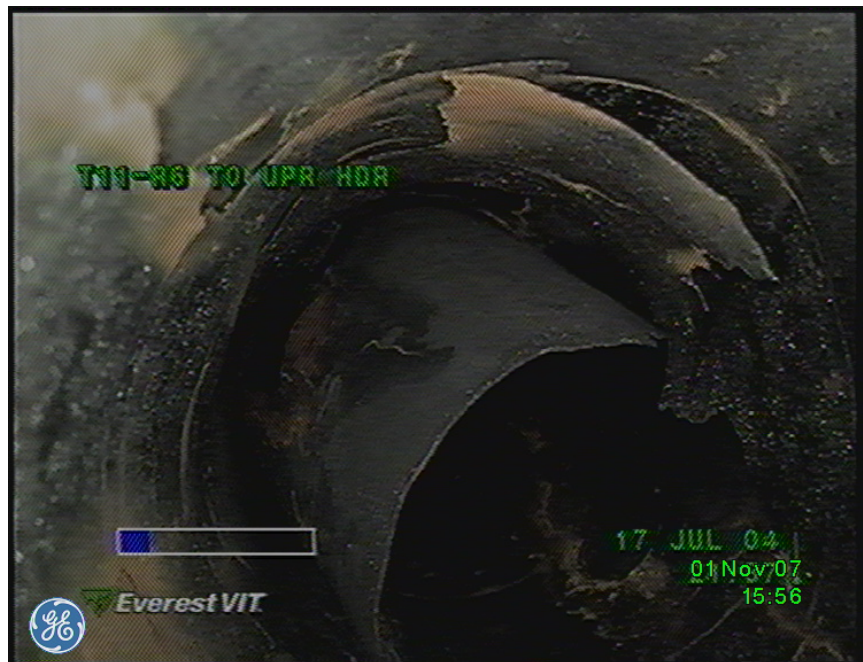
**Figure 7-4**  
**Layered Spalling in the Upper Economizer with Surface Deposit**  
 (This amount of deposit could be considered excessive and should be further evaluated.)

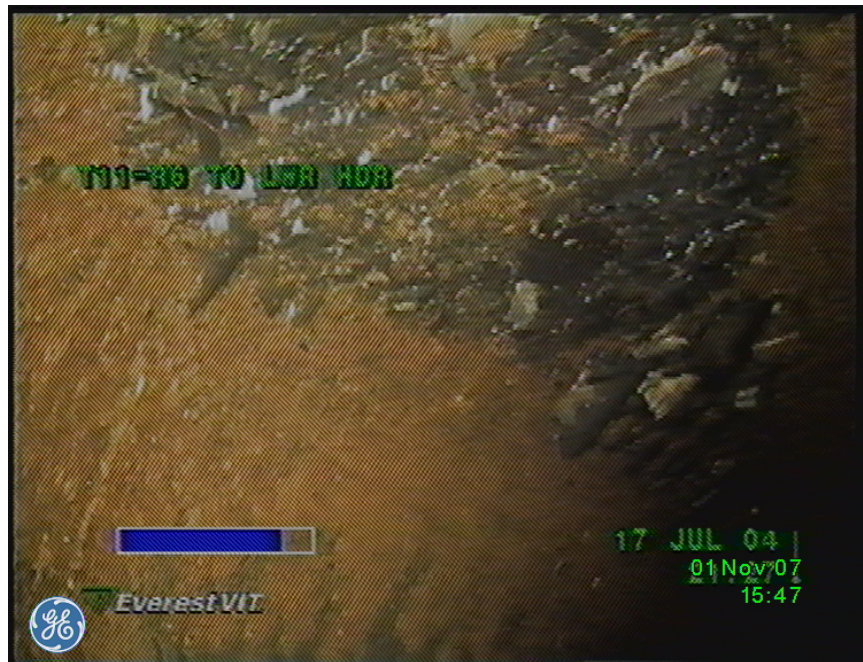
**Figure 7-5**  
**Lower Economizer Header with Some Accumulation of Low-Temperature Rust**  
(This may be a result of inadequate blowdown practices.)

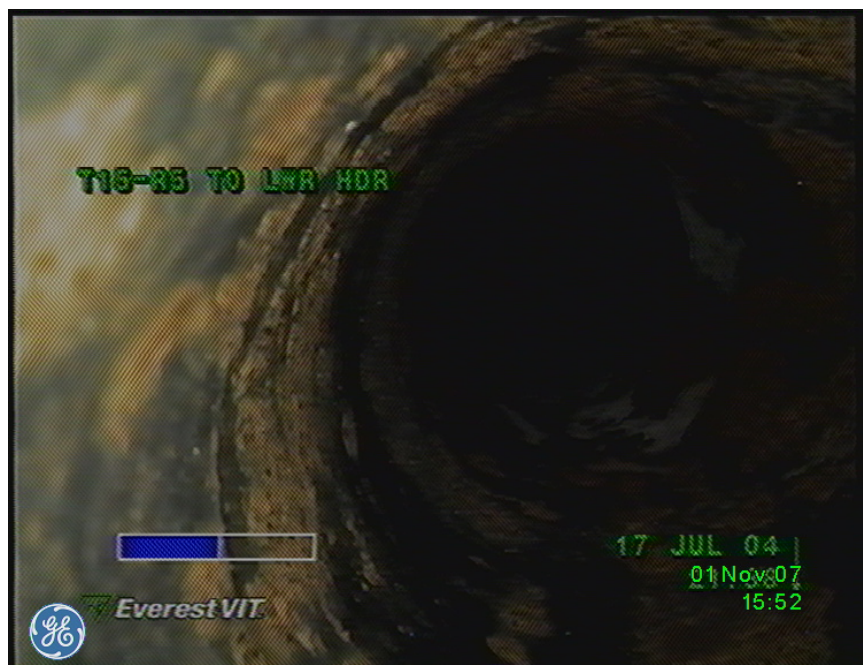
**Figure 7-6**  
 Low-Temperature Rust and Debris in the Lower Economizer Header Which Should Prompt an Evaluation of the Need for Chemical Cleaning

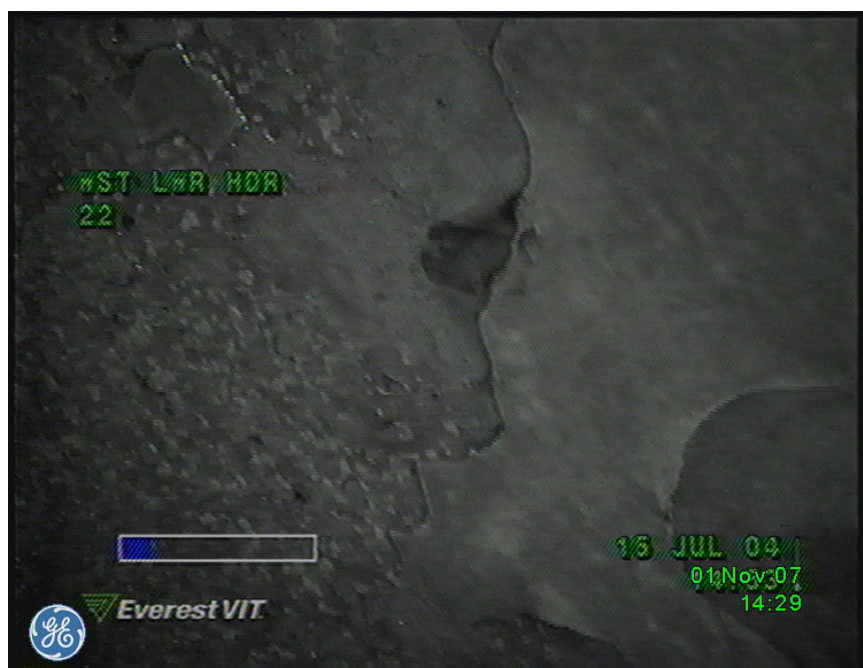
**Figure 7-7**  
 An Additional RVI Image of Low-Temperature Rust and Debris in the Lower Economizer Header That Can Be Used in a Follow-Up Evaluation by a Water Treatment Specialist

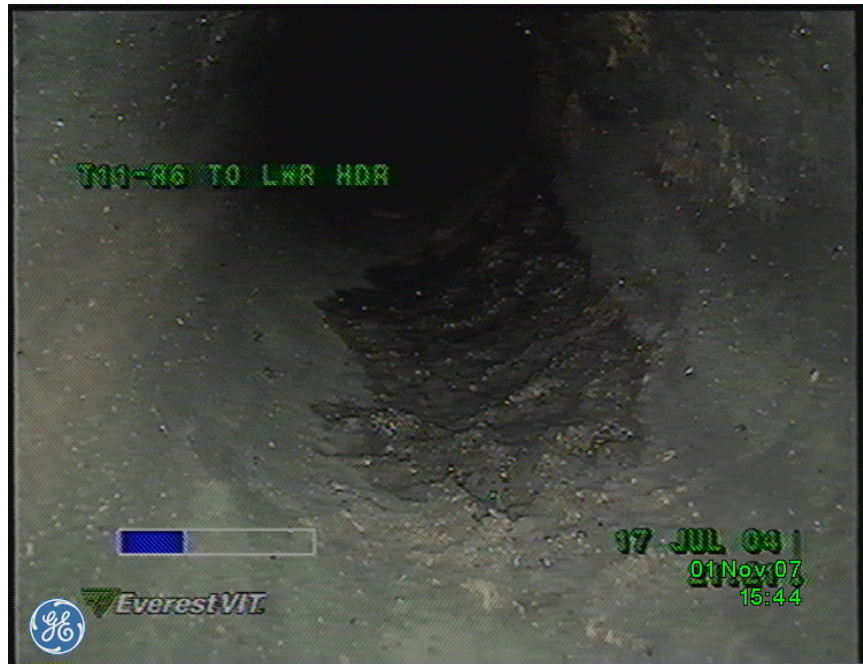
**Figure 7-8**  
**RVI Image of High-Temperature Scale and Debris in the Lower Economizer Header That Can Be Used for an Evaluation by On-Site or Corporate Specialists**

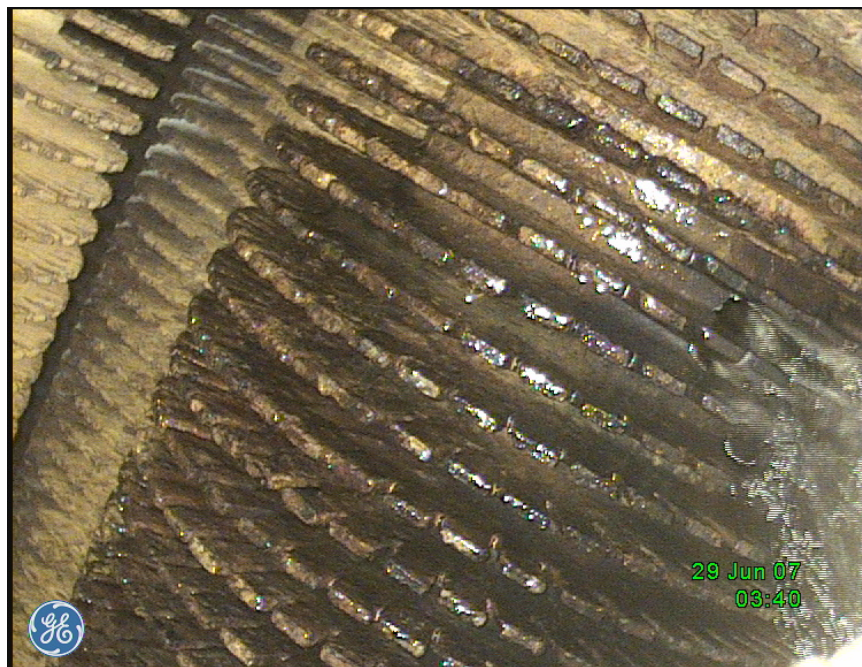
**Figure 8-1**  
**External RVI Image of a Leak in an Economizer Tube Can Be Found Before Significant Staging or Personnel Deployment Is Accomplished**

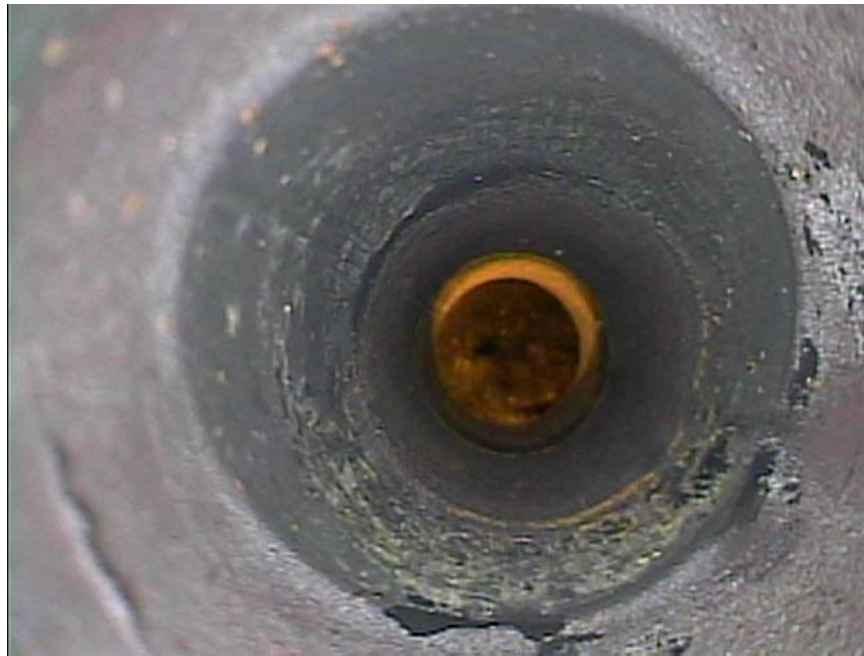
**Figure 9-1**  
**Flow-Accelerated Corrosion as Found by RVI in a Boiler Tube: Localized Wall Loss May Compromise Tube Integrity**
