# Examination of Heat Recovery Steam Generator Plants

*Case Studies of Remote Visual Inspection Techniques*

1014197

Technical Update, March 2008

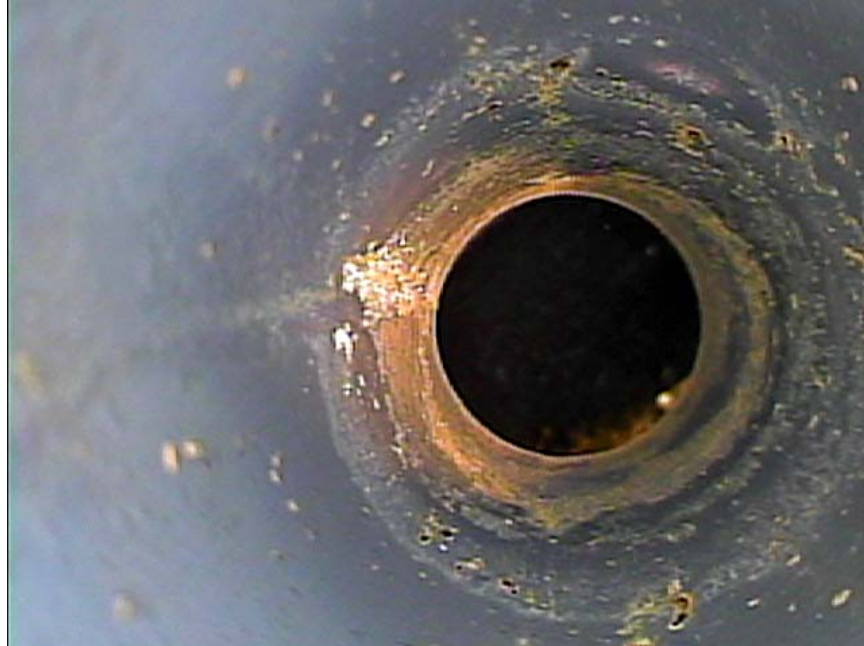
**Figure 9-2**  
**Flow-Accelerated Corrosion as Found by RVI in a Boiler Tube: This Damage Has Been the Cause of Tube Failures**

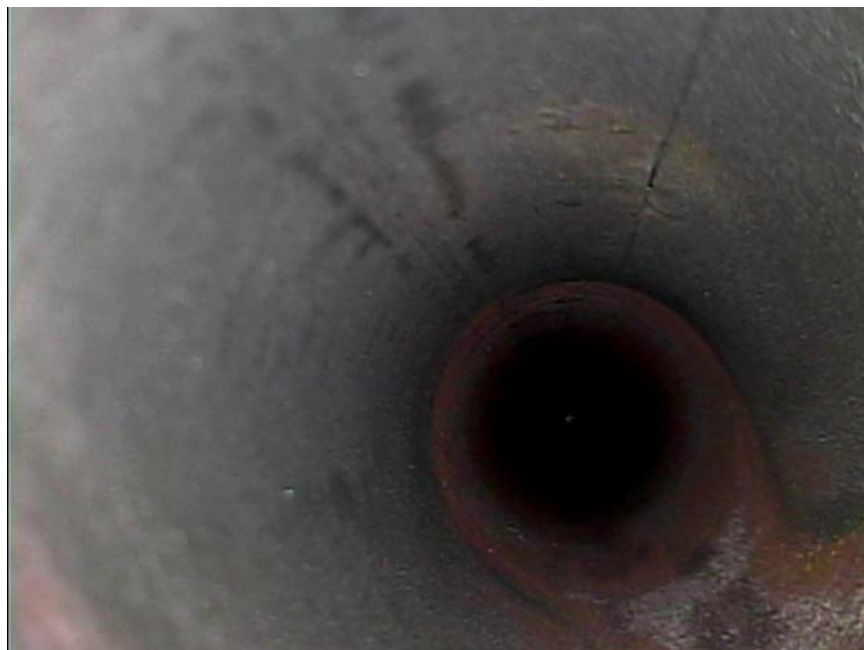
**Figure 9-3**  
**Flow-Accelerated Corrosion as Found by RVI in a Boiler Tube: This Type of Damage May Be Confirmed by External Ultrasonic Examination**

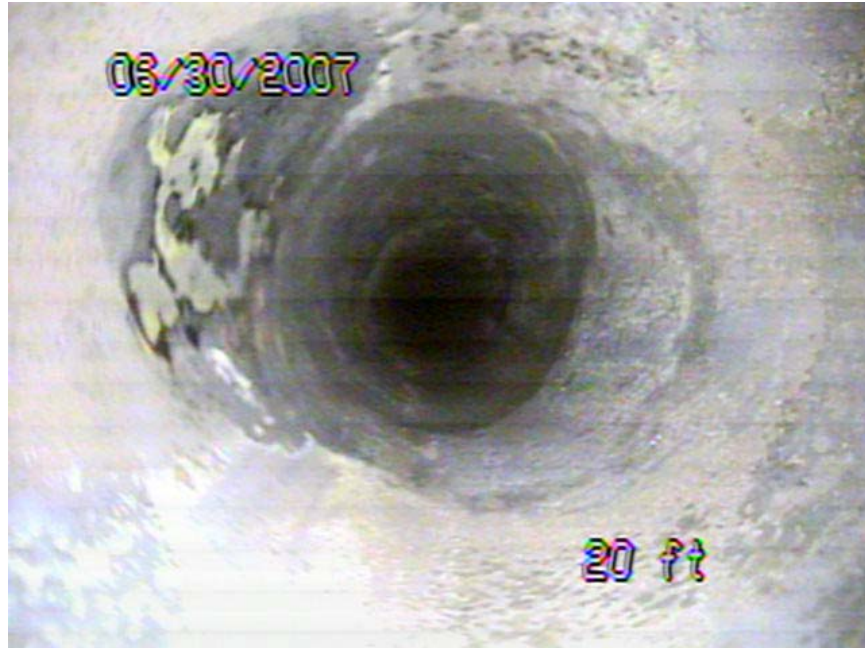
**Figure 9-4**  
**Flow-Accelerated Corrosion as Found by RVI in a Boiler Tube: Tube May Require Removal for Additional Laboratory Evaluation**

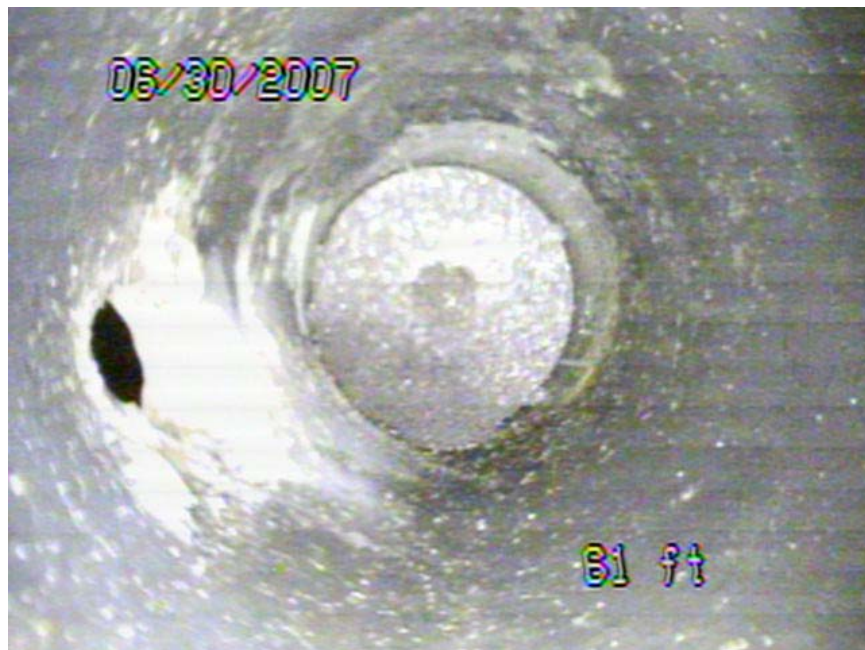
**Figure 9-5**  
**Flow-Accelerated Corrosion with a Hole as Found by RVI in a Boiler Tube**

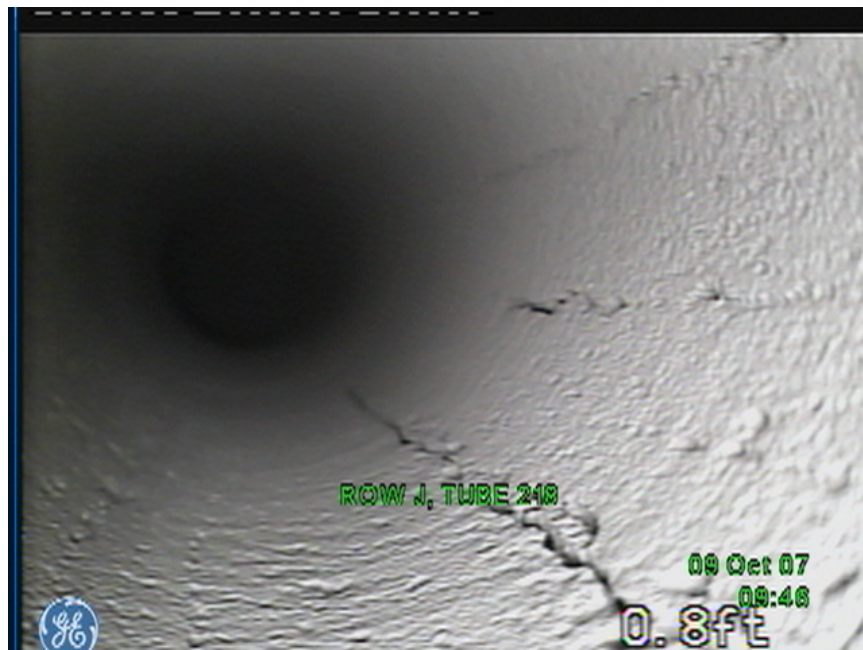
**Figure 10-1**  
**Corrosion Fatigue Cracking in a Boiler Tube as Identified with RVI**  
(There are several longitudinal cracks in this image.)

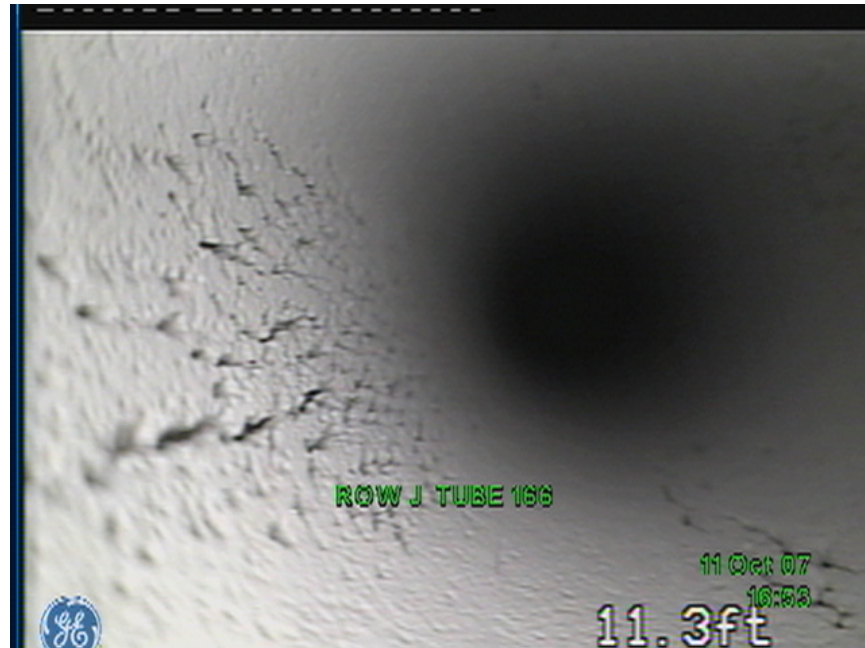
**Figure 10-2**  
**Corrosion Fatigue Cracking in a Boiler Tube**  
(Numerous aligned cracks in this pattern may indicate external attachment.)

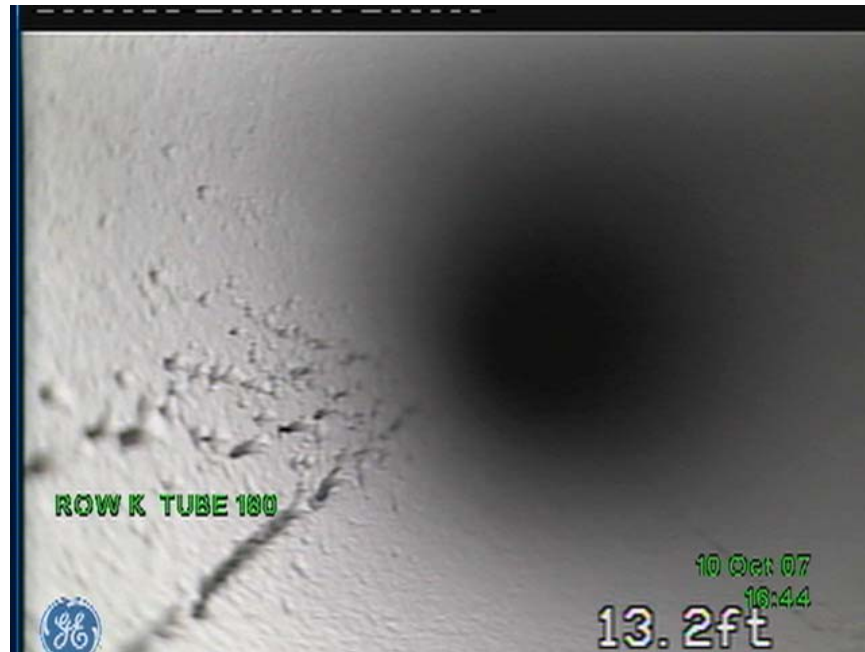
**Figure 10-3**  
**Corrosion Fatigue Cracking in a Boiler Tube**  
(An additional RVI image of similar cluster type accumulation of cracks can be seen in Figure 10-4.)

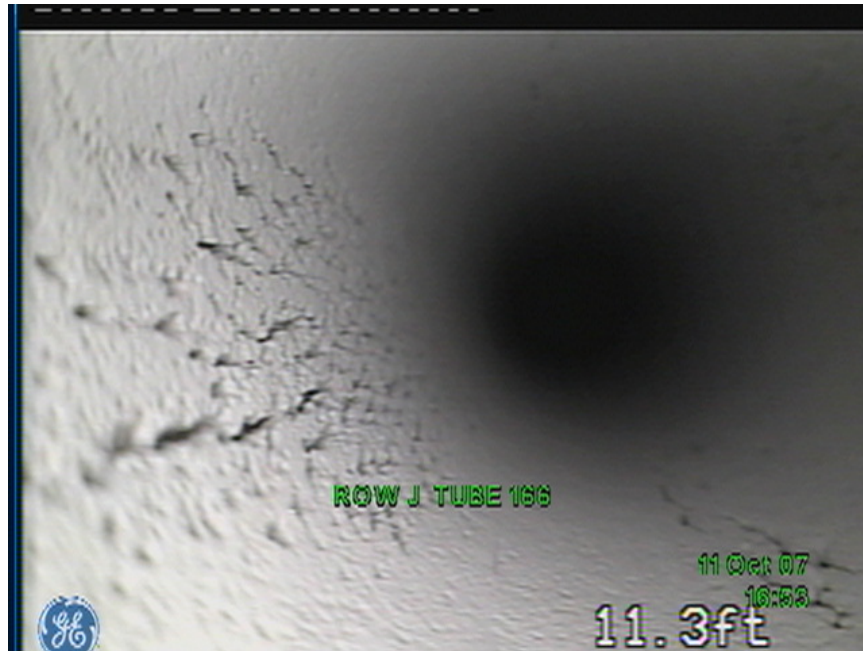
**Figure 10-4**  
**Corrosion Fatigue Cracking in a Boiler Tube May Not Be Detectable by External Examination Because of Access Requirements**

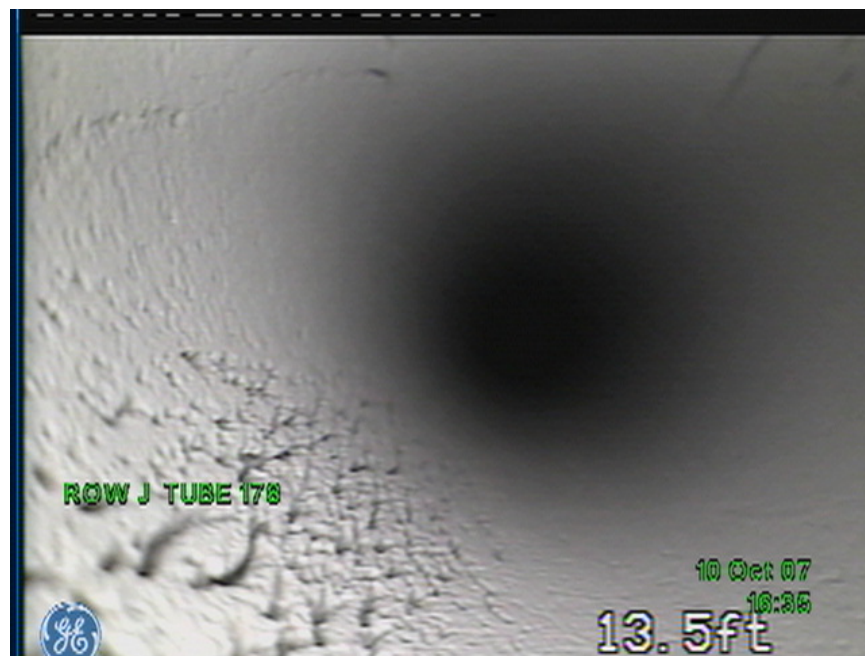
**Figure 10-5**  
Corrosion Fatigue Cracking in a Boiler Tube May Often Require Removal for Diagnosis and Repair

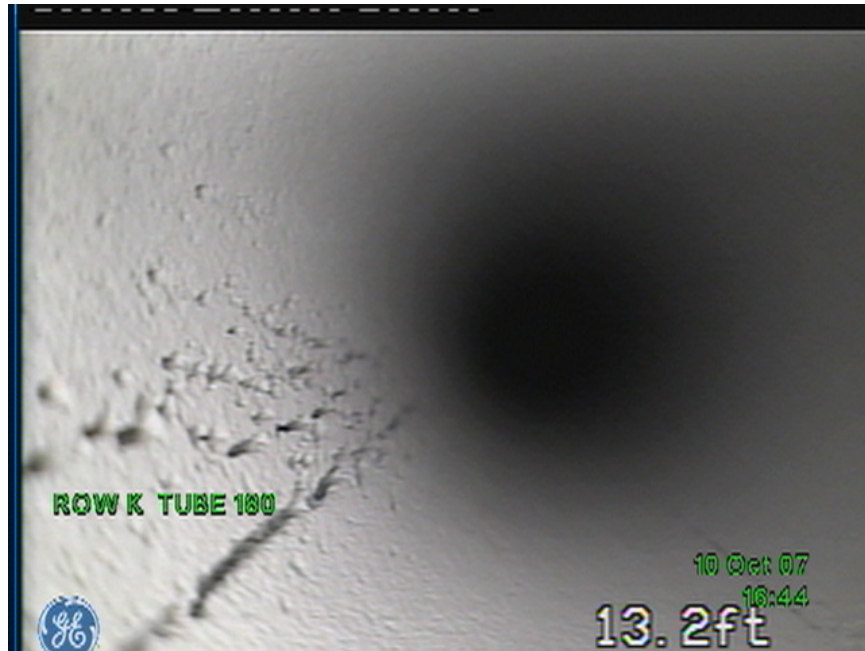
**Figure 10-6**  
**Corrosion Fatigue Cracking in a Boiler Tube with Multiple Longitudinal Cracks**

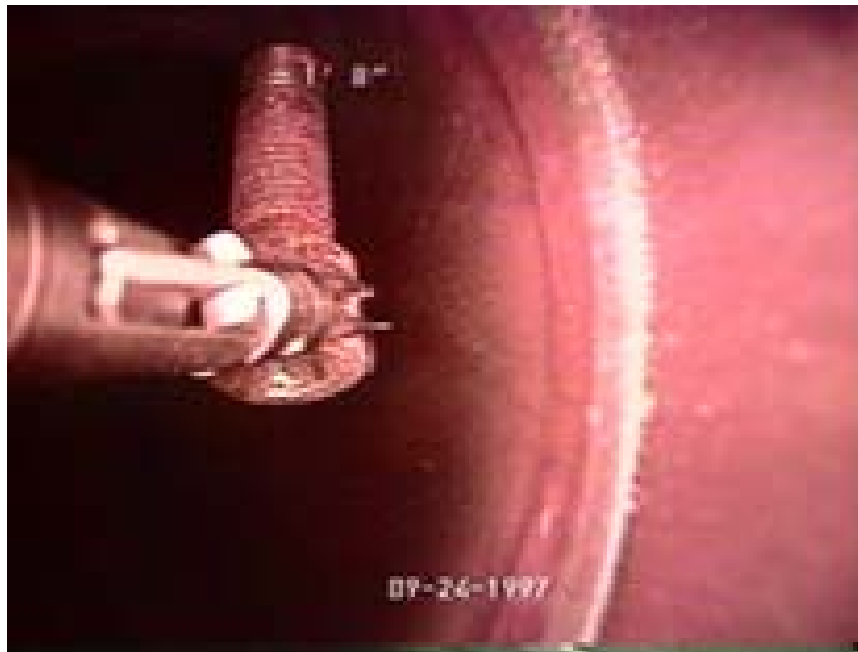
**Figure 11-3**  
**Removal of a Bolt with the Use of a Claw**  
**(Loose parts could cause tube obstruction or other impact damage.)**

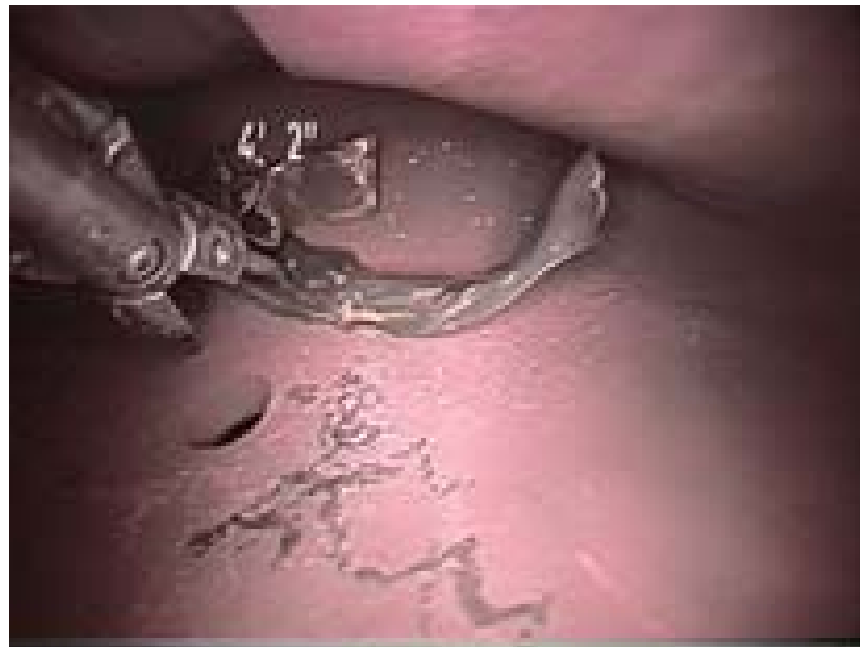
**Figure 11-5**  
**Removal of a Piece of Metal from a Boiler Feed Pump**  
**(Foreign object damage can cause significant damage in rotating equipment.)**
