# **Assessment and Testing of High-Pressure Fluid-Filled (HPFF) Cables**

*New York Power Authority Niagara Power Project*

Technical Update Report, March 2007

**Power Delivery Consultants, Inc.**

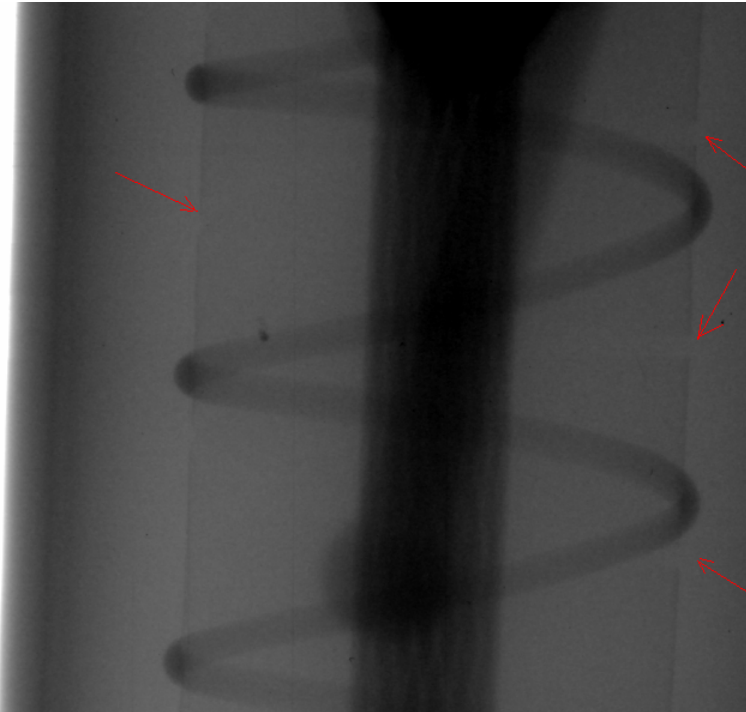
**Figure 4-12**  
**Image from LPGP Feeder #2 Generator Side Riser #2**

viewing software which is somewhat larger than typical (0.08"). However, the butt gap spacings were reasonably uniform in the area where they are visible indicating that there has not been any displacement of the tapes. The dark semi-circular object adjacent to the cable high voltage conductor in the lower part of the image and the dark area to the right of the cable conductor at the top of the image are portions of a metal C-clamp used to hold the image plate in place.

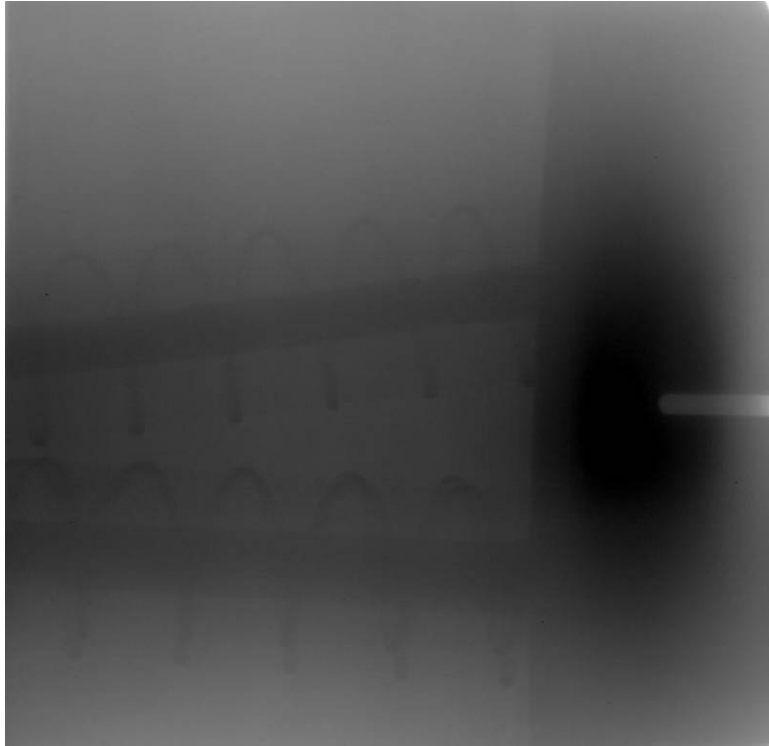
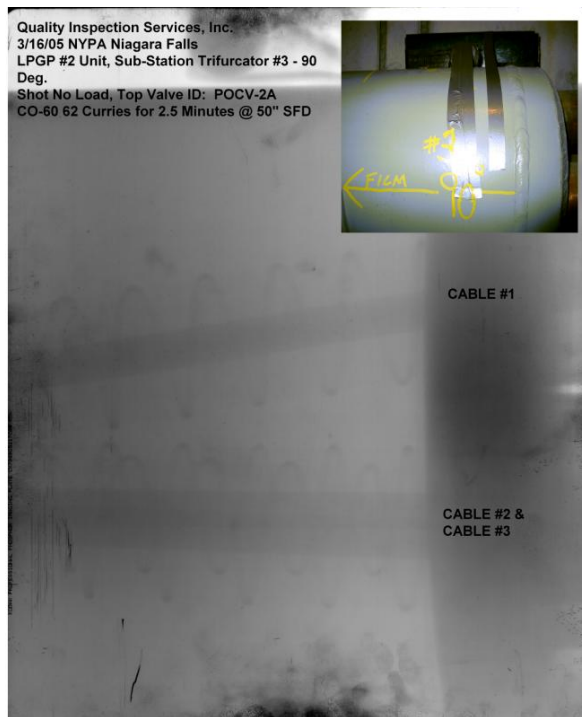
The cables should be gradually bent in the areas where there are transitions between the end of the casing and the end of the joint or spider. This appeared to be the case for all locations except for the LPGP #2 joint casing at location #1 (See Figure 4-15) and the trifurcator casing #3 (See Figure 4-17).

**Figure 4-17**  
**LPGP #2, 230 kV, Substation Trifurcator Casing, Location #3 (Under Load)**

**Figure 4-18**  
**LPGP #2, 230 kV, Substation Trifurcator Casing, Location #3 (No Load)**

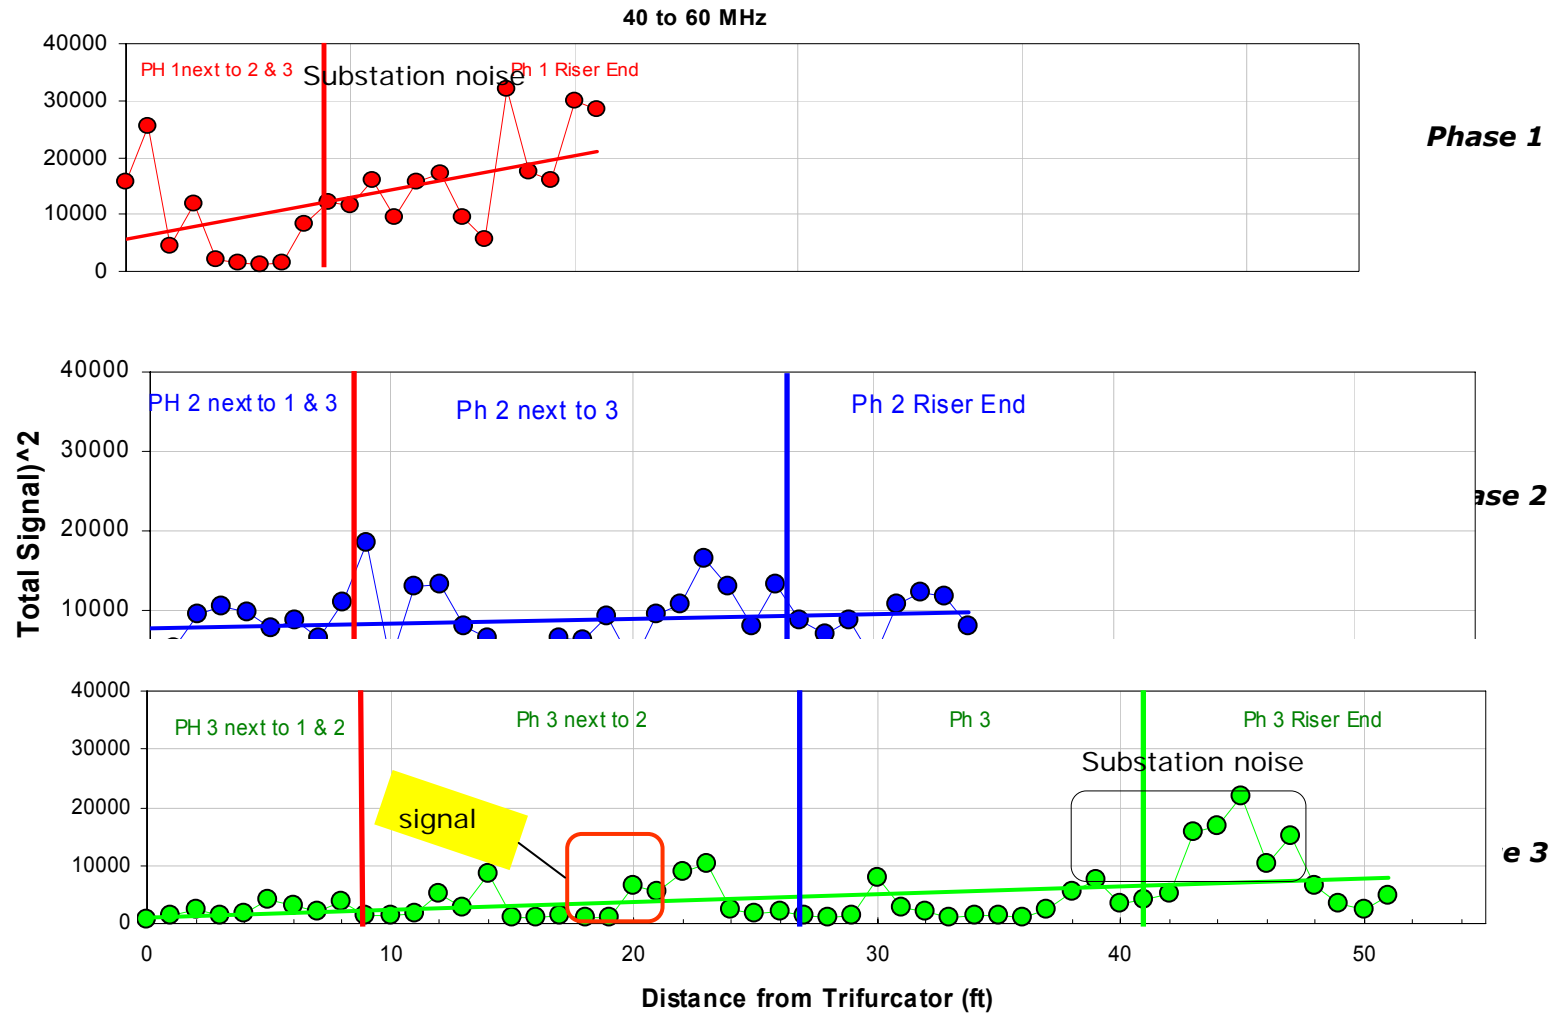
**Figure 4:** The square of the total signal as a function of distance to trifurcator for frequency window 40 to 60 MHz for all three cable phases. Note that the level of total signal is higher for Phase 1 and lower for Phase 3.

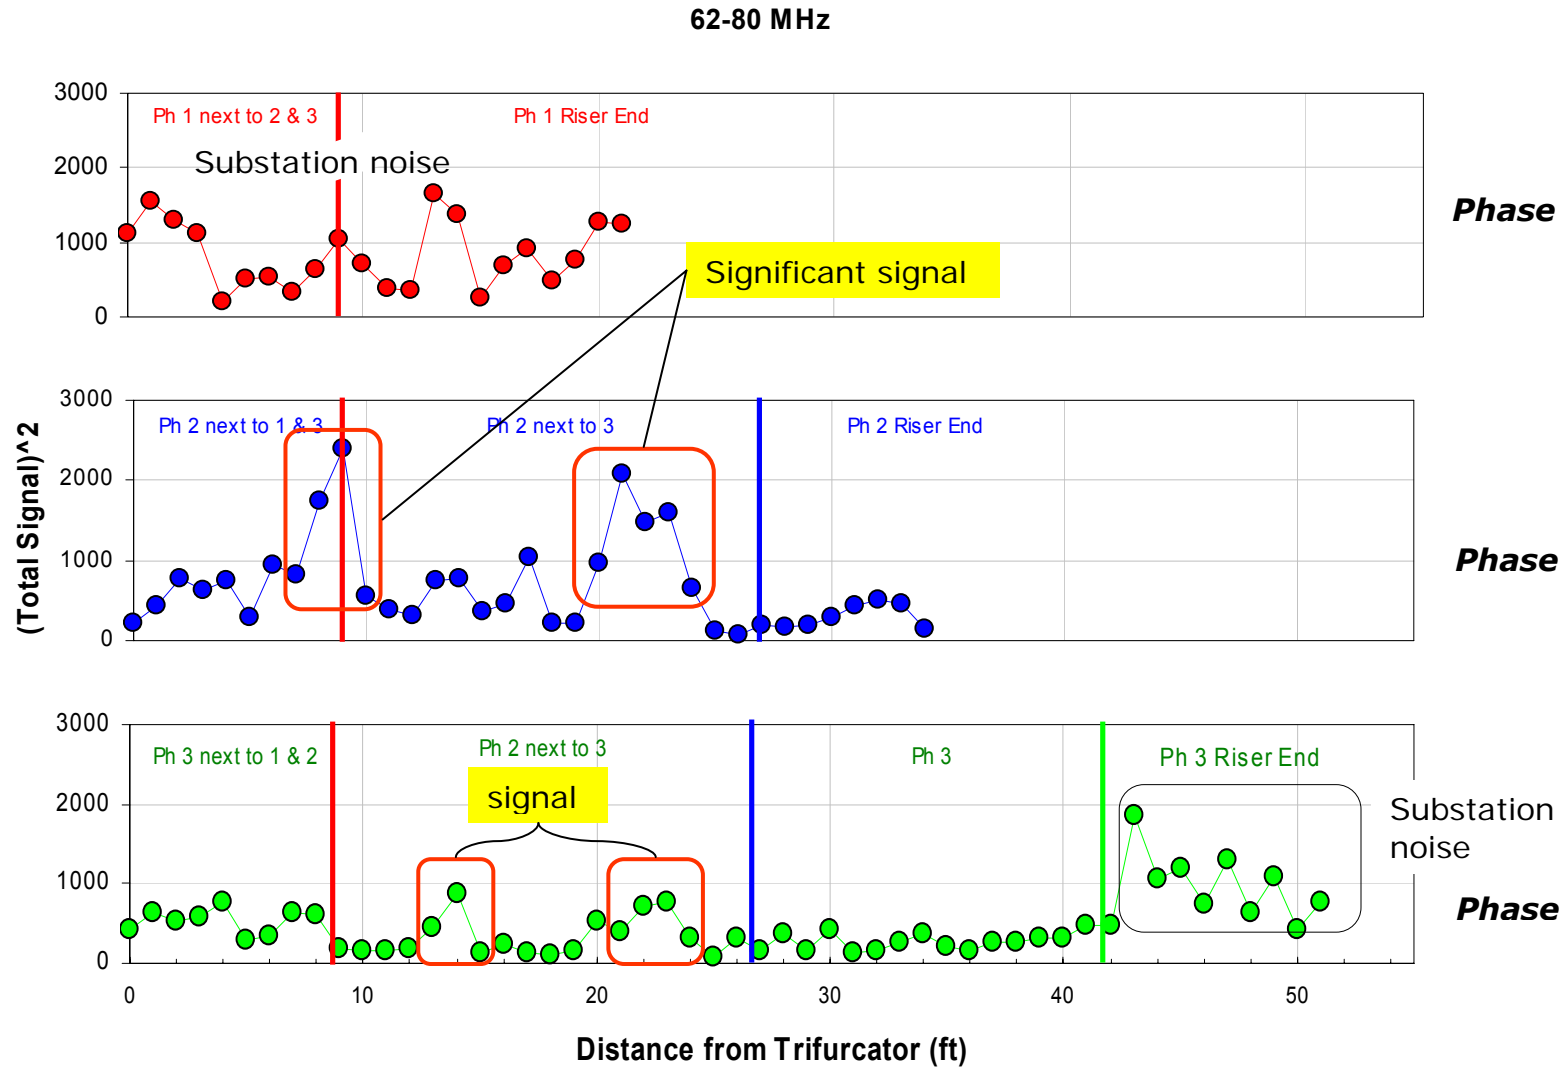
**Figure 5:** The square of the total signal as a function of distance to trifurcator for frequency window 62 to 80 MHz for all three cable phases. Note that the signal level is lower for Phase 3, while distinctive signals were observed at two points in Phase 2.

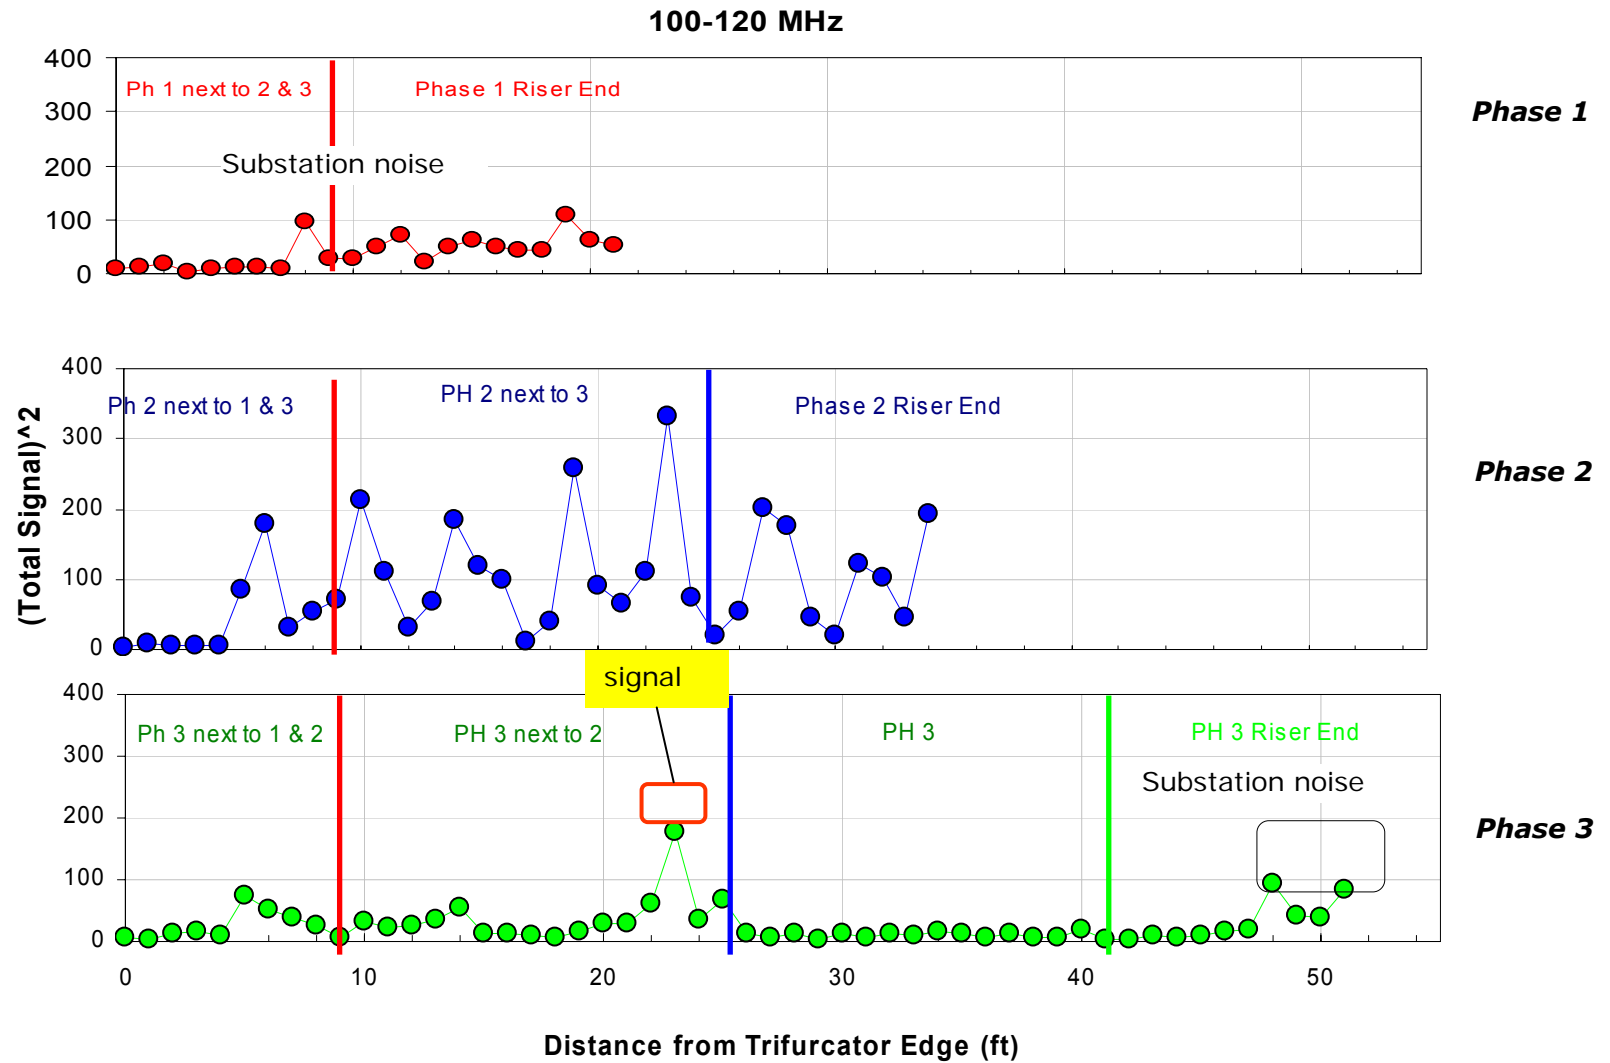
**Figure 6:** The square of the total signal as a function of distance to trifurcator for frequency window from 100 to 120 MHz for all three cable phases. Note that the signal level is higher in Phase 2 compared to phases 1 and 3

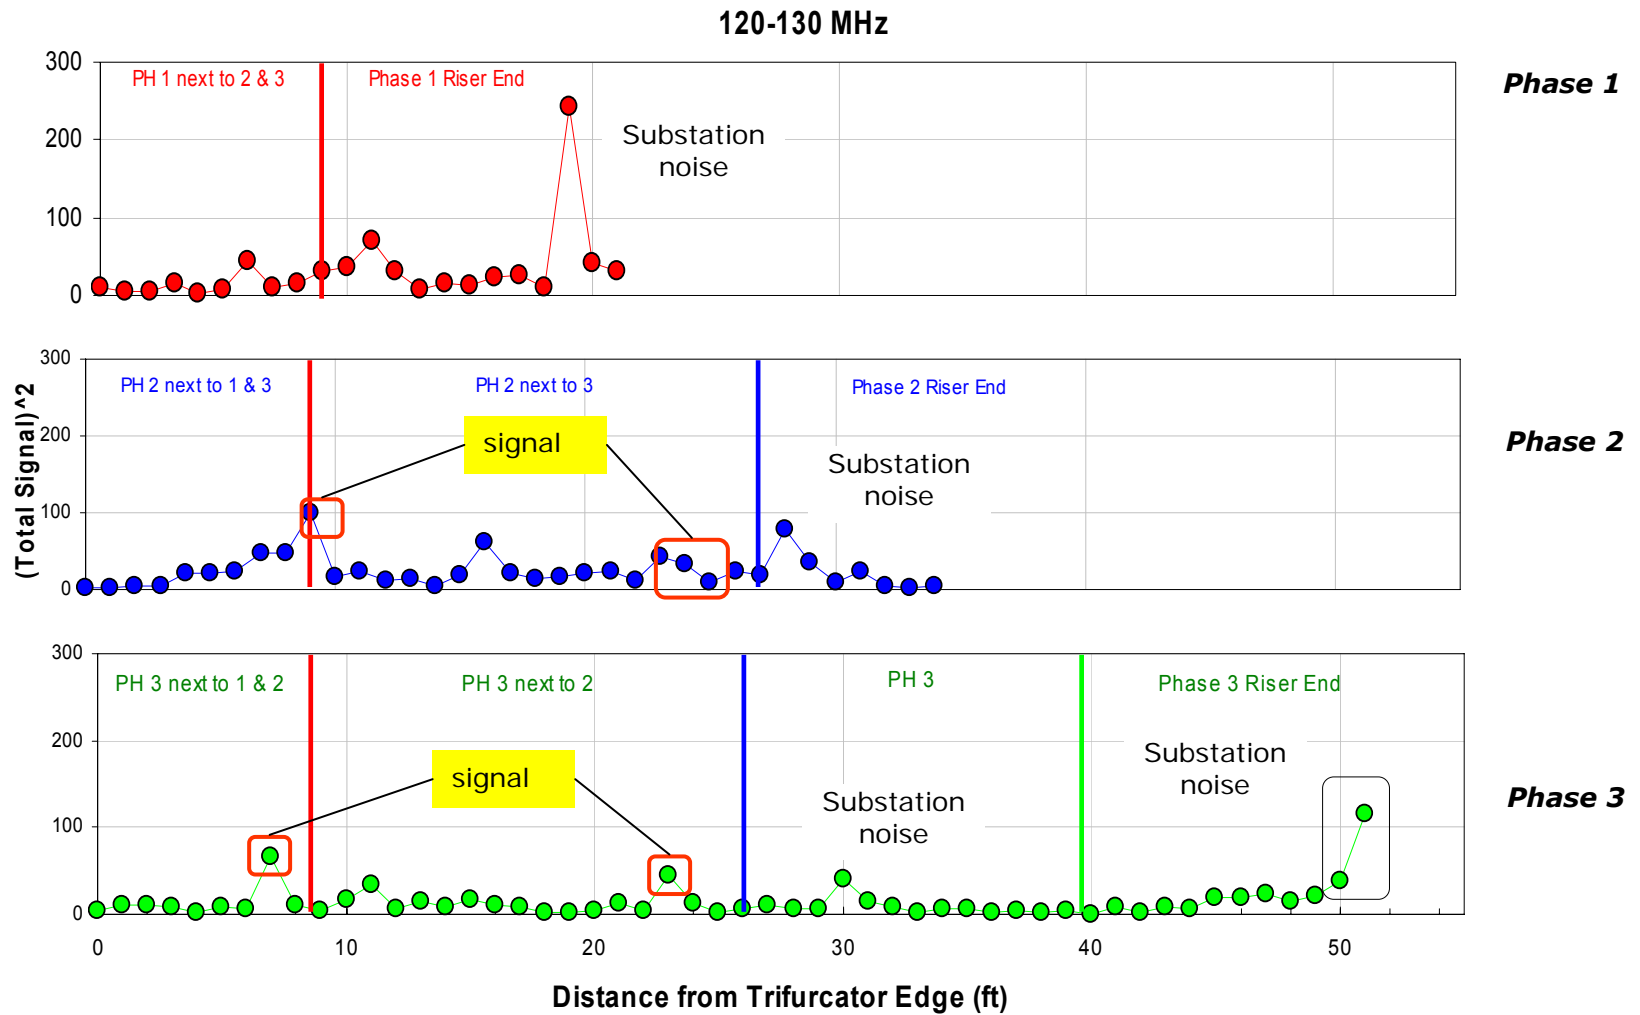
**Figure 7:** The square of the total signal as a function of distance to trifurcator for frequency window from 120 to 130 MHz for all three cable phases. Note that besides the large peak in Phase 1, several small peaks can be observed in all three phases.

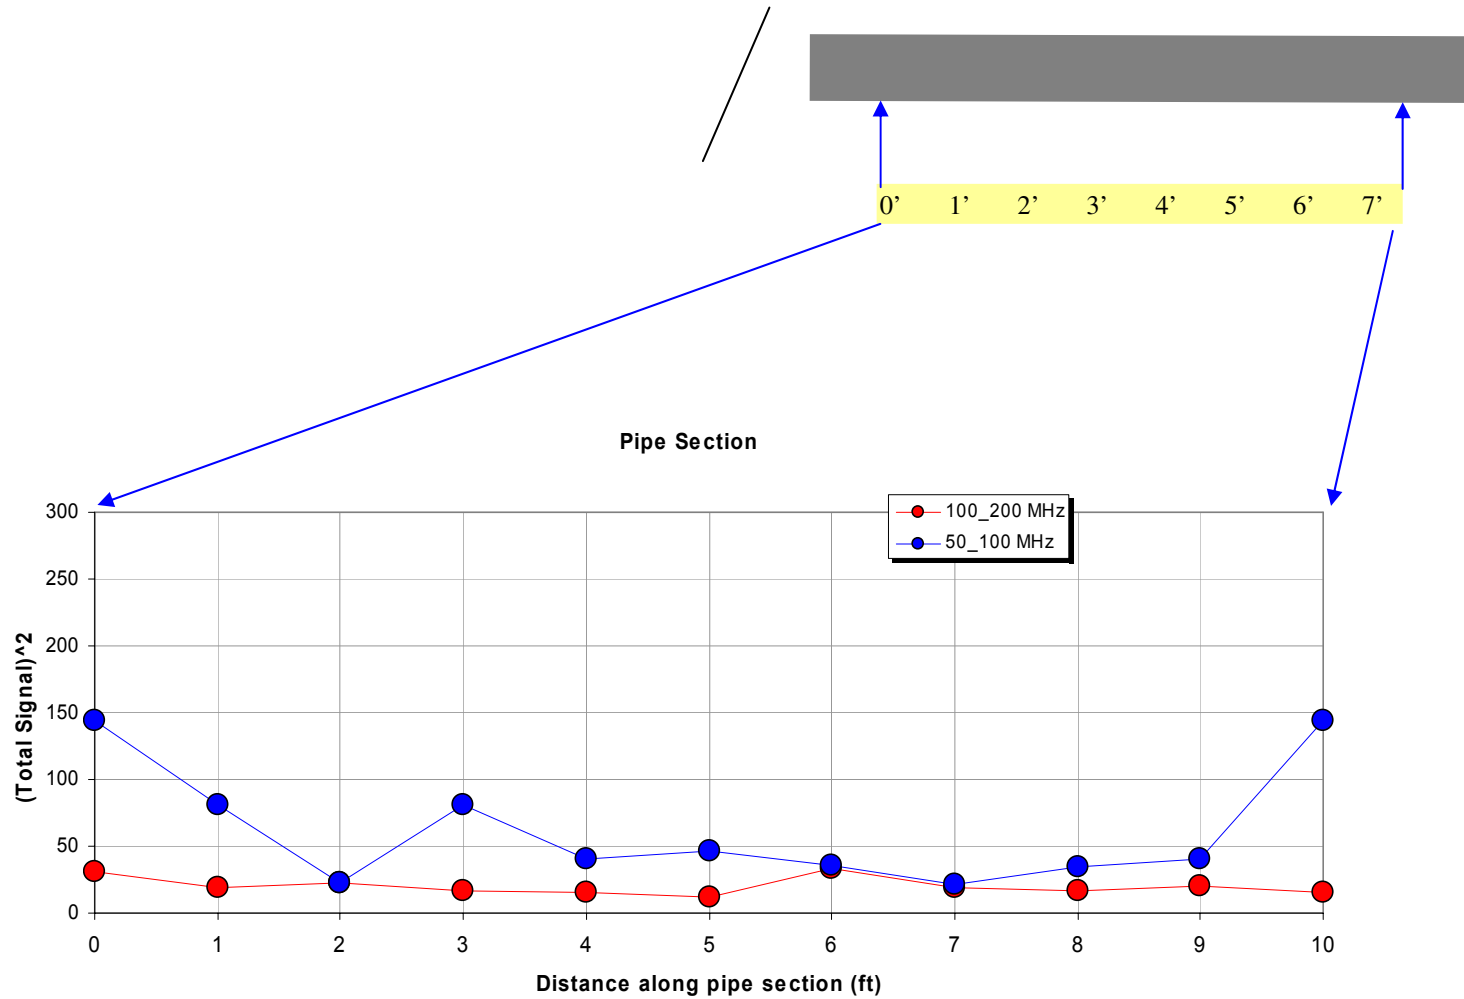
**Figure 10:** Square of total signal from 10-foot pipe section. Notice that the small intensity of signals and the lack of well defined peaks
