Investigation of Cracking on 35-kV Post Insulators Removed from Service

1016044

Technical Update, December 2008

Electric Power Research Institute (EPRI)

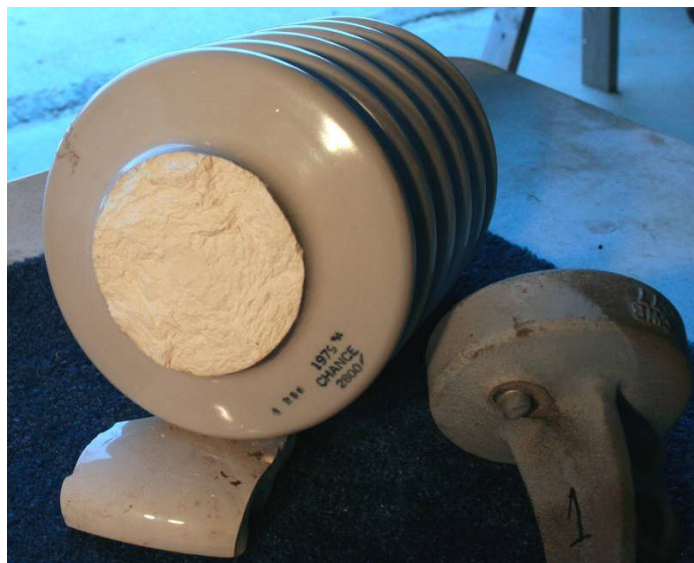
It should be noted that upon opening the shipping crate, sample #1 was found to have broken into two pieces with the energized end cap breaking away from the insulator body as shown in Figure 1-2. This fracture is believed to have occurred during shipping.

**Figure 1-2
Sample #1 Arrived at the Test Facility with the Energized End Broken-Off**

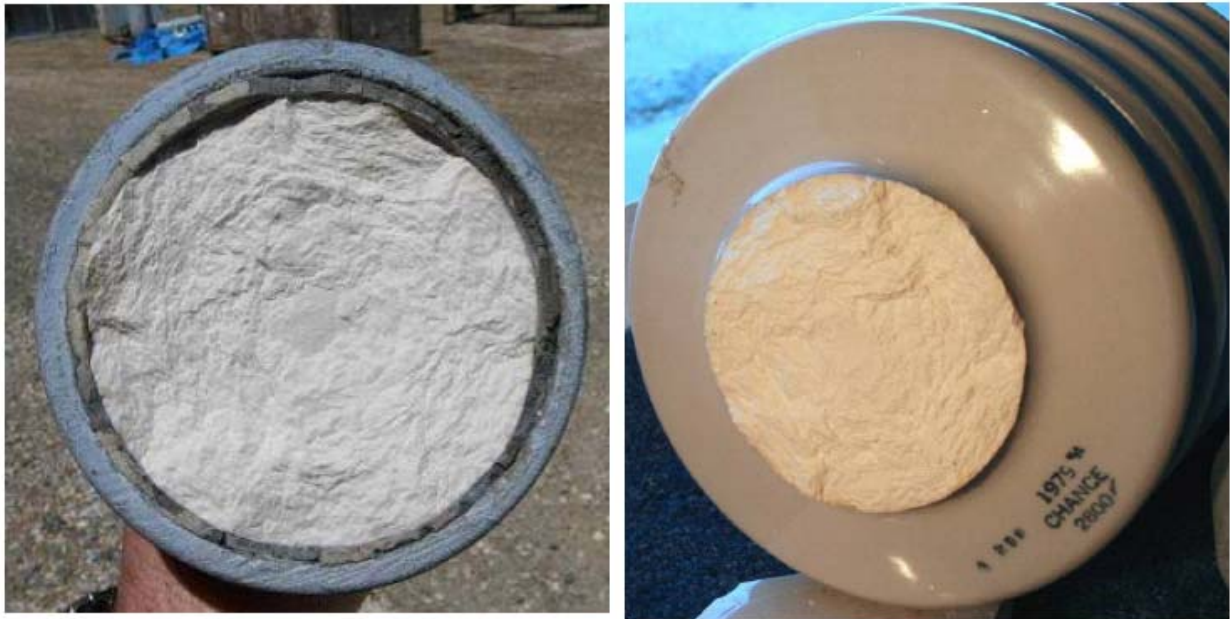
Sample #1 was identified as a CHANCE horizontal line post insulator manufactured in 1979. This unit, bearing the identification number 80-03658WΦ, arrived at the EPRI test facility with the line end trunnion cap broken off (energized end). The line end trunnion cap showed an extremely rough porcelain fracture surface as evident in Figure 2-1.

Figure 2-1
Fracture Surface where the Energized End Broke Away from Sample #1: Endcap (left) and Insulator Body (right)

Sample #1 (1979 CHANCE) exhibits complete vitrification (heat fusion) of the porcelain at the base end with an abrupt transition to incomplete vitrification or underfired porcelain at the line end where the separation failure occurred. This underfired porcelain likely would not pass the dye penetration test for porosity in ANSI C29.1.

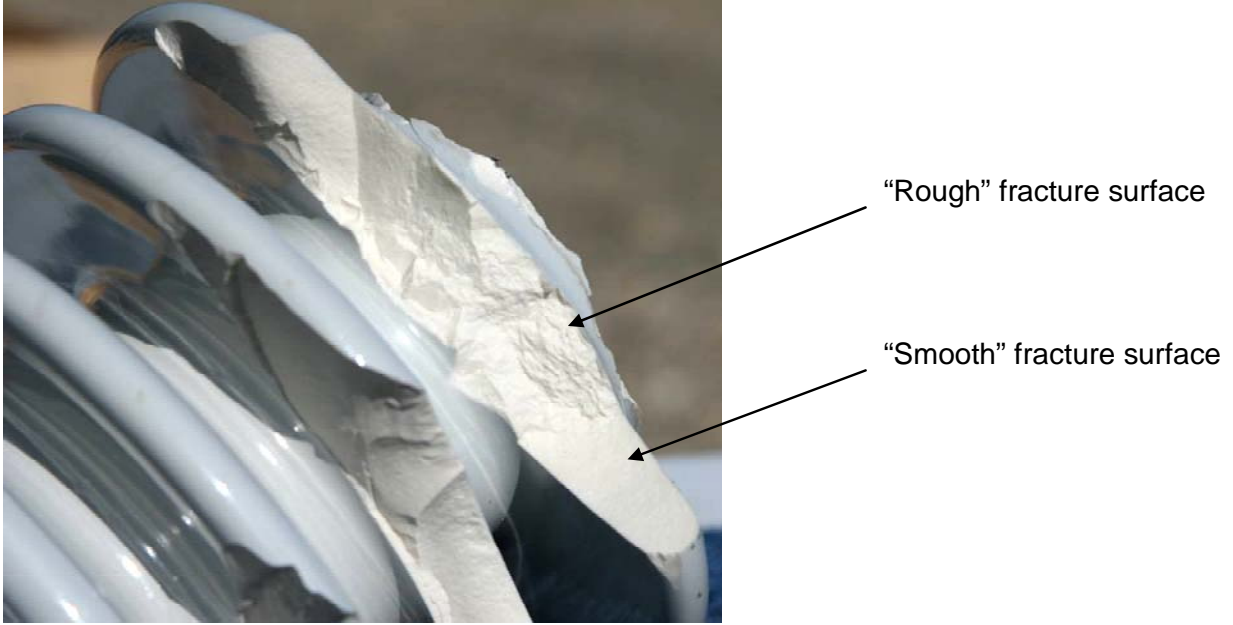
The first and second sheds from the energized end were broken via sledge hammer impact in order to observe how the porcelain material fractured further down the insulator body. Breaking the sheds below the energized end showed progressively less “roughness” of the fractured surface as seen in Figure 2-2. Figure 2-3 shows that sample #1 was also broken closer to the ground end fitting and exhibited a very smooth fracture surface in that area.

Figure 2-2
Fracture Surfaces of First and Second Sheds Below the Energized Trunnion Cap of Sample #1

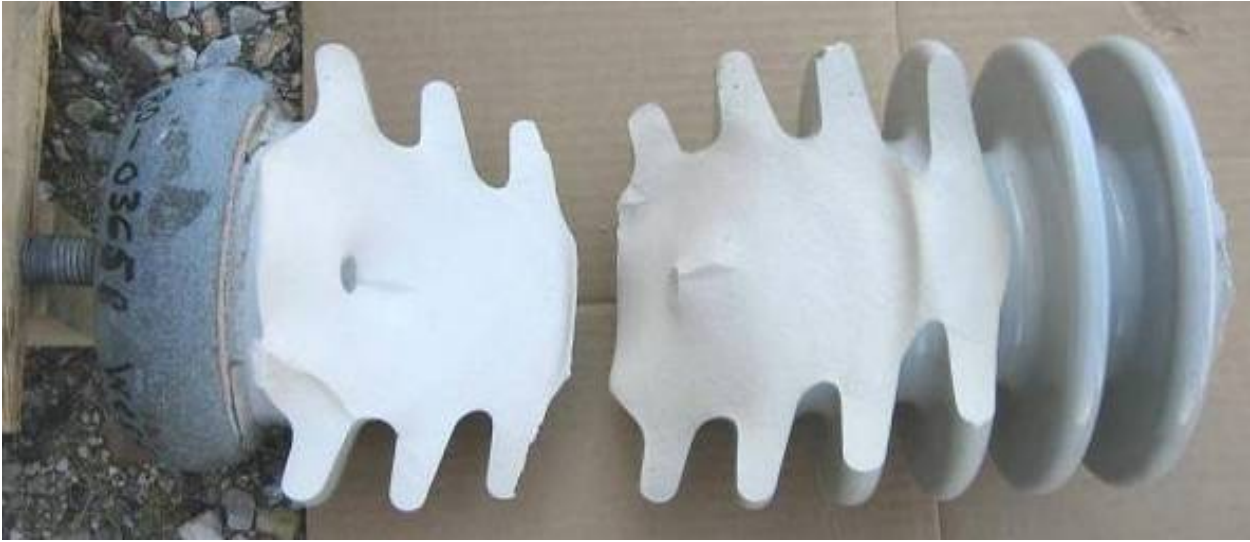
Figure 2-3
Fracture Surface at the Ground End of Sample #1

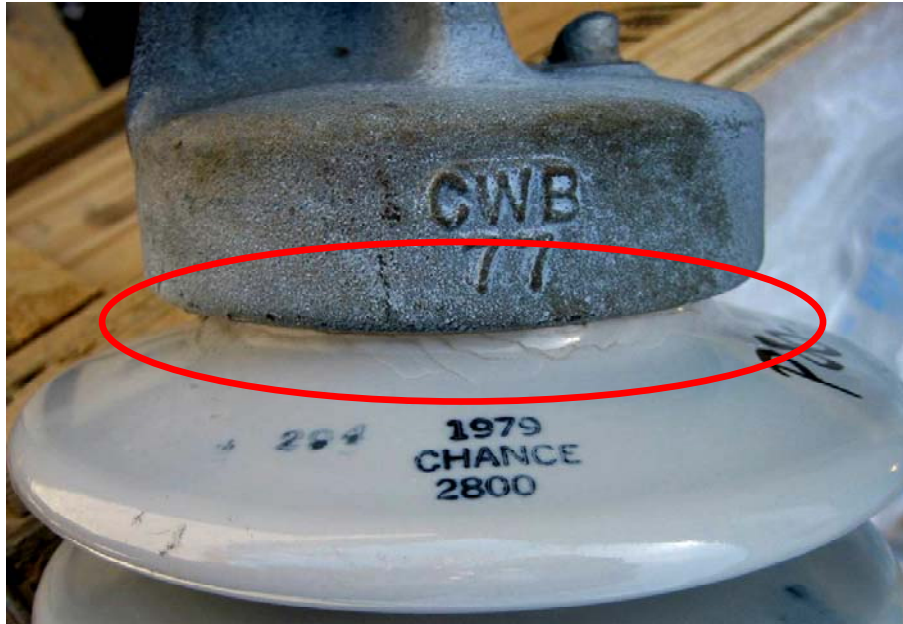
Sample #2 was identified as a 1979 A CHANCE horizontal line post insulator which showed a region of finely divided cracks in the glaze just below the line end trunnion cap as shown in Figure 2-4 and Figure 2-5.

Figure 2-4
Sample #2 Showed a Region of Finely Divided Cracks Just Below the Trunnion Cap

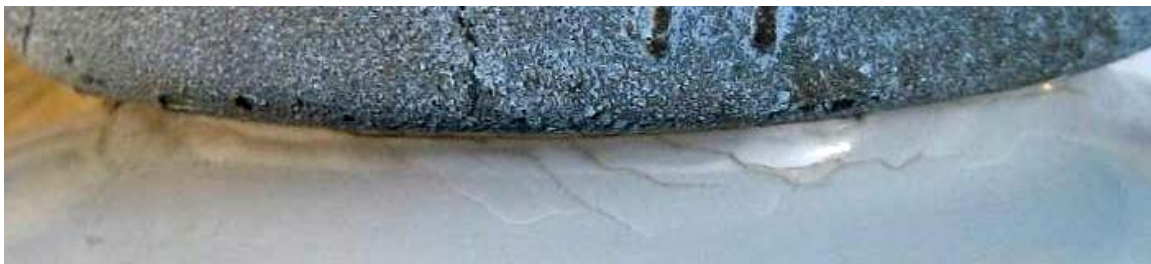
Figure 2-5
Close-Up View of Cracks Just Below the Energized Trunnion Cap of Sample #2

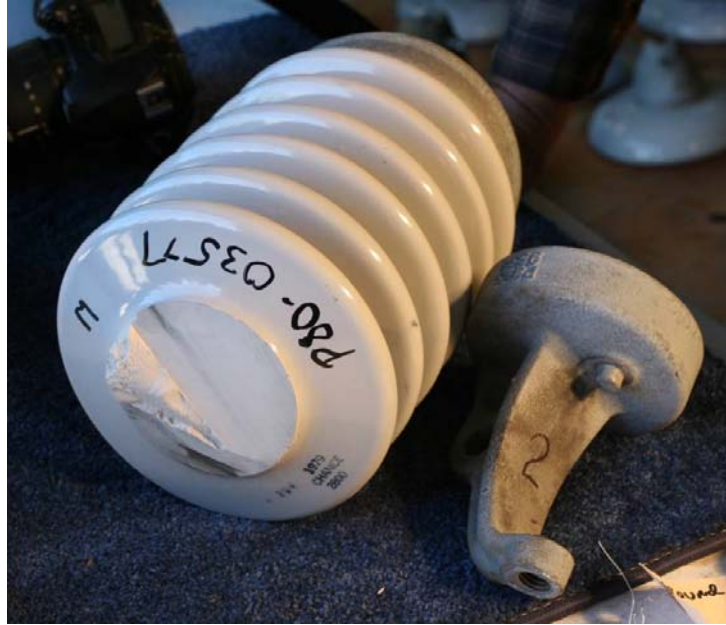
Figure 2-6
The Trunnion Cap was Cut from the Energized End of Sample #2

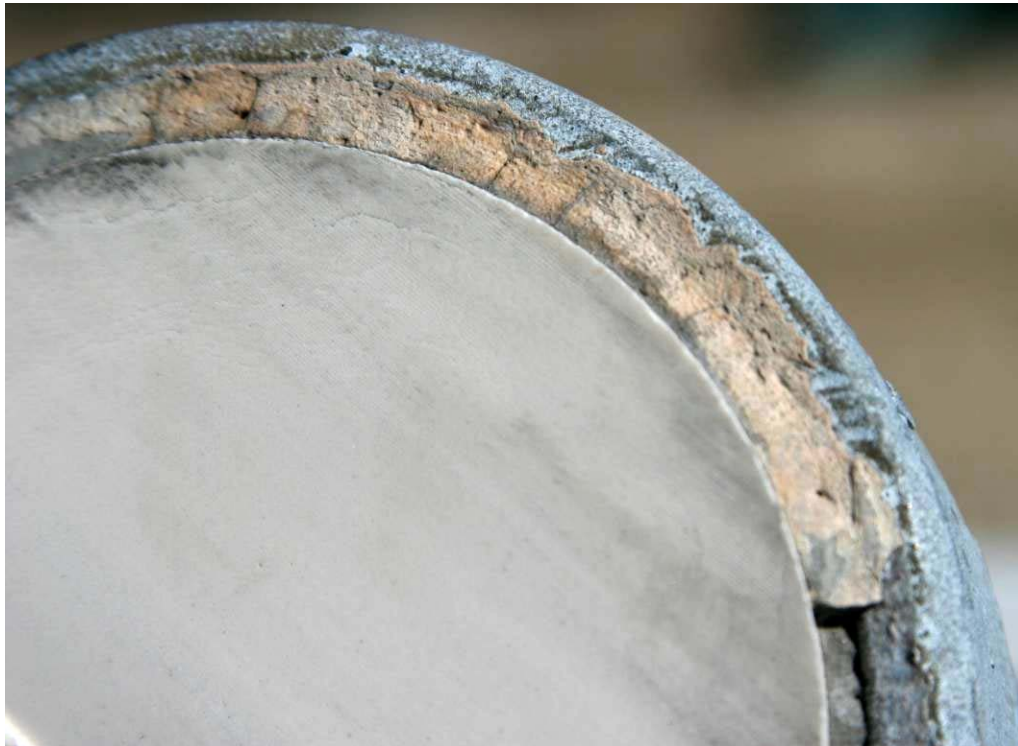
The trunnion cap on the energized end was cut from sample #2 (Figure 2-6) using a band saw equipped with a diamond coated blade. Cutting revealed a multitude of small cracks in the vicinity of the circumference of the post as shown in Figure 2-7. The cracks can be difficult to see in the photograph since the cutting action polishes the surface.

Figure 2-7
Cut Surface of Sample #2 Showing Cracks Near the Circumference of the Insulator

Sample #2 (1979 CHANCE) was cut between the energized line-end trunnion cap and the first shed. Cutting this sample for inspection revealed a multitude of small cracks and fissures penetrating into the insulator. The cutting process polishes the cut surface making underfired porcelain less evident. However, the small cracks and fissures present in the sample are indicative of a layered structure and consistent with underfired porcelain. The sheds adjacent to the energized end of the insulator were subsequently broken to examine the fracture surfaces. The broken surfaces revealed a small area of incomplete vitrification near the energized end.

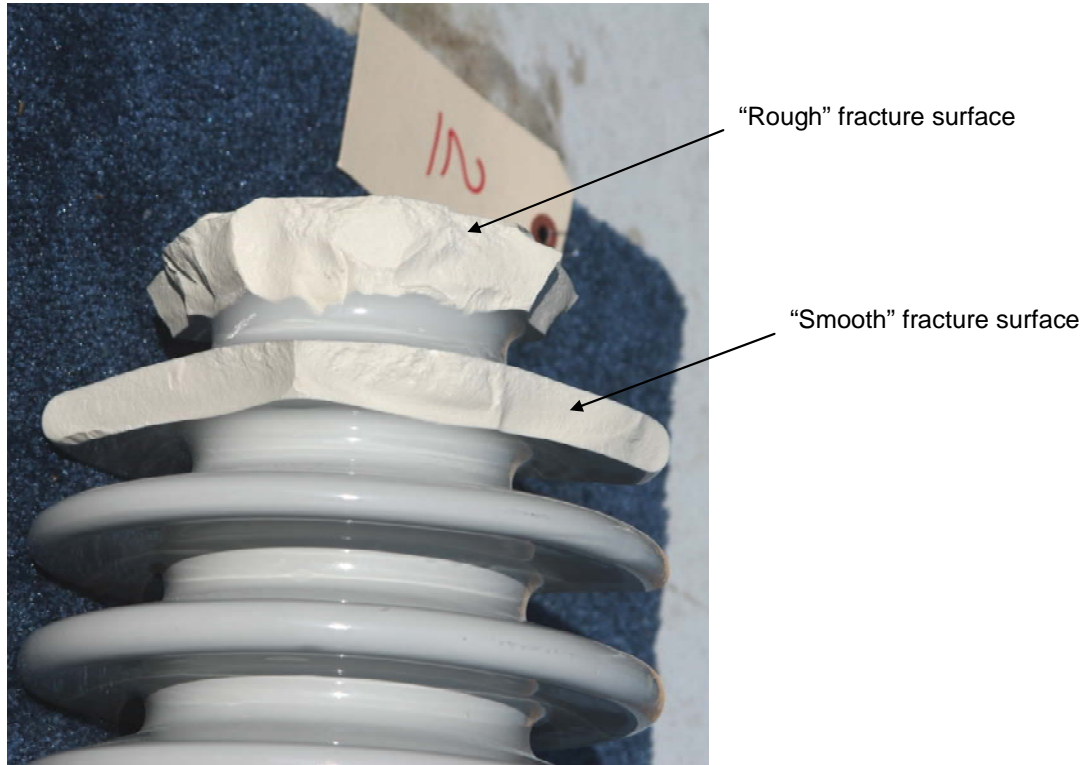
The porcelain sheds of sample #2 were broken with a sledge hammer to observe the fracture surface along the breaks. Sample #2 exhibited a small area of “rough” fracture on the energized end near where the trunnion cap connects to the insulator body as shown in Figure 2-8.

Figure 2-8
Fracture Surfaces of First and Second Sheds Below the Energized Trunnion Cap of Sample #2

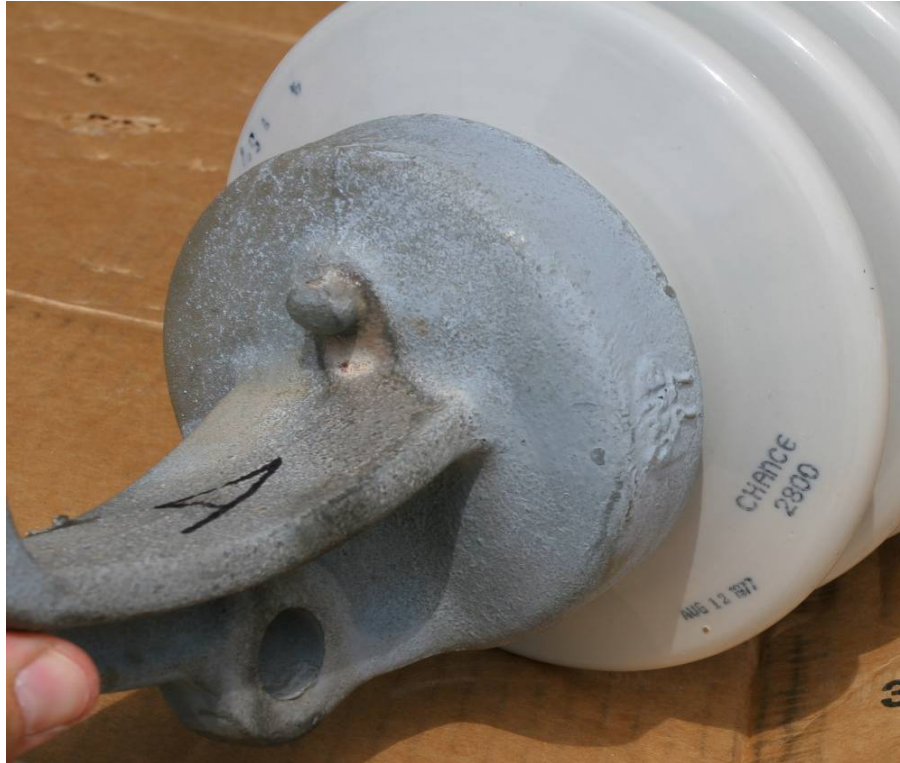
Sample #4 was identified as a CHANCE unit with a date marking of August 12, 1977 on the first shed as shown in Figure 2-9. Sample #4 was also marked 80-03593 WΦ. Sample #4 was chosen for evaluation because it did not show any outward signs of cracking or crazing.

Figure 2-9
Energized End of Sample #4 Showing a Manufacturing Date of “Aug 12 1977”

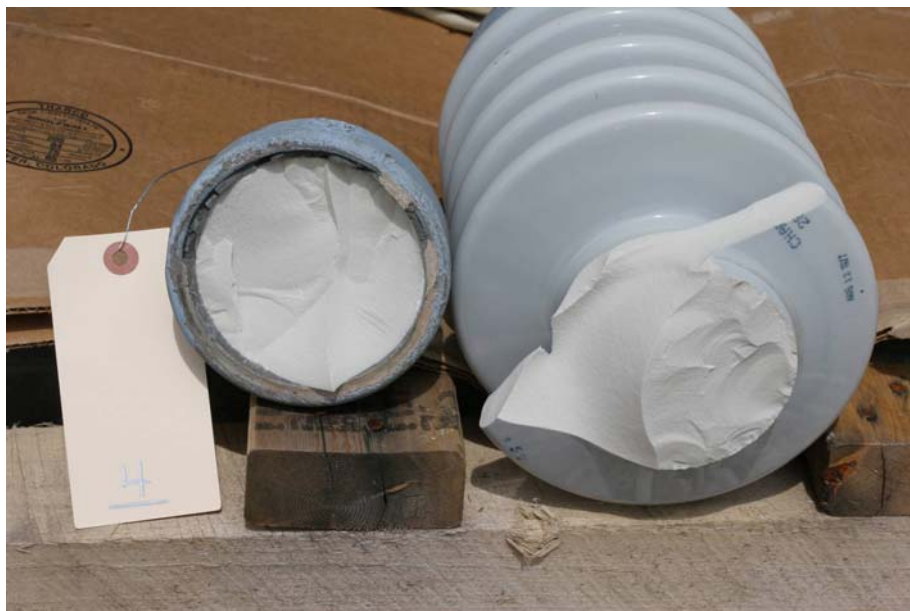
Figure 2-10
Fracture Surface of Sample #4 where the Energized End Trunnion Cap was Broken from the Sample

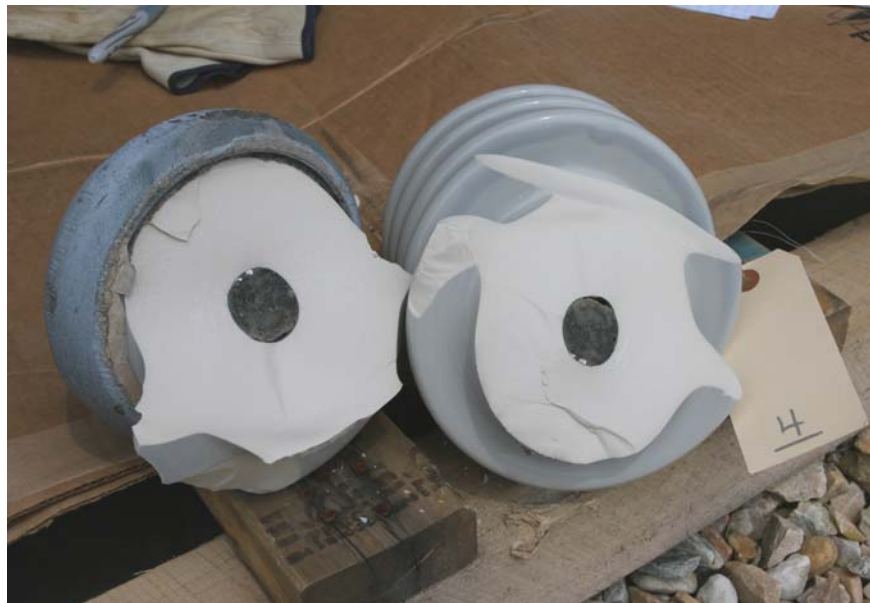
Sample #4 was broken via sledge hammer impact in order to observe how the porcelain material fractured. The initial hammer blow broke the energized end trunnion cap away from the insulator body as shown in Figure 2-10. The bulk of the insulator body was then broken as shown in Figure 2-11. Finally, the base end cap was broken from the insulator body (Figure 2-12). All fracture surfaces appeared smooth and the insulator body appeared to be uniform in texture from end-to-end with no signs of underfired porcelain.

Figure 2-12
Fracture Surface of Sample #4 where the Base Cap was Broken from the Insulator Body

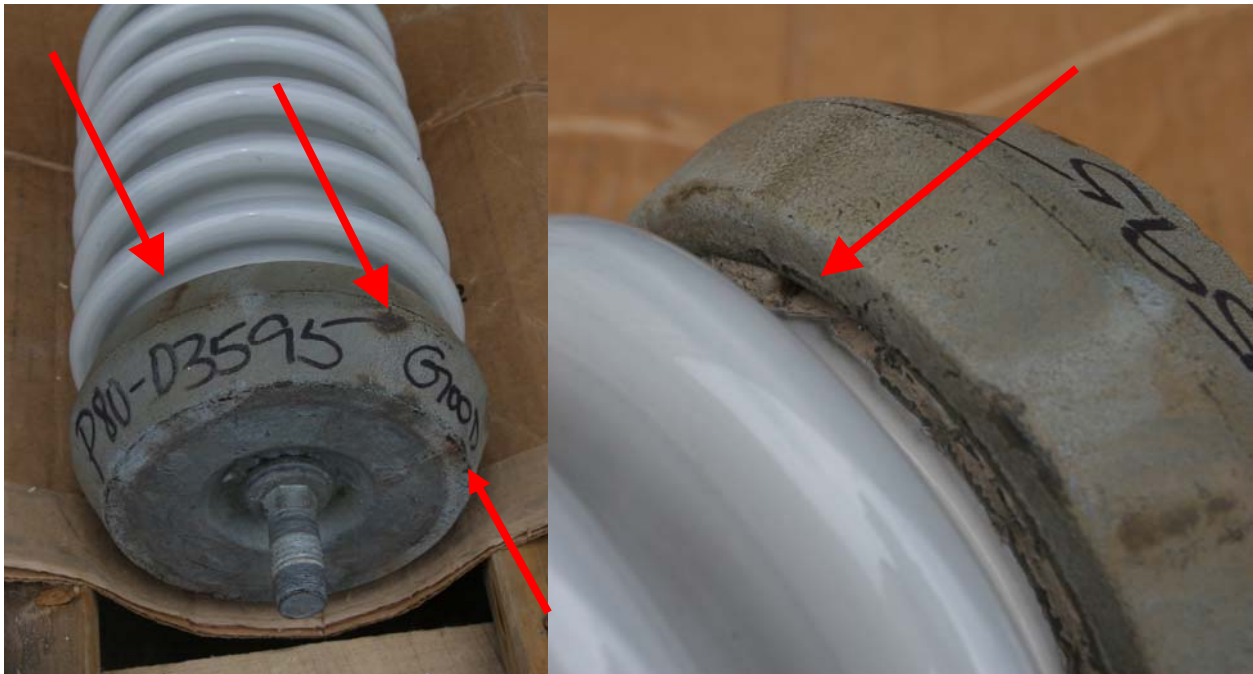
Sample #7 was identified as a 1979 Lapp insulator with the marking P80-03595. Sample #7 did not show any outward signs of cracking or crazing. There was a small section of cement missing from around the pole-end cap but this was deemed inconsequential. Sample #7 also showed several marks of undetermined origin on the base end cap as shown in Figure 2-13. These marks were not evident on the energized-end trunnion cap.

Figure 2-13
Sample #7 Showing Marks on Base End Cap and Small Section of Missing Cement around Base End Cap

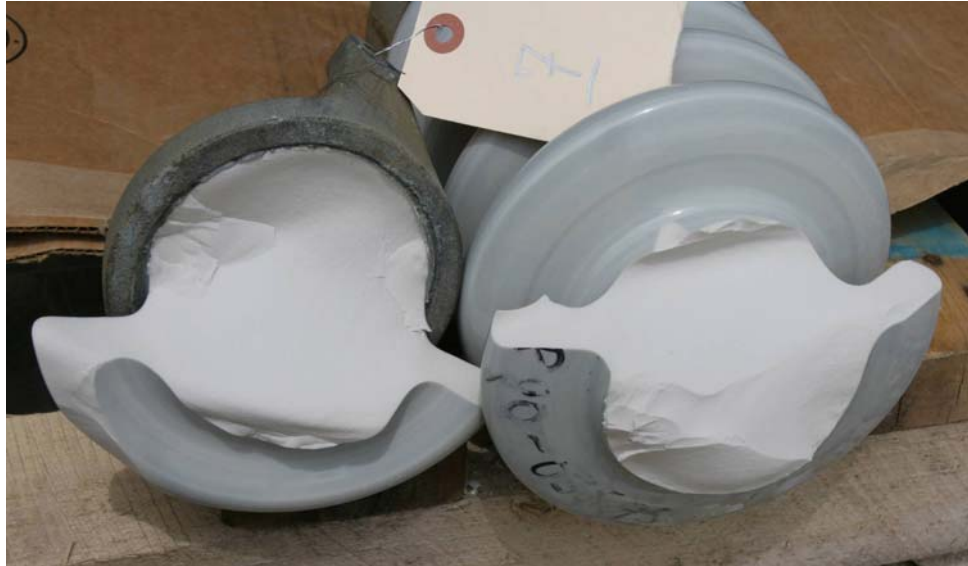
Figure 2-14
Fracture Surface of Sample #7 where the Energized End Trunnion Cap was Broken from the Sample

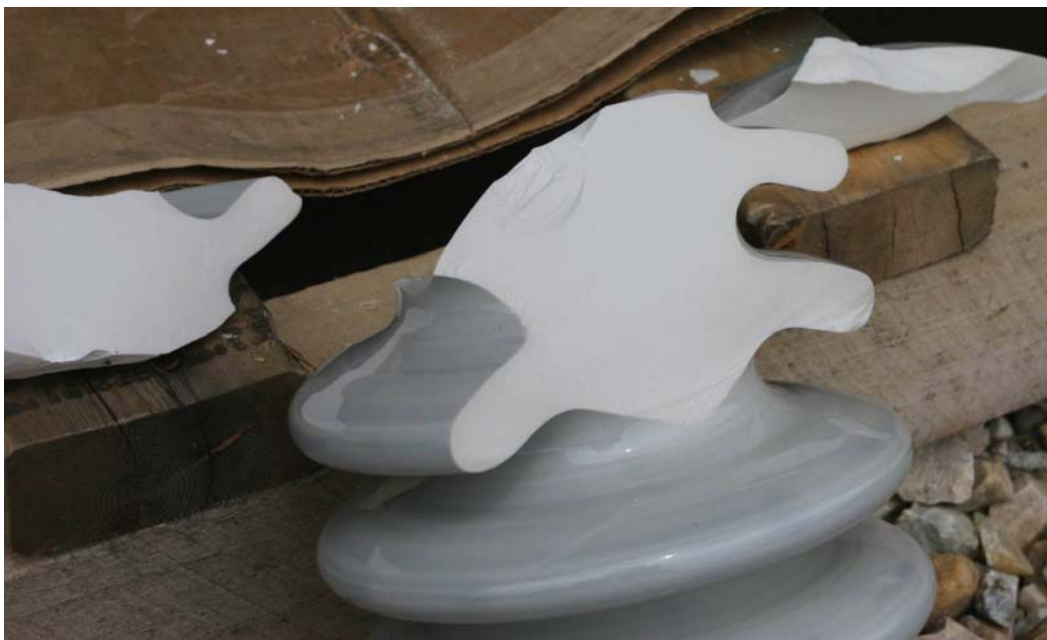
Figure 2-15
Fracture Surface of Sample #7 along the Insulator Body

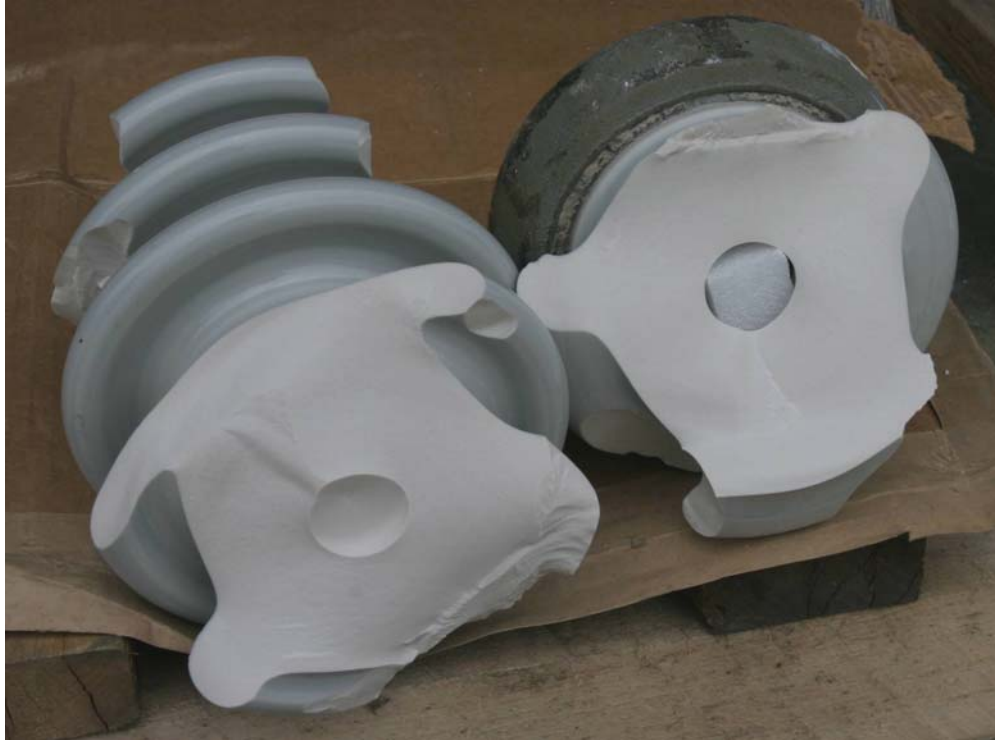
Sample #7 was broken via sledge hammer impact in order to observe how the porcelain material fractured. The initial hammer blow broke the energized end trunnion cap away from the insulator body as shown in Figure 2-14. The bulk of the insulator body was then broken as shown in Figure 2-15. Finally, the base end cap was broken from the insulator body (Figure 2-16). All fracture surfaces appeared smooth and the insulator body appeared to be uniform in texture from end-to-end with no signs of underfired porcelain.

Note that the polystyrene cube visible in the chucking hole in Figure 2-16 is a normal part of the manufacturing process. This configuration is used to prevent cement expansion from exerting a hoop stress on the porcelain body that could result in fracture.

Figure 2-16
Fracture Surface of Sample #7 where the Base End Cap was Broken from the Insulator Body
(note that the polystyrene cube in the chucking hole is a normal part of the manufacturing process)
