Investigation of Cracking on 35-kV Post Insulators Removed from Service

1016044

Technical Update, December 2008

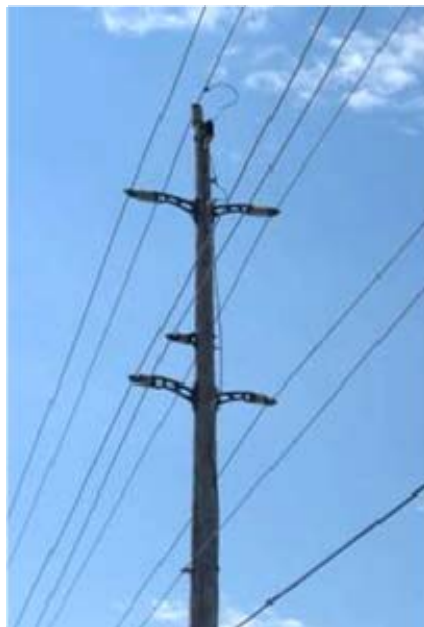
We Energies experienced an elevated occurrence of failures of 34.5-kV porcelain post insulators on their distribution system during spring 2008. The insulators are used in an armless overbuilt circuit design as shown in Figure 1-1. The top circuit is operated at 24.9 kV and the bottom circuit is operated at 8 kV. The insulators in question are used on the top (24.9 kV) circuit.

Figure 1-1
Example of the Armless Construction Design Employed on the We Energies Distribution System

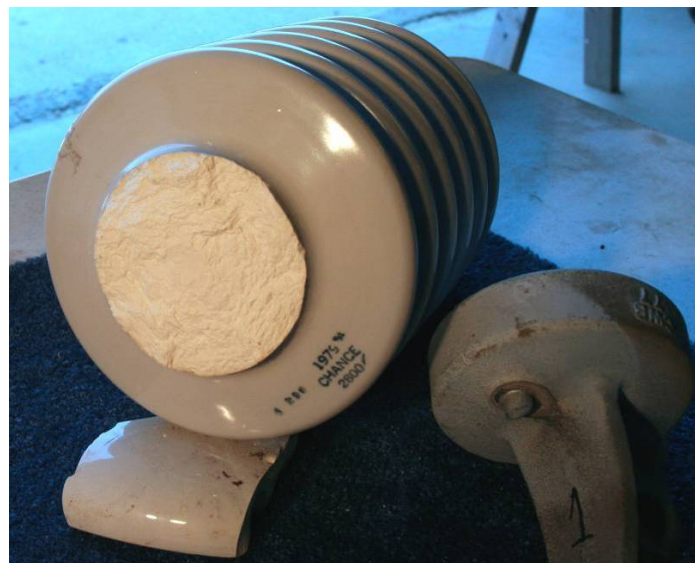
It should be noted that upon opening the shipping crate, sample #1 was found to have broken into two pieces with the energized end cap breaking away from the insulator body as shown in Figure 1-2. This fracture is believed to have occurred during shipping.

Figure 1-2
Sample #1 Arrived at the Test Facility with the Energized End Broken-Off

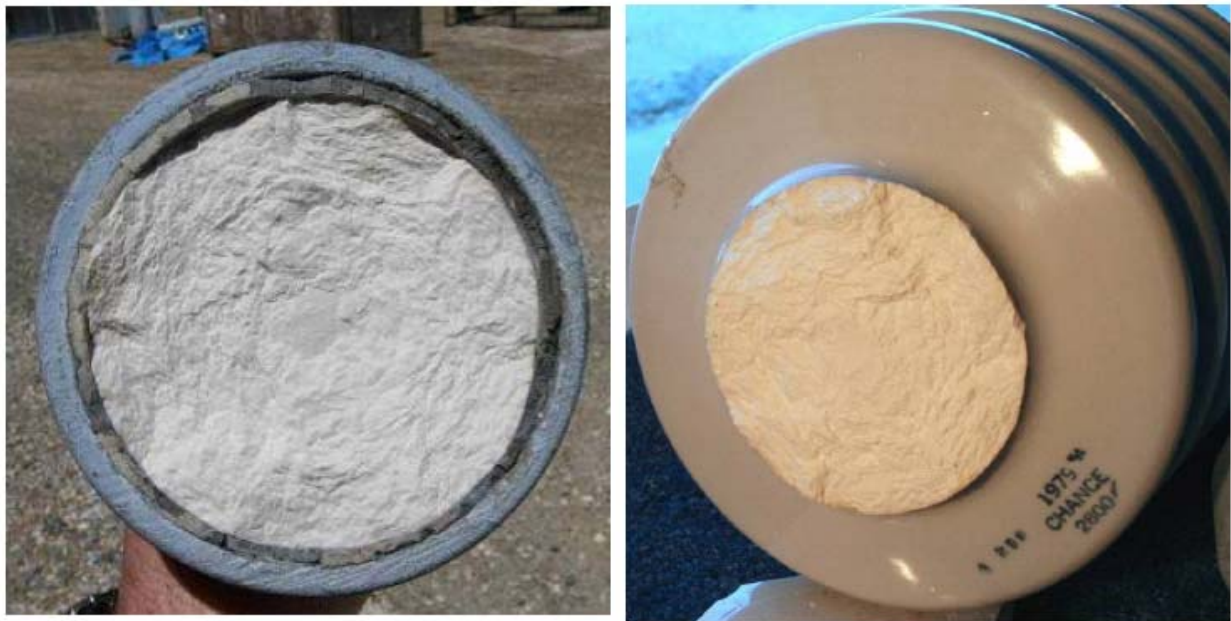
Sample #1 was identified as a CHANCE horizontal line post insulator manufactured in 1979. This unit, bearing the identification number 80-03658WΦ, arrived at the EPRI test facility with the line end trunnion cap broken off (energized end). The line end trunnion cap showed an extremely rough porcelain fracture surface as evident in Figure 2-1.

Figure 2-1
Fracture Surface where the Energized End Broke Away from Sample #1: Endcap (left) and Insulator Body (right)

Sample #1 (1979 CHANCE) exhibits complete vitrification (heat fusion) of the porcelain at the base end with an abrupt transition to incomplete vitrification or underfired porcelain at the line end where the separation failure occurred. This underfired porcelain likely would not pass the dye penetration test for porosity in ANSI C29.1.

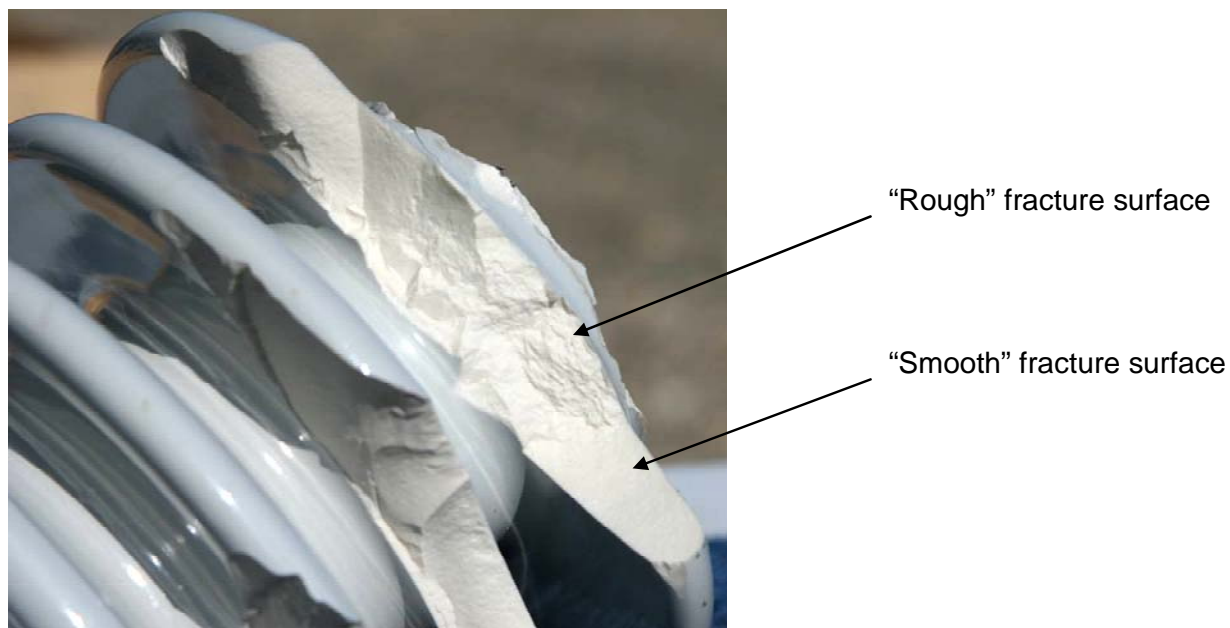
The first and second sheds from the energized end were broken via sledge hammer impact in order to observe how the porcelain material fractured further down the insulator body. Breaking the sheds below the energized end showed progressively less “roughness” of the fractured surface as seen in Figure 2-2. Figure 2-3 shows that sample #1 was also broken closer to the ground end fitting and exhibited a very smooth fracture surface in that area.

Figure 2-2
Fracture Surfaces of First and Second Sheds Below the Energized Trunnion Cap of Sample #1

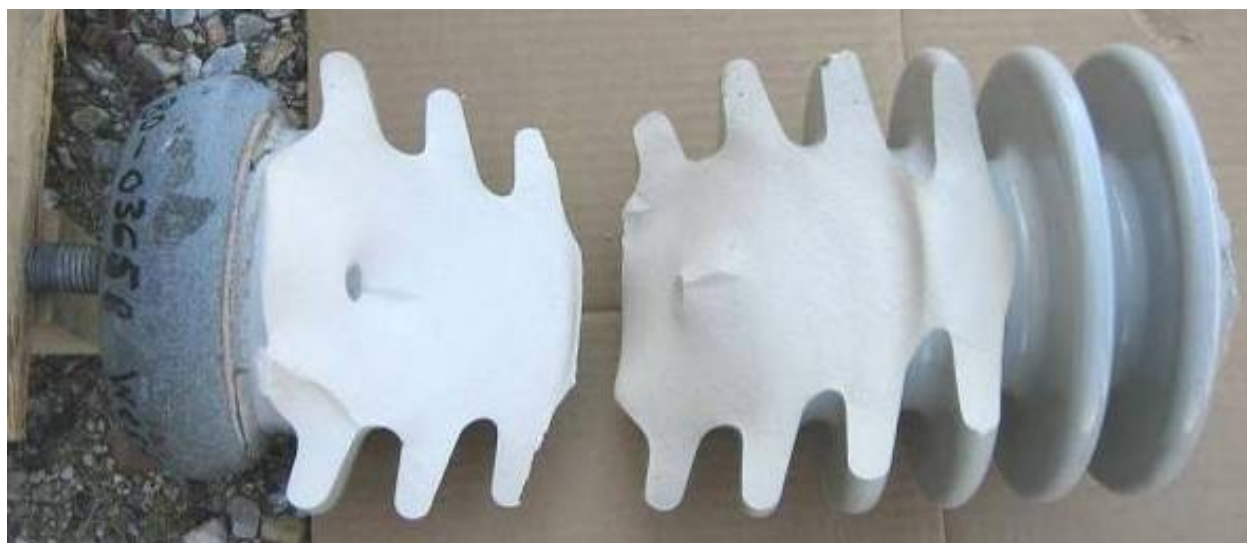
Figure 2-3
Fracture Surface at the Ground End of Sample #1

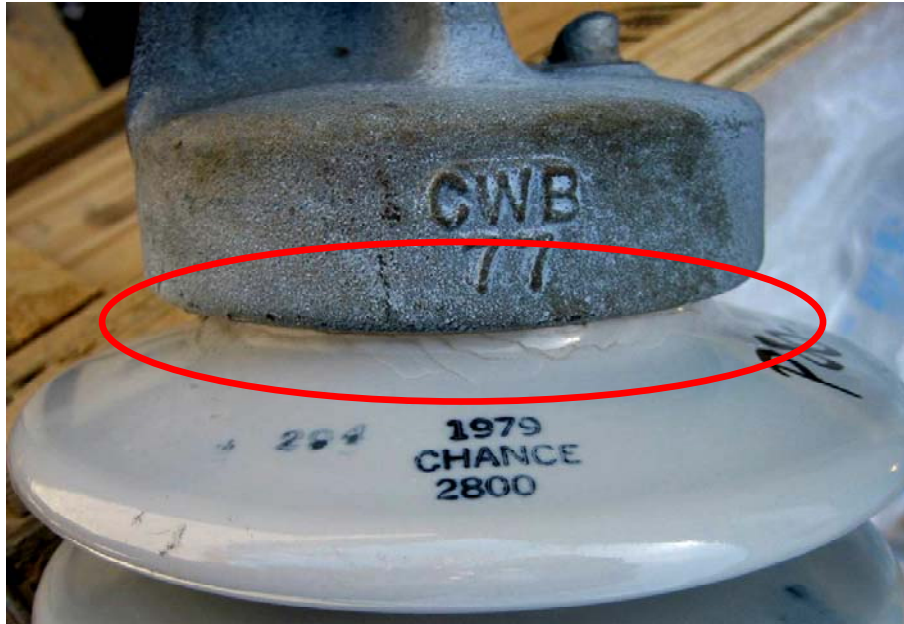
Sample #2 was identified as a 1979 A CHANCE horizontal line post insulator which showed a region of finely divided cracks in the glaze just below the line end trunnion cap as shown in Figure 2-4 and Figure 2-5.

Figure 2-4
Sample #2 Showed a Region of Finely Divided Cracks Just Below the Trunnion Cap

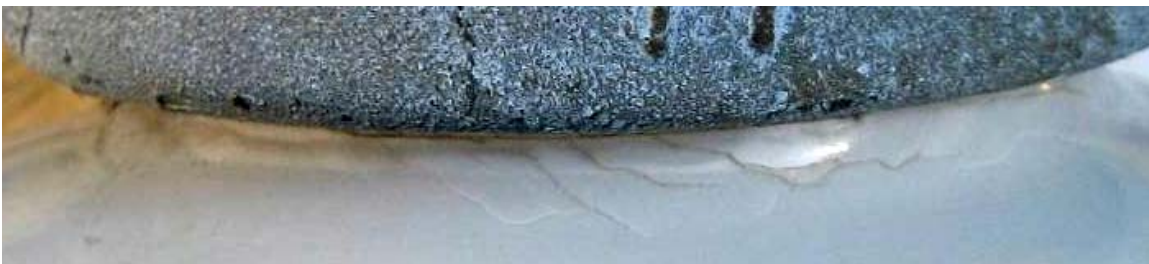
Figure 2-5
Close-Up View of Cracks Just Below the Energized Trunnion Cap of Sample #2

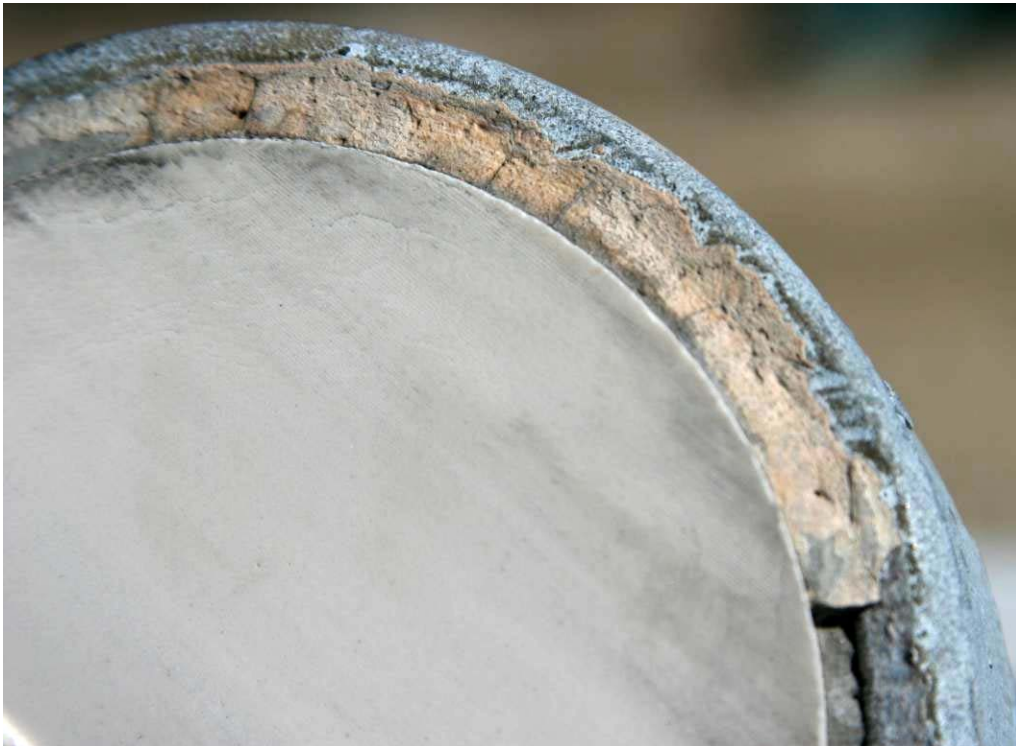
The trunnion cap on the energized end was cut from sample #2 (Figure 2-6) using a band saw equipped with a diamond coated blade. Cutting revealed a multitude of small cracks in the vicinity of the circumference of the post as shown in Figure 2-7. The cracks can be difficult to see in the photograph since the cutting action polishes the surface.

Figure 2-7
Cut Surface of Sample #2 Showing Cracks Near the Circumference of the Insulator

Sample #2 (1979 CHANCE) was cut between the energized line-end trunnion cap and the first shed. Cutting this sample for inspection revealed a multitude of small cracks and fissures penetrating into the insulator. The cutting process polishes the cut surface making underfired porcelain less evident. However, the small cracks and fissures present in the sample are indicative of a layered structure and consistent with underfired porcelain. The sheds adjacent to the energized end of the insulator were subsequently broken to examine the fracture surfaces. The broken surfaces revealed a small area of incomplete vitrification near the energized end.

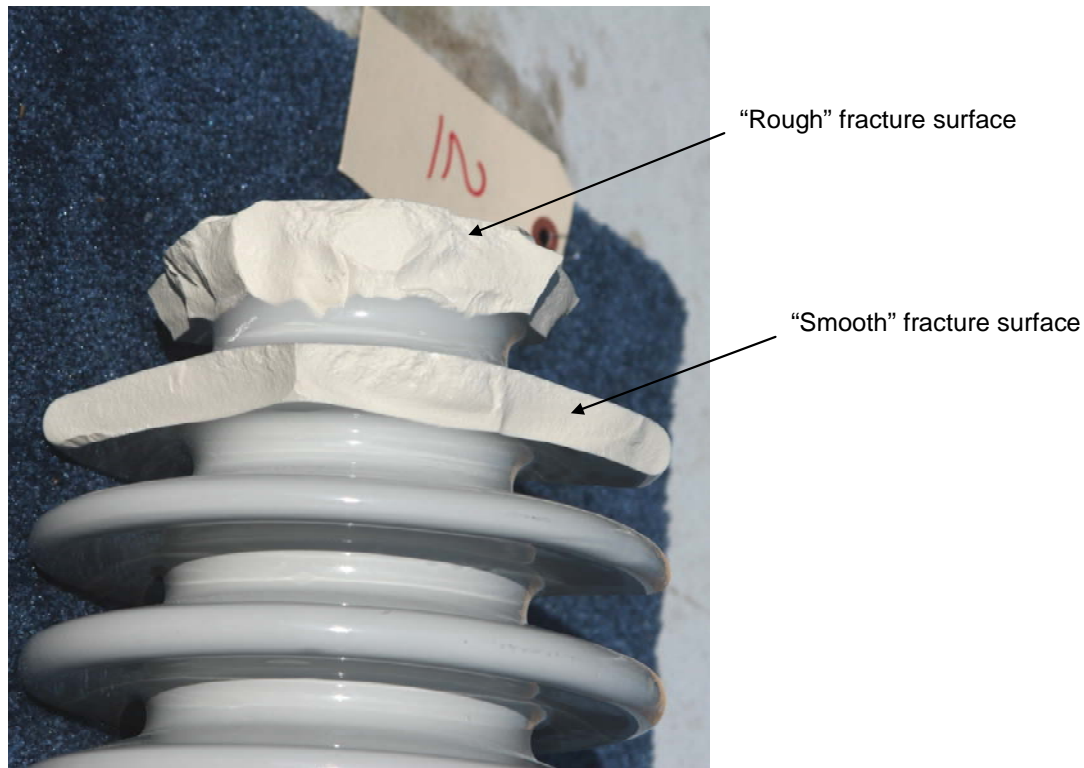
The porcelain sheds of sample #2 were broken with a sledge hammer to observe the fracture surface along the breaks. Sample #2 exhibited a small area of “rough” fracture on the energized end near where the trunnion cap connects to the insulator body as shown in Figure 2-8.

Figure 2-8
Fracture Surfaces of First and Second Sheds Below the Energized Trunnion Cap of Sample #2

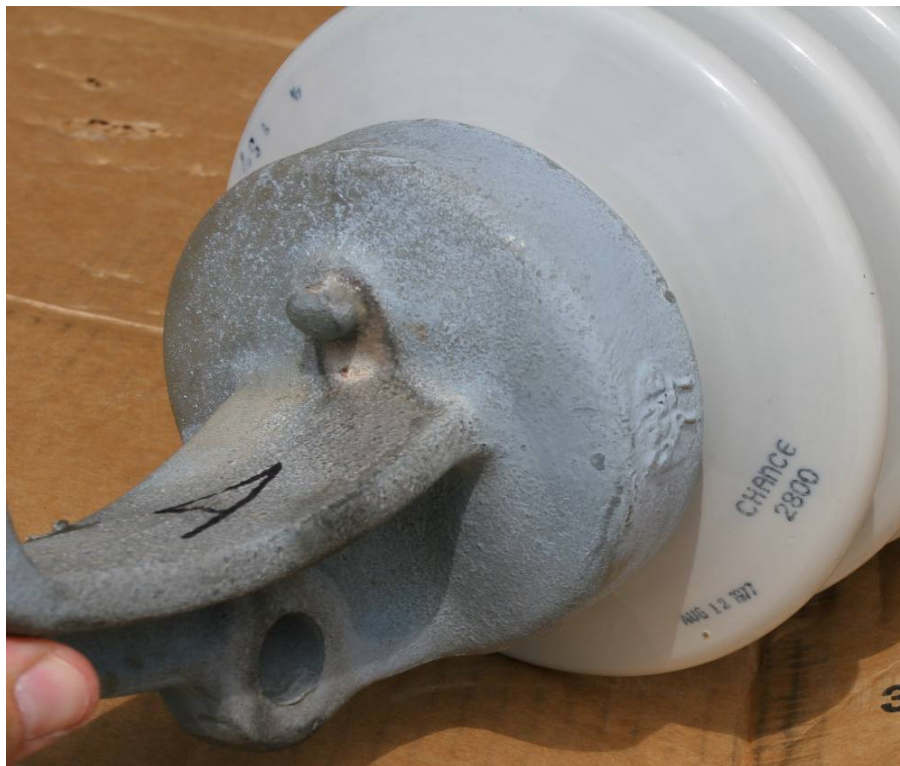
Sample #4 was identified as a CHANCE unit with a date marking of August 12, 1977 on the first shed as shown in Figure 2-9. Sample #4 was also marked 80-03593 WΦ. Sample #4 was chosen for evaluation because it did not show any outward signs of cracking or crazing.

Figure 2-9
Energized End of Sample #4 Showing a Manufacturing Date of “Aug 12 1977”

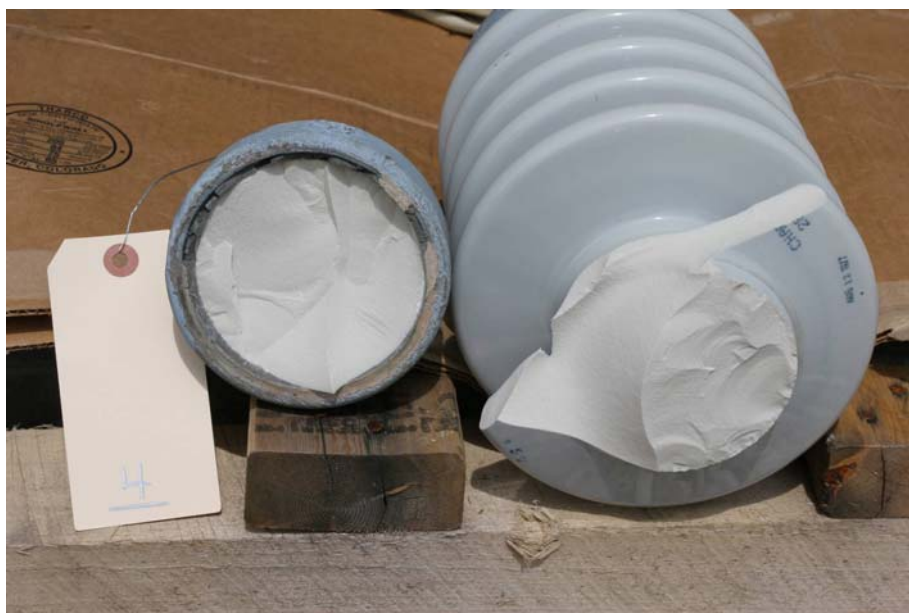
Sample #4 was broken via sledge hammer impact in order to observe how the porcelain material fractured. The initial hammer blow broke the energized end trunnion cap away from the insulator body as shown in Figure 2-10. The bulk of the insulator body was then broken as shown in Figure 2-11. Finally, the base end cap was broken from the insulator body (Figure 2-12). All fracture surfaces appeared smooth and the insulator body appeared to be uniform in texture from end-to-end with no signs of underfired porcelain.

Figure 2-10
Fracture Surface of Sample #4 where the Energized End Trunnion Cap was Broken from the Sample

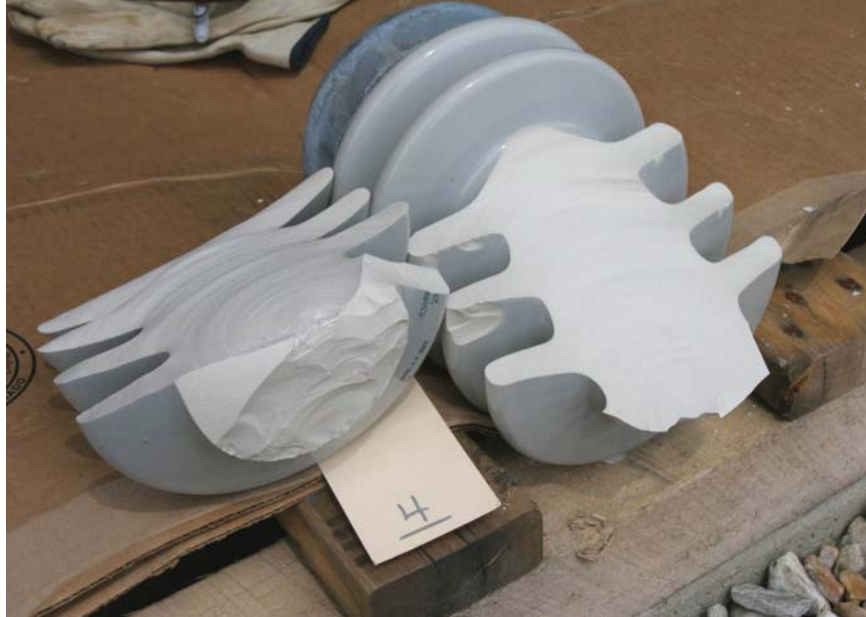
Figure 2-11
Fracture Surface of Sample #4 along the Insulator Body

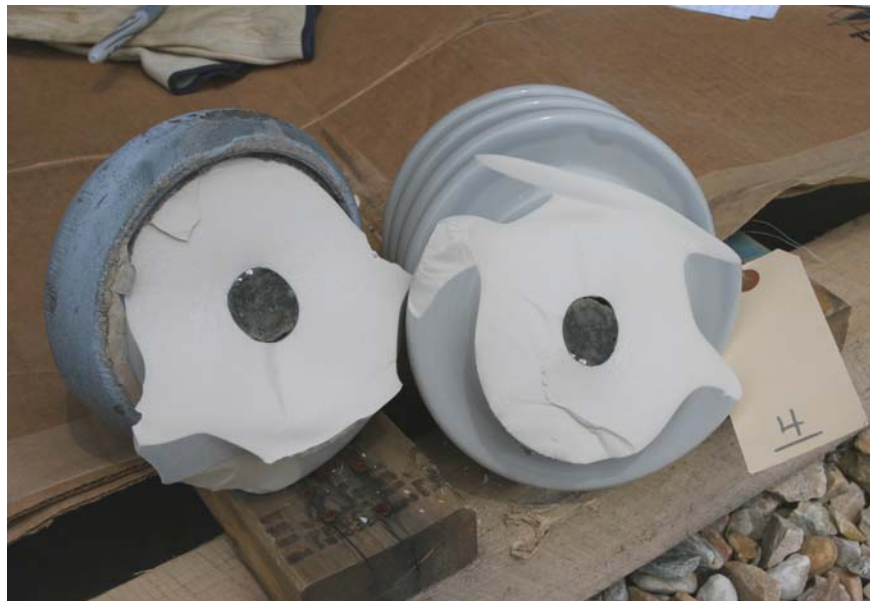
Figure 2-12
Fracture Surface of Sample #4 where the Base Cap was Broken from the Insulator Body

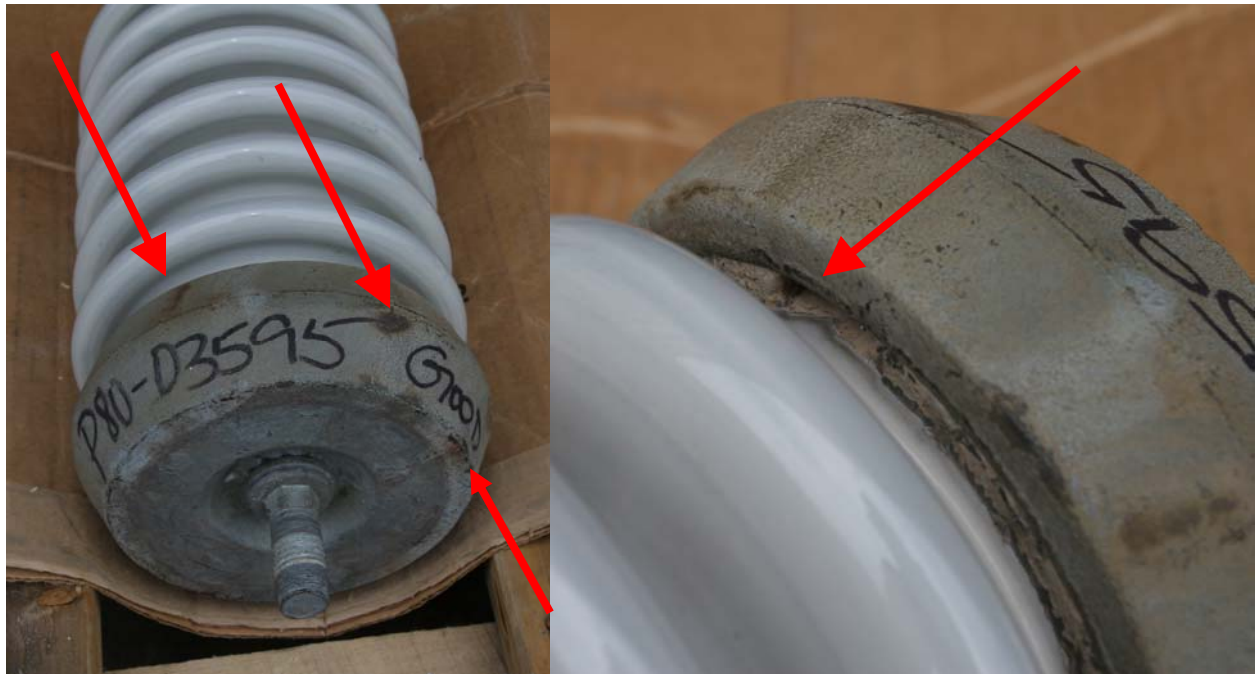
Sample #7 was identified as a 1979 Lapp insulator with the marking P80-03595. Sample #7 did not show any outward signs of cracking or crazing. There was a small section of cement missing from around the pole-end cap but this was deemed inconsequential. Sample #7 also showed several marks of undetermined origin on the base end cap as shown in Figure 2-13. These marks were not evident on the energized-end trunnion cap.

Figure 2-13
Sample #7 Showing Marks on Base End Cap and Small Section of Missing Cement around Base End Cap

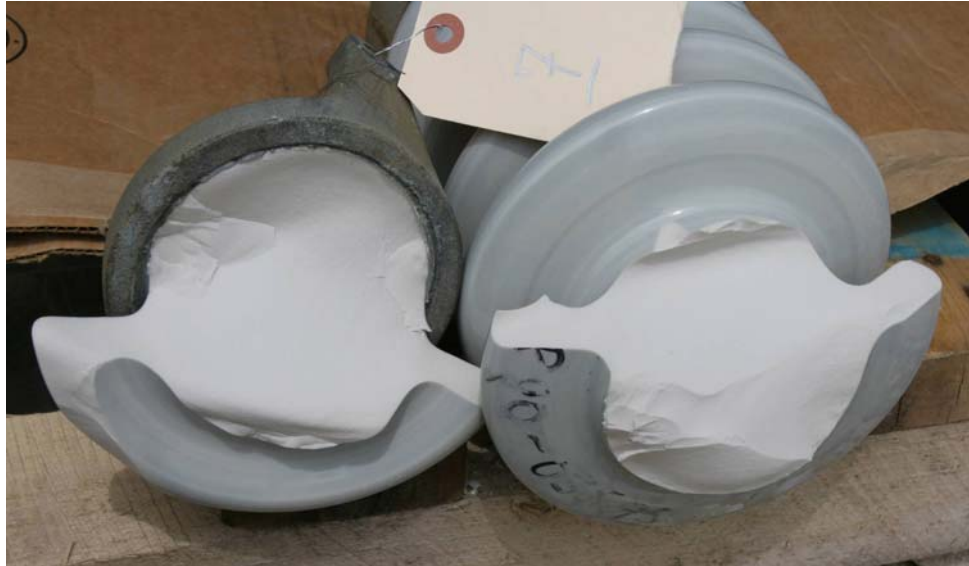
Sample #7 was broken via sledge hammer impact in order to observe how the porcelain material fractured. The initial hammer blow broke the energized end trunnion cap away from the insulator body as shown in Figure 2-14. The bulk of the insulator body was then broken as shown in Figure 2-15. Finally, the base end cap was broken from the insulator body (Figure 2-16). All fracture surfaces appeared smooth and the insulator body appeared to be uniform in texture from end-to-end with no signs of underfired porcelain.

Figure 2-14
Fracture Surface of Sample #7 where the Energized End Trunnion Cap was Broken from the Sample

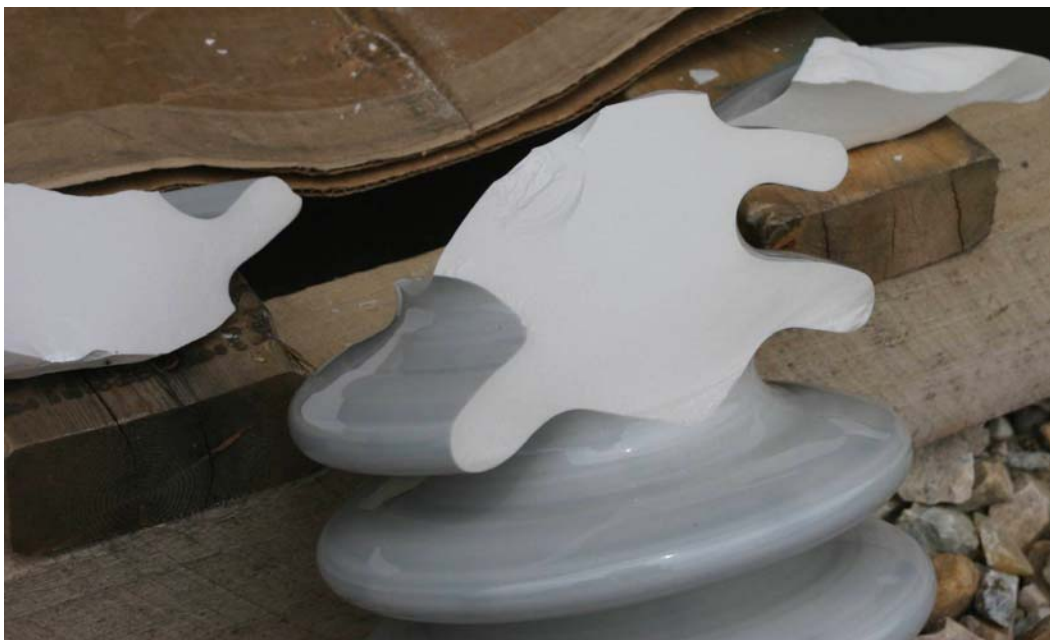
Figure 2-15
Fracture Surface of Sample #7 along the Insulator Body

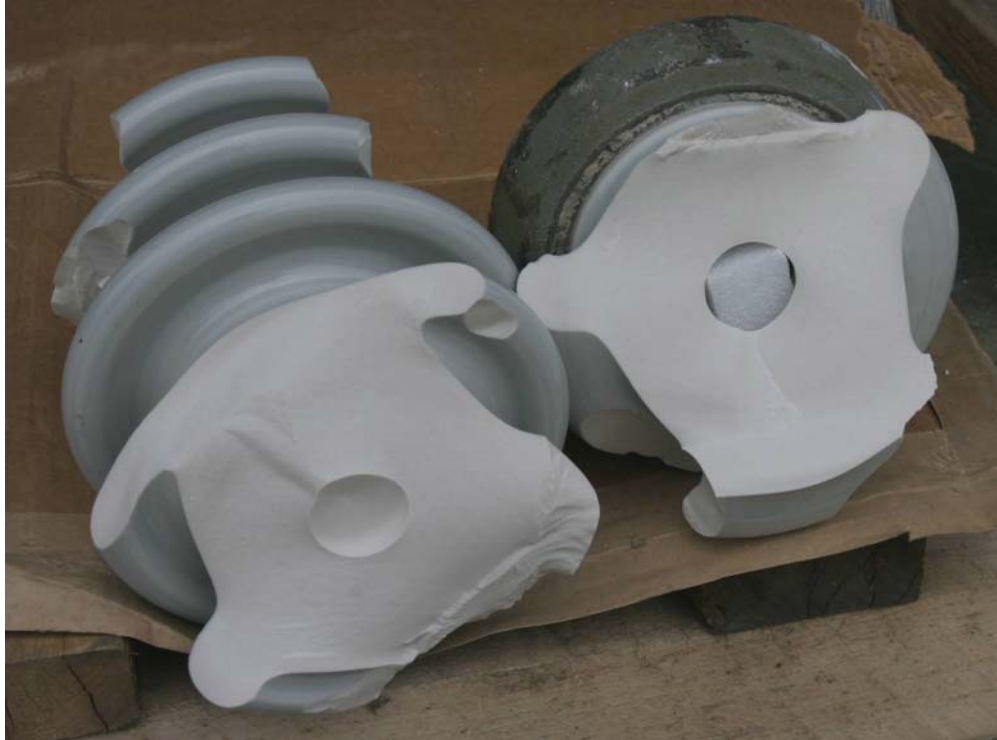
Note that the polystyrene cube visible in the chucking hole in Figure 2-16 is a normal part of the manufacturing process. This configuration is used to prevent cement expansion from exerting a hoop stress on the porcelain body that could result in fracture.

Figure 2-16
Fracture Surface of Sample #7 where the Base End Cap was Broken from the Insulator Body
(note that the polystyrene cube in the chucking hole is a normal part of the manufacturing process)
