Solving Power Quality Problems in Medical Imaging Systems

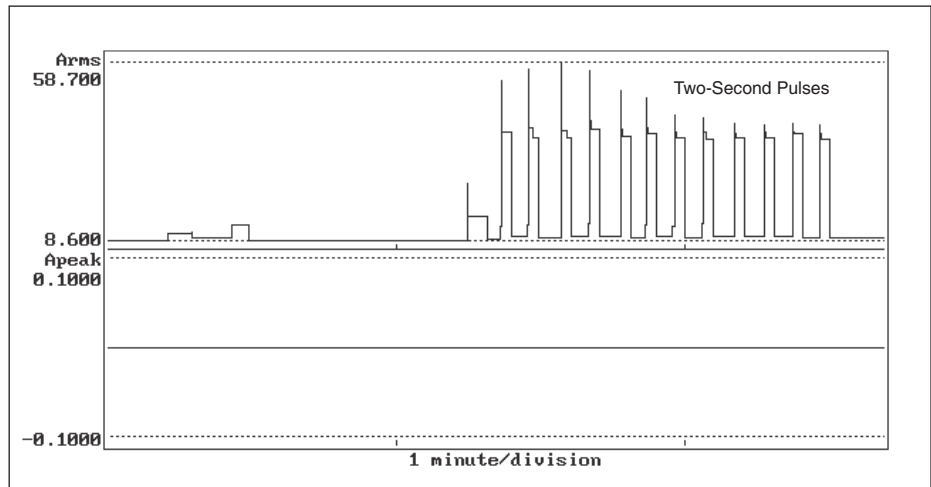
Figure 2. RMS Current of a Typical CT Scanner During a Scan

Like that in the conventional X-ray machine, the X-ray tube of a CT scanner switches on and off repeatedly. However, as shown in Figure 2, the rotating X-ray tube in the CT scanner draws current in pulses lasting about two seconds, whereas the current pulses of a conventional X-ray tube last only about four cycles (70 milliseconds). The longer, two-second pulse of the CT scanner's X-ray tube makes its imaging process more vulnerable to power disturbances. For example, a voltage sag occurring during one of these pulses can cause such severe degradation of the X-ray image that it cannot be used for diagnostic purposes, even if the microcomputer processing the image is not interrupted. Or, if the supply voltage sags below the scanner's undervoltage protection limits, the scanner may reset in the middle of a procedure, losing all the images stored in its memory.

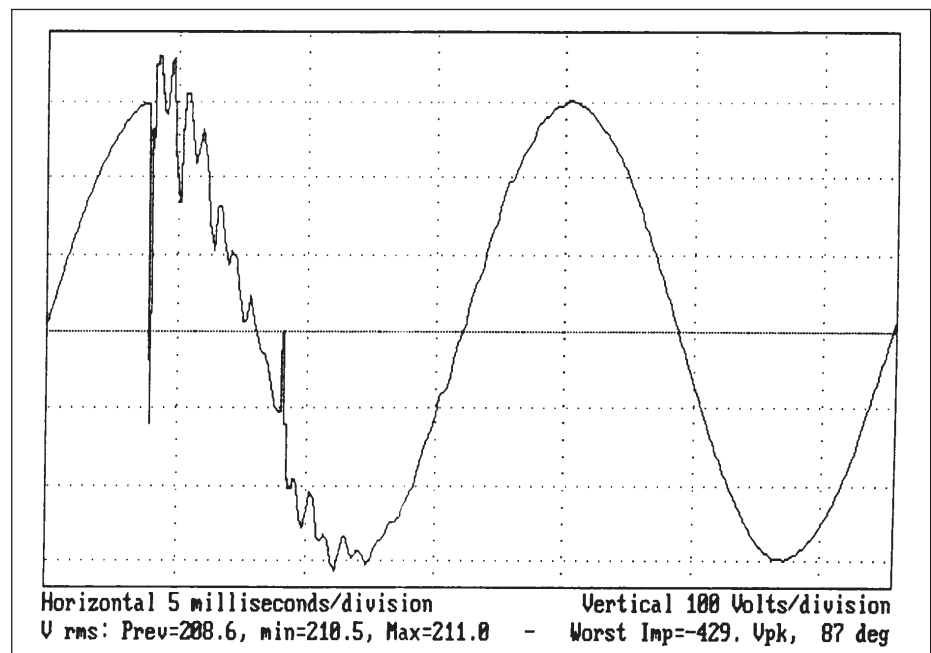
Figure 3. Ringing Transient Recorded at the Nevada CT Scanner

In another medical clinic in Nevada, a CT scanner was experiencing repeated computer lockups and component failures. The power was brought to the CT scanner by a 480-volt service feeding a 480-to-208-volt isolation transformer. Using a power monitor, the medical equipment service company identified the cause of the failures: a voltage transient, shown in Figure 3, produced by the local utility switching on a power-factor-correction capacitor bank, located only a block away. The hospital's isolation transformer had little effect upon the ringing transient.

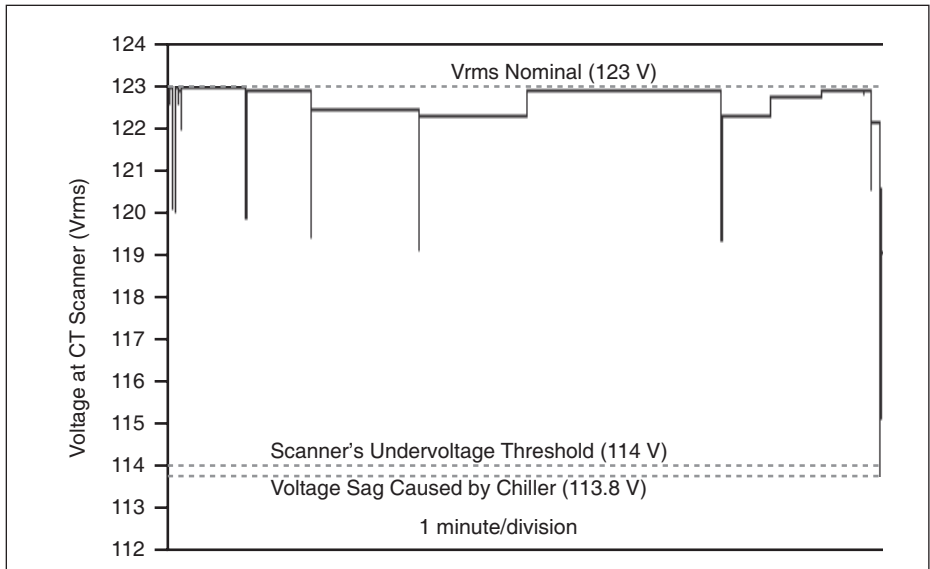
Figure 4. RMS Voltage Recorded at the Kansas CT Scanner

By this time, the director of maintenance for the Kansas hospital had pinpointed another possible cause for the scanner failures: The scanner shutdowns most often occurred when the chiller in the hospital's air conditioning system started. The maintenance director solved the problem by manually

ing of the chiller. Figure 4 shows the RMS voltage at the CT scanner. Most of the voltage sags were caused by the normal operation of the CT scanner. These sags dipped to no less than 119 volts. However, the sag caused by the chiller-starting dipped to 113.8 volts. Jewell determined that the scanner's undervoltage trip threshold was set too high (at 114 volts) by the installer, who misunderstood the manufacturer's instructions. After the manufacturer's field technician reset the threshold to 108 volts, the scanner was able to oper-
