DPQ Event: Overbuilt Transmission Line Downed on Distribution System

Overbuilt Transmission Line Downed on Distribution System

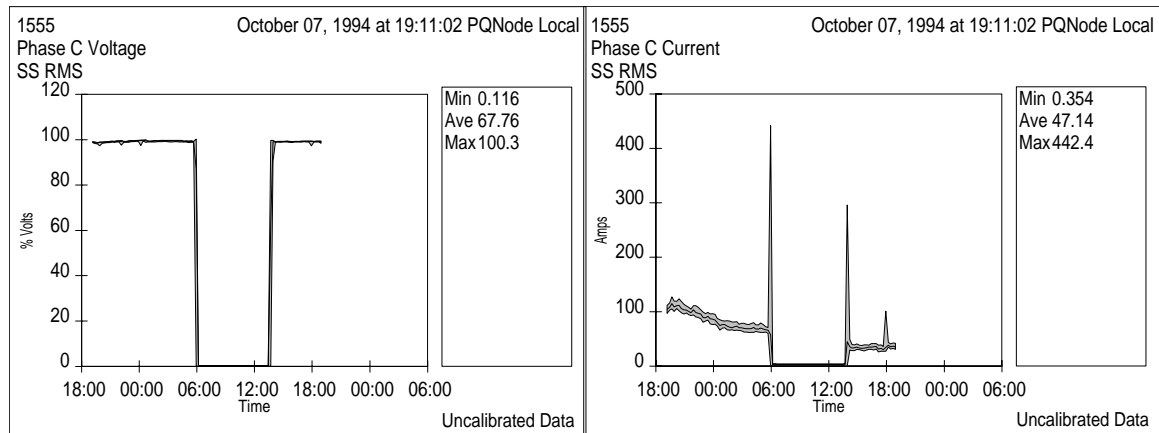
Figure 1: Steady-State RMS Voltage and Current

In Figure 1 we see the steady-state rms voltage and current for a 24 hour period from a feeder being monitored as part of the EPRI Distribution Power Quality Project. The voltage plot has a noticeable gap during a seven hour outage which was the result of a transmission line fault. Due to strong winds, a transmission line was blown into the EPRI DPQ distribution feeder. A series of resulting circuit breaker operations ended in a lockout. After seven hours, the circuit was partially restored by resetting the breaker, followed by a complete restoration after another three hours.

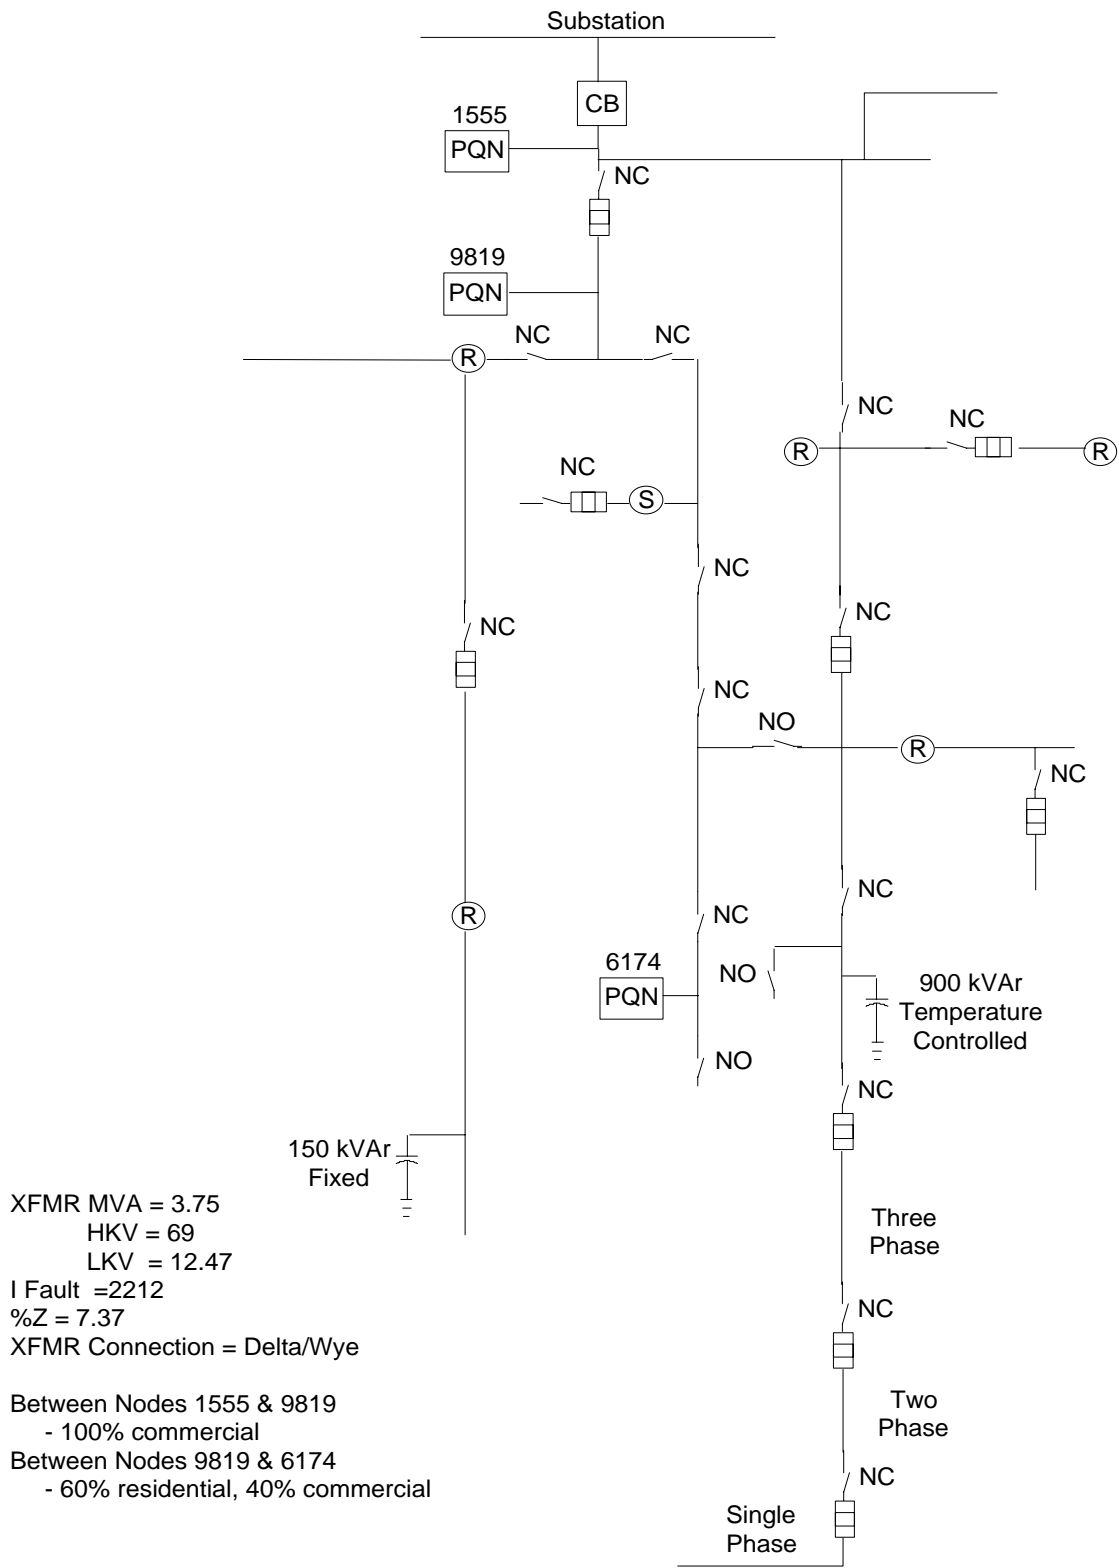
Figure 2: Feeder Diagram

This event occurred on a wye grounded radial feeder (Figure 2) with 12 miles of three-phase circuit and 25 miles of single-phase. The substation transformer's rating is 3.75MVA, and it steps 69 kV down to the feeder's nominal voltage of 13.2kV. It only supplies this feeder; there are no other feeders in parallel. There is a 900 kVAr bank located on one of the feeder's branches.

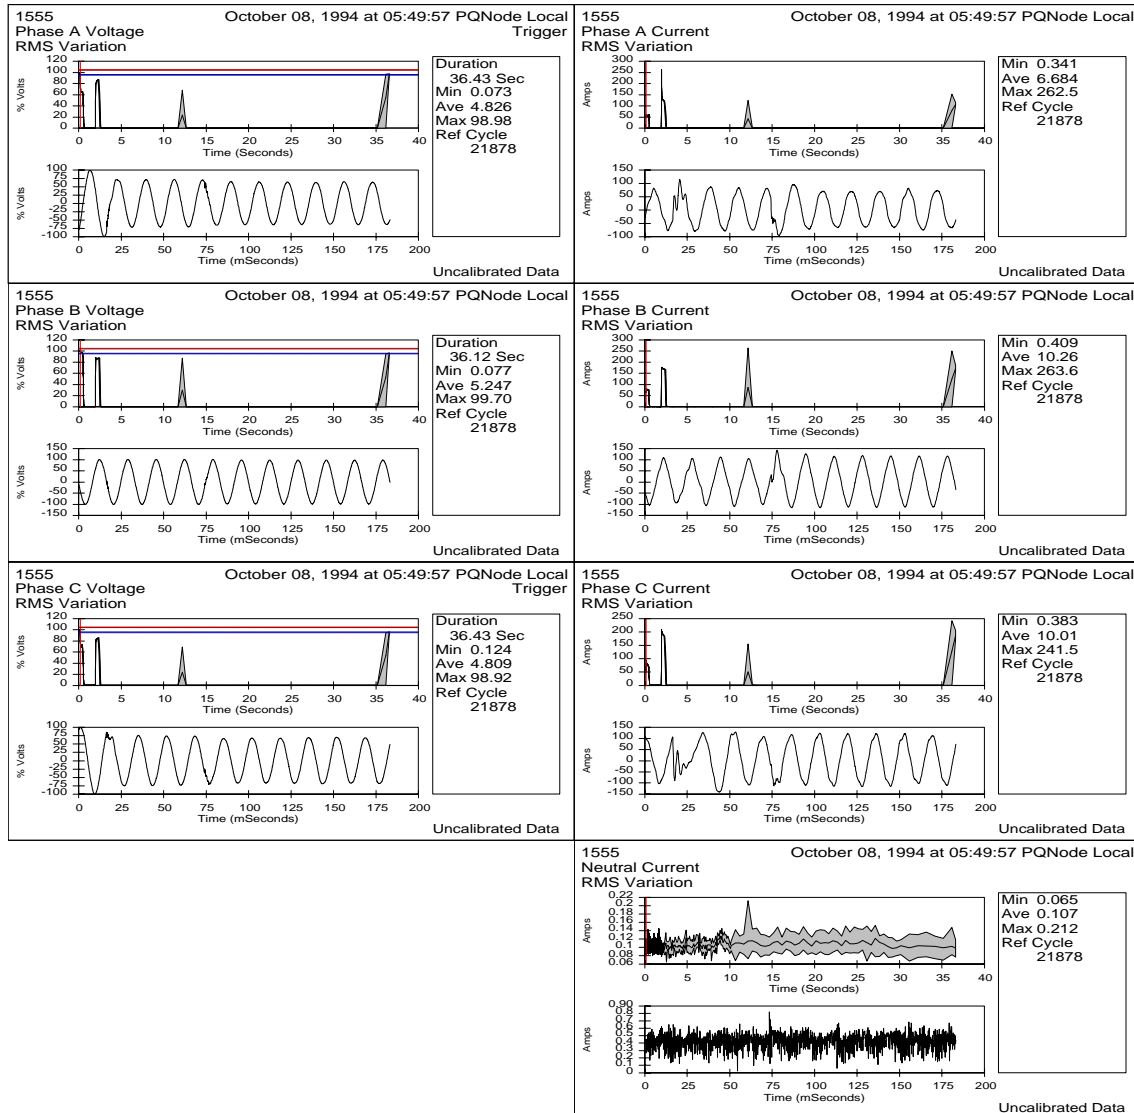
Figure 3: First Fault

This first fault results in three operations of the substation circuit breaker. The breaker reclosed after 2, 10, and finally 25 seconds, with the third operation clearing the initial fault. The cause of the event was wind blowing an overbuilt transmission line onto the distribution somewhere down-line of nodes 1555 and 9819. Node 6174, a good candidate to have seen more of the event, was out of service at the time of the incident.

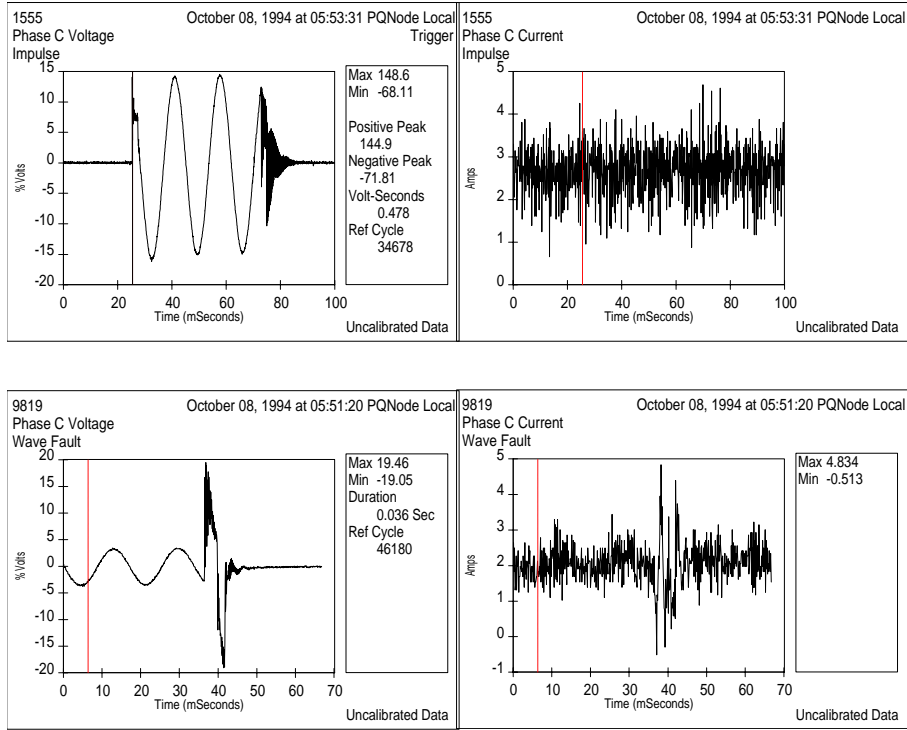
Figure 4: Interesting Waveforms at Node 1555 and Node 9819

This waveform was measured just prior to the breaker lockout. Its high frequency characteristic suggests that it is some type of discharge from an energy storing element. Its frequency is about 5 kHz, which is most probably not accurate since that is around the upper end of frequency which the monitor can measure properly and beyond the

frequency response of the node's PT. The current is at noise level, suggesting that the transient is occurring far away from the monitors. Figure 5 shows all phases of voltage and current for this waveform.

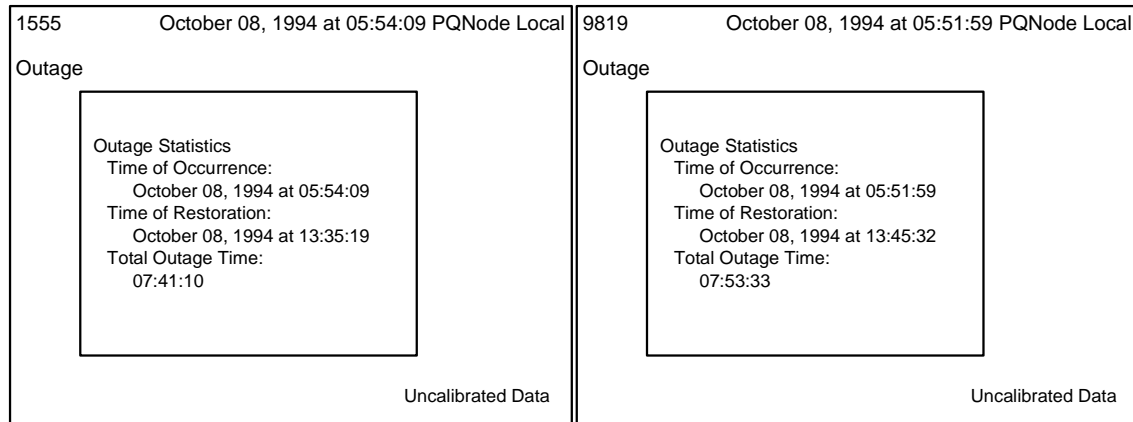
Figure 6: Outage Reports

The outage report for node 1555 differs slightly from 9819. The substation reported an outage with a 7:41:10 duration, while just downline 9819 gave a 7:53:33 duration. The difference of twelve minutes can be explained by the next few figures. Voltage was restored to the monitoring location several minutes before a manual switch was operated, allowing the main feeder to energize.

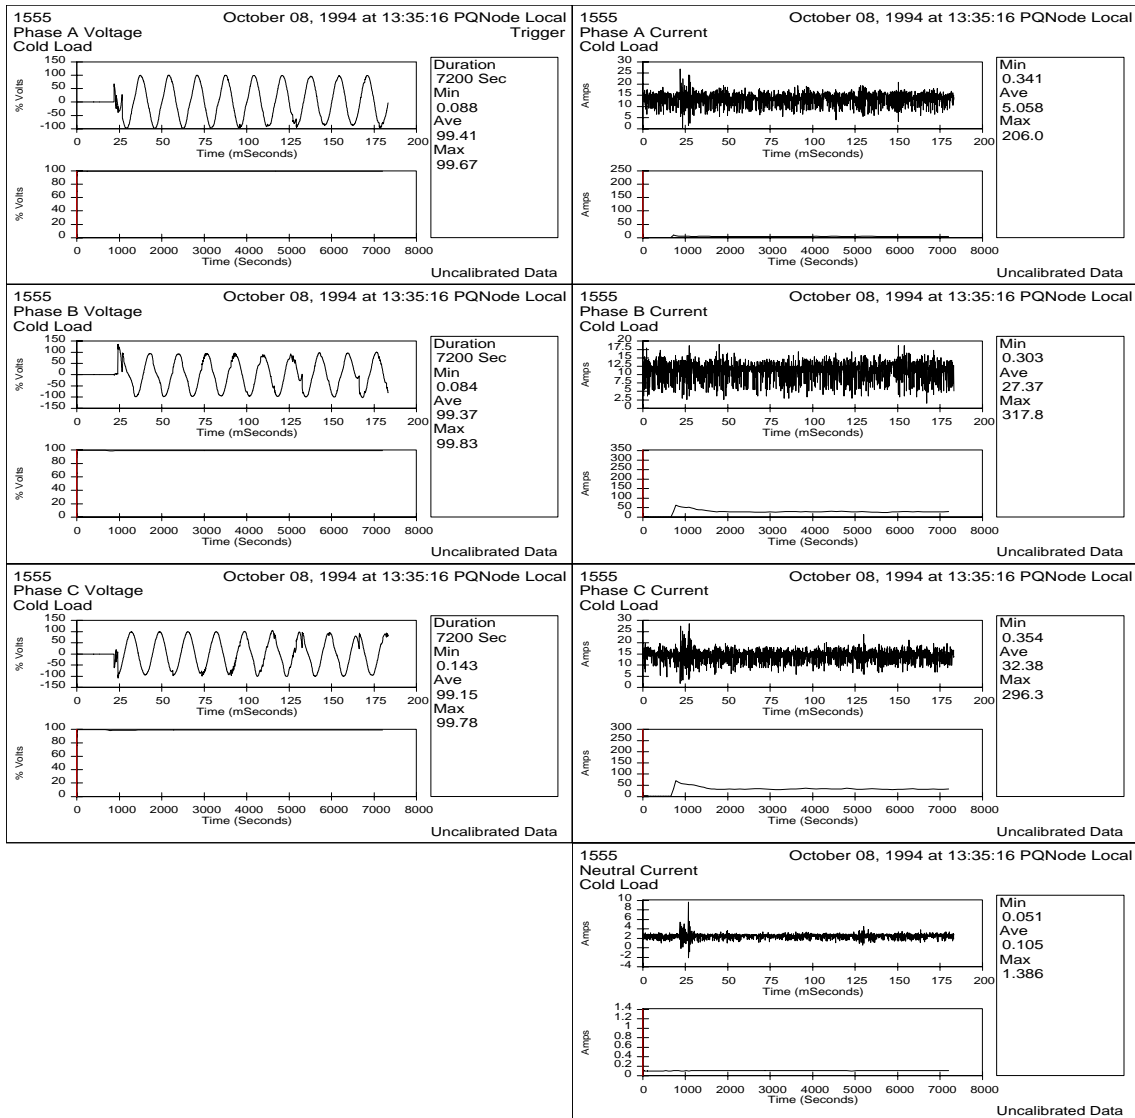
Figure 7: First Inrush

The node recorded a "Cold Load Pickup" event at the restoration of voltage. Note how the voltage waveforms for all three phases are showing sinusoids, while the corresponding current waveforms are still noise. This is because the voltage that the node measured was restored minutes before the main feeder was energized. The measurement also shows the inrush current magnitude during the re-energizing period.

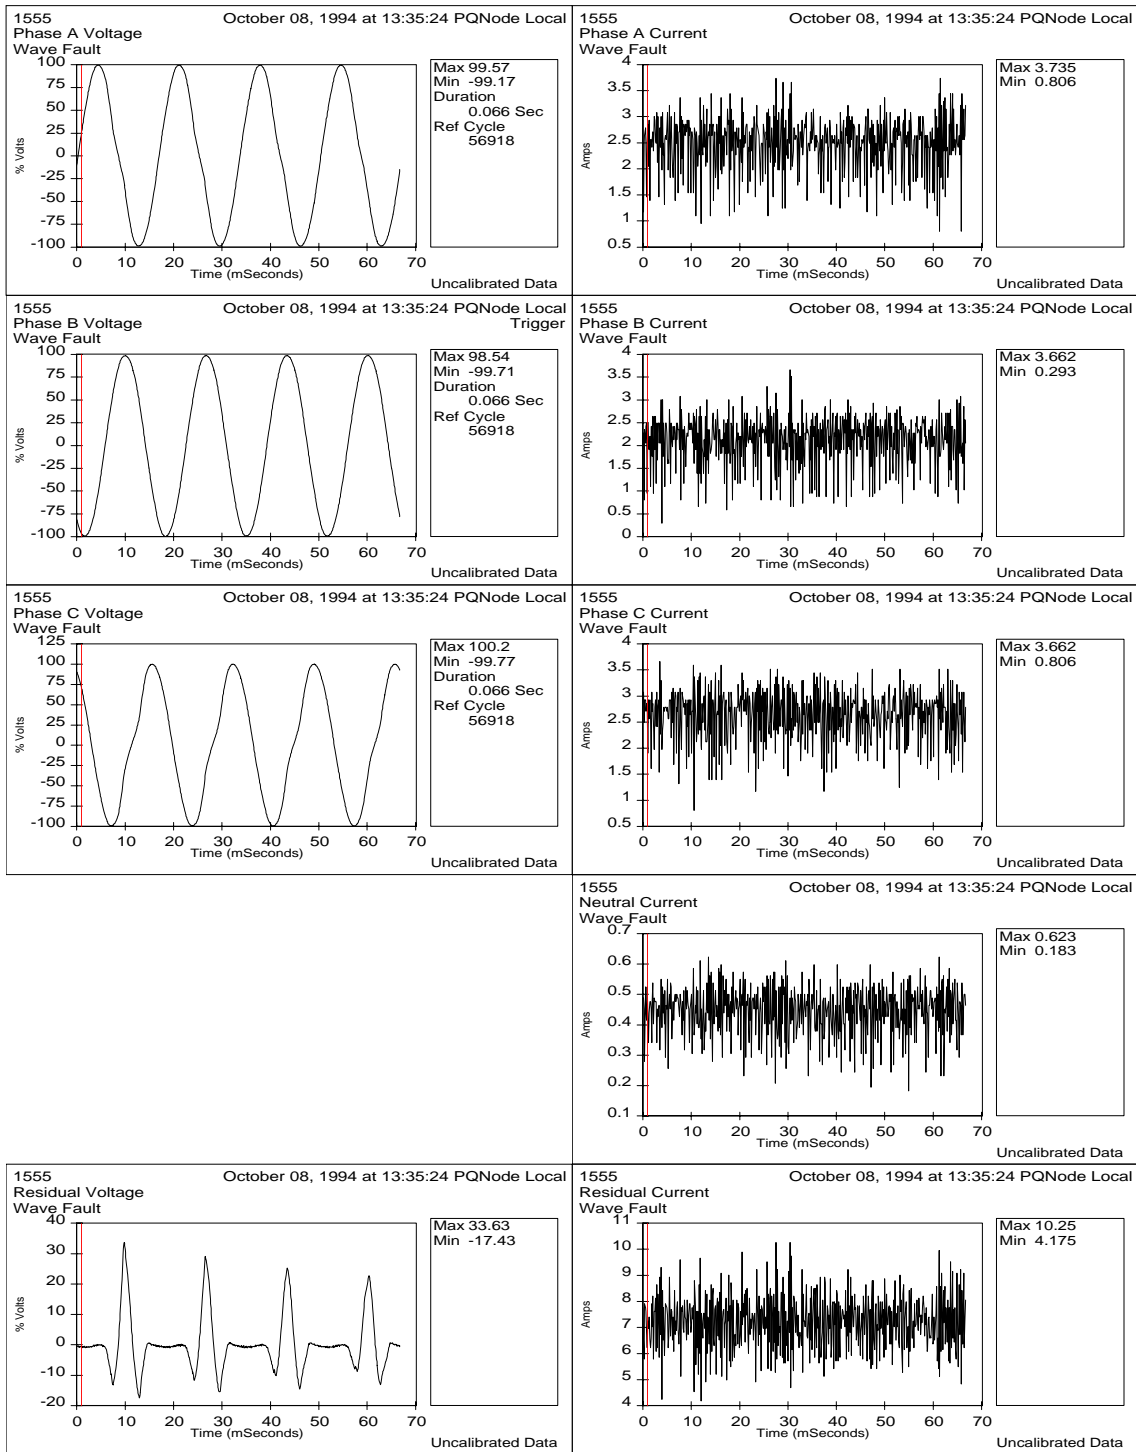
Figure 8: Noise Level Current

This measurement confirms that there was still no measurable current eight seconds after the node first detected voltage.

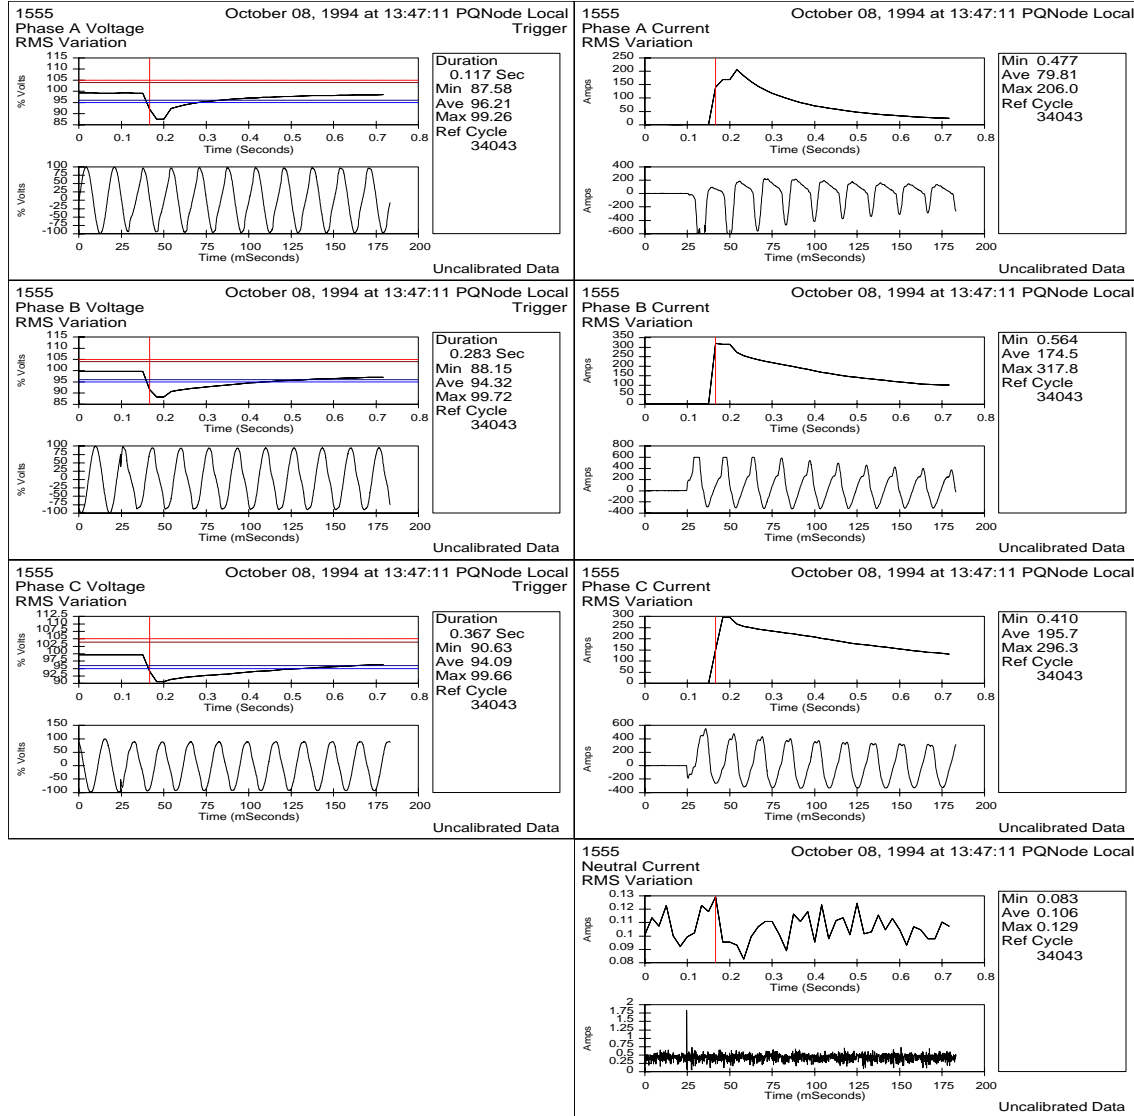
Figure 9: Second Inrush

This voltage sag was recorded by the substation node when a downline single-phase recloser was reset to restore power to a remote section of the feeder, presumably where the transmission fault had occurred.

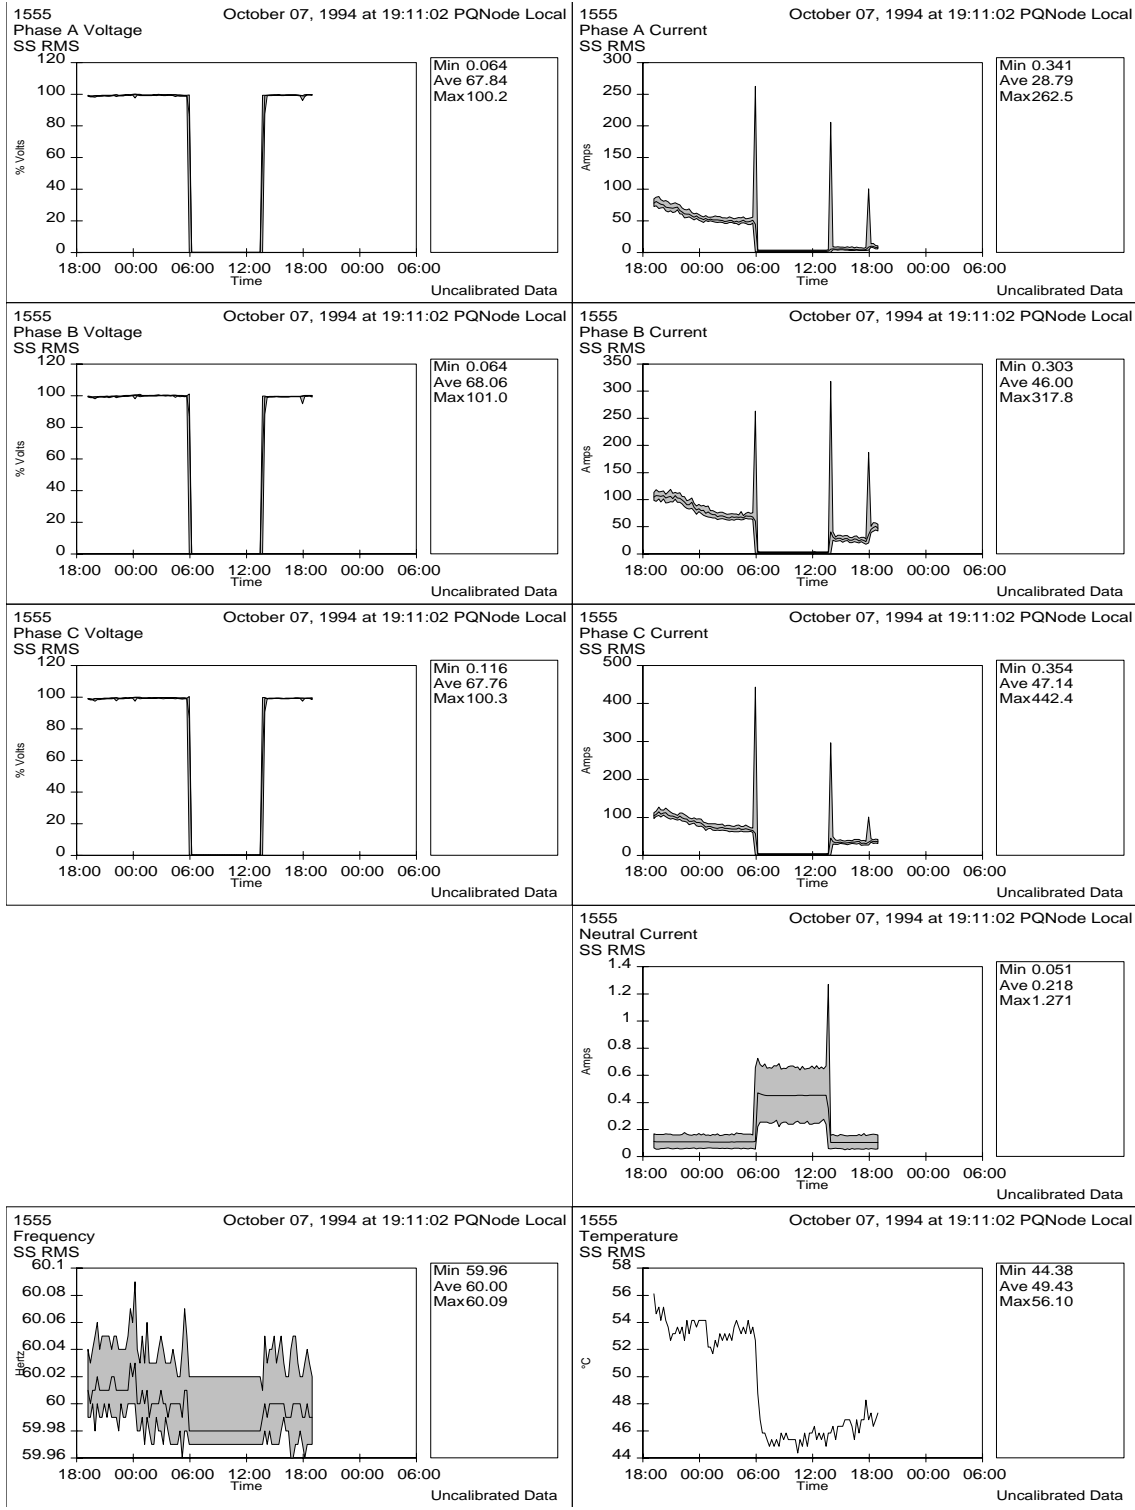
Figure 10: 24 Hour Summary

A summary of the fault, outage, and two inrush periods for all phases of voltage and current.
