Case Study: Rubber/Plastic products - CRT terminals failures

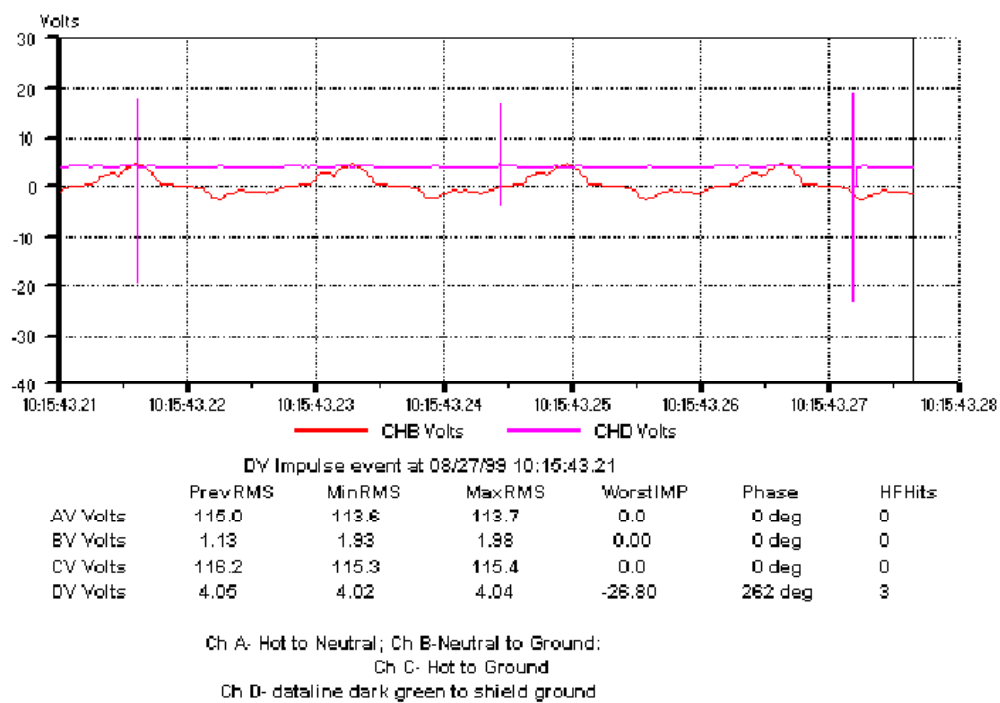
In the investigation no problems of wiring errors were found. The cause of the monitor failures appears to be impulses on the dataline based on the available evidence. Also, the power system is a possibility since neutral to ground impulses with magnitudes up to 108 volts were occurring often. The customer said surge protection on the power and dataline inputs to all of the monitors had been installed for more than a month. This has kept the terminals from being damaged. The customer also mentioned that all of the data line wire that had been strung across the plant ceiling had been re-installed in metallic conduit and that no monitors had failed since this work was done. See Figures 1,2 and 3 for some power quality problems found by the monitoring.

Figure 1: Impulses on dataline

The Engineer recommended that SPD's be installed on the service entrance panel as an enhancement to reliability for the plant. Surge protective devices (SPD) provide a defense against transient overvoltages created by lightning strikes, fuse expulsion, normal utility system operations and load switching internal to a facility.

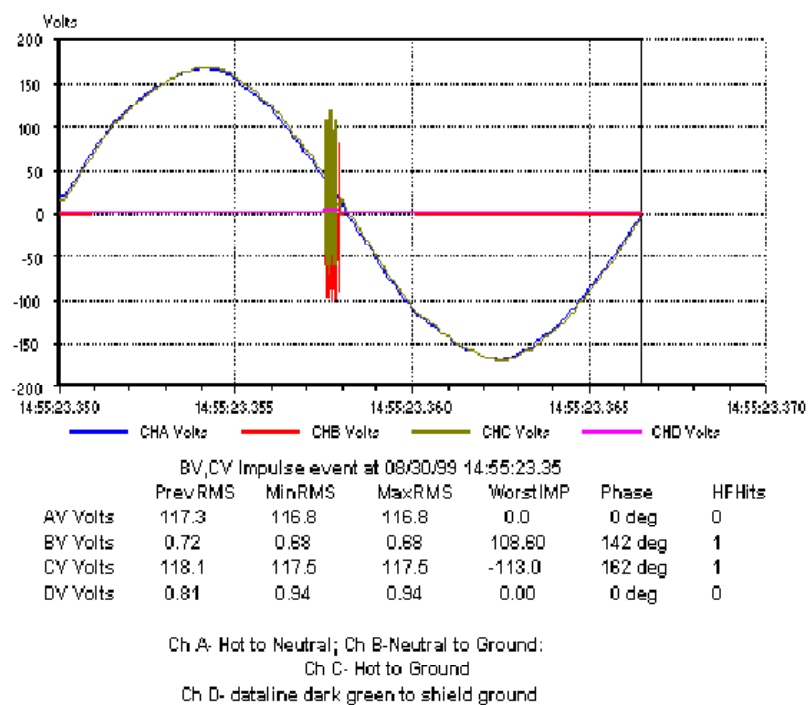
Figure 2: High magnitude neutral to ground impulses

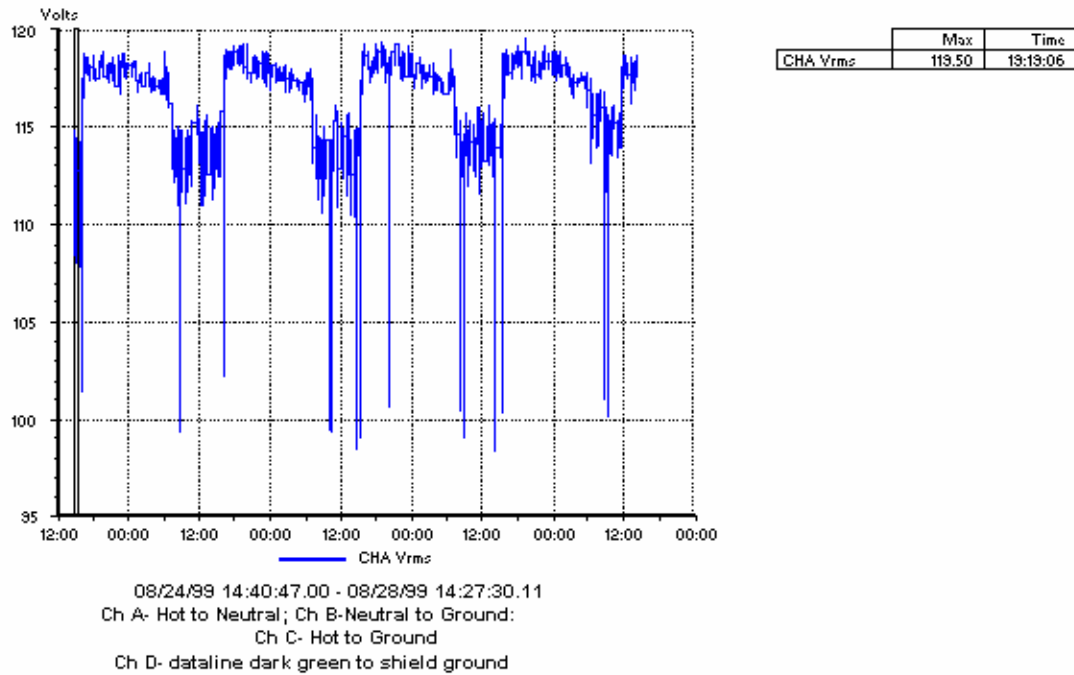
Figure 3: Low voltage at receptacle
