# **Case Study: Transportation - Motor contactor burnt up**

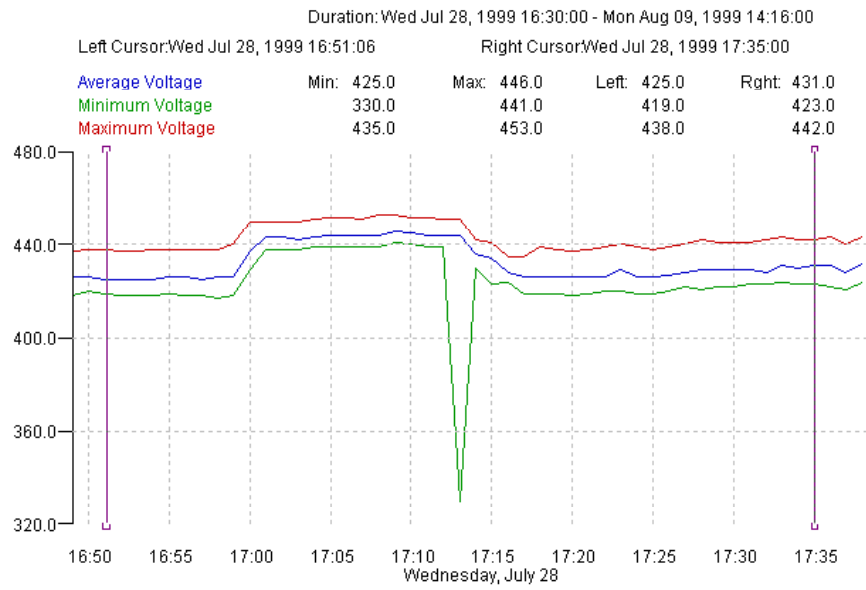
From the datalogger's data, the Engineer saw excessive voltage drop during motor starting. It was due to the distance between the compressor and the utility's service transformers and also to the size of the 3 -10 kva transformers used to serve this 40 HP motor. The voltage during motor starting at the compressor went from 442 volts to 323 volts and at the compressor controls the voltage went from 117 volts to 84 volts. (See Figures 1 and 2) Monitoring with the Dranetz showed what appears to be contactor bounce or "chattering" during motor starting as the current flow was interrupted for a few half cycles during the first four or five cycles of the motor start (See Figure 3).

**Figure 1: Voltage At The Compressor During A Motor Start**

The Engineer recommended to the customer that a Knowtrip contactor ride through device be installed on the motor contactor for the compressor. Contactor dropout, because of power line brownouts, will be eliminated when a KnowTrip is added to the contactor. He also recommended that the customer request the utility company to do a tap position change on the service transformers to raise the voltage.

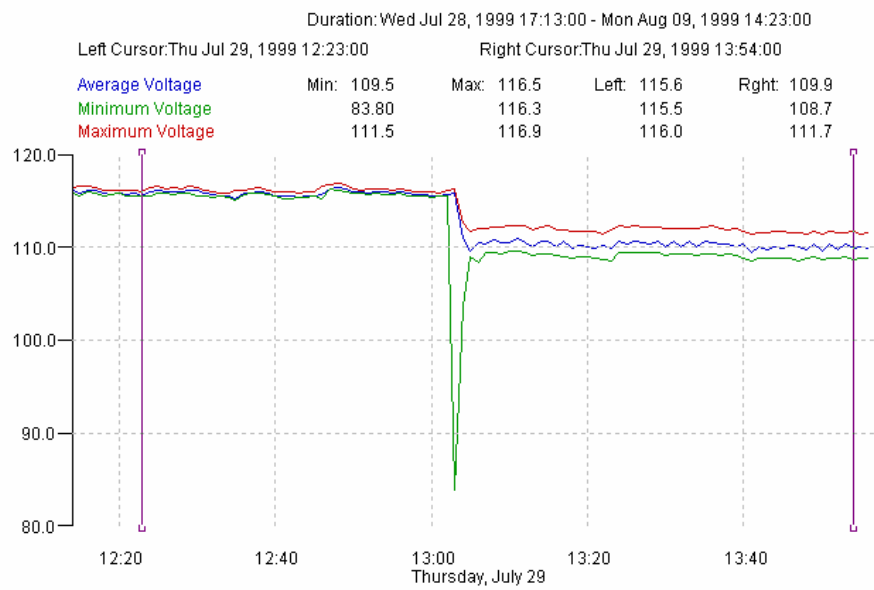
**Figure 2: Voltage At The Controls During A Motor Start**

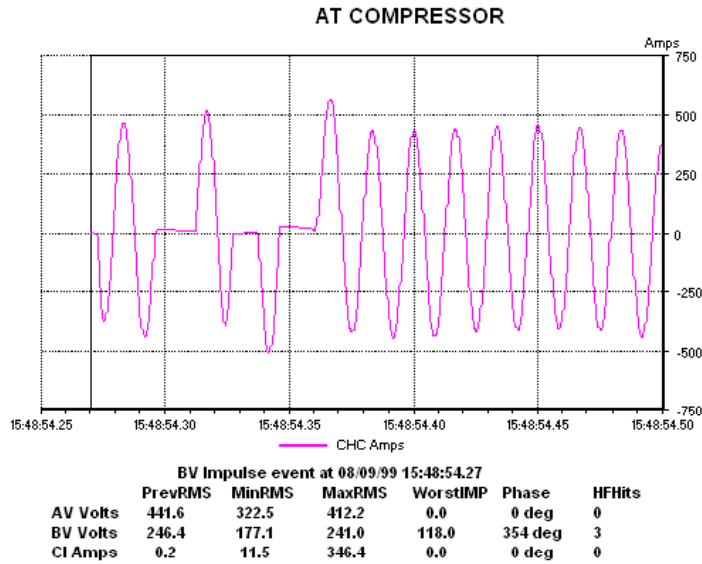
**Figure 3: Current At The Compressor Disconnect During A Motor Start**
