Distribution Conductor Burndown Test Results

Small Bare and Large Covered Conductor

Technical Update, December 2009

Electric Power Research Institute (EPRI)

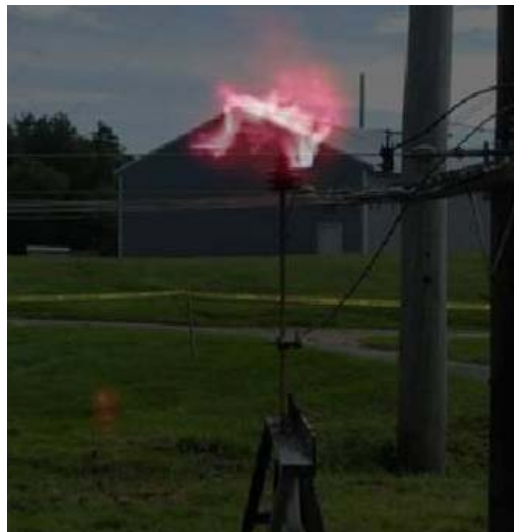
Figure 4-5
Arcs That Remain Relatively Stationary Result in Faster Burndown Times

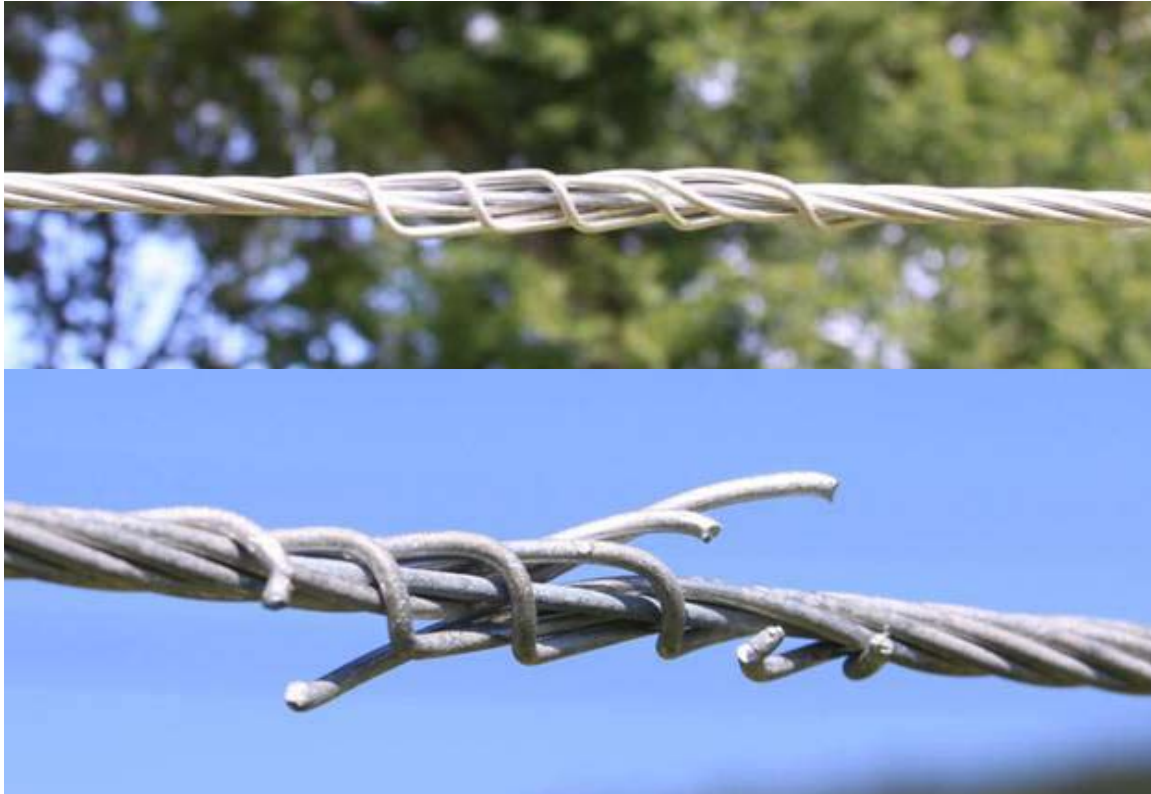
- *Bird caging conductor* – The second of the two conductors the arc was motoring on was not immune from damage. When the arc slowed because of an insulator on the other conductor, it caused a prolonged exposure on both feed lines. This often resulted in a small section of *bird caging*—unraveling of conductor strands. Figure 4-23 shows two instances of bird caging, one of which was severe enough to break the conductor strands. It is not known if this would have occurred had the line been tensioned similar to field conditions.

Figure 4-23
Conductor “Bird Caging” Due to a Motoring Arc Lingering at These Locations

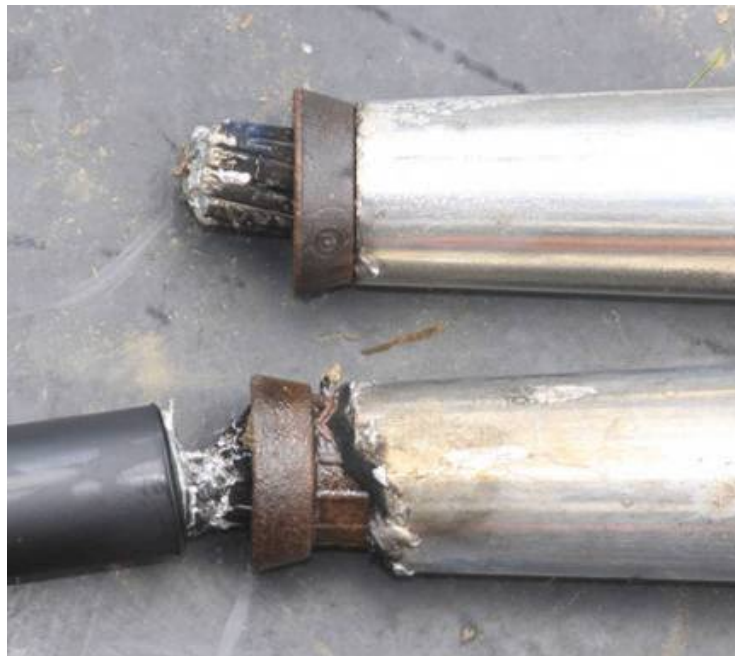
Figure 4-25
The Lower Splice and Conductor Suffered Severe Damage and Probably Would Have Broken Had the Conductor Been Under Tension

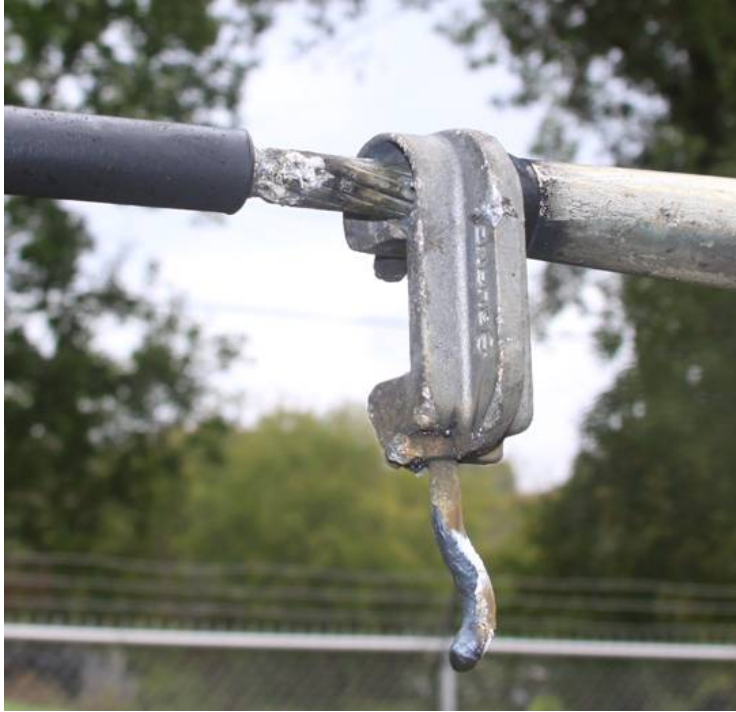
To examine the effect of incorrectly installed arc protective devices, they were placed on the conductor with the APD pushed up against the splice, with a gap between the insulation and the APD. This configuration allows for significant conductor damage during an arcing event, as shown in Figure 4-31.

Figure 4-31
This Improperly Installed APD Allowed Significant Damage to the Conductor
