Distribution Conductor Burndown Test Results

Small Bare and Large Covered Conductor

1017839

Technical Update, December 2009

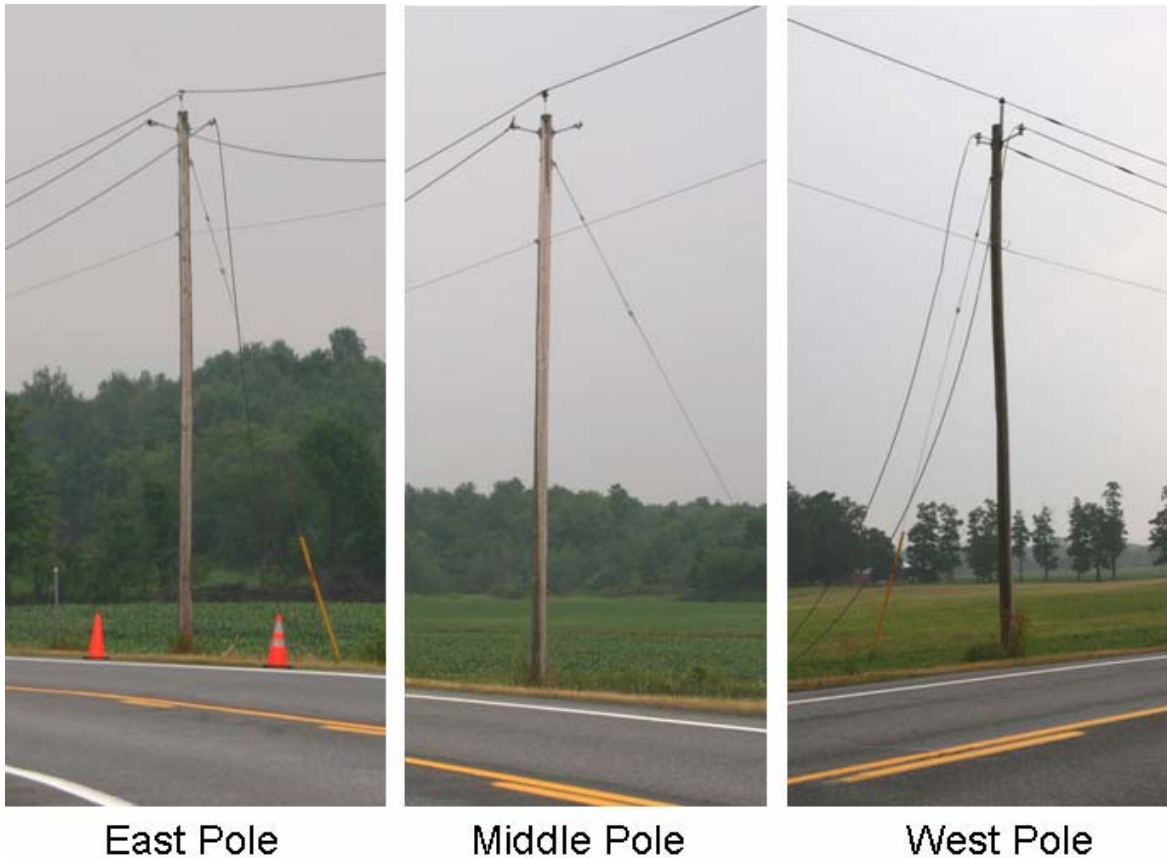
- *High-impedance faults* – Conductor burndowns are a significant cause of high-impedance faults. The conductor usually falls to the ground when it breaks (Figure 1-1). If the falling conductor does not contact the system ground as it falls (neutral or other grounded hardware), the circuit is completed by the high impedance path provided by the contact surface and the earth. If the conductor break cleared the original fault (rather than circuit protection), the energized conductor lies on the ground and may not draw enough current to operate circuit protection. Even if the circuit protection did operate, it might still re-close and hold since the high-impedance fault does not draw much fault current and is difficult to detect.

Figure 1-1
A Lightning-Induced Burndown Event on Covered Conductors Affecting the Conductor over Two Pole Spans

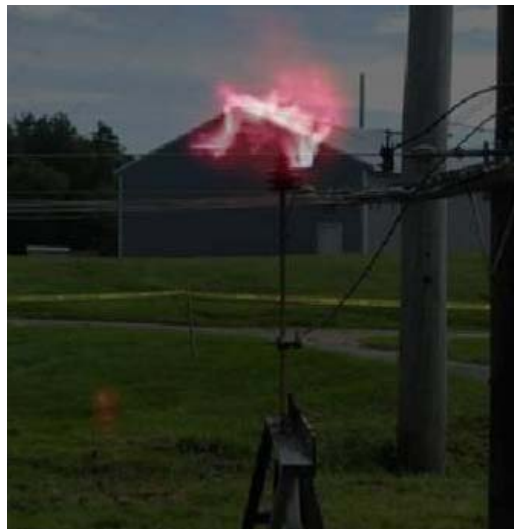
Figure 4-5
Arcs That Remain Relatively Stationary Result in Faster Burndown Times

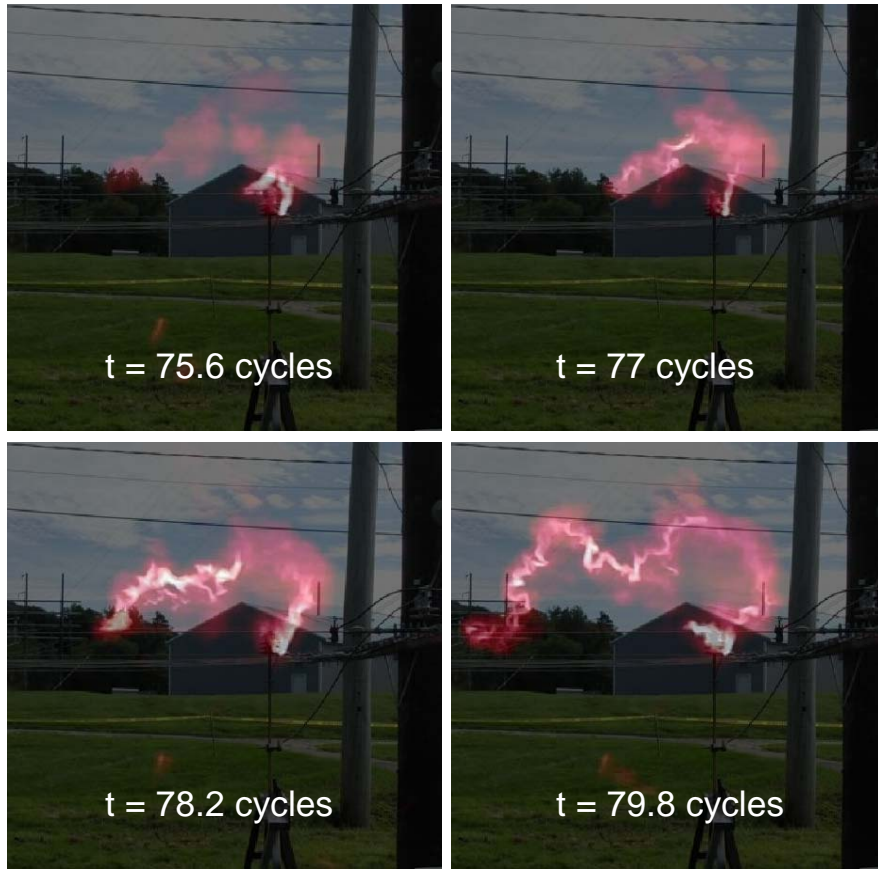
Although each test was initiated in a nearly identical manner, some arcs would motor along the conductor until they broke and then re-strike at the insulator and motor again as shown in Figure 4-6. This arc behavior results in longer times to failure since the arc attachment point is moving along the conductor rather than injecting heat at one location. This behavior is influenced by fault current level, wind speed, and direction. Higher fault currents have a stronger motoring action, making those arcs more likely to move around on the conductor. Wind will also push the arc and have the greatest influence when it is pushing the arc in the same direction as the motoring.

Figure 4-6
Arcs That Repeatedly Motor and Break Result in Slower Burndown Times

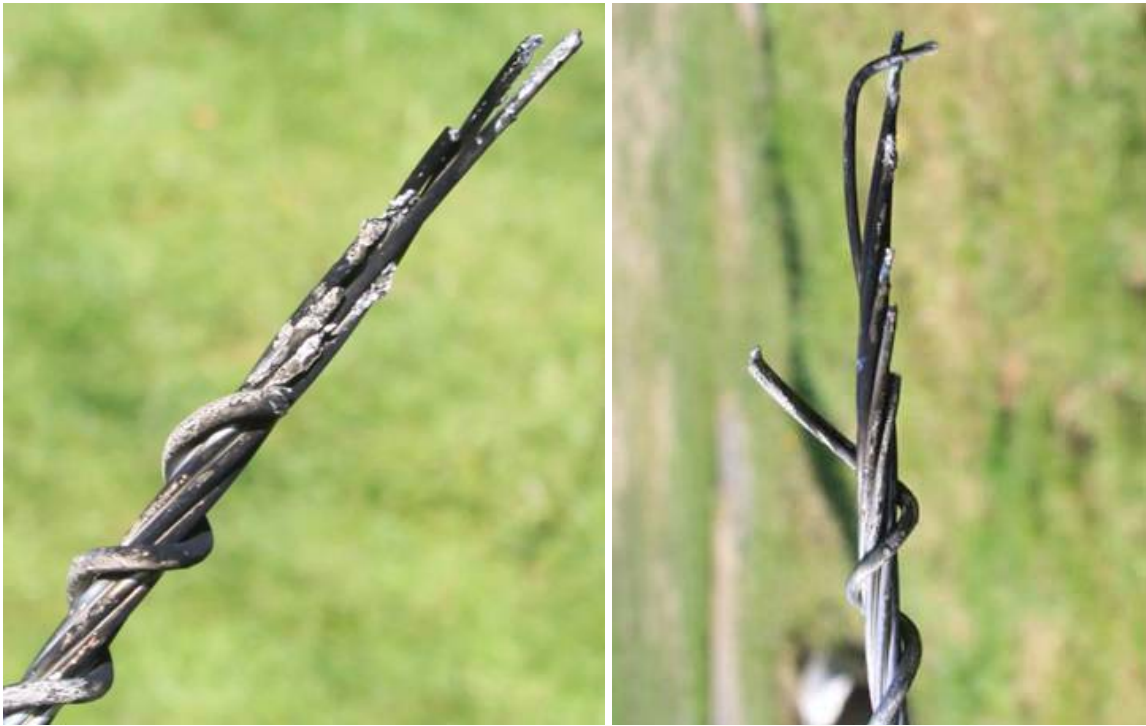
Figure 4-16
The End of the Conductor That Becomes De-Energized After Separation Shows That the Conductor Strands Separate at Different Locations

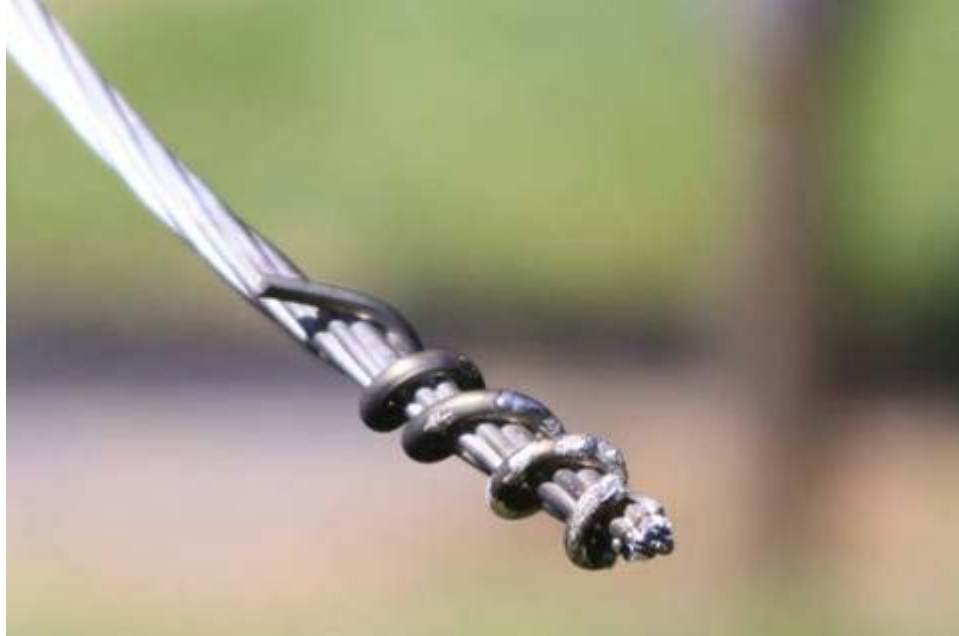
Figure 4-17
The End of the Conductor That Remains Energized After Separation Continues Arcing, Causing the Broken Strands to Be Vaporized Back to a Nub

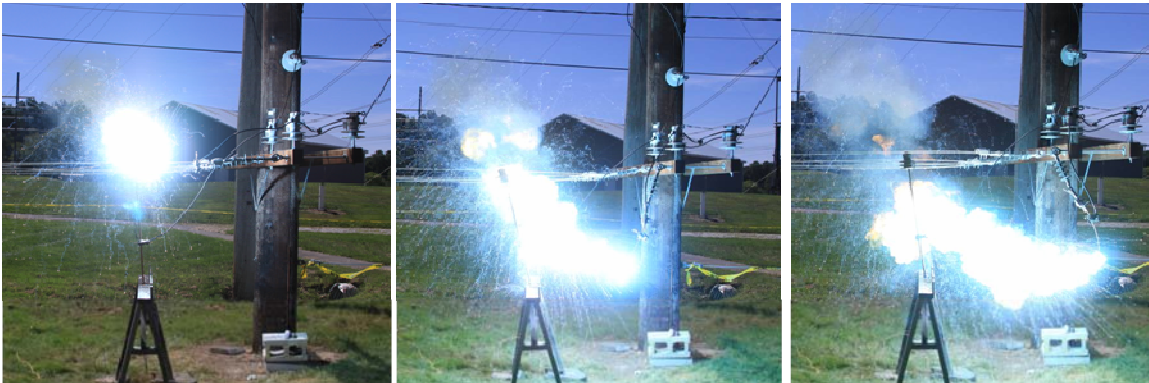
Figure 4-18
When the Conductor Breaks, the Energized End Swings Down, Pulling the Arc Out

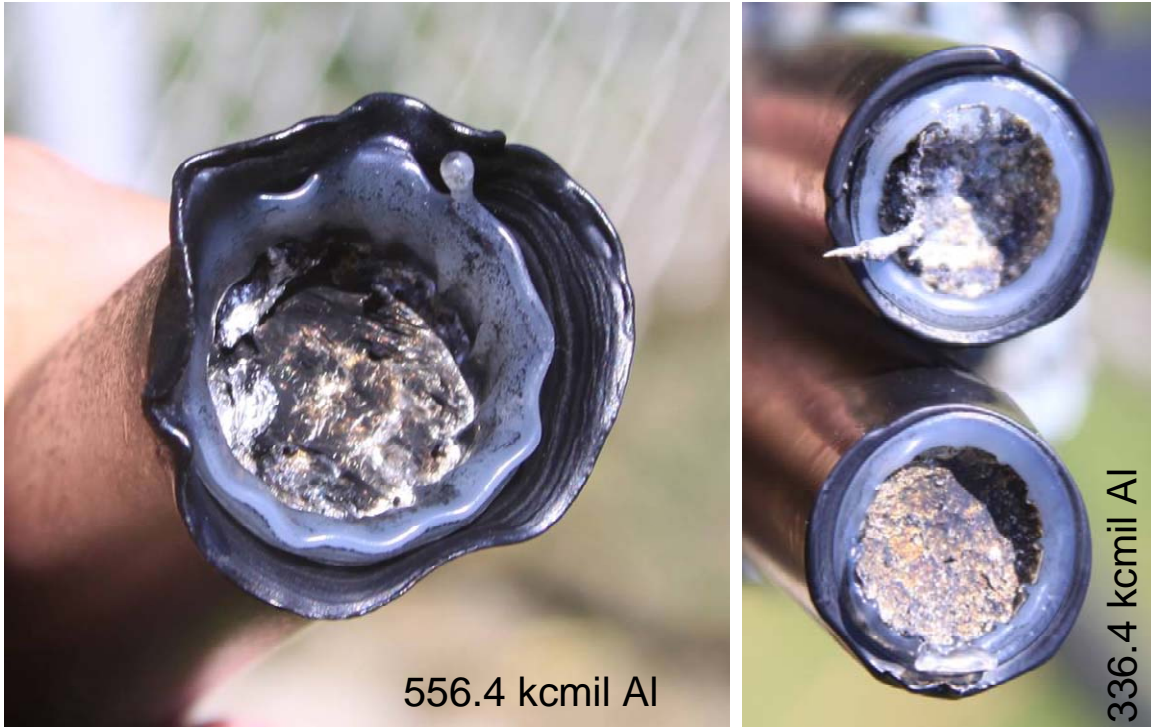
The covered conductor did not show the same type of broken strands at the de-energized end as the bare conductor. Instead, the covered conductor was expelled from the covering on both sides of the separation point, resulting in relatively flat surfaces recessed into the covering, as shown in Figure 4-19. It could not be determined if the covered conductor failure was due to loss of tensile strength or section loss due to vaporization of the conductor.

Figure 4-19
The Strands of 556.4-kcmil (281.9-mm²) Aluminum Covered Conductor (Tree Wire) Are Vaporized During a Burndown Event

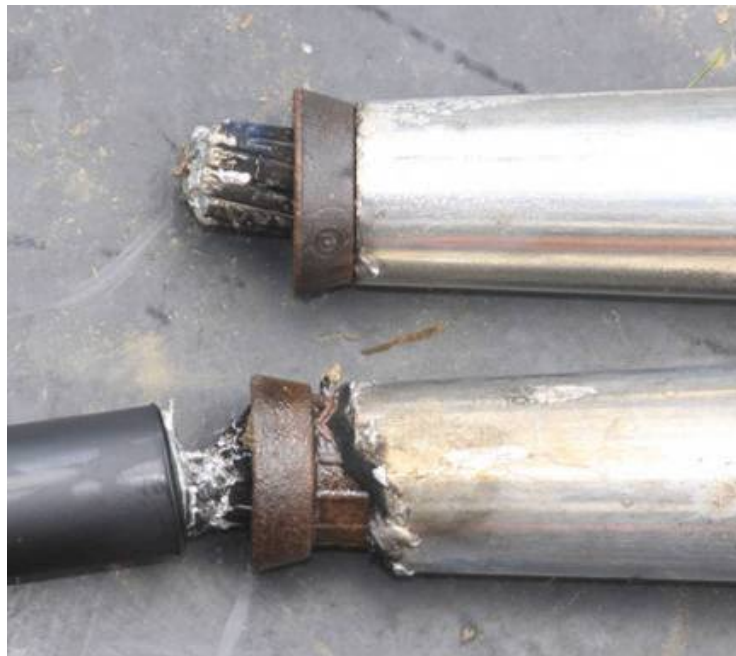
Figure 4-25
The Lower Splice and Conductor Suffered Severe Damage and Probably Would Have Broken Had the Conductor Been Under Tension

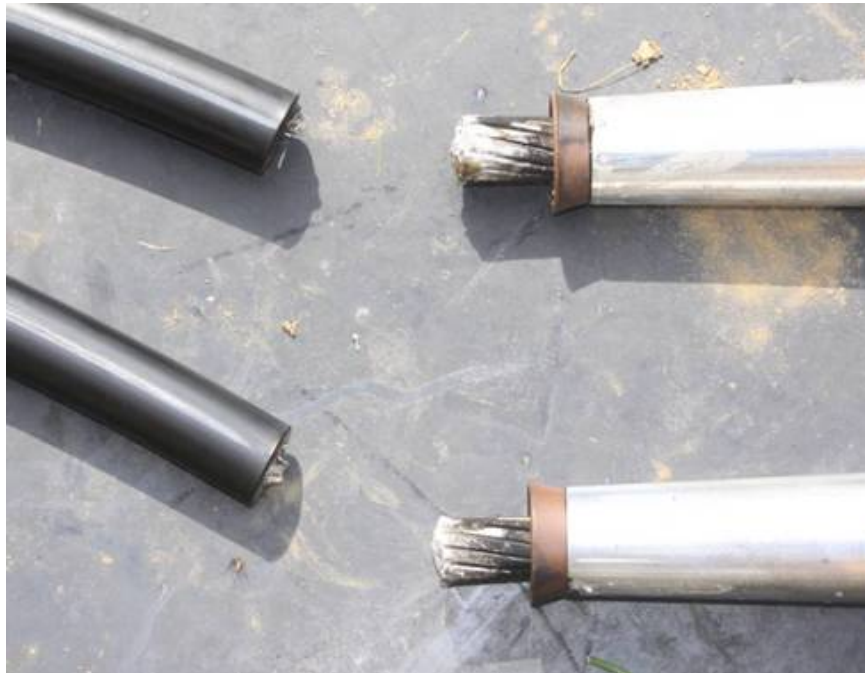
The second test, shown in Figure 4-26, resulted in burndown of both conductors. The burndown locations are shown in Figure 4-27.

Figure 4-27
Breakage Occurred on the Load Side of the Automatic Splices

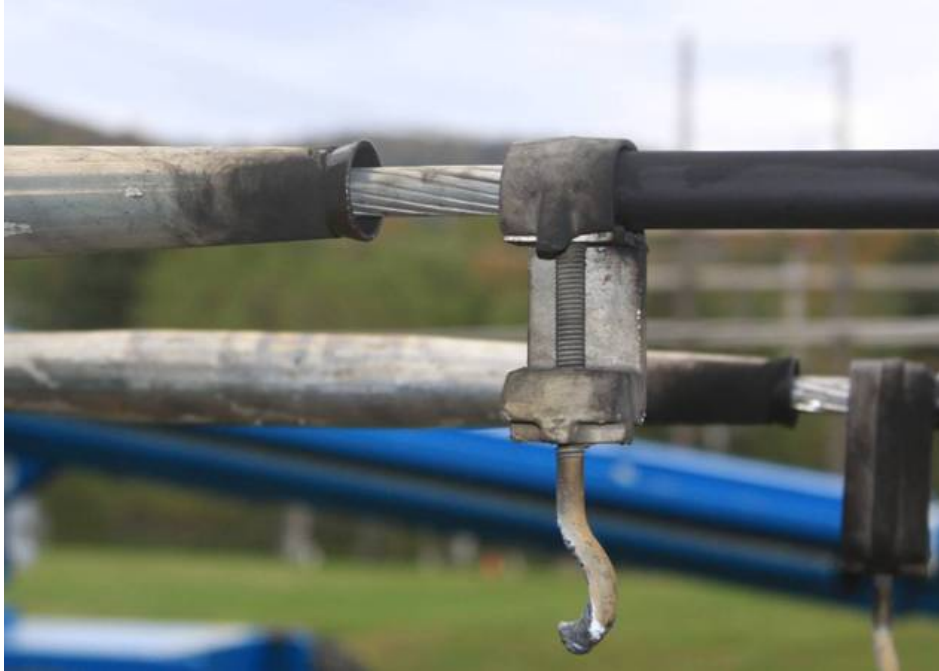
Figure 4-29
This Arc Protective Device Prevented the Conductor from Being Damaged During the Arcing Fault

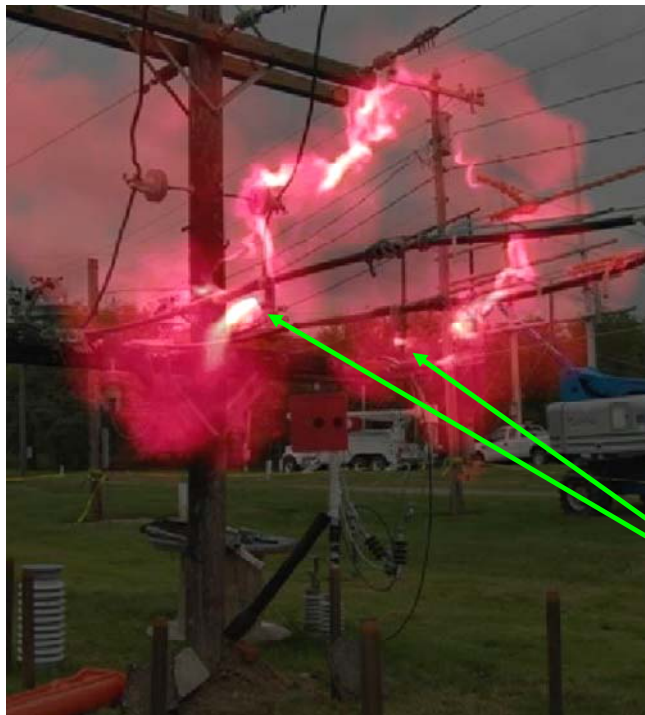
Arc anchored on
arcing protective
devices

Figure 4-30
Arc Anchored on Arcing Protective Devices During Testing

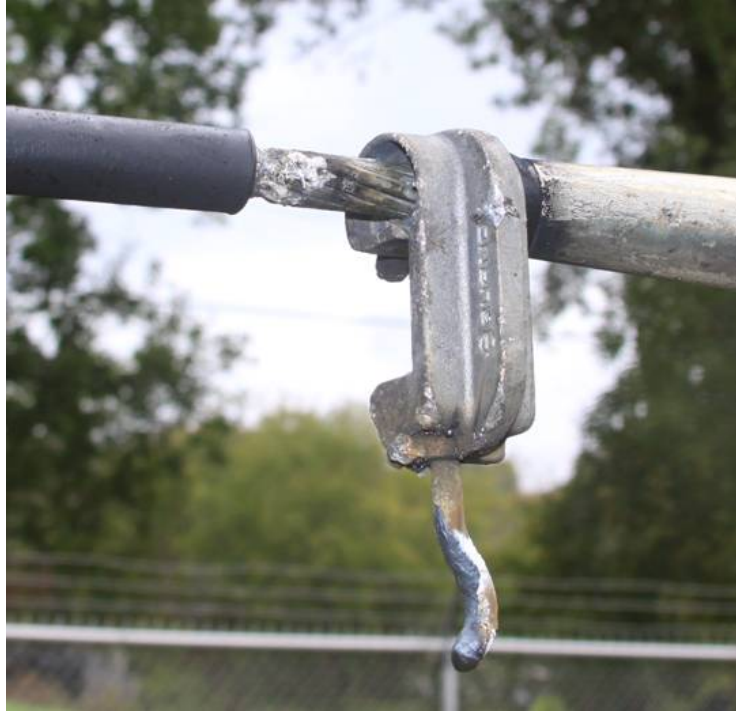
To examine the effect of incorrectly installed arc protective devices, they were placed on the conductor with the APD pushed up against the splice, with a gap between the insulation and the APD. This configuration allows for significant conductor damage during an arcing event, as shown in Figure 4-31.

Figure 4-31
This Improperly Installed APD Allowed Significant Damage to the Conductor

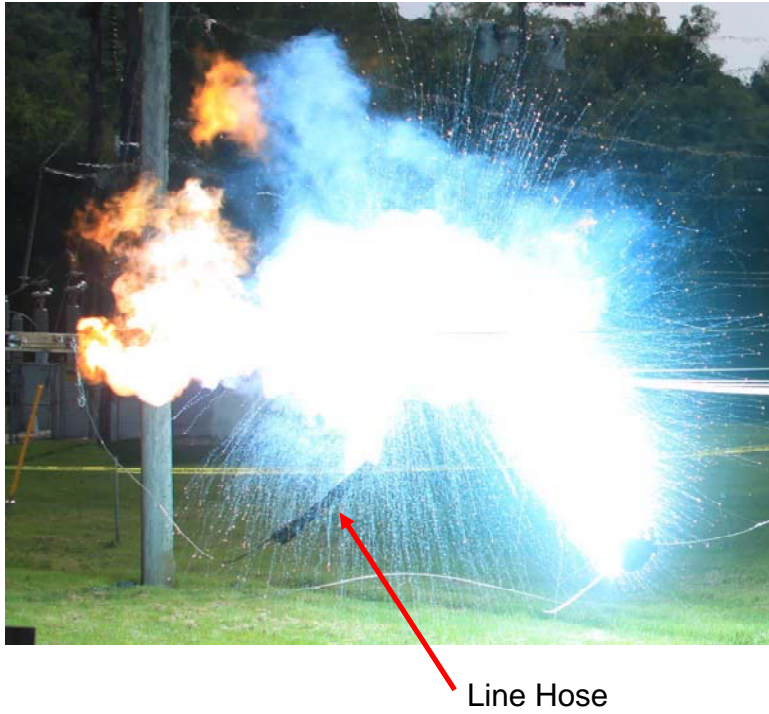
Figure 4-32
Conductor Burndown at a Line Hose on #4 ACSR Bare Conductor

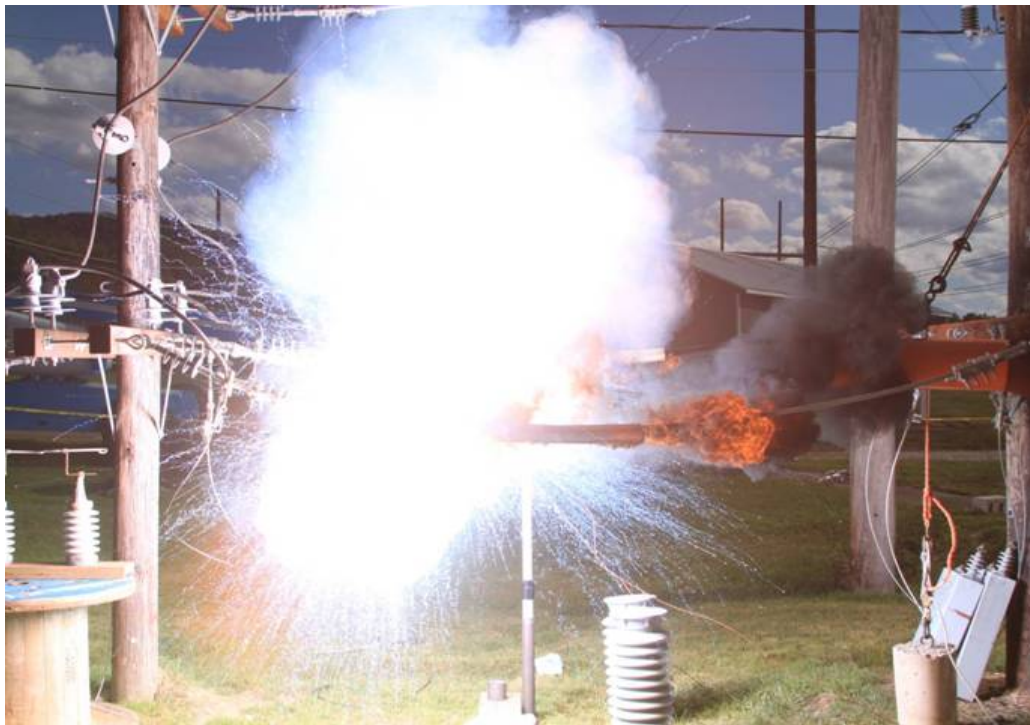
Figure 4-33
Conductor Burndown on 336.4-kcmil (170.5-mm²) Aluminum Conductor at a Line Hose

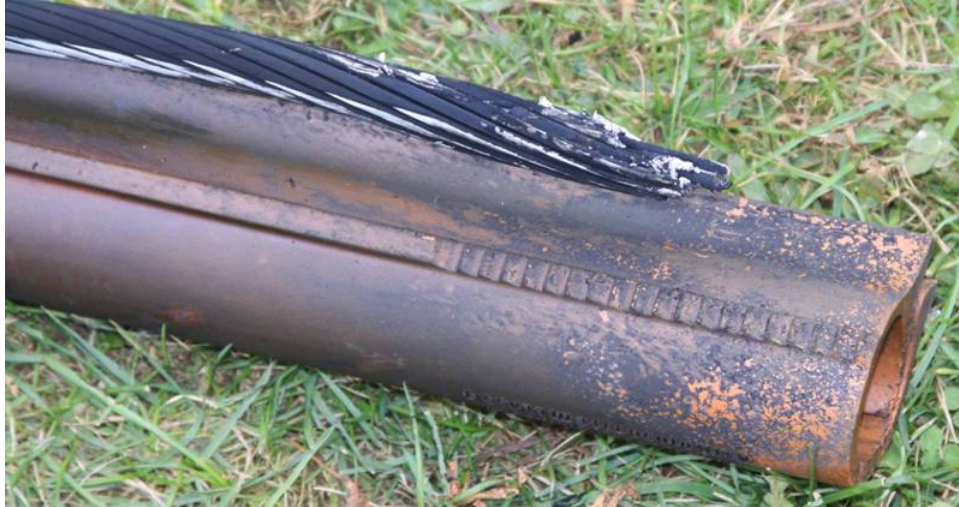
Figure 4-34
Section of 336.4-kcmil (170.5-mm²) Aluminum Conductor After Burndown Event

Note: The insulation was stripped from this conductor prior to testing. The black appearance is due to soot buildup inside the line hose during the test.

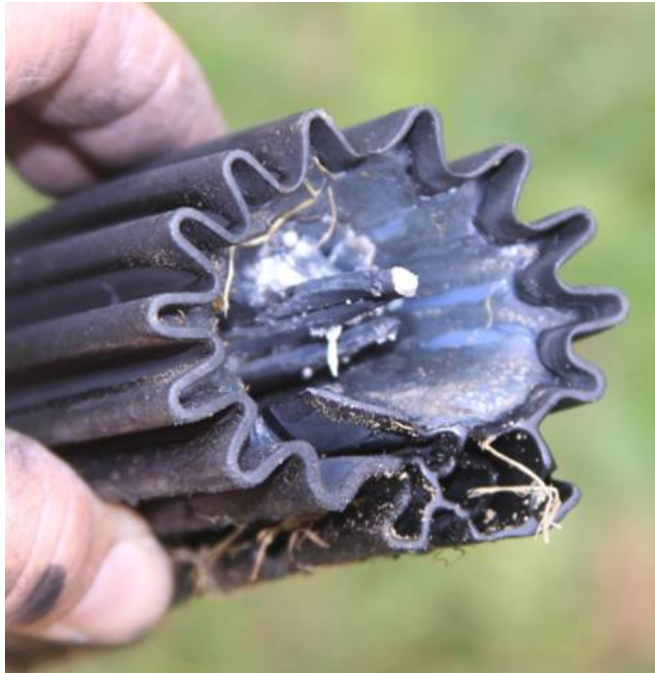
to inhibit arc initiation). In each test an arc was established between two parallel 336.4-kcmil (170.5-mm²) aluminum conductors. The arc current level was nominally 2,800 amps at 4,160 volts phase-to-phase. The arc motored down the line to the gel wrap. The conductor was fully severed in each burndown test. Figure 4-36 shows the result of one of the burndown tests. Notice how most of the conductor strands have been vaporized back into the wrap. The last strands to break did not have a chance to vaporize and are protruding from the gel wrap.

Figure 4-36
Burndown at Gel Wrap on 336.4-kcmil (170.5-mm²) Aluminum Conductor
