Accelerated Corrosion Testing of BORAL®

1018911

Final Report, April 2009

Northeast Technology Corporation

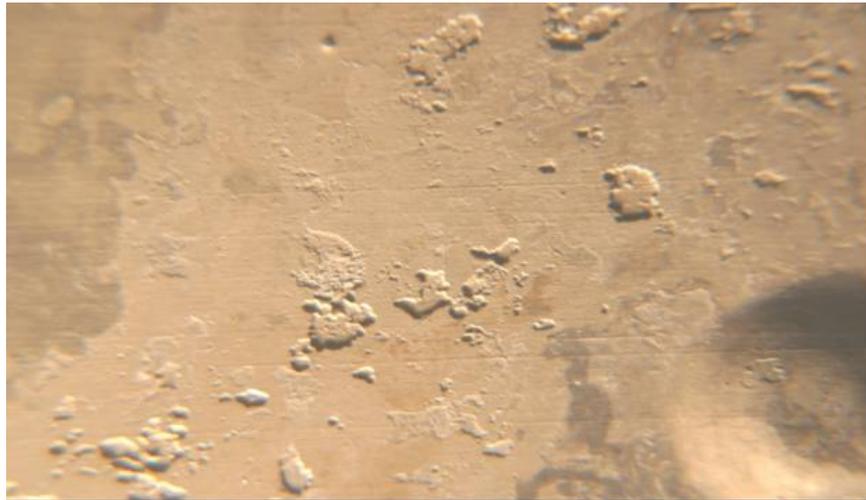
Figure 1-2
Microphotograph (8X) of Corrosion Field

During inspections three and four, further corrosion and blister growth were observed. The corrosion on two of the coupons had advanced to a condition where the corrosion products were spalling off as relatively large flakes, resembling exfoliation corrosion (See Figures 1-2 and 1-3).

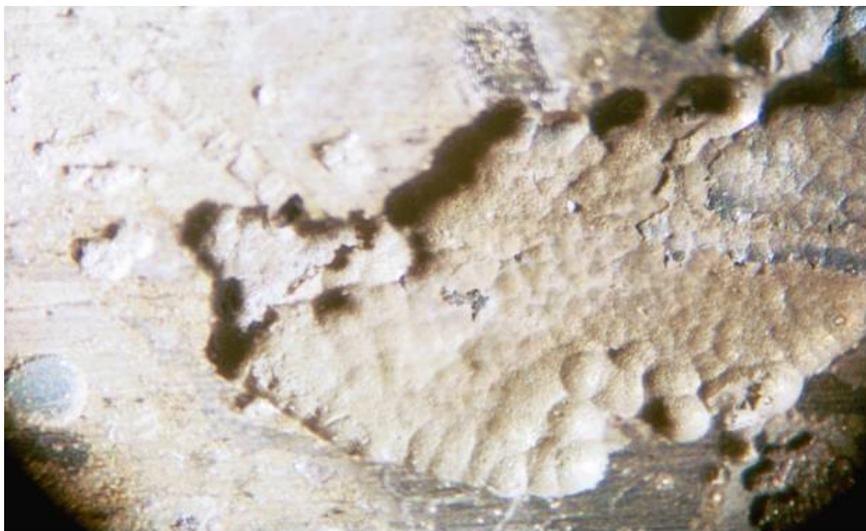
Figure 1-3
Photomicrograph (40X) of Through-Cladding Corrosion Pit

The extent of corrosion on these coupons is not typically observed in BORAL surveillance coupons. While significant pitting corrosion and heavy corrosion along the edges of coupons resulting in separation of the cladding and core have been observed^[2], the surface area of the corrosion fields and their extent on some of the Seabrook coupons is atypical.

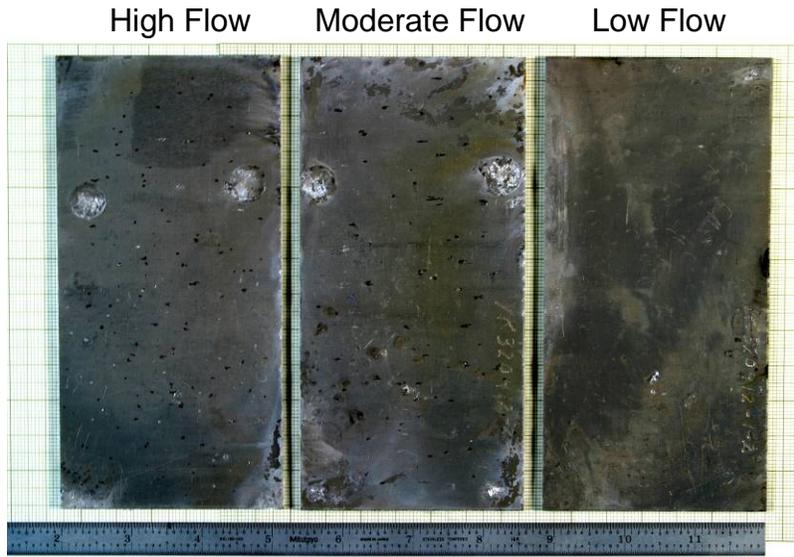
Figure 3-1
Continuous Exposure for Four Months – Front Side

Figures 3-1 and 3-2 show the front and back sides of the continuous exposure coupons after 4 months in the corrosion bath. Qualitatively, the low flow coupon has less surface corrosion than either the moderate or high flow coupon. A blister had developed on the back side of the coupon in the moderate flow capsule as shown in Figure 3-3. The blister was 0.43 inch in diameter and 0.038-inch high.

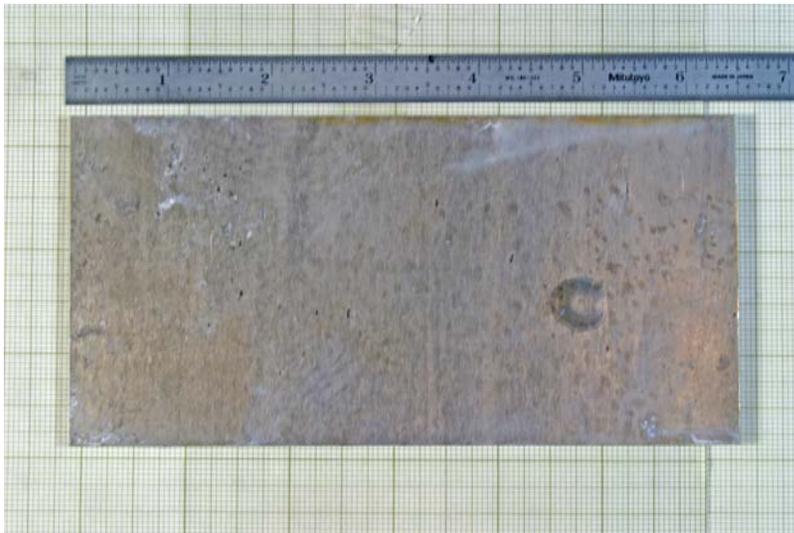
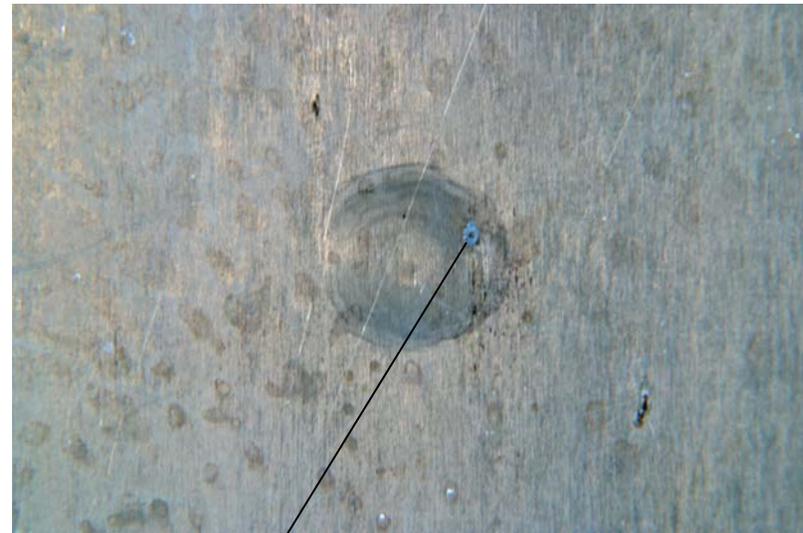
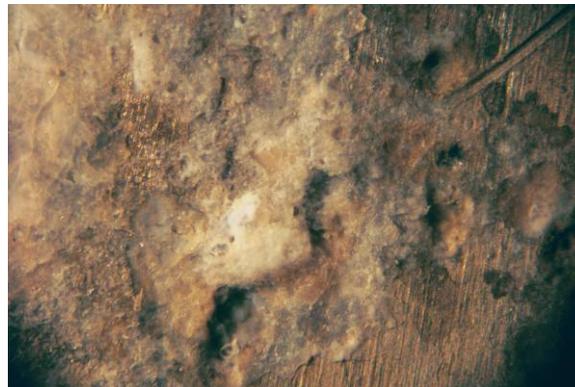
Figure 3-3
Blister in Back Side of Coupon from the Moderate Flow Capsule

Photomicrograph: Through-cladding pit on cap

Figure 3-3 shows a through-cladding corrosion pit had developed in the blister cap. It is believed that water entered the core material through the pit and the blister formed due to pressure buildup of hydrogen from subsequent corrosion. This type of blister formation phenomenon has been observed before.^[4]

In one coupon, a blister formed in the central region of the coupon. Inspection of the blister cap revealed what had been a through-cladding corrosion pit. It is believed that moisture entered the core region of the BORAL through the corrosion pit. Subsequent corrosion around the pit sealed the pit, preventing a path for the escape of hydrogen from the core.

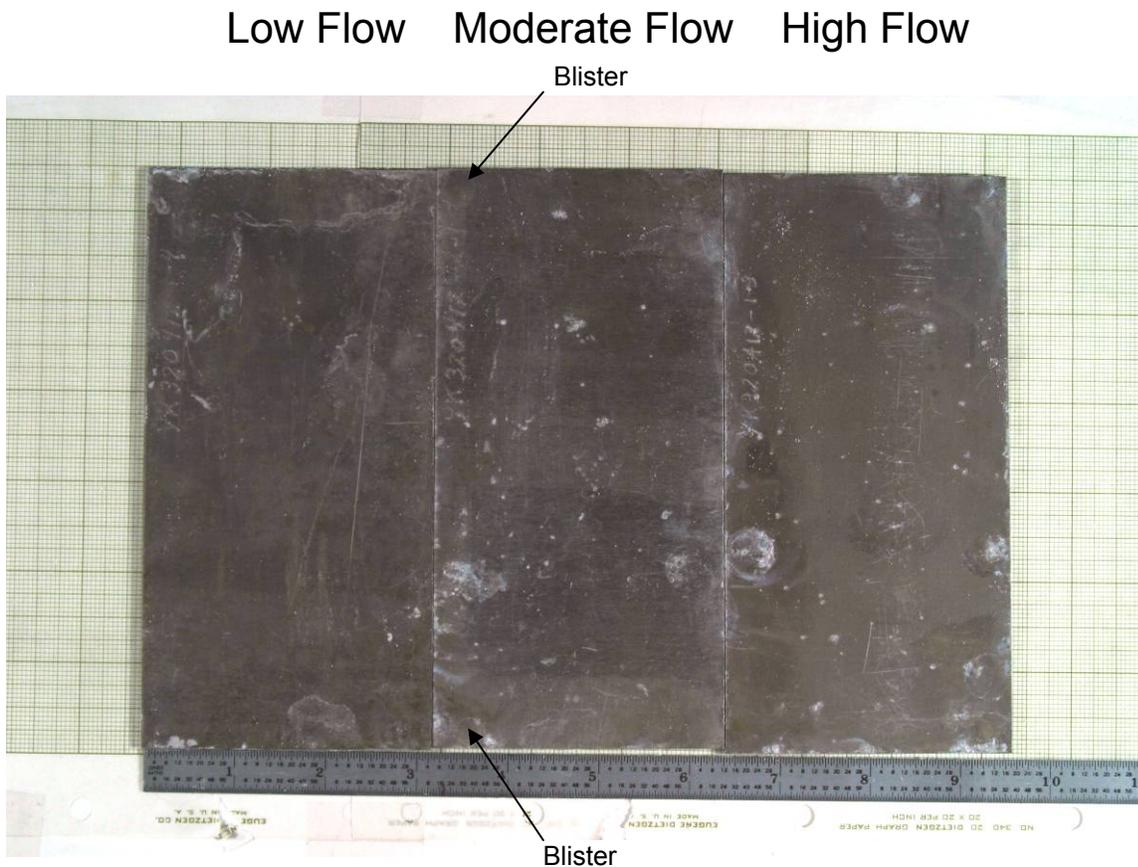
Figure 3-4
Front Side of Cyclically Exposed Coupons

Figures 3-4 and 3-5 contain macrophotographs of the front and back sides of the coupon subjected to cyclic exposure. Appearance-wise, the cyclically exposed coupons are not substantially different from the continuously exposed coupons. The coupon in the low flow capsule has less surface oxide than either the coupon in the moderate or high flow capsule.

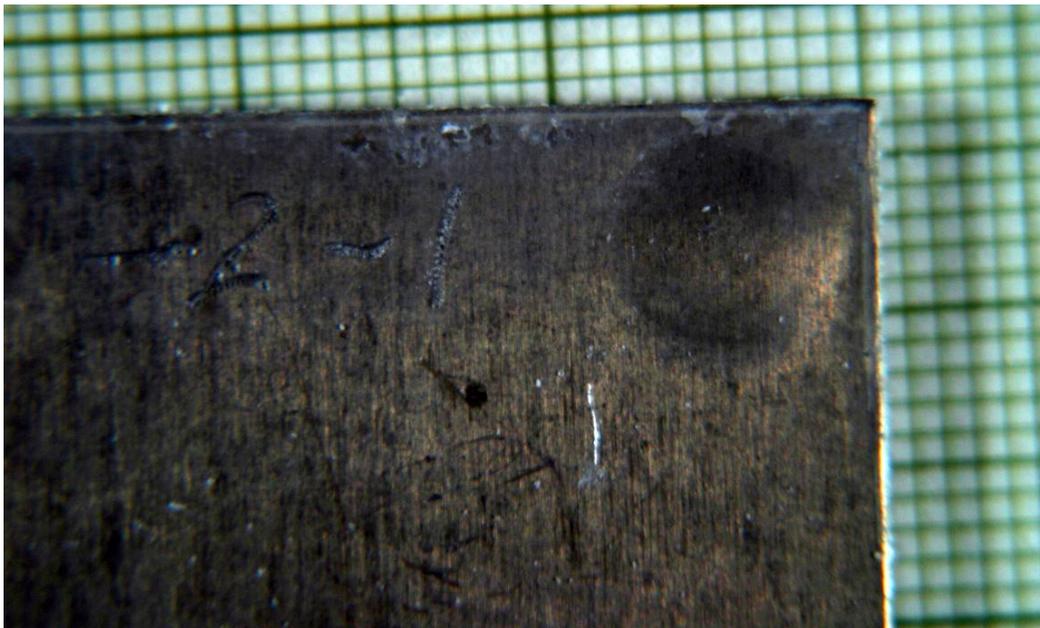
Figure 3-6
Microphotograph (8x) of Blister in Upper Left Corner of Coupon from Moderate Flow Capsule

During the fourth exposure cycle, two small blisters developed on the front side of the coupon in the moderate flow capsule. One blister was in the upper left corner; a second in the lower left corner. Figures 3-6 and 3-7 are microphotographs of these two blisters at 8X magnification. The blister in the upper left corner was 0.35 inch in diameter and 0.020-inch high. The blister in the lower left corner was 0.30 inch in diameter and 0.015-inch high. Neither blister had a corrosion pit in the cap.

It is therefore presumed that moisture entered the core region through the edge of the coupon and subsequent hydrogen generation caused the cladding to delaminate.

In another coupon, two small blisters formed on two corners of one side of the coupon near the coupon edges. In this case, no corrosion pits were observed on the blister caps and it is believed water entered the core through porosity in the cut edges of the BORAL.

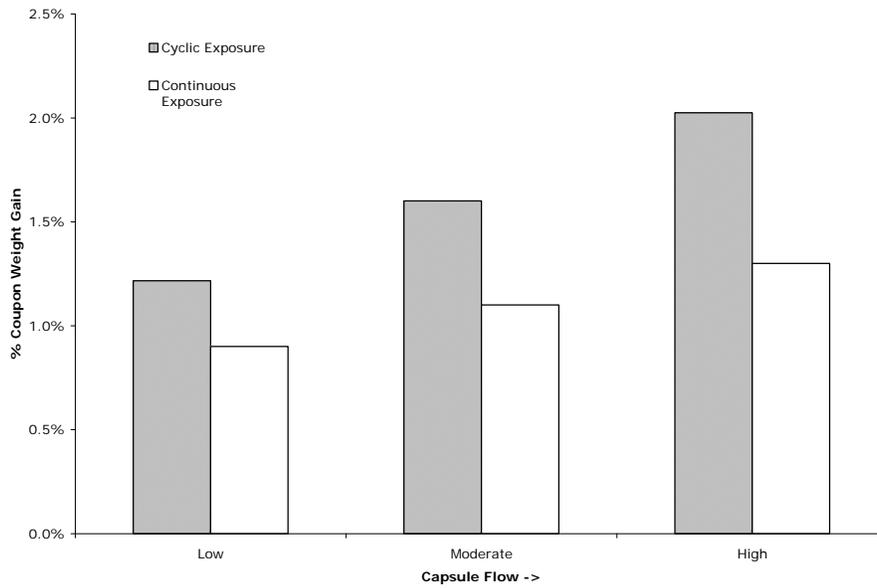
Figure 3-9
Coupon Weight Gain

The initial weight of all coupons was measured after drying in a desiccator. The coupons subjected to continuous exposure were removed from the boric acid solution after 4 months, dried in a desiccator for 48 hours, and reweighed. After each exposure cycle, the cyclic coupons were dried in a desiccator for 48 hours and reweighed. Figure 3-9 contains a plot of percent weight gain.

The data in this figure are quantitative confirmation of the qualitative conclusion based on visual appearance that moderate flow and high flow capsules result in greater coupon weight gain from corrosion products than the coupons in the low flow capsule. Further, all coupons subjected to cyclic exposure sustained greater weight gain than the corresponding coupons subjected to continuous exposure. This confirms the effect of cyclic immersion followed by dryout and re-immersion although the extent of corrosion observed in these tests was considerably less than that sustained by some of the coupons in the Seabrook surveillance program.
