Turbine-Generator Topics for Power Plant Engineers: Motoring of a Synchronous Generator

1022588

Technical Update, February 2011

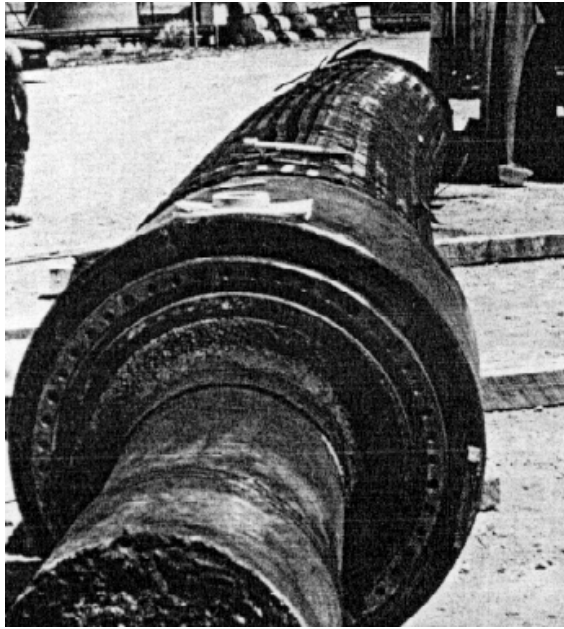
Both motoring currents and negative sequence currents will be discussed here. It is difficult to discuss one problem without the other; they both cause unwanted and harmful current to flow on the rotor forging. Like many maladies there are extremes. Operating with negative sequence currents near the design limit and motoring a unit from rest are both harmful to the rotor, in either case there was over heating of the rotor. One more severe than the other. Here is an analogy of walking and tripping. You can trip on the nap of a rug and fall, or you can trip off the top of the Sears Tower. In either case you fell, one more severe than the other. Photo 1 is an example of a Sears Tower rotor over heating event.

Damage evaluation is easy in some motoring situations, once the smoke has cleared. See the first photograph in the Photo Section. But, for a majority of motoring events, generator or turbine damage is not immediately clear; and in many cases no damage or insignificant harm occurs. If other than Synchronous Motoring takes place for tens of minutes, the generator casing may need to be opened for a visual inspection.

1. Worst case motoring

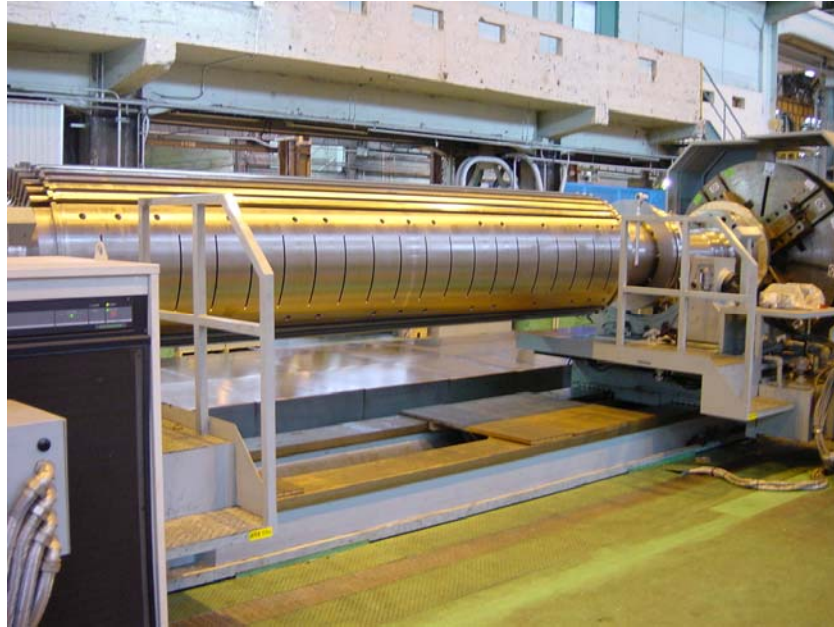
On the 2 pole forgings, pole face “cross slots”, also called body flex slots, are machined into the forging to balance out the stiffness of the forging. [Photo 2] Motoring surface currents can not bridge these slots; as the current flows axially along the forging it bunches up at the end of the cross slot causing heating. [Photos 3 and 4] This localized heating, if severe, will increase the forging steel material hardness which could become the source for a forging crack. All of the overheated areas on the forging must be checked for changes in hardness.

2. Pole forging with cross slots

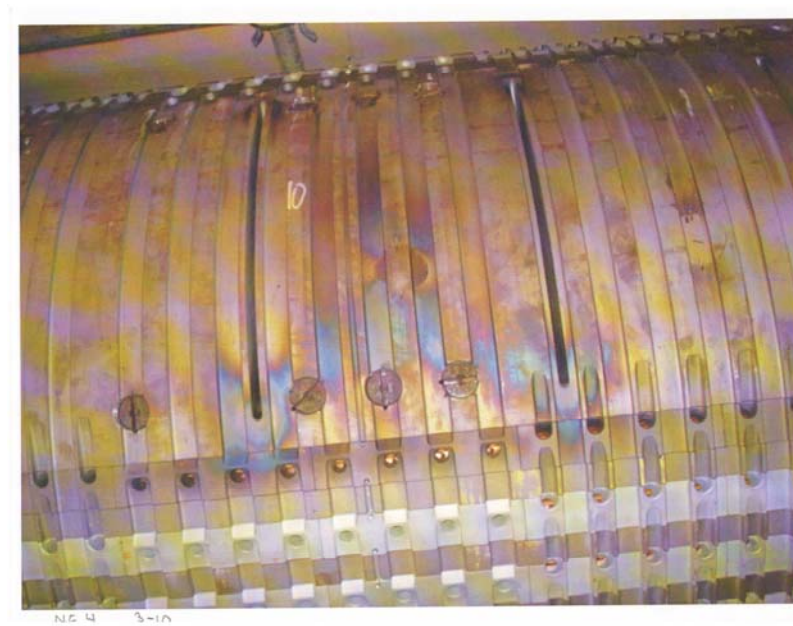
The major areas of concern are: 1) the forging at the ends of the cross slots. [Photos 3 and 4]; 2) the interface where slot wedges butt together [Photo 5]; 3) the interface between the retaining ring fit and the forging or the retaining rings and the wedges [Photo 6]; and 4) the slot wedge to body interface. See the sketch below from Reference 1.

3. Overheating at cross slot (You can almost see the current flow path)

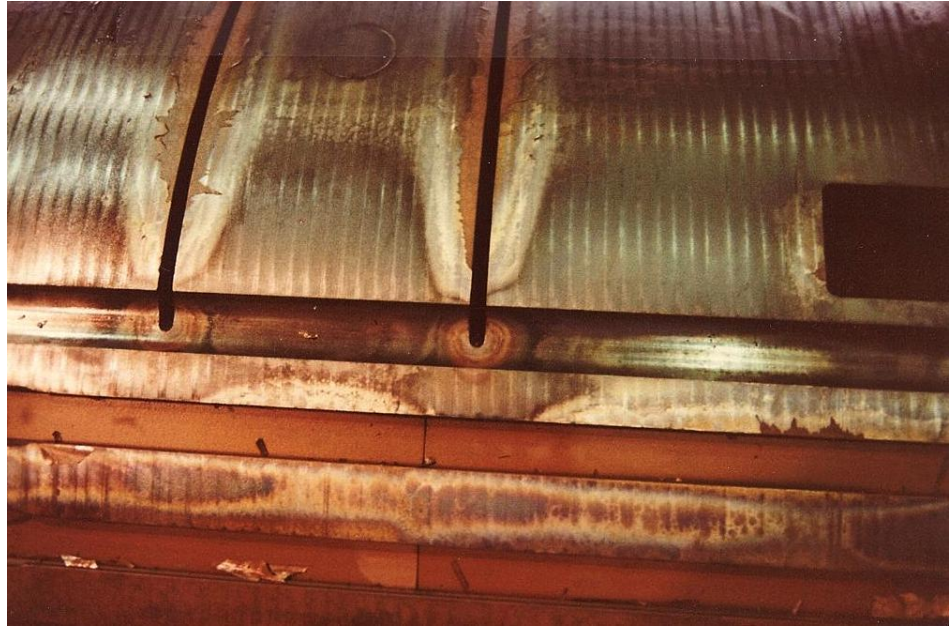
4. Overheating at cross slot

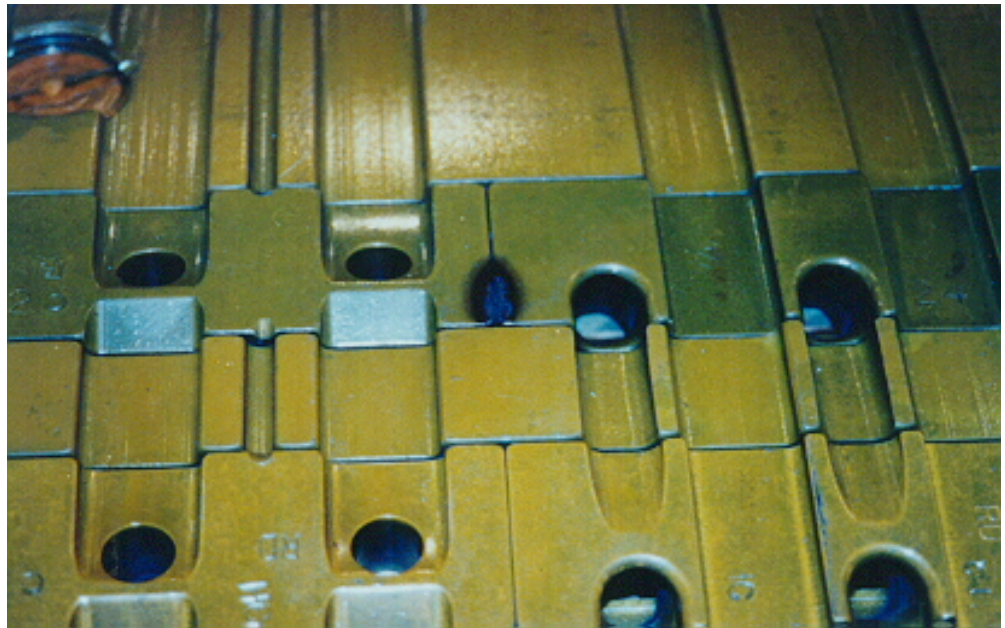
5. Overheating at wedges

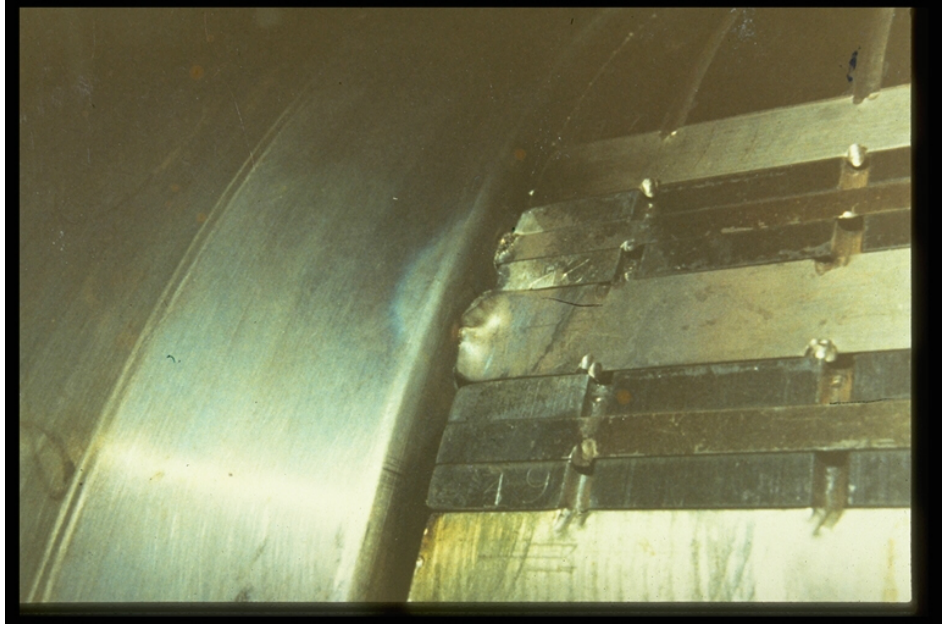
6. Overheating, welding, at the retaining ring
