# Plant Engineering: Emergency Diesel Generator Excitation System End of Expected Life Guidance

2013 TECHNICAL REPORT

**3002000568**

Final Report, December 2013

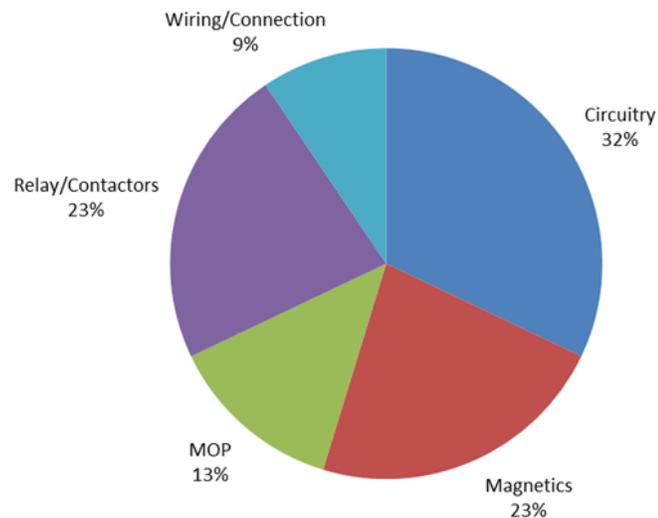
Figure 2-1  
Failure summary of subcomponents

- The largest percentage of failures occurred in the circuitry components, followed by magnetics and relays/contactors. Figure 2-1 shows the percentages of failures in each component category. There was one failure in exciter brushes, but it was excluded from the chart because a large majority of EVRs currently in service are of the static exciter type, which does not use brushes.

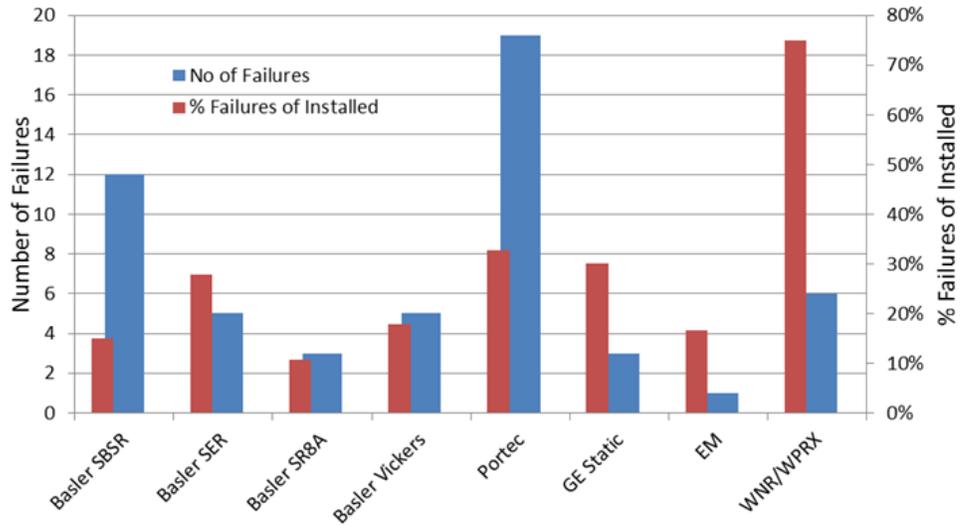
Figure 2-2  
Failure percentage of exciter-voltage regulator models

- Of the installed EVR system, the Portec had the highest failure count, followed by the GE Static and Basler SER. Westinghouse EVRs have the highest percentage failure, followed by Portec. Figure 2-2 shows the failure count and percentage of installed EVR types.

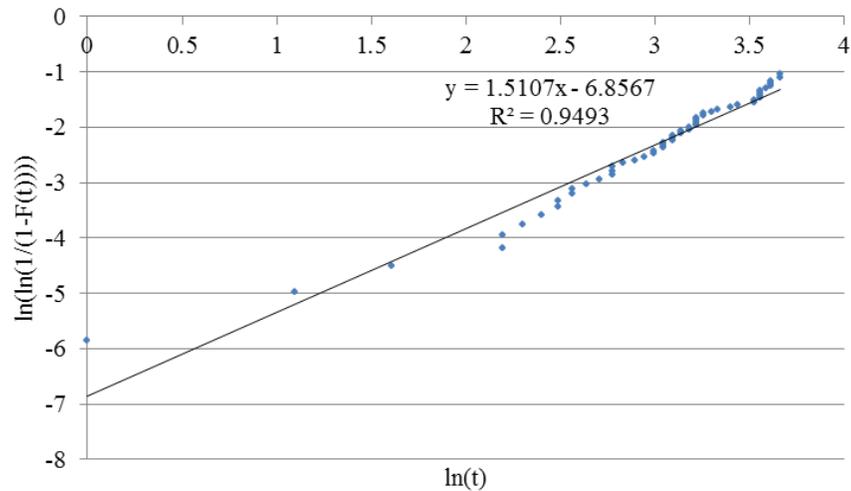
Figure 3-1  
Weibull plot with failure data

Therefore, the data in Table 3-1 are used to plot  $\ln(t)$  and  $\ln \left( \ln \left( \frac{1}{1-F(t)} \right) \right)$ , with a straight line fit, as shown in Figure 3-1.

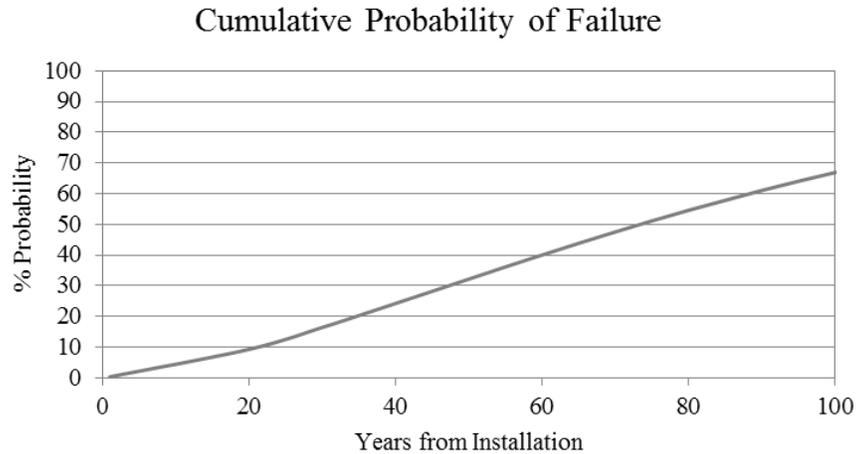
Figure 3-3  
Holistic probability of failure of exciter-voltage regulator subcomponents

Therefore, a calculated Weibull shape parameter of 1.43 indicates an increasing failure rate representing a wearout period. The root causes identified in the OE review show that this wearout is accelerated by external factors such as PM deficiencies, operational errors, and so on. Figure 3-3 shows how the cumulative probability of failure changes with years after installation.

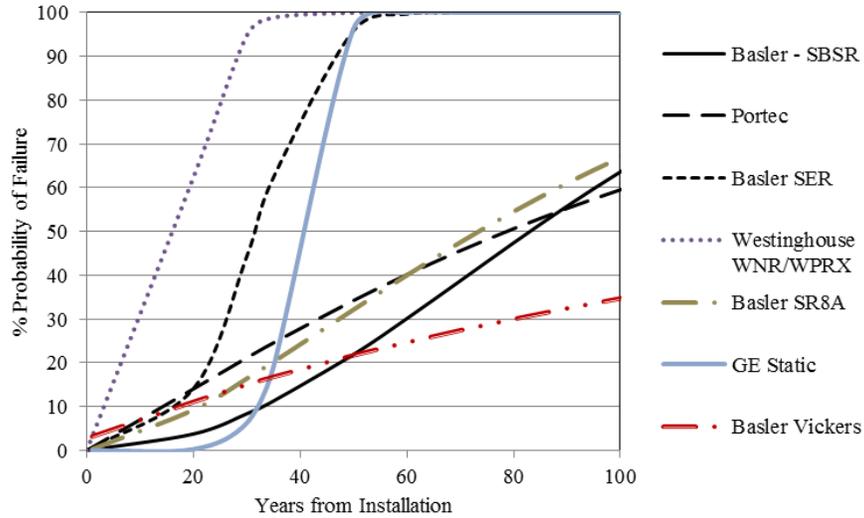
Figure 3-4  
Probability of failure of exciter-voltage regulator subcomponents for different models

Weibull Parameter	Basler SBSR	Portec	Basler SER	WH	Basler SR8A	Basler Vickers	GE Static
Shape parameter, $\beta$	2.03	1.11	3.32	2.72	1.51	0.80	7.70
Scale parameter, $\alpha$	99.44	109.01	35.24	20.16	93.57	289.90	42.80

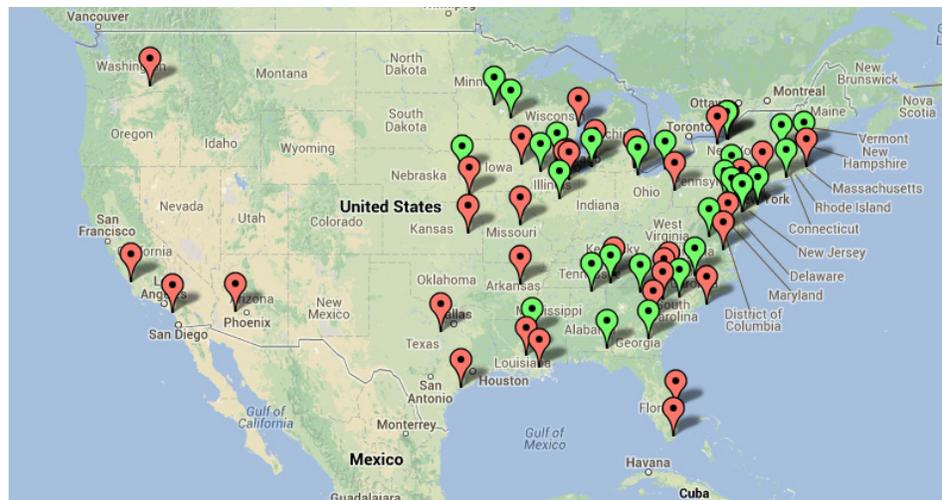
Figure 3-5  
Locations of U.S. plants with exciter-voltage regulator failures (red markers)

It can be seen that the failures in EVRs occurred in all geographical locations and climate types. Therefore, it does not appear that geographical location and local climate condition play a large role in EVR degradation. However, it is important to understand the significance that these environment stressors have in contributing to the EVR system degradation.
