Lessons Learned from Exelon's Non-Segregated Bus Inspections

3002000707

Final Report, November 2013

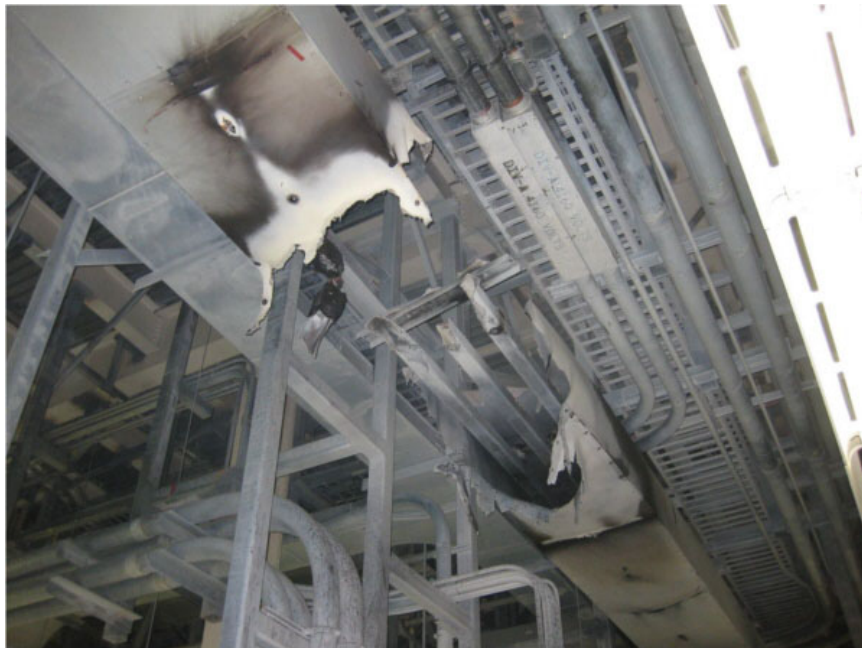
In August 2009, a U.S. nuclear power plant experienced a reactor scram and main turbine trip. This nuclear plant trip was partially caused by an electrical fault in the 6.9-kV electrical distribution system. The non-segregated bus's flex connections overheated and failed catastrophically. All three bus conductors melted and resulted in a fire and significant damage. Figures 2-1 and 2-2 illustrate the effects of the electrical fault and resulting fire.

Figure 2-1
The catastrophic failure of a 6.9-kV non-segregated phase bus at a U.S. nuclear power plant

The most likely cause of the failure was a combination of overheating of the flex connection and torque relaxation because of thermal cycling over time. Contributing causes to the failure included a lack of torque checks on the connection bolting and insufficient temperature monitoring.

It should be noted that, to better monitor the connection temperatures, the plant installed thermography windows to allow for periodic infrared thermography inspections.

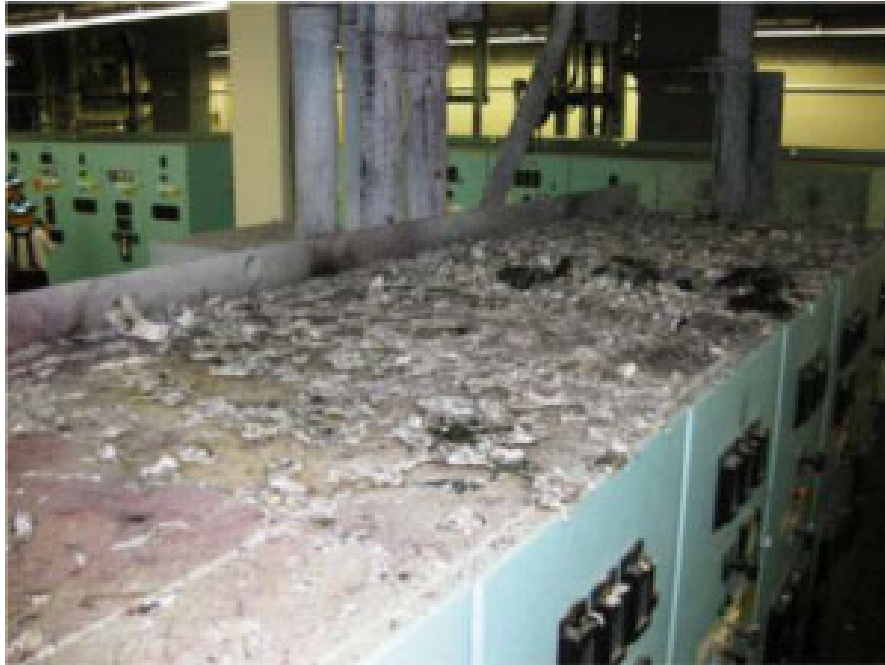
**Figure 2-2**

Debris from the catastrophic failure of a 6.9-kV non-segregated phase bus

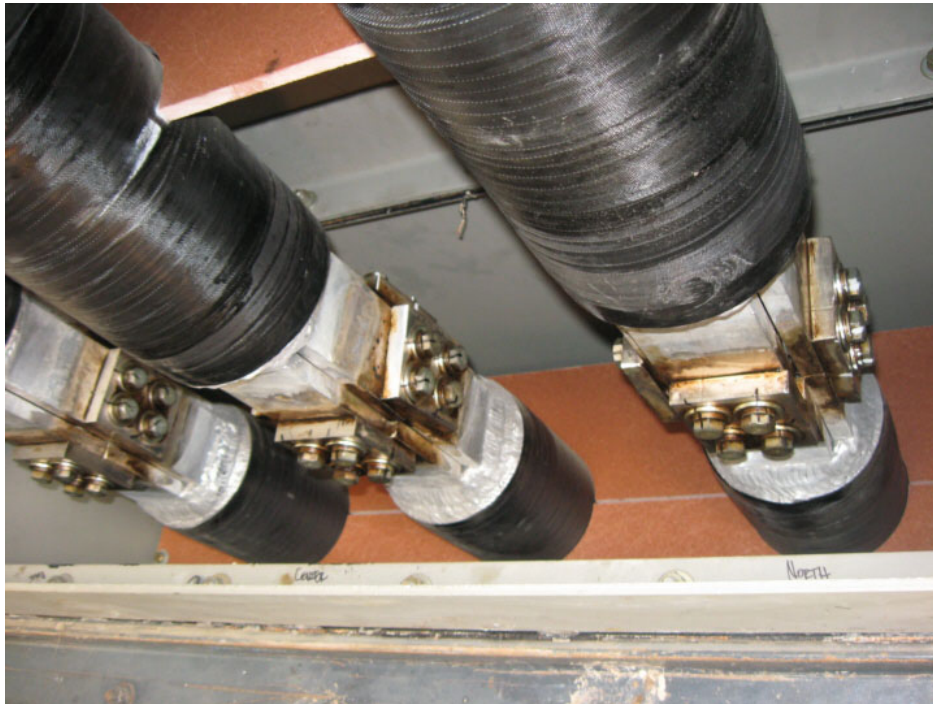
Figure 3-1
The splice plates installed at Dresden Unit 2

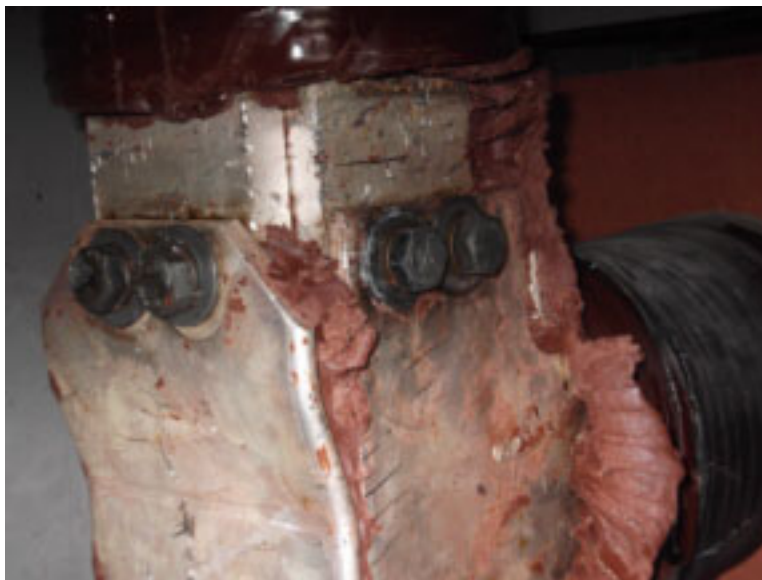
Figure 3-2
A 4-kV non-segregated bus joint at Quad Cities

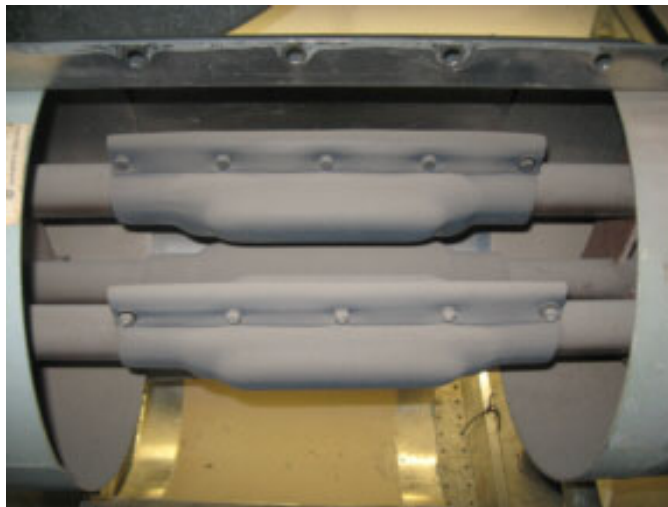
Figures 4-1 and 4-2 illustrate as-found conditions at one Exelon plant indicating that dust does enter the emergency diesel generator non-segregated bus internal because the inspection covers (clam shells) are not sealed. The manufacturer recommended cleaning all of the internals before a high-potential test of these buses at 4 kV, and although they are dusty inside, they are not extremely dusty.

Figure 4-1
Dust found in non-segregated bus internals, Example 1

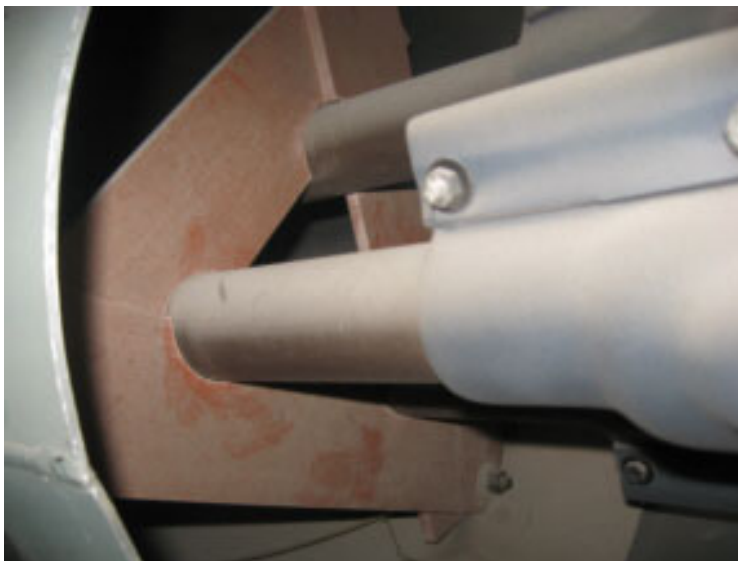
Figure 4-2
Dust found in non-segregated bus internals, Example 2

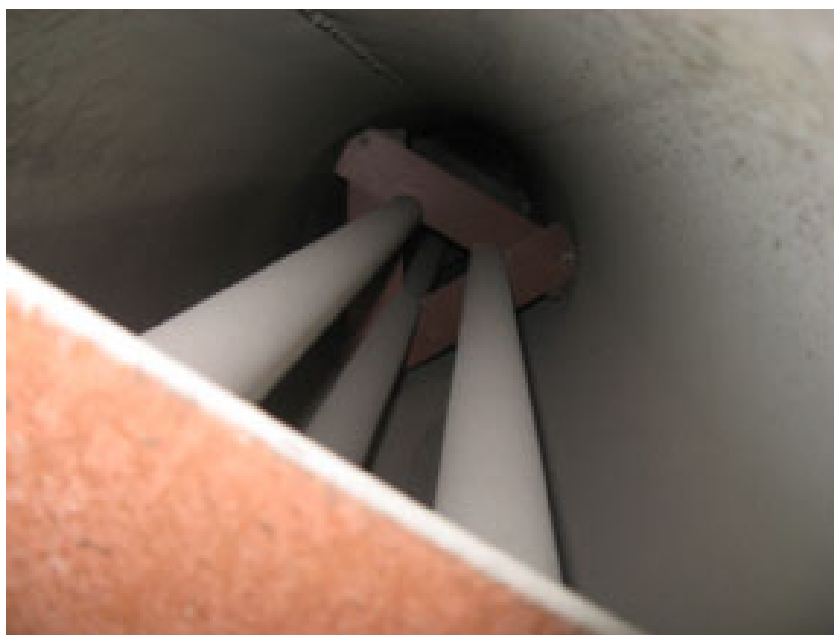
Figure 4-3 illustrates that there can be long runs between clam shells where it is not possible to reach from the inspection points to reach all internals to clean them thoroughly before a high-potential test.

Figure 4-3
Long runs between clam shells preventing thorough cleaning

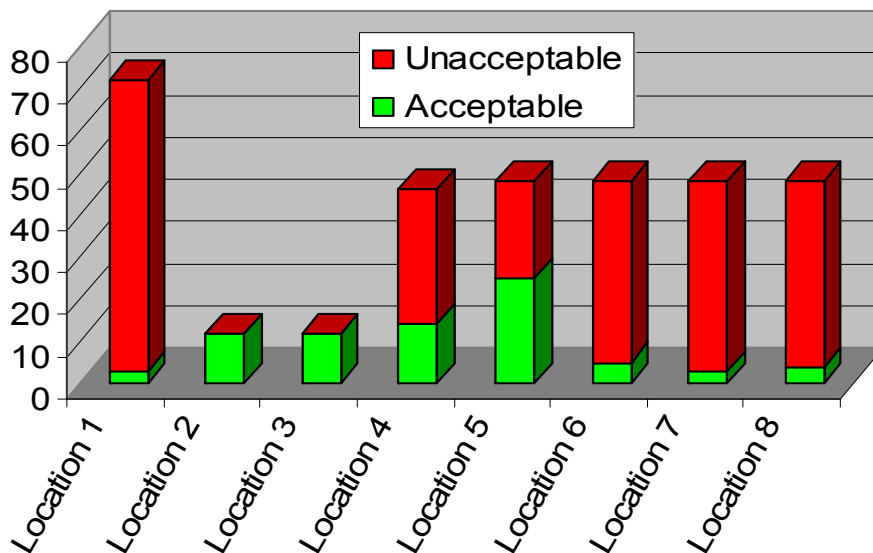
Exelon collected as-found bolt torque data on numerous connection bolts in non-segregated buses at eight Exelon stations over a two-year period and found that approximately 75% of the bolts on buses with aluminum conductors have as-found torque levels below the acceptance criterion, which is 70% of the design installation torque.

Extensive bolt torque data were produced during the ongoing bus connection assessments. Data illustrated in Figure 5-1 were collected at one site and are typical of those for all Exelon plants. Figure 5-1 illustrates that, with the exception of two locations, the vast majority of bolts inspected were found to be unacceptable, meaning that the as-found torque was <70% of the rated value.

Figure 5-1
Typical results of bolt torque inspections
