# Losses of Offsite Power at U.S. Nuclear Power Plants

## Summary of Experience Through 2015

2016 TECHNICAL REPORT

**3002008101**

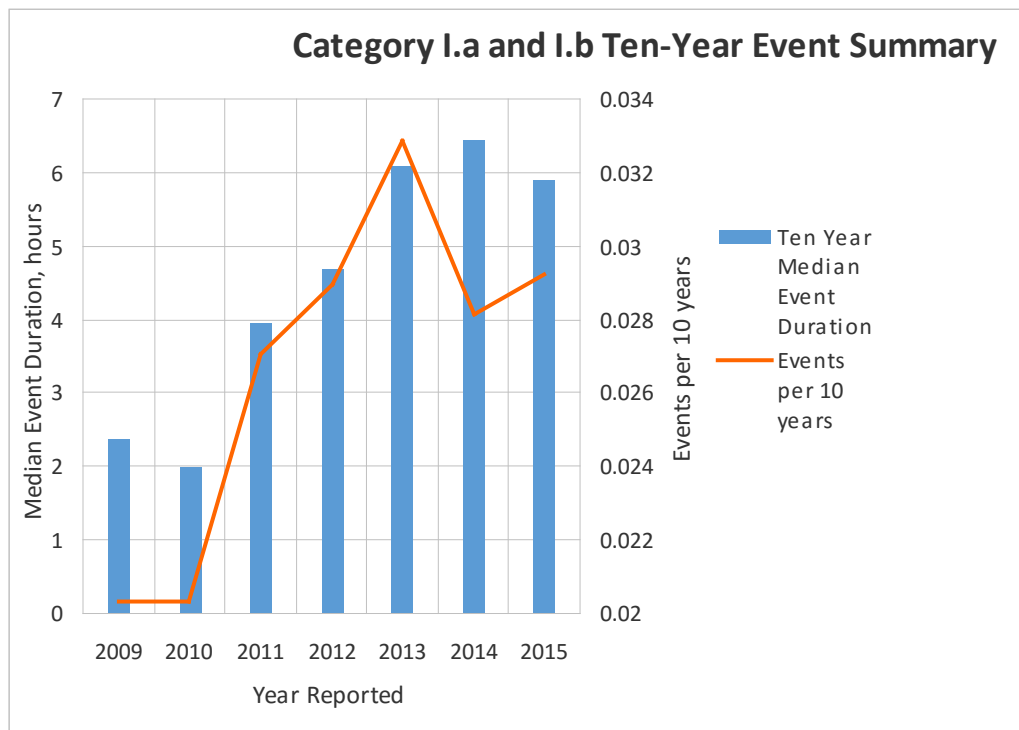
**Figure 3-1**  
**Ten-Year Category I Frequency and Duration: Summary**

Figure 3-1 presents the median LOOP duration (in hours) and the event frequency for the ten-year periods ending in 2009 through 2015. The graphs utilized data from a ten-year period, and some data for years 1999 and 2000 was not available for the year 2009 and 2010 points. Note that with the exception of the past two years (2014 and 2015) since 2010 there has been an increasing trend both in the duration of category I LOOP events and in their frequency. While weather was a predominant cause of these events in several of the years, it is not the only significant factor. As discussed above regarding Table 3-5, thirteen errors were noted associated with the thirty Category I events occurring between 2006 and 2015 that significantly contributed the progression of an event to a total LOOP.

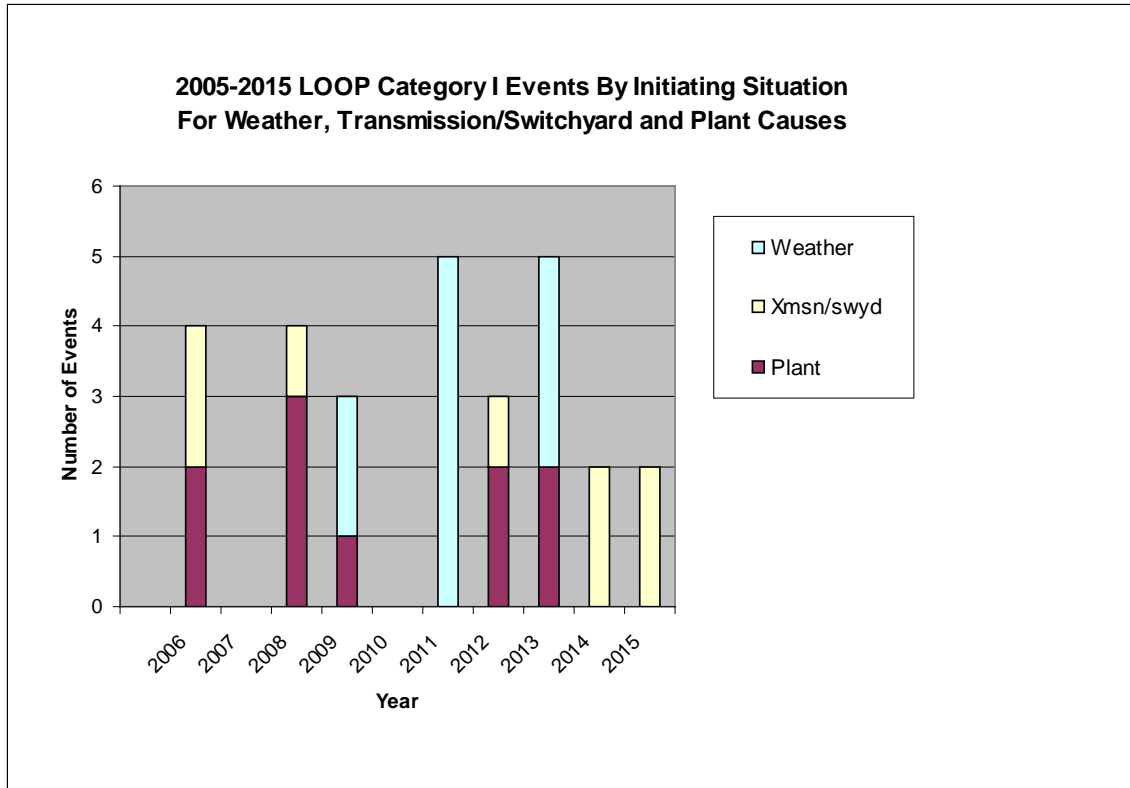
**Figure 3-2**  
**Category I Events by Initiating Situation (2006–2015)**

A compilation of the initiating events and complicating factors for the 30 events in Category I.a and I.b that occurred in the ten-year period from 2006 through 2015 is presented in Table 3-5. Thirteen of the thirty events were potentially avoidable and involved errors noted in the table. Three of these errors were related to the initiating cause of the event, and the remaining ten manifested following the initiating event and contributed to the progression of the initiating event to a Category I or total LOOP. There were no events in 2015 where error was a factor in total Category I LOOPS. However, two Category II events and two events of interest occurred in 2015 where errors contributed to the events.

The median duration of all 30 events involving a total loss of offsite power during the past 10 years was 5.92 hr. The median duration of the 10 weather-related events during the most recent ten-year period was about 8.03 hours, while the median duration of the 20 non-weather-related losses of all offsite power was 5.68 hours. Equipment failures in the plant and switchyard caused losses with median durations of 5.68 hours. The median duration of losses associated with transmission system failures was 5.92 hours.
