# Losses of Offsite Power at U.S. Nuclear Power Plants

## Summary of Experience Through 2016

3002010672

Final Report, September 2017

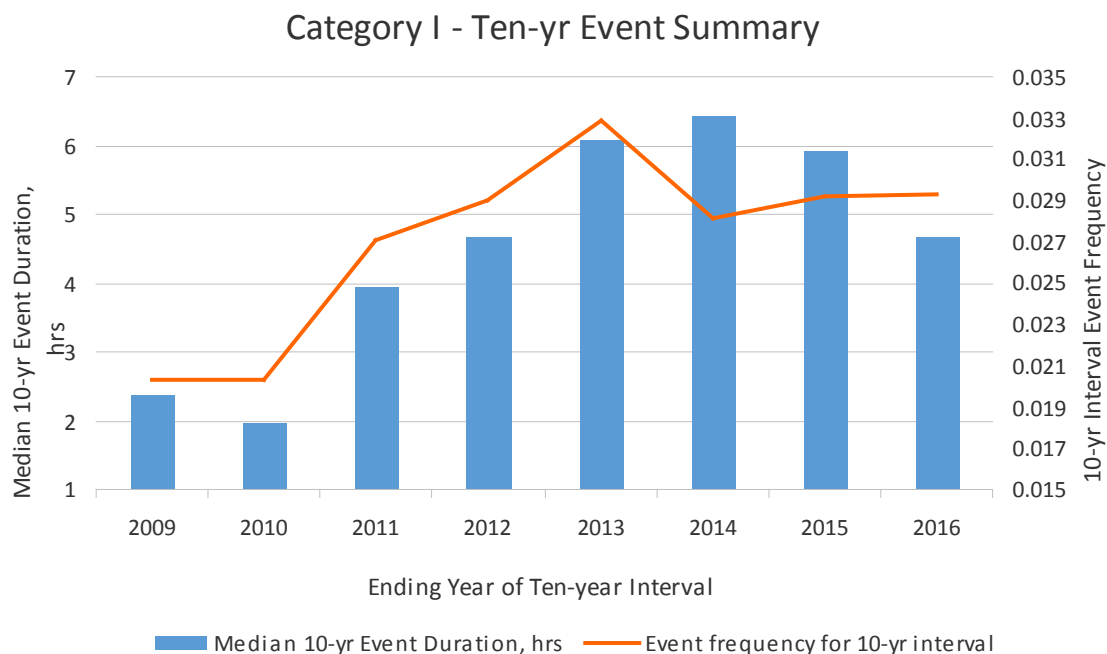
**Figure 3-1**  
**Ten Year Category I Frequency and Duration Summary**

Figure 3-1 presents the median LOOP duration (in hours) and the event frequency for the ten-year periods ending in 2009 through 2016. The graphs utilized data from a ten-year period, and some data was not available for the year 2007 and 2008. While weather was a predominant cause of these events in several of the years, it is not the only significant factor. As presented in Table 3-5, seventeen errors were noted associated with the thirty Category I events occurring between 2007 and 2016 that significantly contributed the progression of an event to a total LOOP.

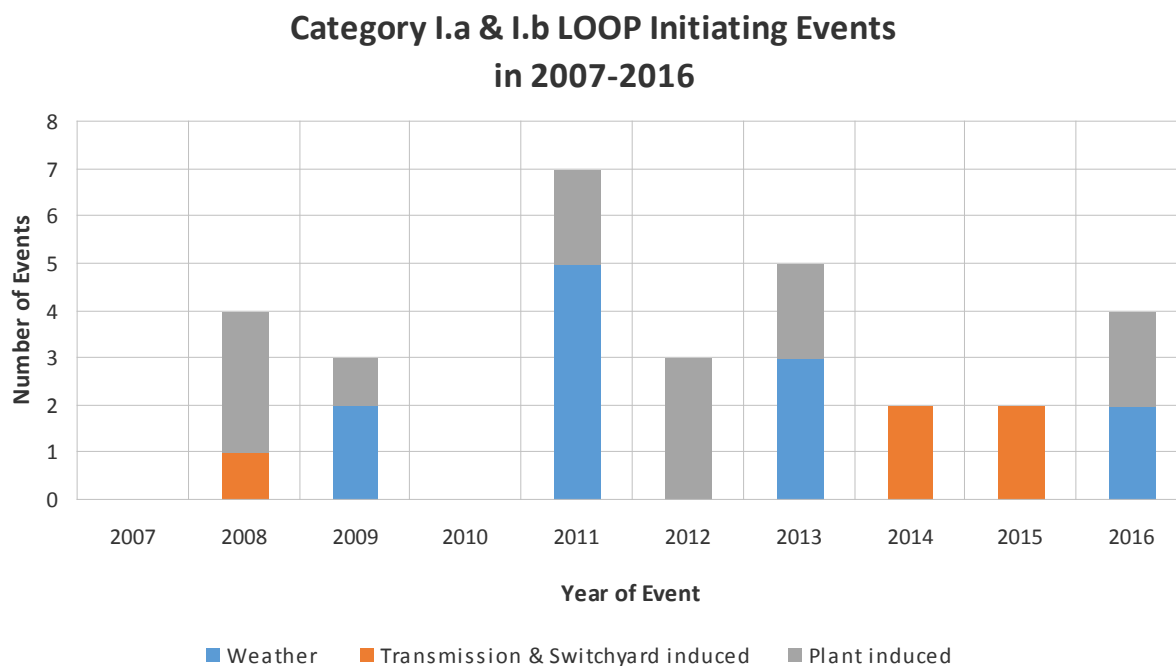
**Figure 3-2**  
**Category I.a and I.b LOOP Initiating Events in 2007-2016**

Data collected over the long term (rolling ten-year periods) indicates a reduction in event duration and a leveling of event frequency for the period of 2014-2016. The event frequency was lower in 2014 and 2015, than in 2013. The event duration also decreased in 2015 and 2016, as depicted in Figure 3-1. It appears that the frequency of losses of offsite power is affected by many factors including plant failures, errors, and weather and grid conditions at and beyond the plant switchyards (see Figure 3-2).

Figure 3-2 presents the number of LOOPs and initiating events in each year from 2007-2016.

\* In 2011 the two plant events were caused by seismic activity.
