Deterioration and Evaluation of Steel Liners and Vessels: Operating Experience

Technical Brief — Nondestructive Evaluation, P41.04.01

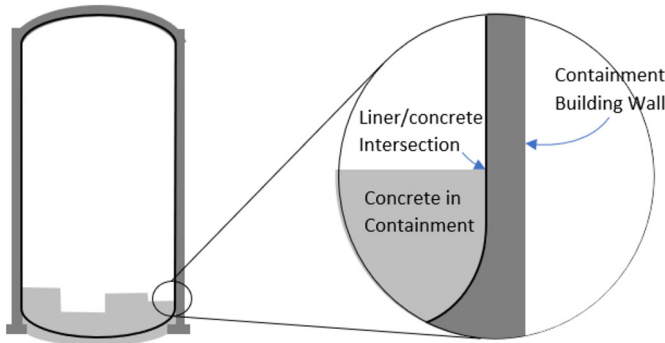
In the first case, corrosion may be caused by a gap or separation between the liner and concrete at the intersection of the concrete and liner (see Figure 2-1). The vertical portion of the liner becomes embedded in concrete on the interior of the containment to allow the concrete to be a walking surface or support for equipment. As the liner becomes embedded in concrete, it gradually transitions with some curvature to the plate from a vertical to a horizontal position. If water accumulates at the region between the concrete and the steel liner, the environment becomes favorable to promote corrosion of the liner. In some containment structures, the transition region consists of a cavity with a liner in contact with each surface of the cavity. In some cases, the cavity is filled with alkaline water to prevent deterioration and corrosion of the steel plate.

Figure 2-1. Containment liner at the intersection of an interior horizontal concrete surface

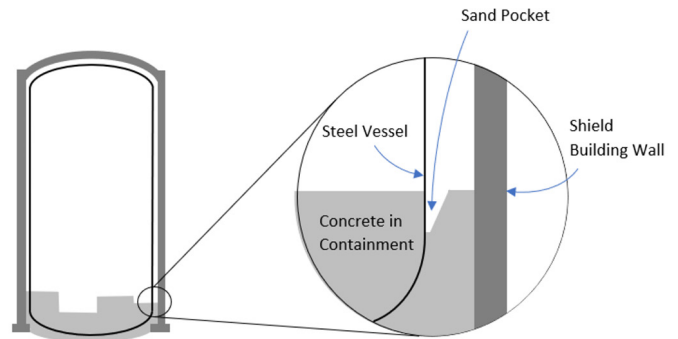
The scenario of corrosion on the exterior of the steel vessel plate is common for freestanding steel containments with a shield or enclosure building that protects the containment vessel from the elements (see Figure 2-2). In this type of structure, it is common to find a cavity between the steel plate and shield building. Within the cavity, the concrete might intersect the exterior of the steel plate. Similar to the case of corrosion on the interior of containment, a gap between the steel plate and concrete plus the presence of moisture could generate an environment that promotes corrosion.

In both scenarios of corrosion—interior or exterior—deterioration has been detected through visual inspection followed by ultrasonic thickness measurement of the steel plate. If the steel plate thickness is within the allowable limit, the steel is cleaned and coated, and the concrete is restored. If the thickness of the plate has been compromised, a plan to restore the thickness of the plate is put in place. This typically consists of welding an additional thickness of plate or performing a weld overlay.

Figure 2-2. Steel vessel, shield building, and general detail of the sand pocket region

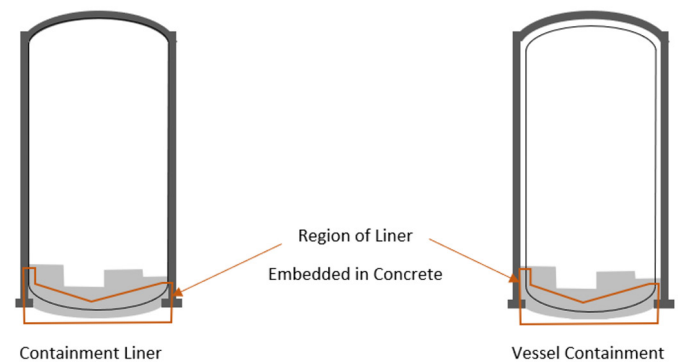
This type of corrosion can be found in regions beyond the intersection of the concrete-liner interface (see Figure 2-3) and in containment buildings that have a steel liner embedded in concrete (see Figure 2-4). The main concern with this type of deterioration is that it cannot be detected through visual inspection because the liner is fully embedded in concrete. Some indications of deterioration of liners embedded in concrete have been realized by analyzing the results from leak rate testing and through-wall gas leakage detection. However, the gas leakage detection method provides only an approximate location of the deterioration. Concrete removal from inside the diameter of containment has been performed during these scenarios to find and repair the defects. Once the concrete is removed, visual and ultrasonic thickness measurements of the steel plate are performed to detect the extent of the condition. When defects have been found, these were caused by embedded wood objects, voids, or honeycombing resting against the surface of the plate.

Figure 2-3. Examples of liner and vessel embedded in concrete

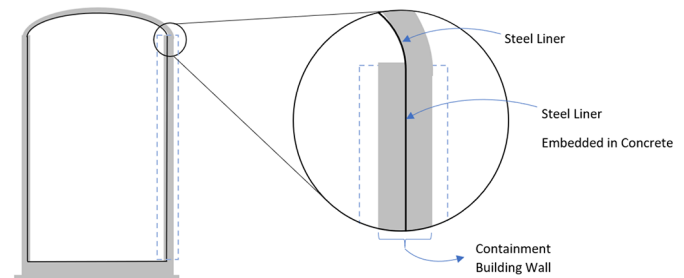
Figure 2-4. Example of containment with liner embedded in the containment wall

Once the defects are detected, the concrete behind the plate is restored, a new section of plate is welded, and the concrete cavity on the interior diameter of the containment is filled. A follow-up leak rate test is performed to verify the effectiveness of the repair.

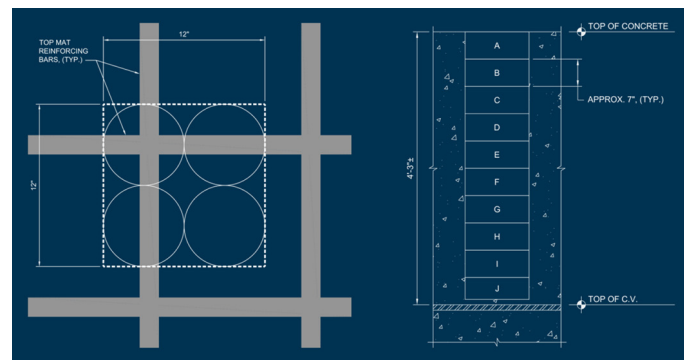
The engineering team responsible for the inspection restricted the amount of concrete and reinforcement that could be removed to reach the concrete plate. The team recommended removing an area no larger than 30 cm x 30 cm (12 in. x 12 in.), and only one piece or reinforcing could be removed for each layer. For removing the concrete, four 15-cm-diameter (6-in.-diameter) cores were marked in the 30 cm x 30 cm (12 in. x 12 in.) area. The cores in the first set were drilled to a depth of 15 cm (6 in.) from the top horizontal surface using a wet coring method. Once the depth was reached, the cores were extracted, and a new layer of cores would be removed. The remaining depth of coring was completed using a dry coring bit that is typically used for drilling through masonry. The reason for performing dry coring was to avoid including any water in the process and to see if a source of water was present along the depth or near the plate. At each layer of concrete removal, ground-penetrating radar was performed to identify any potential interferences not documented in the drawings. Figure 3-1 presents a plan and cross-section of the concrete removal sequence. Figure 3-2 presents the wet coring of the top surface of the concrete and the concrete cavity near the bottom layer of reinforcement.

Figure 3-1. Plan and elevation of the concrete removal sequence (Used with permission from Energy Harbor.)

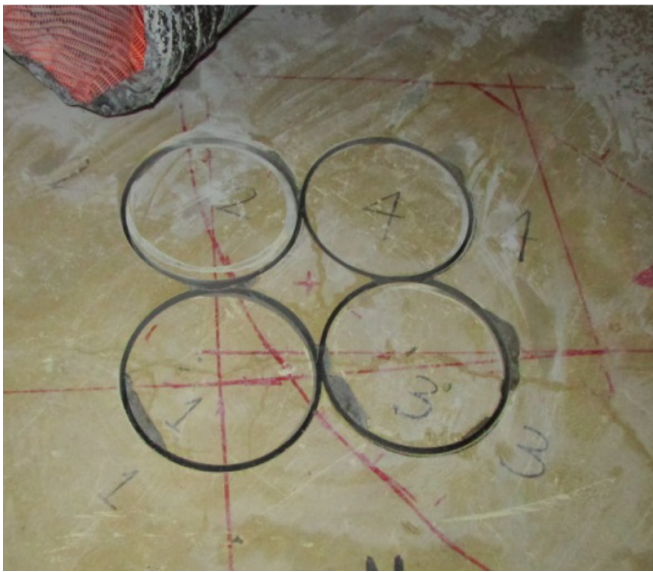
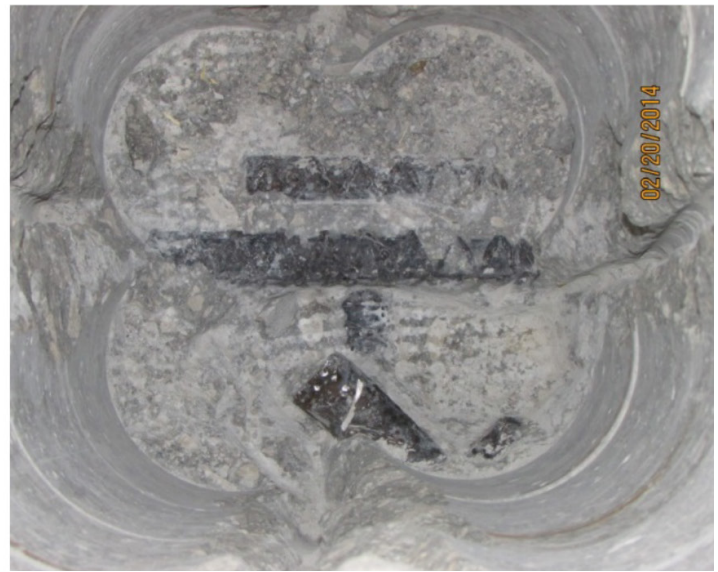
Once the plate was reached and exposed, an ultrasonic thickness measurement of the plate was collected. The thickness of the plate was within the acceptable range noted in the design drawings, and no water was observed during the concrete removal process. After performing the thickness measurement of the vessel plate, the cavity was filled with bagged repair mortar. The samples removed during the demolition process were subjected to petrographic examination and compressive strength. The petrographic examination did not indicate deterioration of the concrete, and the

Figure 3-2. Top surface of the concrete after wet coring (left) and bottom of the cavity a few centimeters away from the plate (right) (Used with permission from Energy Harbor.)

compressive strength was documented to be in the range of 75.8 MPa (11,000 psi), which is more than twice the design compressive strength of 34.5 MPa (5000 psi).

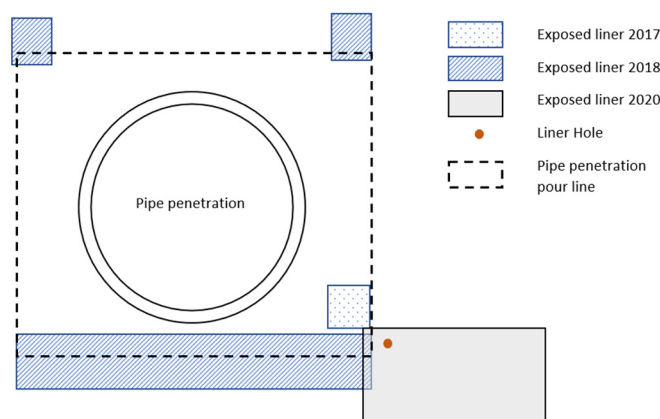
In Swedish containments, the steel liner is embedded in the concrete of the containment building. In 2017 and 2018, concrete was removed, and the liner was exposed from the inside wall of the containment building in multiple areas near the penetration that was noted to have some leakage in 2016. During this inspection cycle, no damage to the liner was found. In 2020, a new area of the liner was exposed, and through-wall corrosion was found in one location. The area of corrosion, with an approximate

size of 15 cm x 40 cm (6 in. x 16 in.) was caused by a wood wedge located against the liner; the hole in the liner was noted to be approximately 7 cm (2.8 in.) in diameter. Figure 3-3 is a general sketch of the areas of the liner exposed during the three investigation phases that required concrete removal. When isolated areas of the liner away from the penetration were exposed to investigate suspected deterioration, no deterioration was found. The damaged area of the liner was replaced, and concrete was restored. A containment integrity test was performed and deemed acceptable. No leakage through the concrete was detected.

Figure 3-3. Pipe penetration and investigation openings performed between 2017 and 2020 to inspect the liner (not to scale)
