2023 White Paper

Transformer Bushing Failure Investigation

High-Voltage Oil-Impregnated Paper Bushing Reliability, Operational, and Safety Concerns

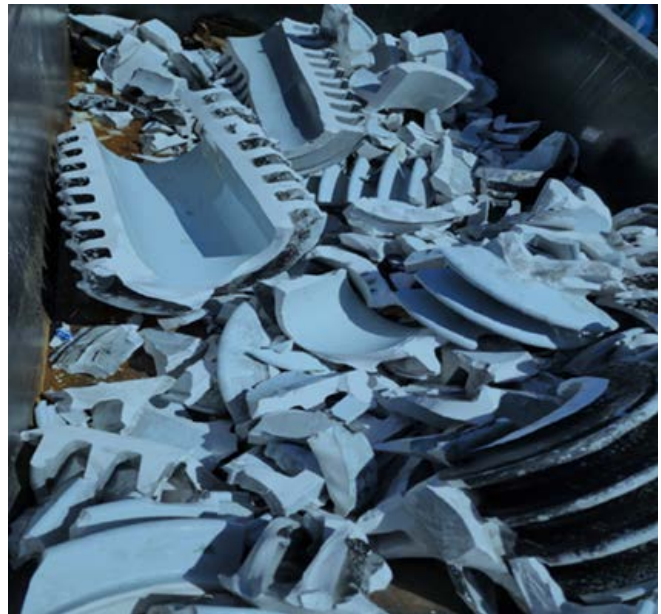
The failure of this bushing type has caused collateral damage when the porcelain sheds shatter. Figure 5 illustrates the severity of a failure. In some cases, the associated transformer was damaged or destroyed.

Figure 5. Illustration of Destroyed OIP Bushing Sheds

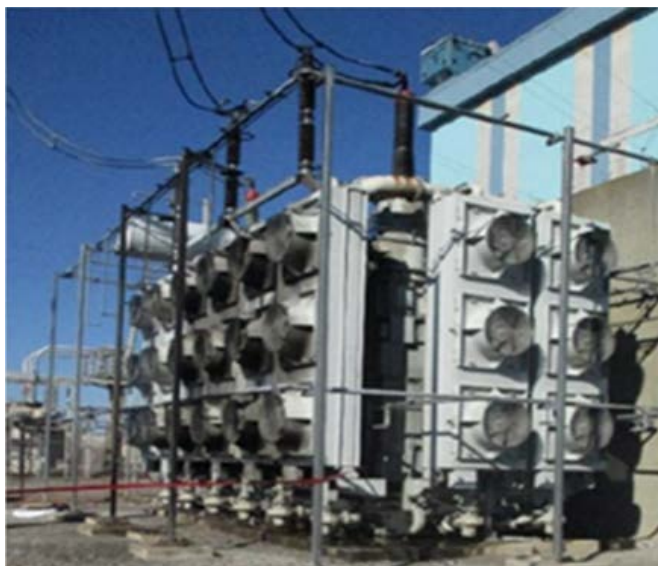
The first case study covers a recent bushing failure at a member's nuclear generating station. Figure 6 shows the damaged GSU. This HV bushing failure led to a catastrophic transformer failure and a costly forced outage.

Figure 6. GSU Transformer External View: Catastrophic Failure of HV Bushing Center Phase

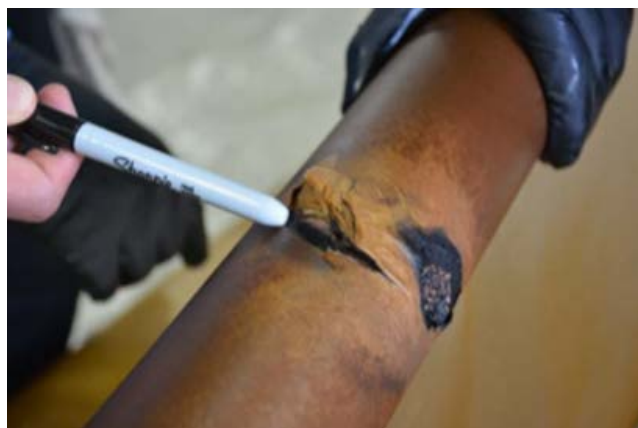
The heavily damaged H2 bushing was removed from the transformer and brought to EPRI's Lenox lab for teardown and detailed examination. The subject bushing was a porcelain 230-kV oil-impregnated bushing manufactured in 2009. The condenser core consists of kraft paper sheets wrapped over a copper center conductor and electrically graded using conductive ink layers as shown in Figure 4. The condenser core was heavily damaged by fire, with most of the fire damage at the lower and upper ends of the condenser core. Prominent arc flash damage with significant melting of the copper center conductor was located near the lower end of the center conductor as shown in Figure 7.

Figure 7. B-Phase Extended Internal Damage of 230-kV Bushing with Copper Center Conductor

No other evidence of arcing was noted along the center conductor as shown in Figures 7 and 8. Examination of the H2 bushing capacitance stud and the cover displayed

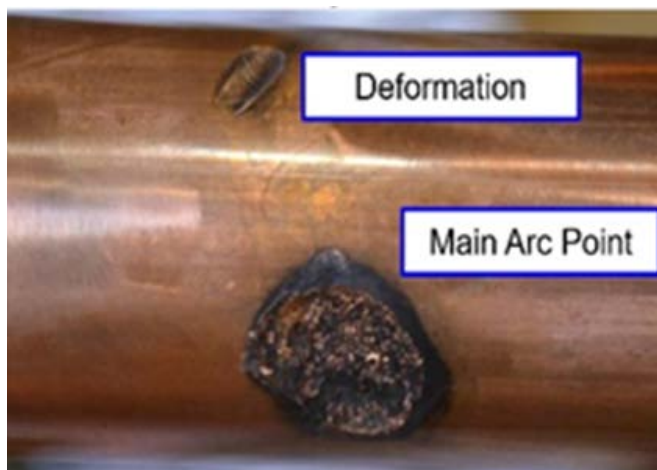
The working hypothesis is that the paper layers found at the two locations of the condenser core are sliced off from the lower end to form the lower taper that was inadvertently wound in during the lower end winding process. Given the location of these strips in the direct vicinity of the main failure point, the presence of these errant paper strips may have played a role in the failure. In the layers of paper nearest the center conductor, a second area of torn paper and carbon was noted above apparent arc strike marks or deformation almost the size of a golf ball in the copper of the center conductor near the main arc point (roughly 2 in. [51 mm] away circumferentially) as shown in Figure 8.

Figure 8. B-Main Arc Point of 230 kV with Copper Center Conductor

Examination of the bare center conductor shows mechanical deformation in this area, a raised edge of approximately 1/8 in. (3.2 mm). There does not appear to be melting of the copper in this area that would be indicative of arcing. The upper and lower ends of the center conductor were also examined for any evidence of overheating. Any discoloration observed was consistent with the fire that followed the failure and not long-term overheating.

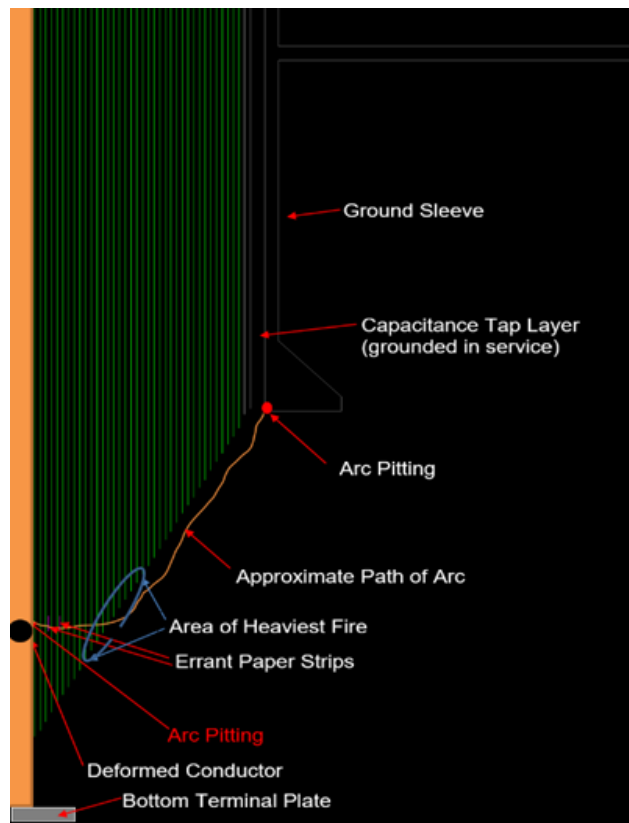
The key findings from the forensic examination of the H2 bushing remnants are depicted schematically in Figure 9. This figure illustrates the main arc points on the center conductor and shows the approximate path of the electrical failure to the ground sleeve. Note that the path of the arc extends outward from the center conductor and then up through the oil gap between the lower taper of the condenser core and the lower porcelain, up to the lower capacitor edge of the ground sleeve bypassing the grounded capacitance tap layer.

In discussing potential failure causes, the initial conversation included the possibility of a failure external to the bushing (perhaps in the active part) such as the transformer main tank or environmental external conditions. The known arc termination points inside the bushing reveal a dielectric failure toward the lower end of the insulated condenser core. The only termination along the center conductor was located 400 mm (15.74 in.) from the lower end of the center conductor and beneath 13–15 conductive layers of the insulation or roughly 1/3 of the total radial build of the solid insulation shown in Figure 9.

Figure 9. Illustration of Diagram of Lower End of H2 Bushing Depicting Key Findings from Forensic Examination

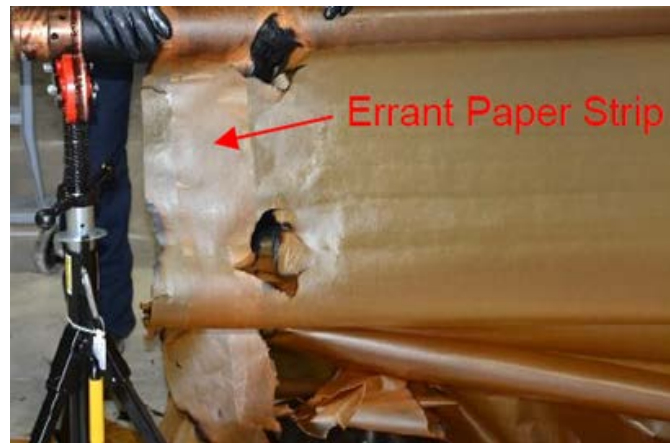
Figure 10. Discovery of Errant Paper Strip Between Ink Layers

During bushing disassembly, an errant paper strip, as shown in Figure 10, was found wound on the condenser core, which could create a small void at the edge of the strip where it rests between the adjacent layers of paper insulation. This void may have been larger in areas where the strip is wrinkled or folded back on itself. Because the permittivity in the void is lower than in oil-impregnated paper, the electrical stress would be higher in the void. This condition could result in PD activity in the void. PDs generate gases and could carbonize the adjacent paper insulation, forming conductive byproducts and perpetuating the discharge. This cycle of degradation would progress until sufficient solid insulation was damaged to compromise the dielectric strength of the insulation, resulting in dielectric failure.

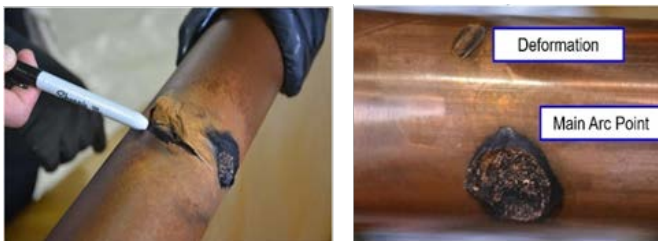
As shown in Figure 11, a mechanical “deformation” was noted on the surface of the center conductor near the main failure point. Some carbon and torn paper were noted, extending several paper layers out from the surface of the center conductor. The “deformation” has a raised edge of about 1/8 in. (3.2 mm). This protruded edge would cause increased stress because of the divergent electrical field caused by irregularities in the conductor surface. In addition, the paper insulation would not sit flat over this area, creating an air gap that would provide an initiation site for partial discharging to occur. Although some or all of the carbon may be from the main failure, it is likely that there was some PD activity in this area.

Figure 11. Illustration of the Main Arc Point and Deformed Center Conductor

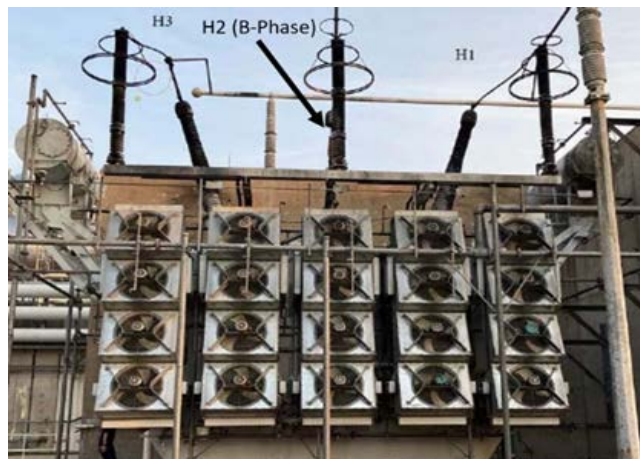
In this case study, the transformer bushing failure led to a reactor trip and fire on the GSU transformer. The fire ignited the B-phase high-voltage bushing as illustrated in Figure 12. During the initial inspection of the B-phase HV bushing, arc strike damage was discovered on the bushings, grading rings, and surrounding structures.

Figure 12. Image of H2 Bushing Catastrophic Failure

The bushing in Case #2 had metal foil for the voltage tap connection. Along with the adjacent insulation paper burn marks, creases were discovered during the unwinding of remanent paper layers in the H2 bushing similar to the Case #1 assessment. This is most likely the initiating point that led to the failure condition.

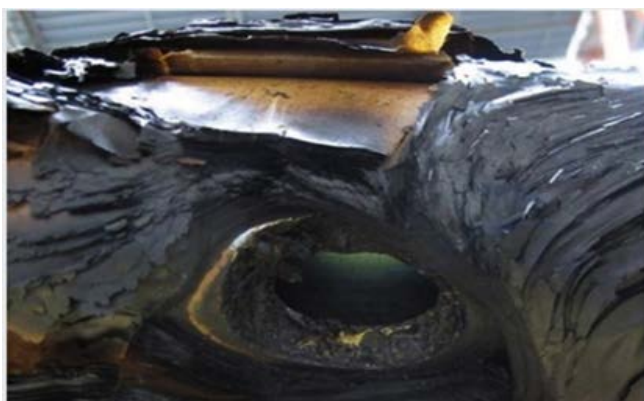
Moreover, during generator spin-down, Figure 13 shows that a major fault occurred 64 in. (1.63 m) below the top of the H2 bushing, which was halfway between the top of the bushing and the top of the mounting flange. Arc strike marks on the voltage tap pin and the internal adapter were also noticed in the H2 bushing. Multiple arc strike marks were also discovered on the H1 and H3 bushing expansion chambers, grading rings, and surrounding structures.

Figure 13. Illustration of 345-kV Bushing: Close-Up of the Major Fault Location Through the Insulation to the Center Conductor

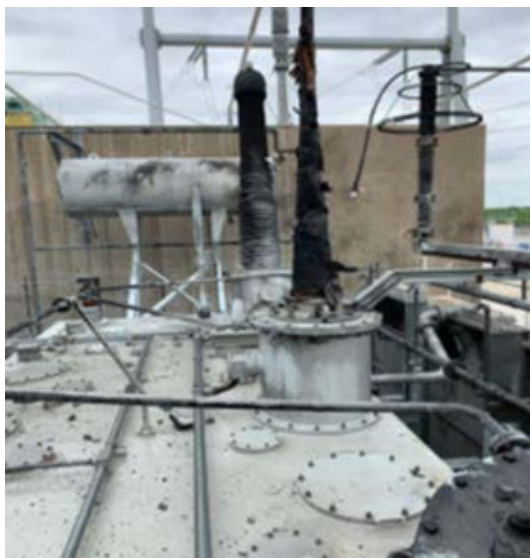
Although H1 and H3 were not destroyed, during the bushing teardown all three bushings had metal foil creases inside the insulating papers. The voltage tap had pin scratches on the bushings that may have been a source of electrical stress. At 345 kV, all creases and scratches can be a stress point that could result in catastrophic bushing failure as shown in Figure 14.

Figure 14. Illustration of A-Phase HV Bushing and Mounting in a Turret with a Surge Arrestor

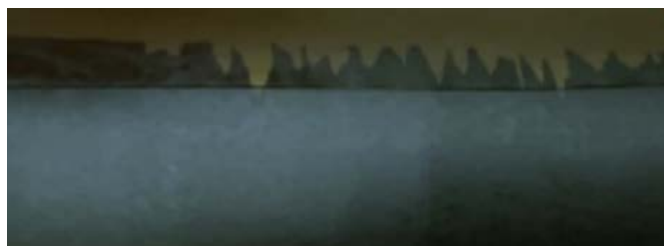
Figure 15. Illustration of Ink Printed Layer Treeing

The investigation team believes that the printing defect shown in Figure 15 was the problem. Over many years of energized service, this condition can cause slow and progressive insulation degradation. Figure 15 shows conductive ink

lines that have existed since the original fabrication—those lines should not be there. The lines on the insulated paper created stress points within the grading layers of the bushing; the capacitance is no longer equal. This unequal grading of the capacitance over time would degrade the insulation of the condenser to withstand the penetrating electrical field caused by current flowing through the conductor.

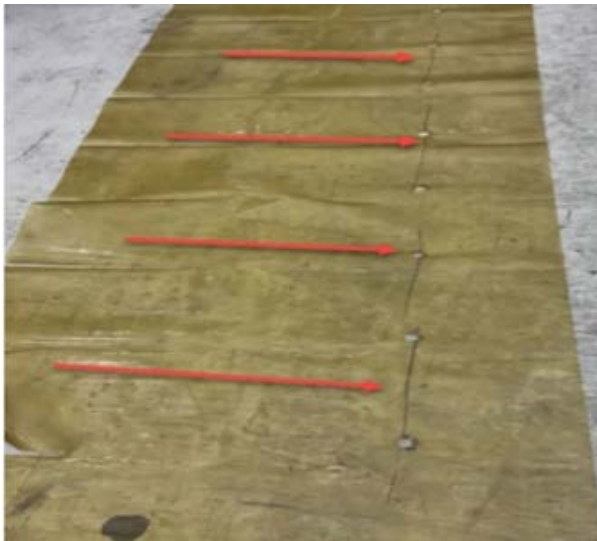
Some ink layers had small gaps where the ink was not wholly applied. There was no evidence of PD (breakdown) activity in these areas; however, for a bushing to perform successfully over many years, the insulation must remain effective both in composition and design shape and is the critical factor in the bushing's survival.

Figure 16. Punctured Insulation Because of Leakage Path Overcomes the Dielectric Strength

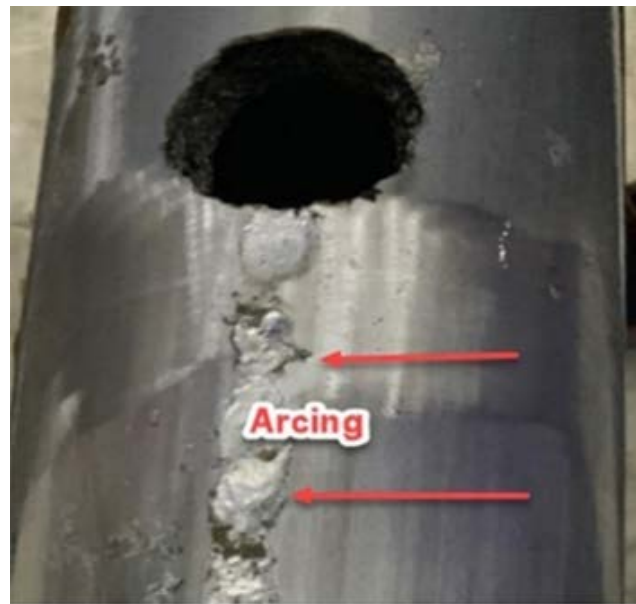
In general, HV bushings are designed to withstand the high electrical field force or stress produced in the insulation when any grounded conditions occur. As the strength of the electrical field increases (electrical force), leakage paths may develop within the insulation as shown in Figure 16 along the red arrows. If the energy of the leakage path overcomes the dielectric strength of the insulation, it may puncture the insulation and allow the electrical energy to conduct to the nearest grounded material, causing burning and arcing as shown in Figure 17.

Figure 17. Illustration of Punctured Conductor with Signs of Arcing and Burning

The root cause team concluded that the most probable cause of the 345-kV bushing failure was the presence of one or more manufacturing defects related to printing ink. The vendor investigation team believes that the improperly designed ink layers initiated the electrical event, resulting in an electrical discharge. This discharge continued until pressure was generated, which shattered the remaining kraft paper around the condenser—creating an arc with enough energy to cause overpressure and ultimately leading to a catastrophic failure of the HV bushing.

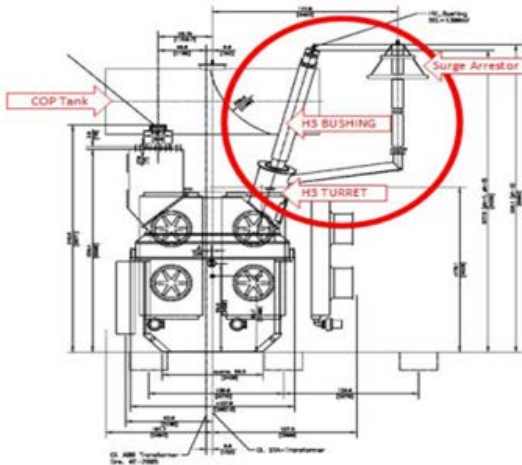
In this case, the transformer was equipped with 345-kV bushings. This station automatically scrambled on the GSU transformers phase-to-ground fault and fire. Figure 18 shows the A-phase HV bushing that suffered catastrophic damage.

Figure 18. Illustration of A-Phase HV Bushing and Mounting in a Turret with a Surge Arrestor

The team concluded that this failure was a sudden, unanticipated, catastrophic HV bushing failure because of an unknown material issue attributable to manufacturing and/or design issues by the original equipment manufacturer (OEM).

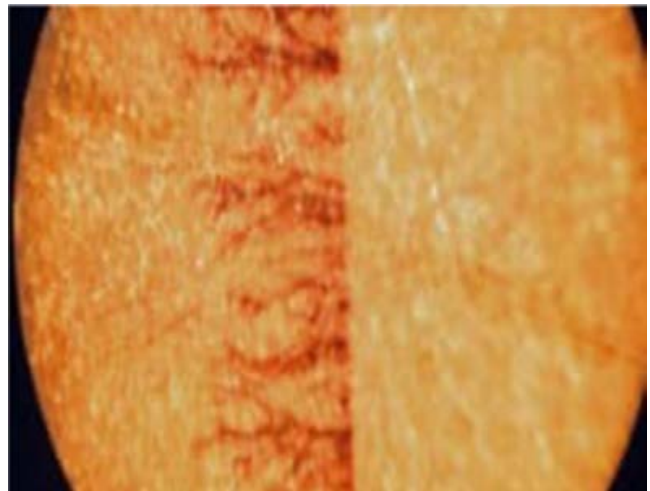
It appears that electrical treeing was caused by the manufacturing/design of the foil edges. The foil edges were cut with a device similar to a standard office paper cutter. This results in "sharp" edges that do not control the electrical stresses at the foil/paper interface, as shown in Figure 20.

Figure 20. Image of Copper Migration Witnessed on Oil Bushings Equipped with Copper Conductor
