An EPRI White Paper

# CARNEGIE ROAD ENERGY STORAGE SYSTEM FAILURE RESPONSE, RECOVERY, AND REBUILD LESSONS LEARNED

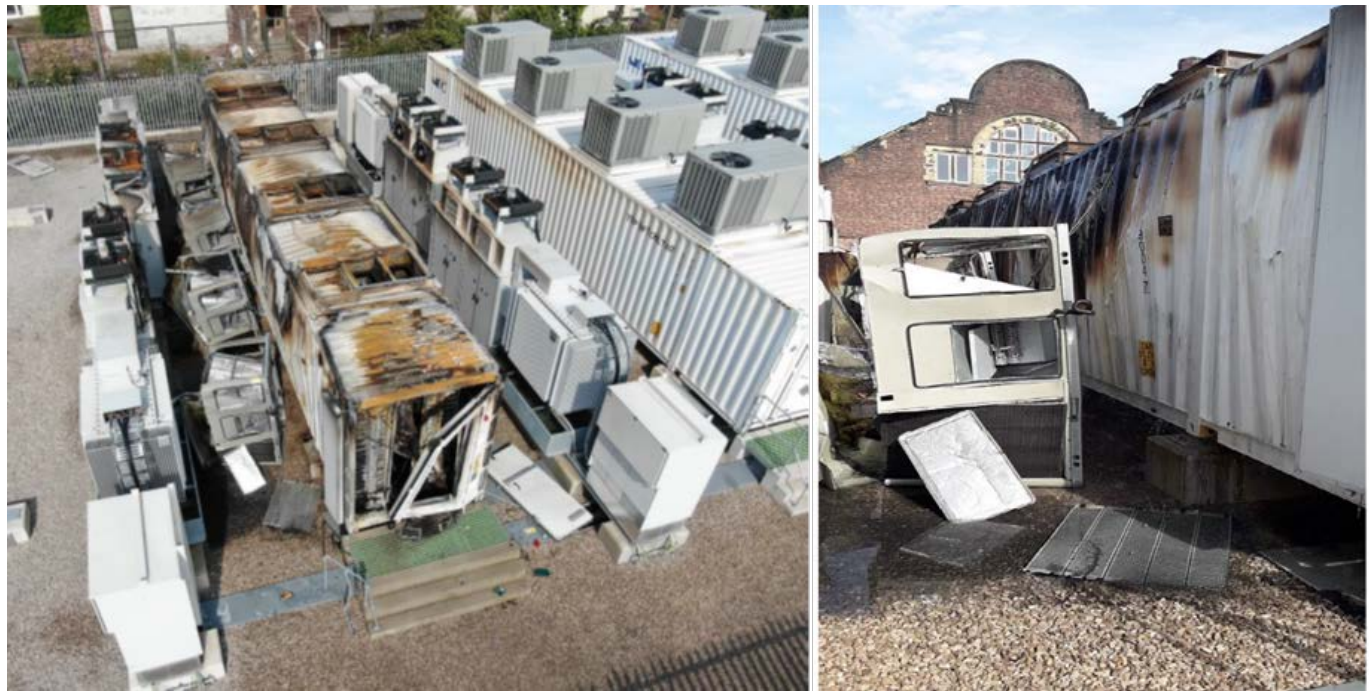
The failure occurred in Container 1 of 3. Figure 3 shows bowing of the container walls because of pressure buildup within, dislocation of the air conditioning units that were attached to the top of the container, and severe charring from the fire. The doors on both ends of the container had been blown open, seen in Figure 4. The door exiting to the yellow metal stairs had been torn off the hinges, further illustrating how powerful this explosion was. Bowing, sagging, and melting of the interior components are the result of extreme temperature exposure. Pools of hardened aluminum were found at the base of the racks and below the container, suggesting that the fire temperatures exceeded 660°C (1221°F).

Aerial photo of Carnegie Road BESS after incident (left) and side view of Container 1 (right); source: MFRS

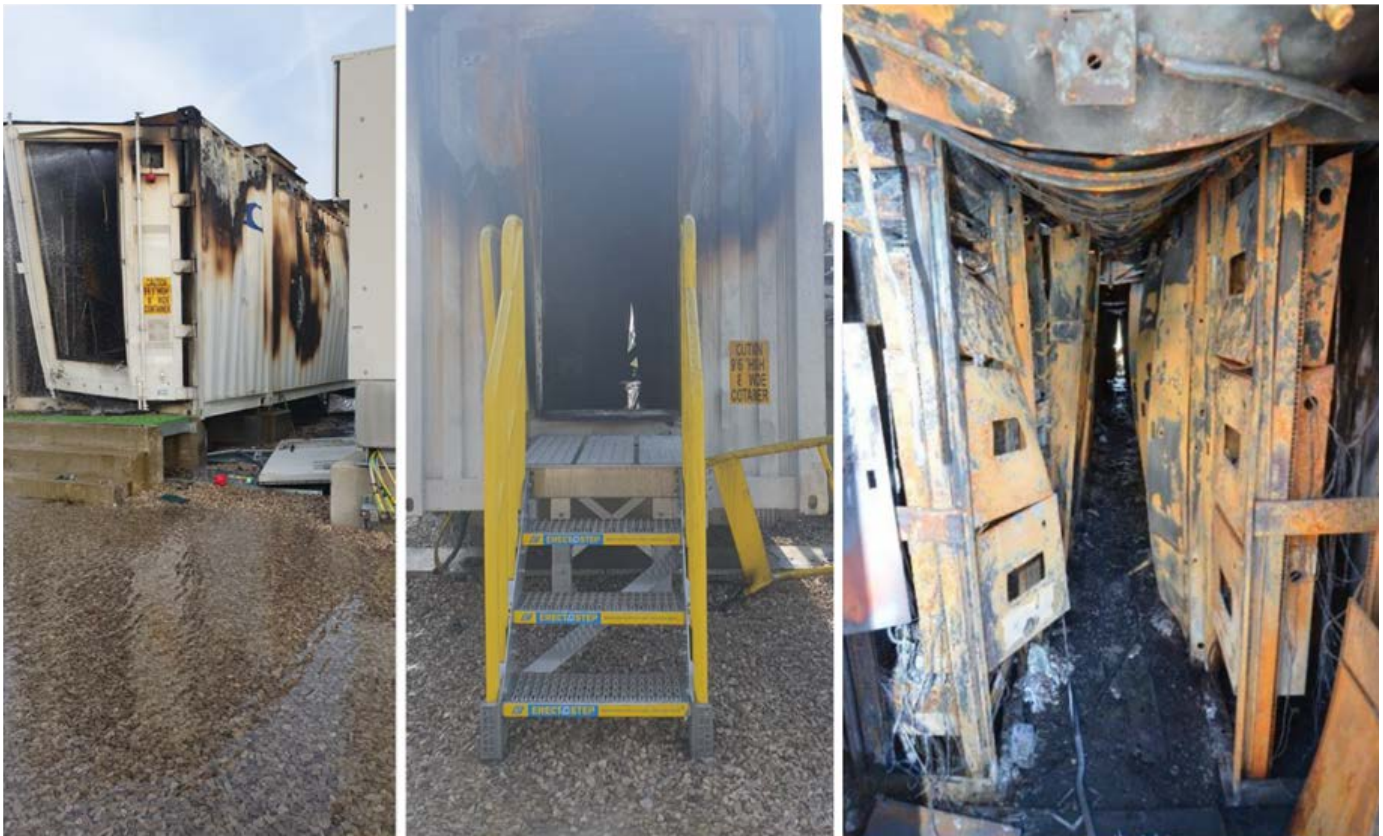
**Figure 4**  
Image of doors blown open (source: NEC) and inside the container; source: MFRS

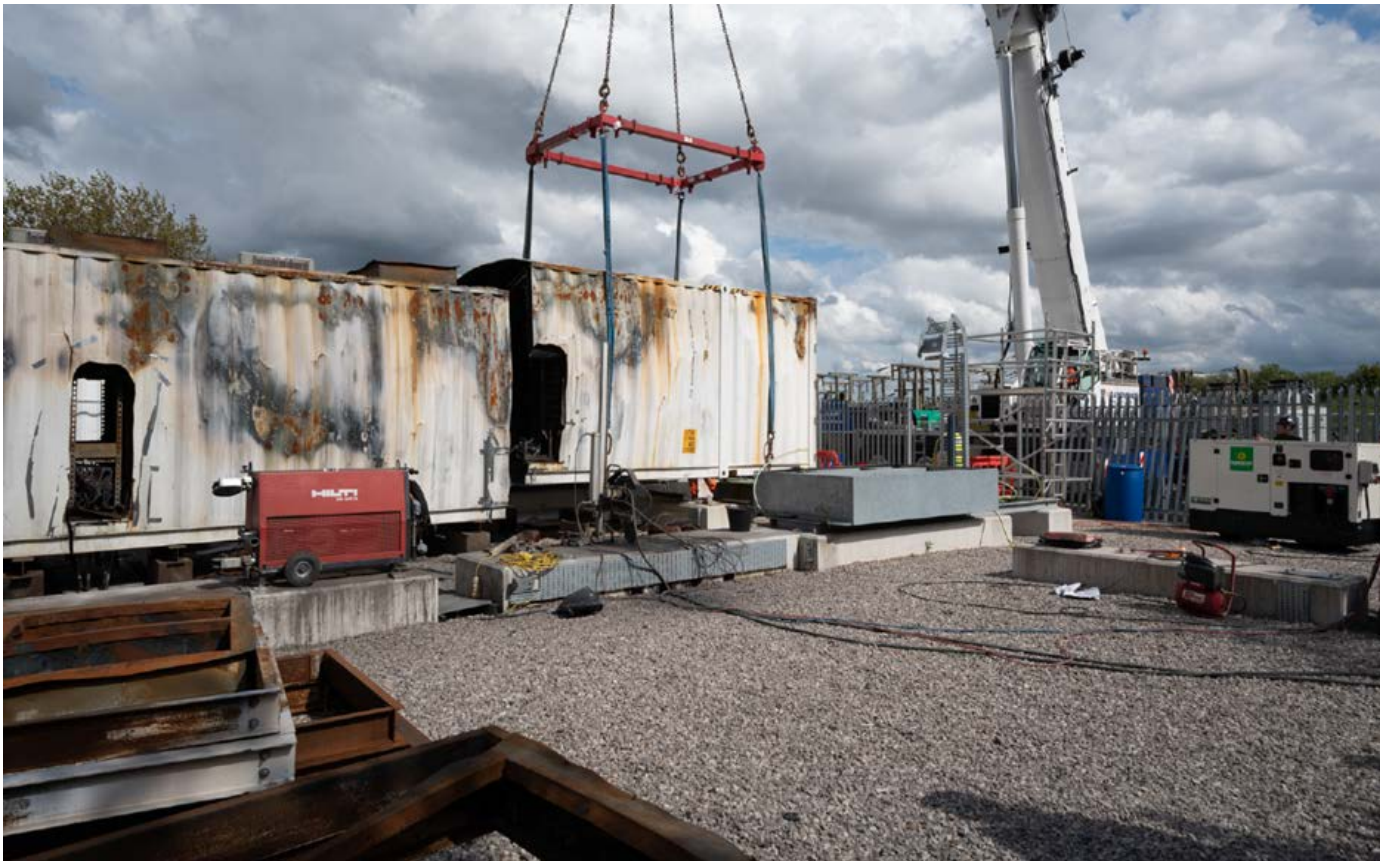
Disassembly and removal of Container 1 commenced in May 2021. The container was cut into three sections and craned into a staging area where further investigation of the system could occur. This allowed a more comprehensive assessment of the container and target rack without risk to health and safety. Retrieval of the batteries for further inspection was difficult because they were extremely brittle and not easily separated. Some sections of the modules needed to be sawed apart and removed from the racks. See Figure 5.

*Figure 5*  
View of Container 1, Section 1 being removed (source: SAFE Laboratories and Engineering Corp.)
