Swedish Utility Experience With ASEA- ATOM-Design Top Guides

Technical Report

NP-5947
Research Project 1930-4

Final Report, August 1988

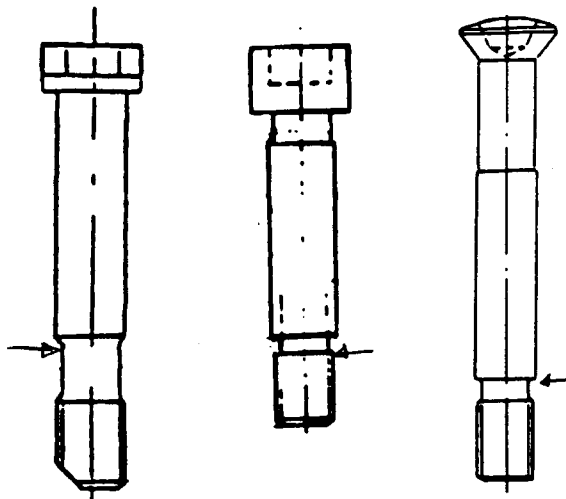
Figure 4-1
Core Grid Bolts for Forsmark 1, Forsmark 2, TVO 1 and TVO 2 (left), Oskarshamn 1 (center) and Ringhals 1, Oskarshamn 2, Barsebeck 1 and Barsebeck 2 (right). (Ringhals 1 is slightly different.)

The A286 material for the Forsmark 2 bolts was precipitation hardened to a yield strength of approximately 665 N/mm^2 (hardness 300 Brinell). The two bolts investigated belonged to the same guide bar assembly. They had both cracked in the area of smallest diameter, the lower bolt in the plane of the area reduction and the upper 3 mm further down, i.e., both bolts had cracked in the region subjected to the highest stress (see arrow in Figure 4-1). The fracture surfaces were covered with a dark oxide layer.

Both fractures were almost completely intergranular. Small areas (less than 2-3 mm) with different appearance were interpreted as residual fractures. This indicates that IGSCC has propagated through the whole cross section. Hardness of the upper bolt was measured and found to be approximately the same as for new material. When the cracks were discovered in 1982, Forsmark 2 had been in operation for only one year and the neutron fluence received by the bolts should have been relatively low.

The cracking of the A286 bolts was considered as a clear case of IGSCC, possibly accelerated by the crevice geometry. The bolts may have been stressed to approximately 80 % of the yield strength. It has been known for some time that precipitation hardening alloys, if highly stressed, are quite sensitive to IGSCC in normal BWR water chemistry (1). This is especially true for the A286 alloy, and it is therefore not surprising, that the bolts did crack.

The bolts from the two damaged guide bar assemblies in Oskarshamn 1/1 were investigated in 1984. The upper bolt in the deformed guide bar assembly was found to be completely broken at the first thread (see arrow in Figure 4-1). The fracture surfaces were oxidized. The bolts in the guide bar assembly that had been broken loose by the falling fuel bundle had fresh fractures. Microstructural investigations showed that all four bolts had numerous shallow intergranular cracks. In threads and recessed areas, a slightly cold worked structure was present close to the surface. This was not related to the cracks. No grain boundary carbides were found. The hardness has increased from 170 to 235 Vickers approximately, which could be expected due to the irradiation hardening. No difference between upper and lower bolts was observed.

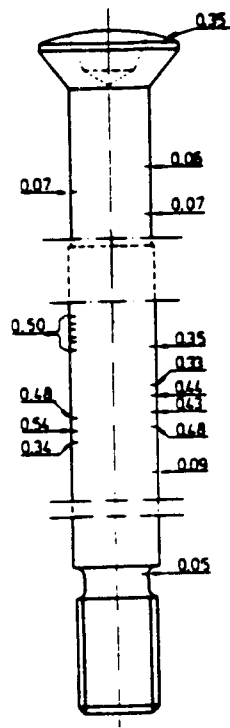
Figure 4-2
Crack Pattern in one Ringhals Bolt
Numbers indicate depth in mm

In 1985 bolts from Oskarshamn 2/1, Barsebeck 1/1 and Ringhals 1/1 were successively investigated. The general picture was similar to Oskarshamn 1/1. Numerous rather shallow intergranular cracks were found in all investigated bolts. However, with few exceptions, the cracks were concentrated to the cylindrical part with the largest (8,5 mm) diameter. An example of crack distribution is shown in Figure 4-2.

Two of the Ringhals 1/1 bolts belonging to the same guide bar assembly were removed because of ultrasonic indications. These two bolts were completely broken. The fractures were located in the recess area, where the diameter changes from 8,5 to 8,0 mm.

Microstructures were in all cases normal for solution annealed material. No signs of sensitization were found. As in Oskarshamn 1/1 slightly cold worked areas were observed, especially in threads and recesses. However, no cold work was found in the area where most cracks were observed, i.e. the largest diameter region. Crevice and/or wear marks were observed locally in this region. In some cases cracks had been initiated there.

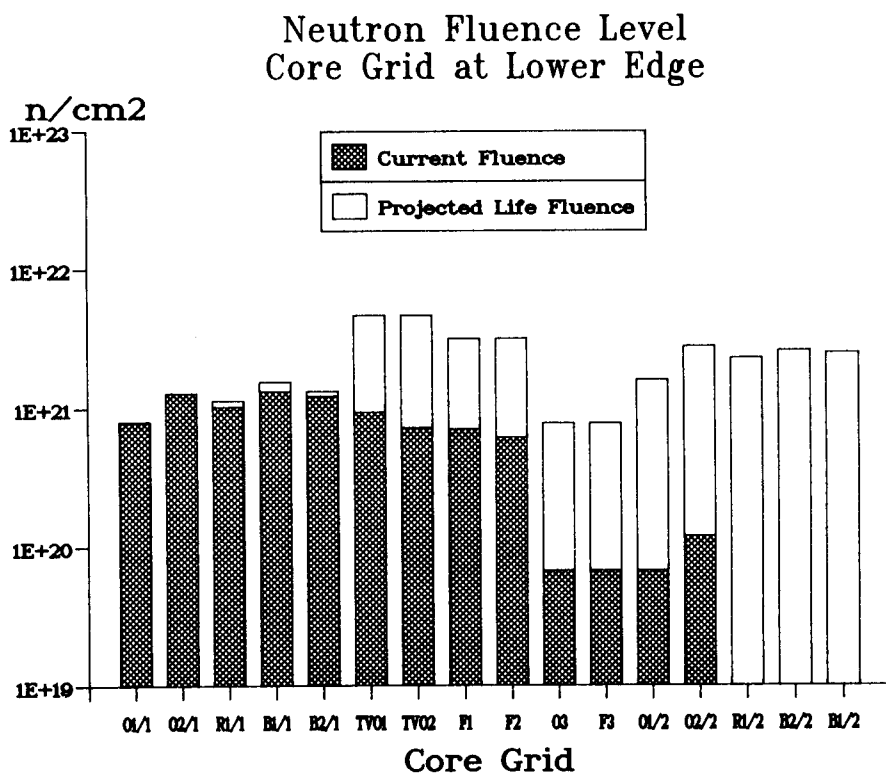
Figure 6-1
1987 Status of ABB ATOM Core Grids
(O, R, B and F stand for Oskarshamn, Ringhals, Barsebeck and Forsmark respectively, R1/2 means the second core grid in Ringhals 1 etc).

Figure 6-1 is a summary of the ABB ATOM core grid 1987 status. Shaded bars show the maximum fast neutron fluences received in the different grids so far. For Oskarshamn 1/1 and 2/1 these bars represent the final fluences as the grids were replaced in 1986. White bars show estimated fluences for the expected remaining life of the other grids. For the grids from Forsmark 1 on, it is assumed that the reactors will be decommissioned in the year 2010 which is required by Swedish law. For TVO 1 and 2 a life of 40 years has been assumed. Ringhals 1/1, Barsebeck 1/1 and 2/1 grids will be replaced in the near future, and therefore only small additional fluences will be received.

That IASCC may be a problem in austenitic stainless steels when the fast neutron fluence reaches values above approximately $5 \cdot 10^{20}$ n/cm² is now generally accepted (3). It is also accepted that certain impurities such as silicon and phosphorus play an important role for this form of stress corrosion. A summary of laboratory results is presented in Figure 6-2 (4). These results are not necessarily relevant for in-reactor condition. According to these data 50 % of the cracked area is intergranular when testing after irradiation to a fluence of approximately $2 \cdot 10^{21}$ n/cm².

The old core grid of Oskarshamn 2 (O2/1) has recently been investigated visually in the reactor pool. No cracks or other damage were found. The maximum fast neutron fluence was $1.3 \cdot 10^{21}$ n/cm² (see Table 2-1). As evident from Figure 6-1, all grids are expected to receive fluences higher than $5 \cdot 10^{20}$ n/cm² during their life time. Replacements may therefore be justified. The fact that Ringhals 1/2, Barsebeck 1/2 and 2/2 are manufactured from steels with low impurity concentrations makes it probable that they can be safely used for the rest of the operating time. Research under way in Sweden (5) and in other countries will certainly create a more solid basis for later judgements.
