Advanced Gas Turbine Guidelines: Hot Gas Path Parts Condition and Remaining Life Assessment for GE 7FA in Baseload Operation

TR-106329
3125-02

Final Report, December 1996

The Guideline on Hot Gas Path Parts Condition and Remaining Life Assessment provides results of monitoring and inspection of four General Electric (“GE”) MS 7221 FA Advanced Gas Turbines, in baseload service at Florida Power & Light’s (“FP&L”) Martin Station, Indiantown, Florida.

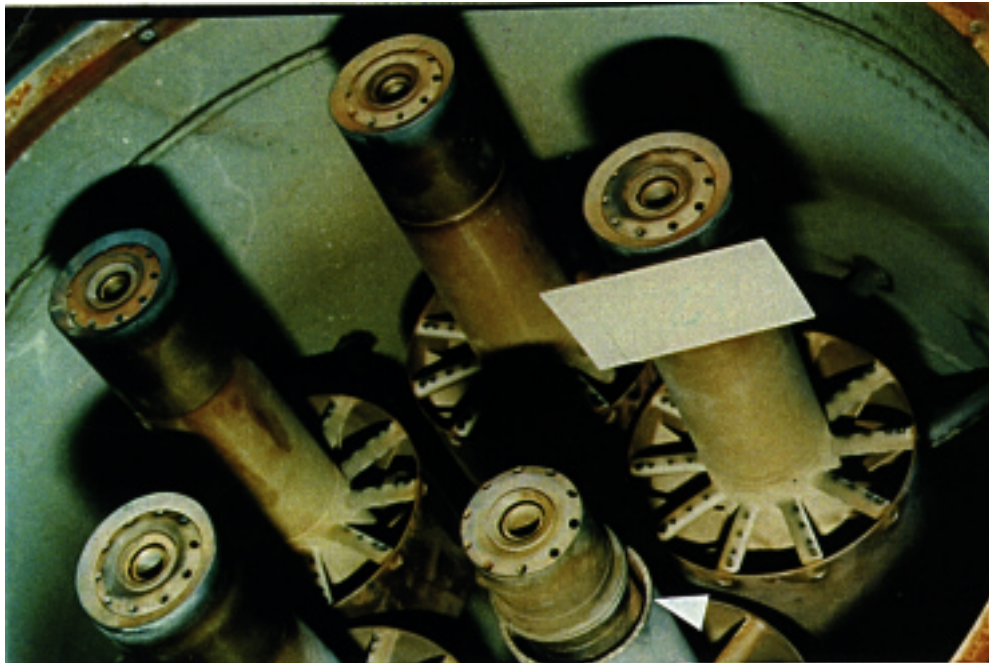
Figure 3 Unit 3B 5/94, 4,082 Hrs. Fuel Nozzle Tip.

Loss of a fuel nozzle tip (See Figure 3 & 4) was discovered at the scheduled inspection of 5/23/94 (there have been no subsequent tip losses). This is a 2"x2" (50.8 x 50.8 mm) cylinder of 60-120 mil (1.524 - 3.048 mm) wall thickness and 4 ounce weight. No defects were found in metallurgical examination and the observations were consistent with a fuel flashback. Exhaust temperature spreads were normal two months before, but were skewed within two weeks of, the inspection (no interim data was available). It is believed that the tip loss triggered the exhaust temperature shift, and both occurred from combustion flashbacks. The downstream damage was surprisingly little. The 1st stage nozzle partitions and buckets were both removed for repair; while 2nd and 3rd stage nozzles and buckets were left in the machine. Leading edges on three 2nd stage buckets and two 3rd stage buckets were carefully blended in the machine.

The fuel nozzle tip was lost after 2,500 hours. This failure was attributed to a fuel flashback.

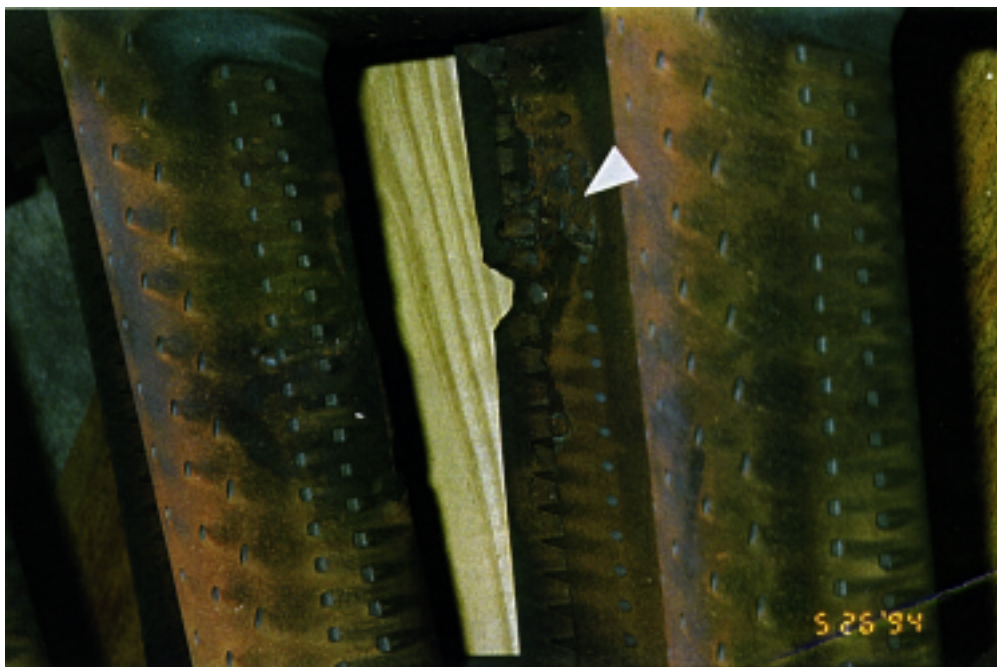
Figure 4 Unit 3B 5/94, 4,082 Hrs. 1st Stage Nozzle.

1st stage nozzle showing heavy oxidation in the single throat where the fuel nozzle tip lodged temporarily. The other nozzle throats were unaffected.

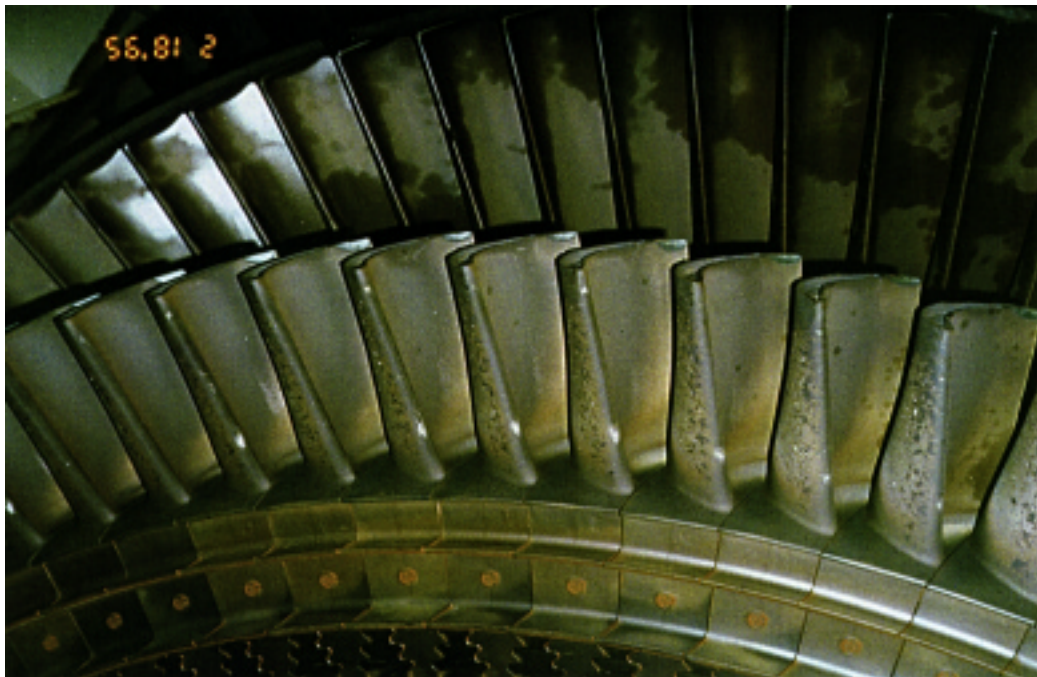
The 1st stage buckets are shown after the impactions from the compressor blades.
Figure 6 Unit 4A 2/95, 6,120 hrs. 1st Stage Buckets.

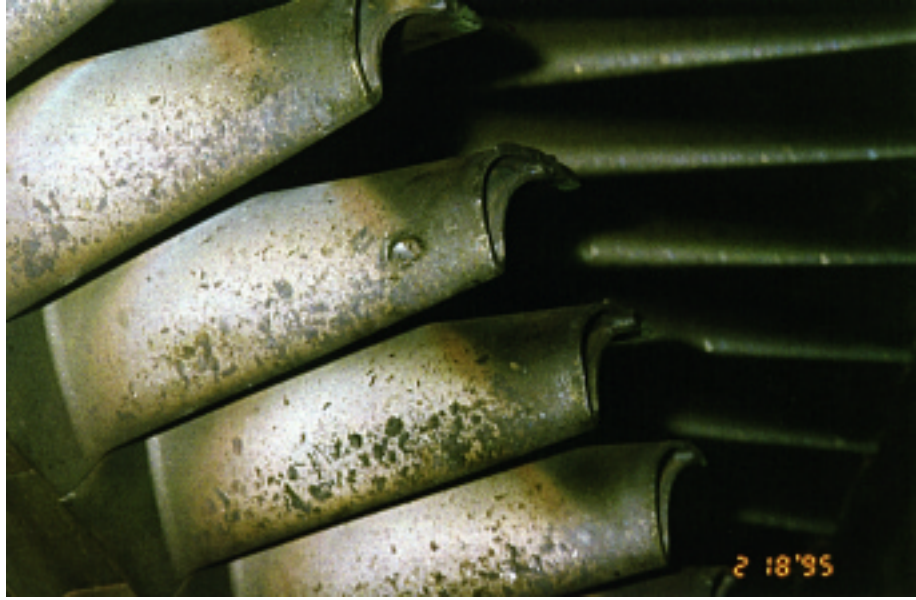
1st stage buckets showing convex side damage from compressor blade impactions.
Figure 7 Unit 4A 2/95, 6,120 hrs. 1st Stage Buckets.

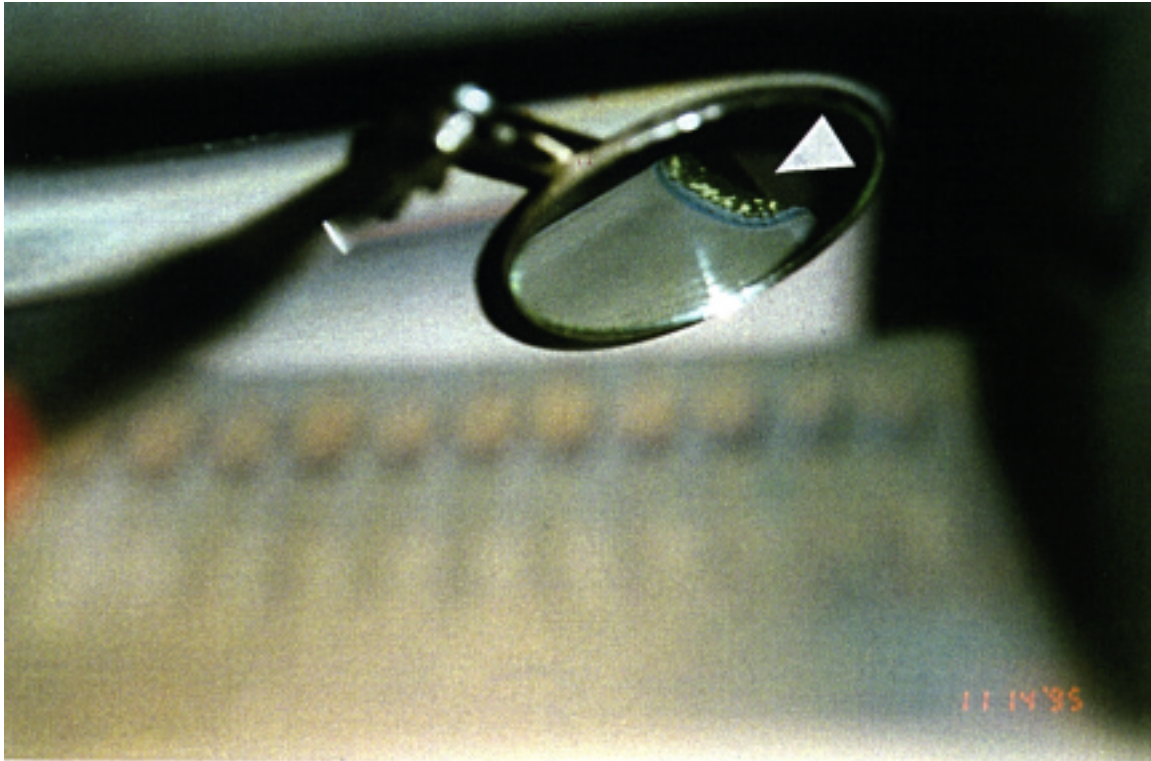
Trailing edge tip oxidation has been noted on all MS 7221F/FA to date and appears to be almost linear with time. It removed 120-150 mils (3.05-3.81 mm) of the trailing edge tip by 14,000 hours (**See Figure 9**). It is still felt that this oxidation will be self-limiting by virtue of the nearby trailing edge cooling holes. Both the cavity floor.

One 1st stage bucket viewed through a mirror, shows oxidation at the tip of the trailing edge.

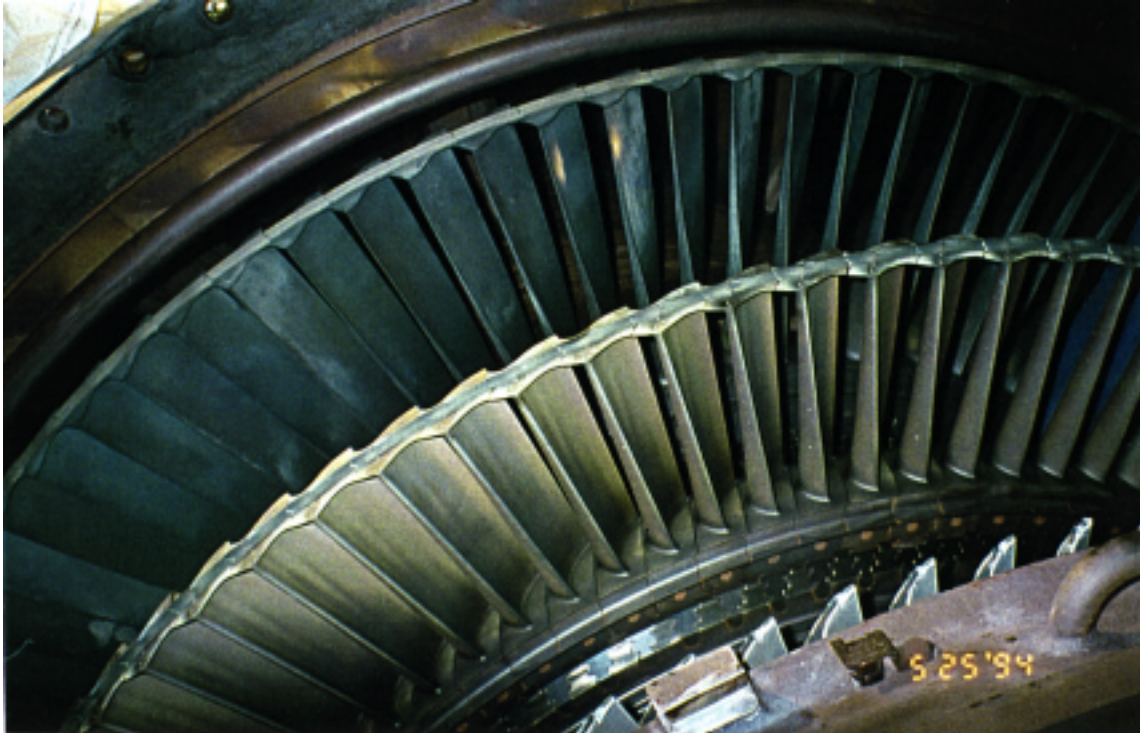
The 2nd and 3rd stage buckets (See Figure 10), including the tip shrouds, appeared to be in good condition after some 14000 hours of service except for occasional impactions/FOD. The 2nd stage vane coating appear to have at least 24000 hours capability at this site. Significant parts of the 3rd stage coating (~ 25%) were no longer in place, but it may have been thin as originally installed. This, however, is of little significance at FP&L in that the coating was only applied for hot corrosion protection which has not been a factor at this site.

Overall view of 2nd and 3rd stage buckets.

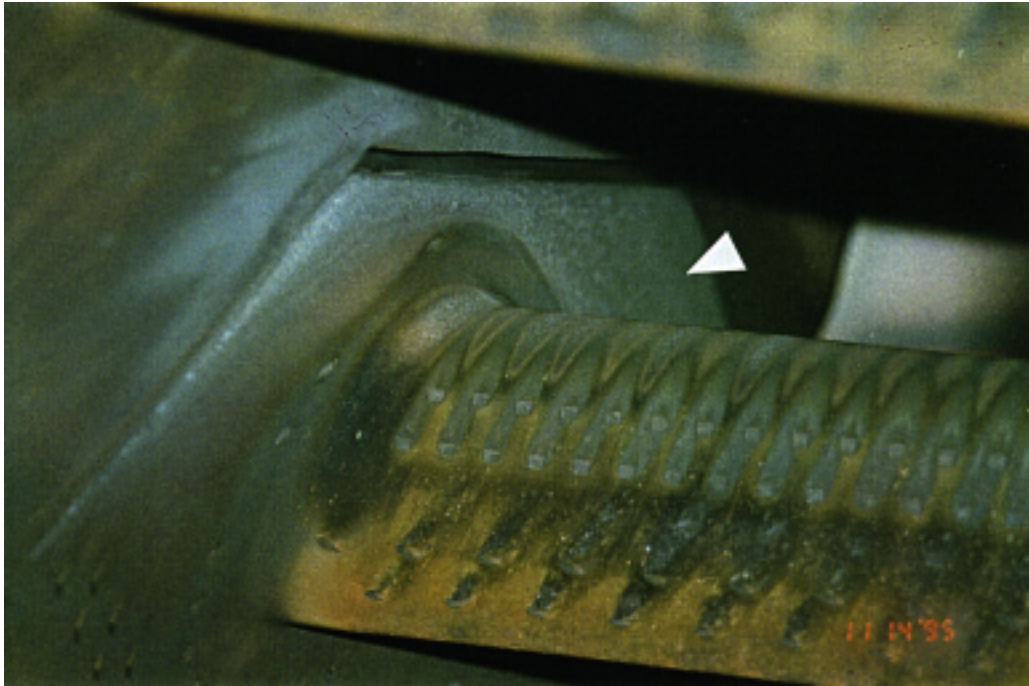
First Stage Nozzle shows Significant Sidewall Oxidation.
Figure 11 Unit 4B 11/95, 14,264 hrs. 1st Stage Nozzle

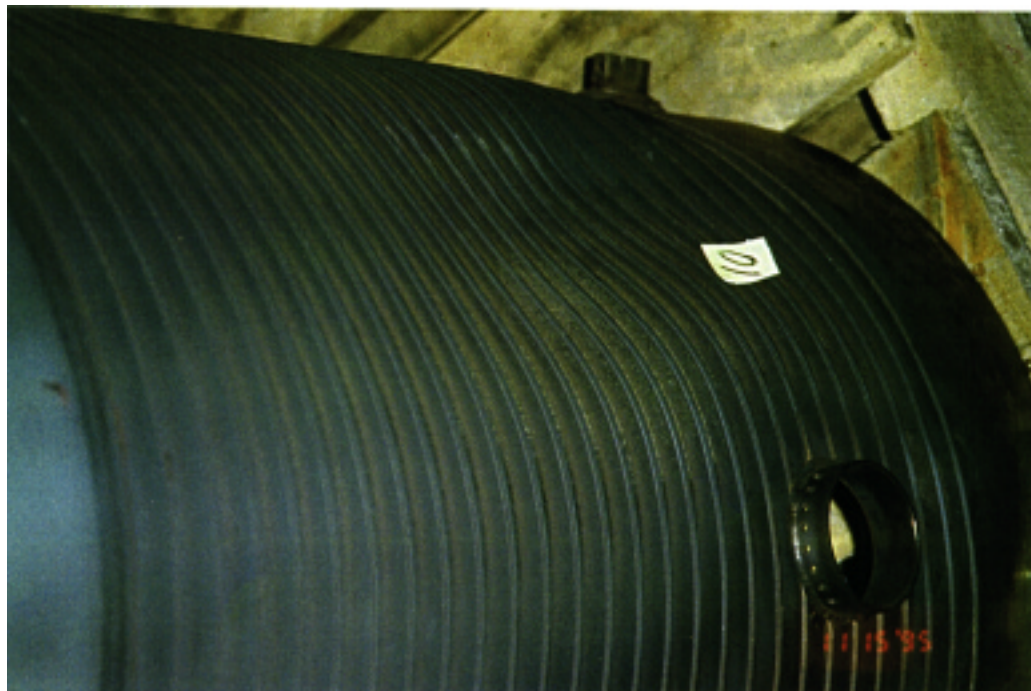
Figure 12 Unit 4B 11/95, 14,264 hrs. Combustion Liner.

Combustion liner shows typical inward bulging distortion after 9682 hours of operation. (Seen on all liners.)

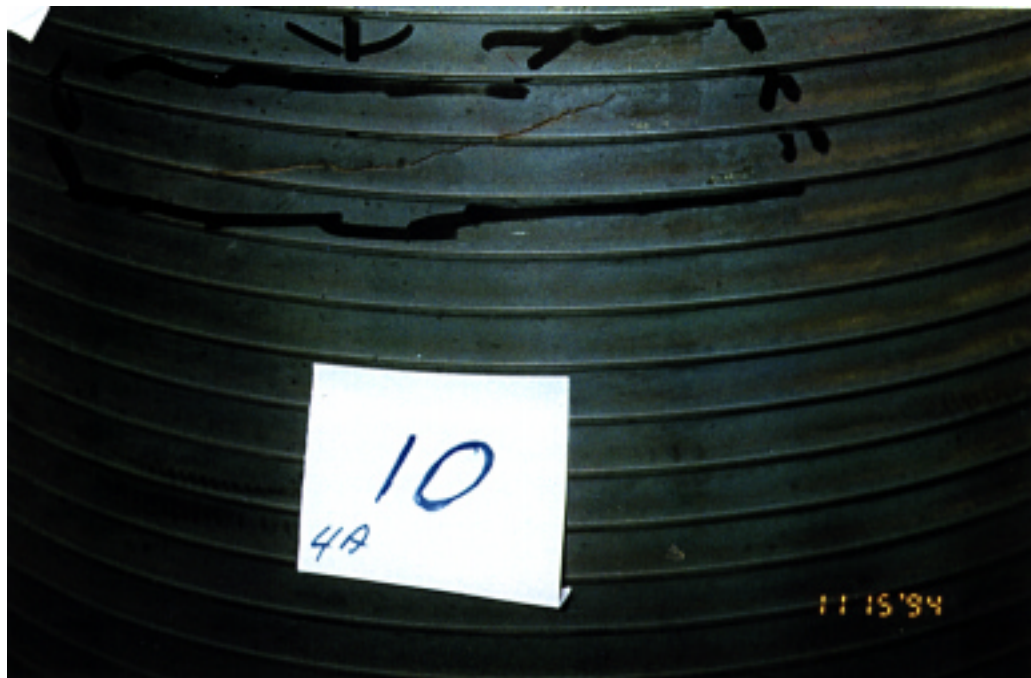
Three liners (of the 112 liners examined) also had a crack, (**See Figure 13**) but all were in completely different locations. Although of concern, the cracks suggested isolated manufacturing problems as opposed to a generic design problem. One was at an exit end weld, one was in the body, and the other was at a cross fire tube collar weld.

Combustion liner showing body crack, after 4868 hours. (Seen in one liner only).

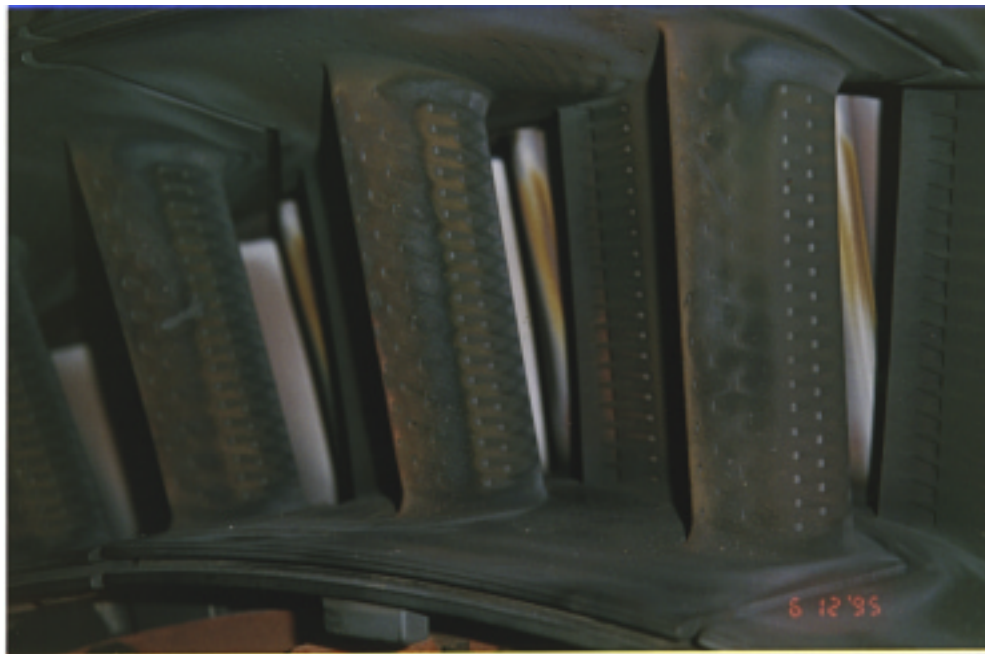
Figure 8.2 Unit 3B 6/95, 12,586 hrs.

The coating of the 1st stage buckets appears to be in good condition after 8,504 hours of GT operation.

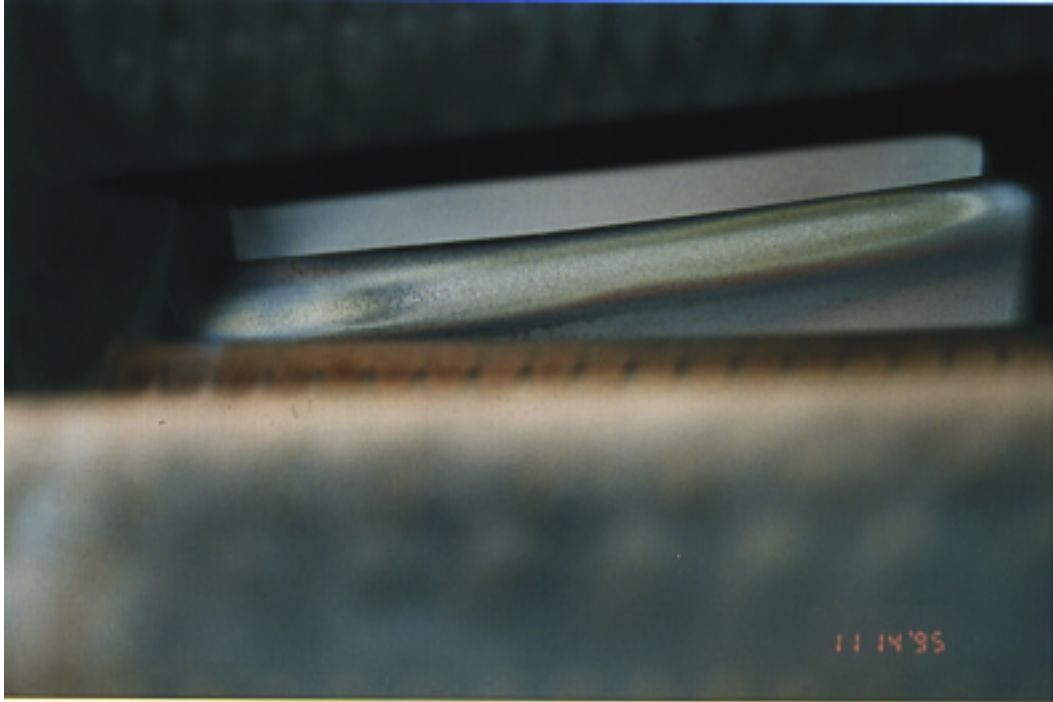
Figure 8.3 Unit 4B 11/95, 14,264 hrs. 1st Stage Buckets.

1st stage bucket shows good coating condition.

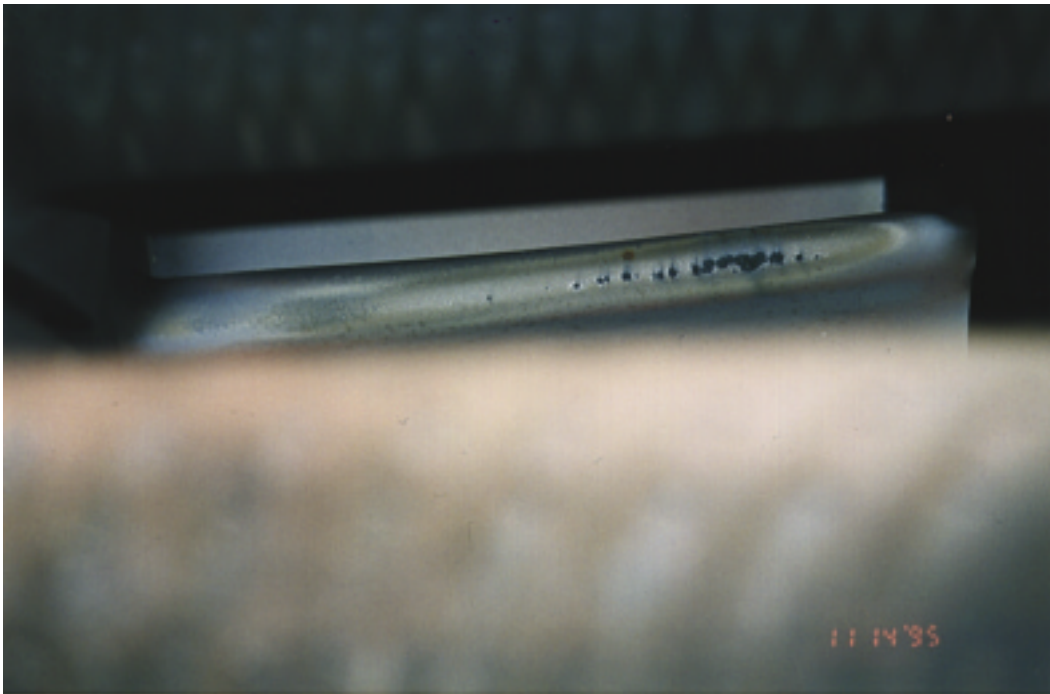
1st stage bucket shows localized oxidation has breached the coating on the leading edge.

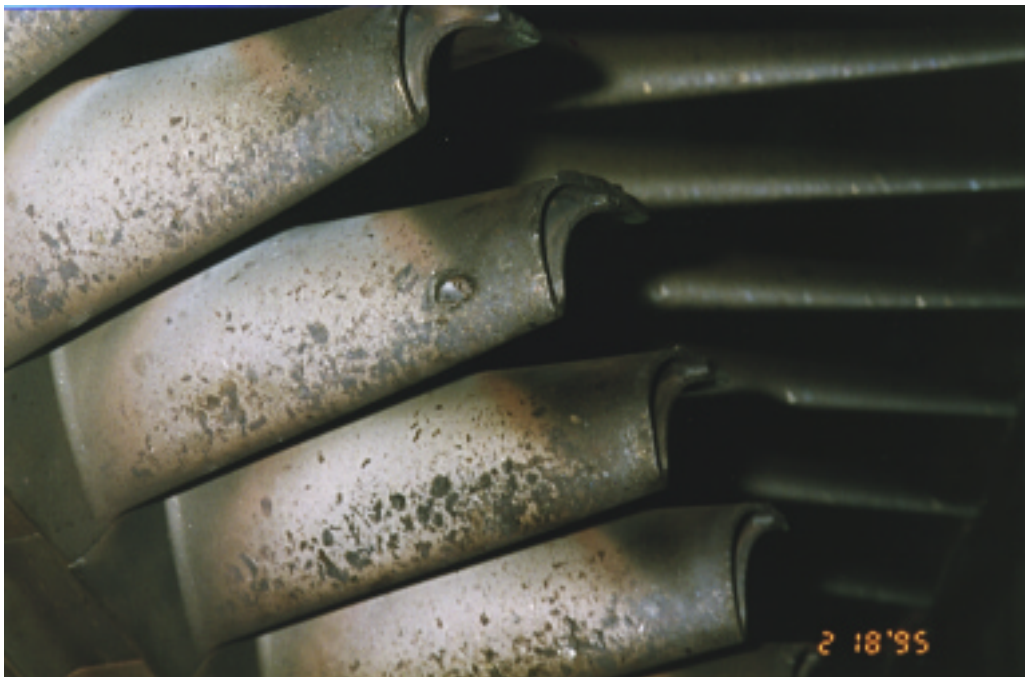
1st stage buckets showing convex side damage from compressor blade impactions.
Figure 8.10 Unit 4A 2/95, 6,120 hrs. 1st Stage Buckets.

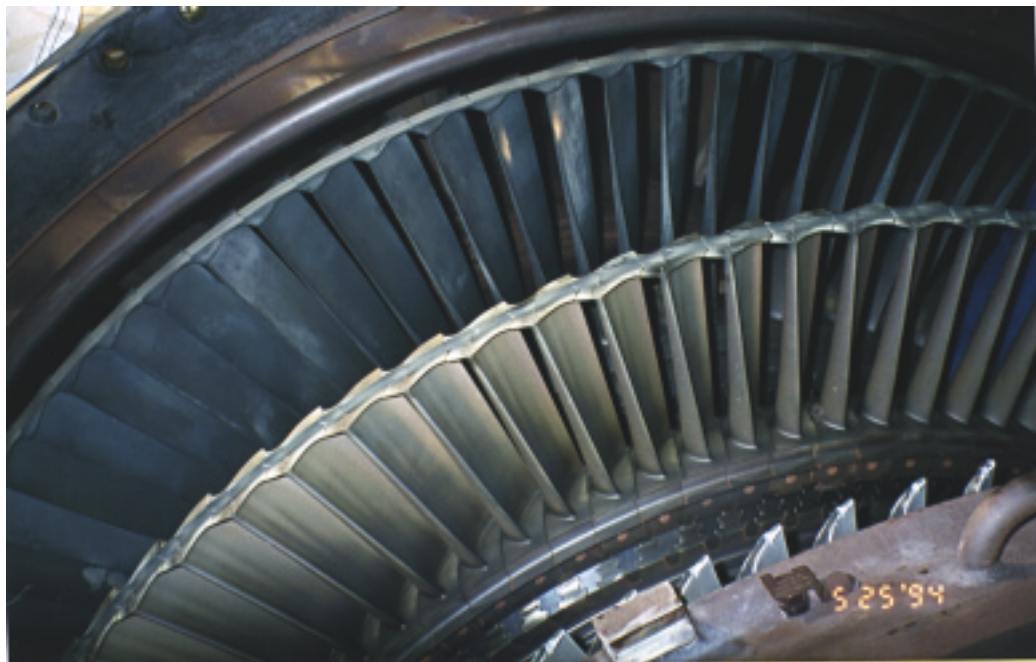
Figure 8.11 Unit 3B 5/94, 4,082 hrs. 2nd And 3rd Stage Buckets.

Overall view of 2nd and 3rd stage buckets.

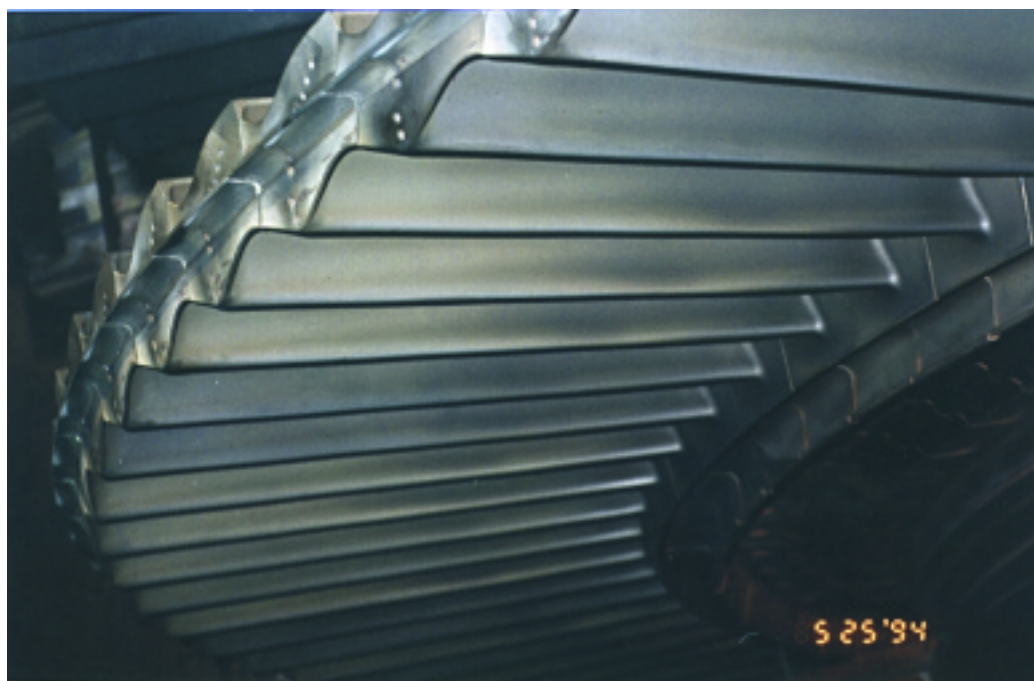
Figure 8.12 Unit 3B 5/94, 4,082 hrs. 2nd Stage Buckets.

View of the 2nd stage buckets looking from the leading edge side. The shroud and the bucket coating are both in good condition.

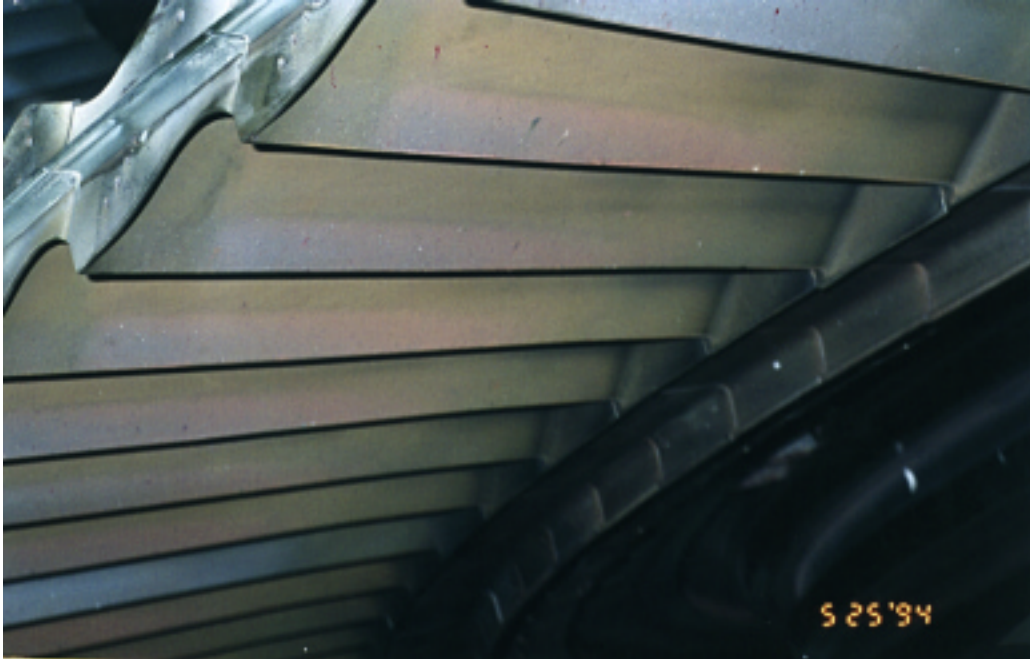
2nd stage buckets viewed from the trailing edge side.
Figure 8.13 Unit 3B 5/94, 4,082 hrs. 2nd Stage Buckets.

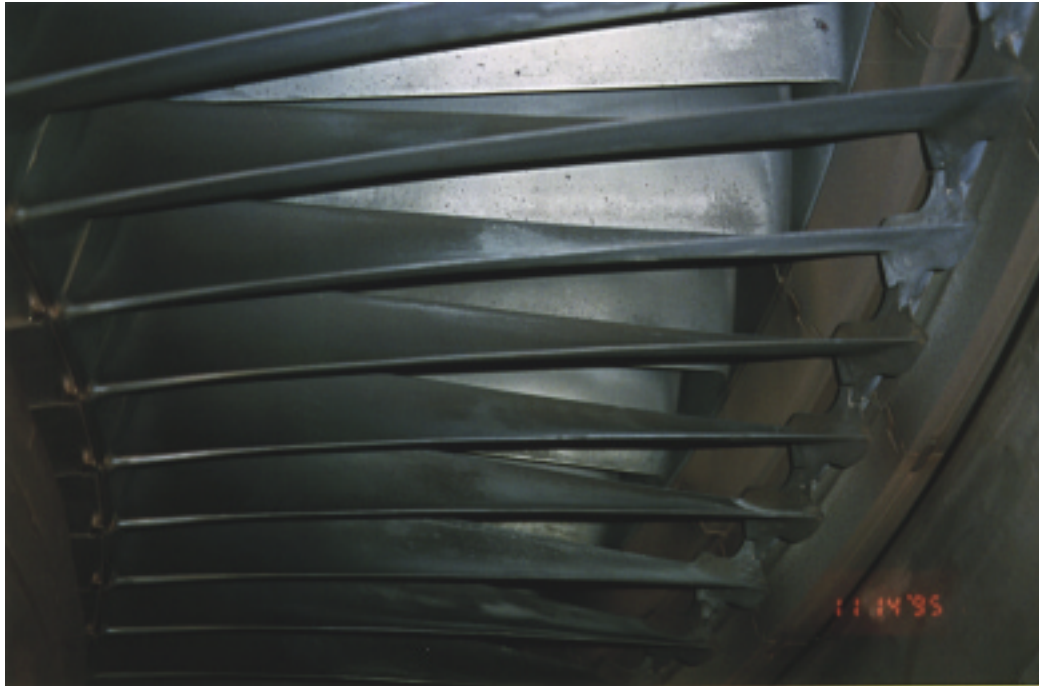
Figure 8.15 Unit 4B 11/95, 14,264 hrs. 3rd Stage Buckets.

3rd stage buckets and nozzles in good condition.

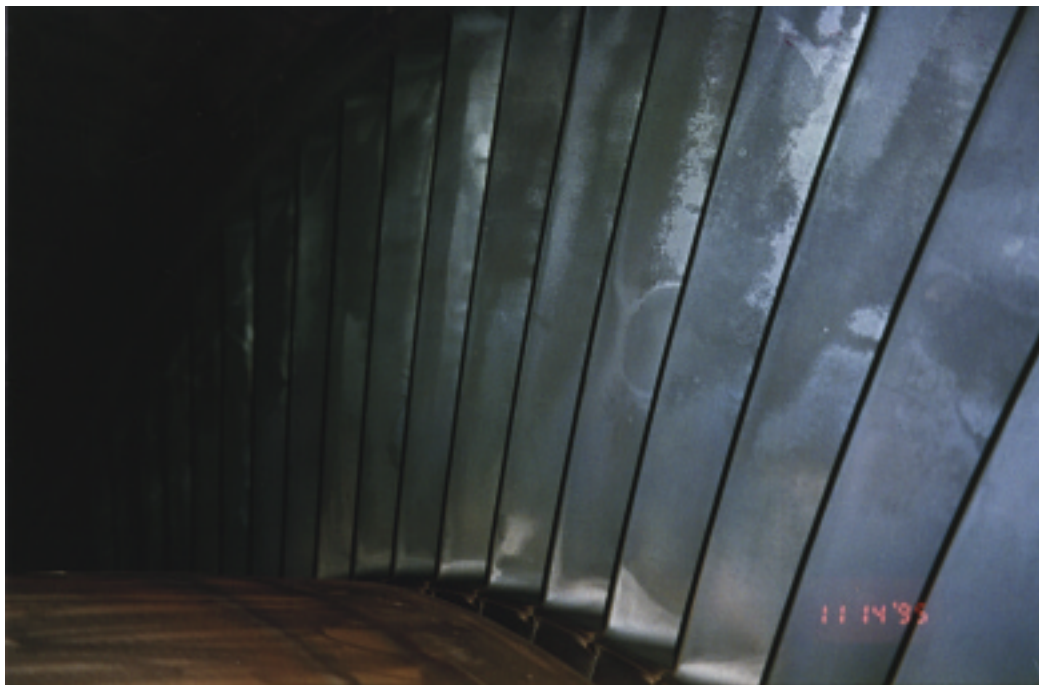
Figure 8.16 Unit 4B 11/95, 14,264 hrs. 3rd Stage Buckets.

3rd stage buckets and nozzles showing local loss of coating on some vanes.

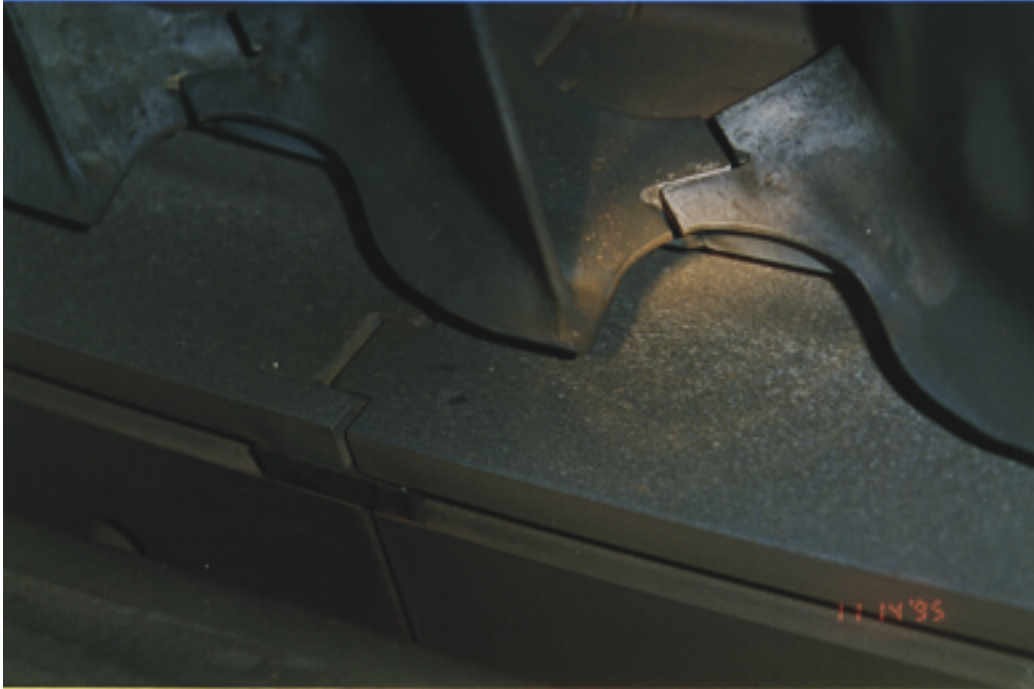
Figure 8.17 Unit 4B 11/95, 14,264 hrs. 3rd Stage Buckets.

The 3rd stage buckets and nozzles are generally in good condition.

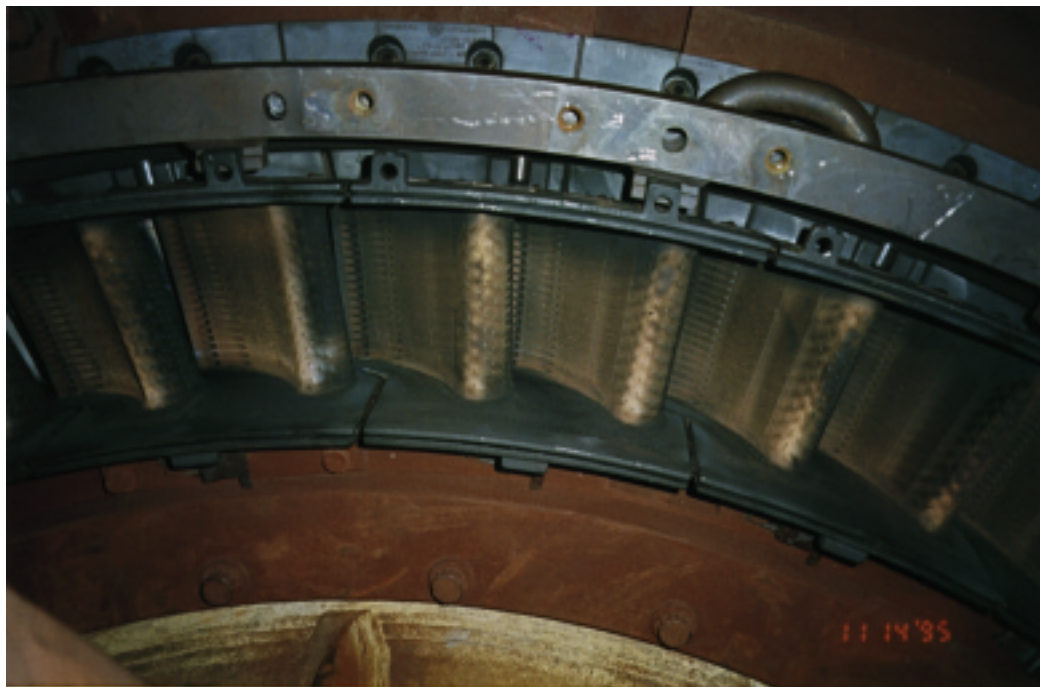
Figure 8.18 Unit 4B 11/95, 14,264 hrs. 1st Stage Nozzle.

1st stage nozzle showing good condition.

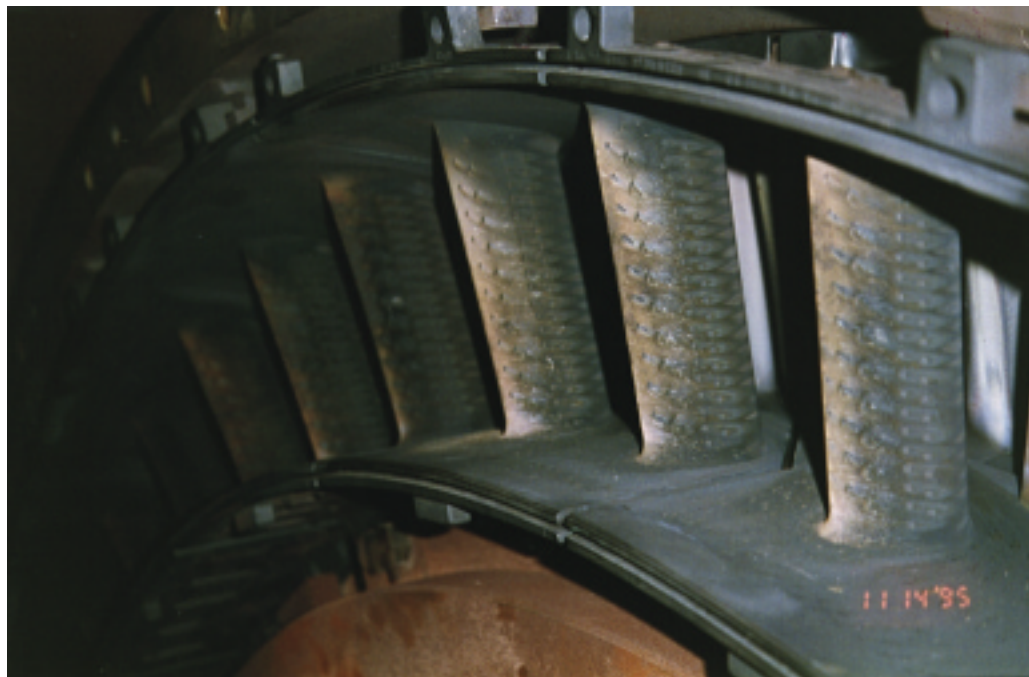
1st stage nozzle showing good condition.

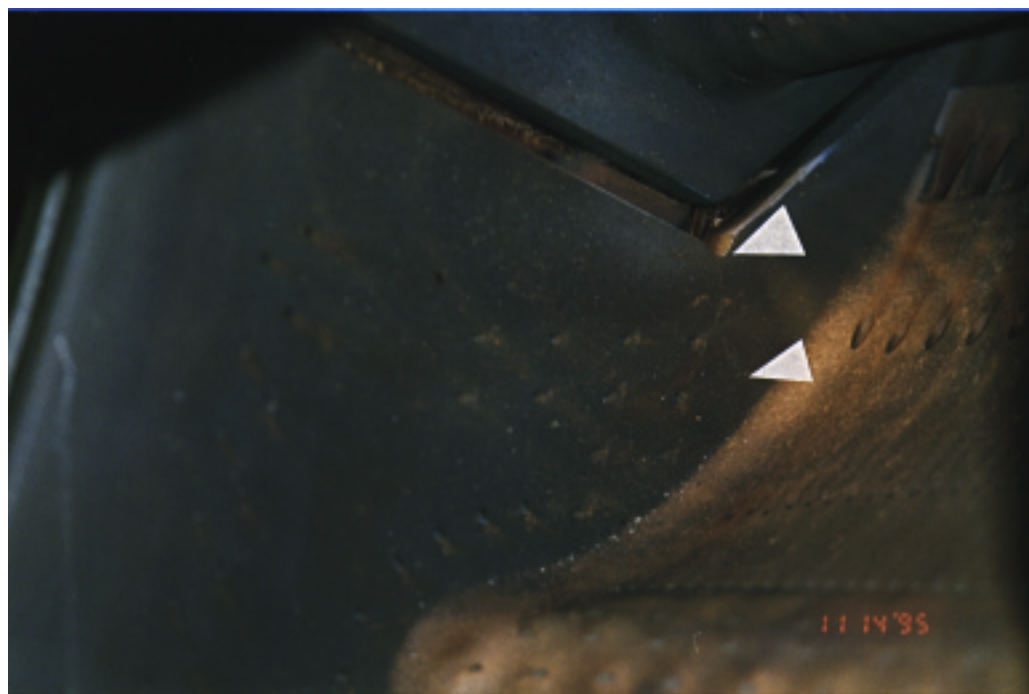
1st stage nozzle sidewall, showing fine crack at Z-Notch and slight oxidation of 2x2 and 4x4 cooling holes (flashlight lit).

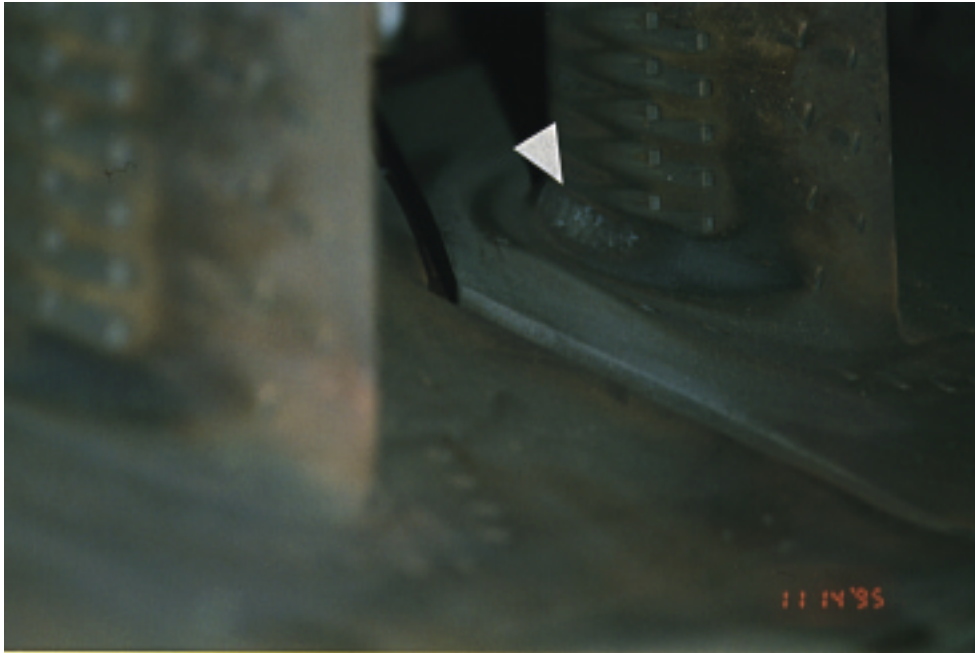
1st stage nozzle showing slight oxidation on forward convex fillet and Z-Form.
Figure 8.21 Unit 4B 11/95, 14,264 hrs. 1st Stage Nozzle.

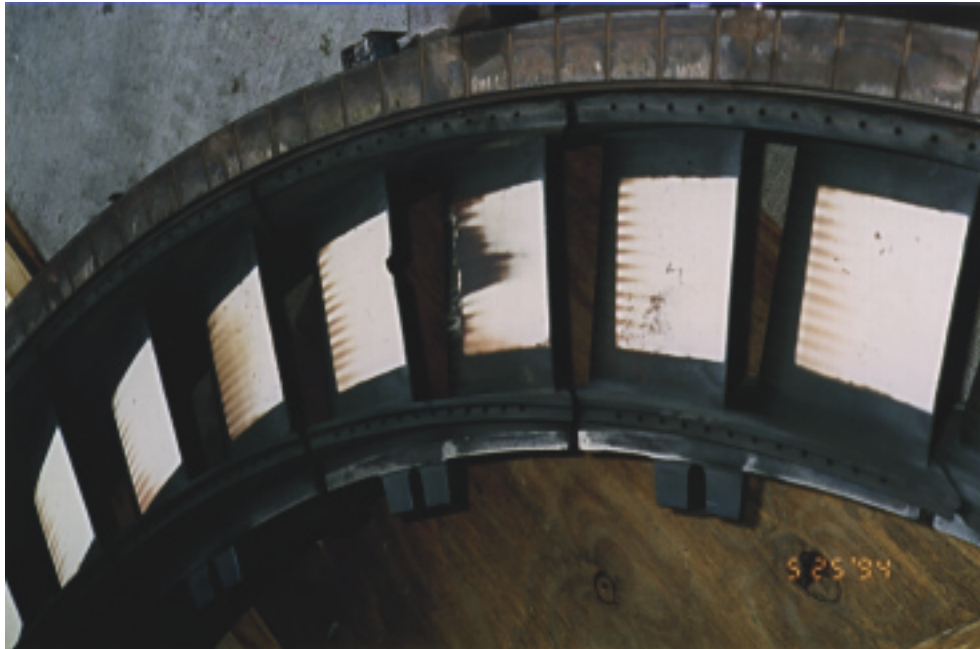
Aft side of nozzle throat shown In Figure 8.23. The coating is in good condition except for the local deterioration where the nozzle tip lodged temporarily.

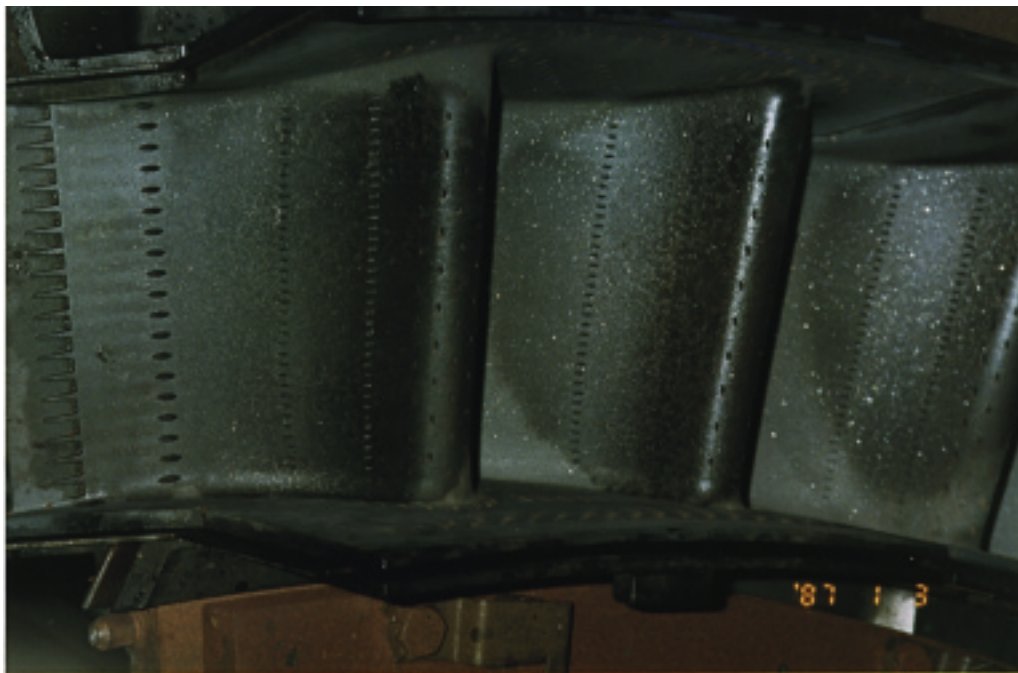
The 1st stage nozzle shows minor concave side damage from the compressor blade impactions.

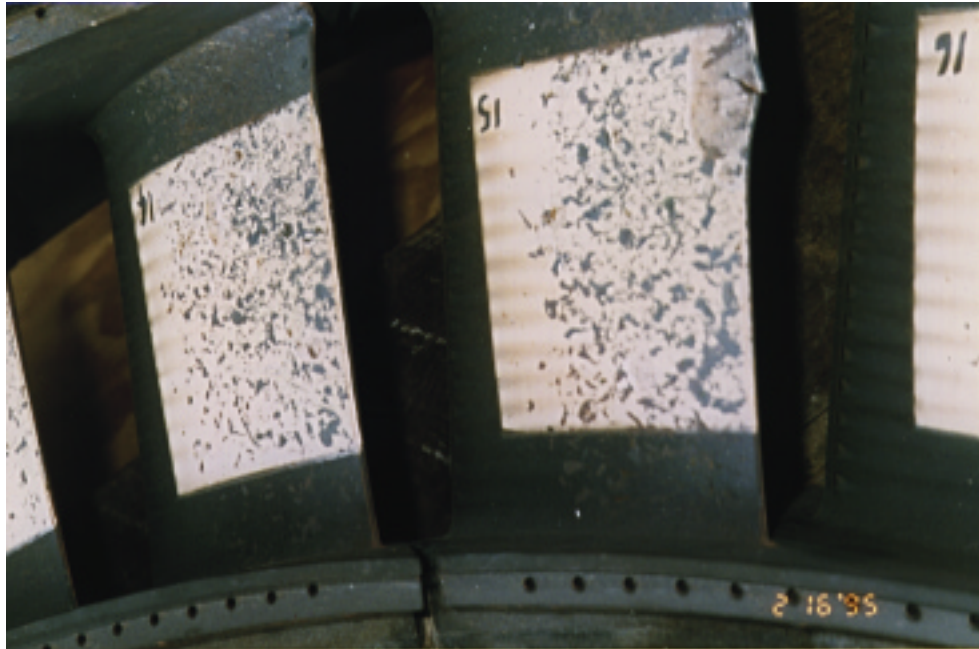
The 1st stage nozzle showing convex side and coating damage from the compressor blade impactions.

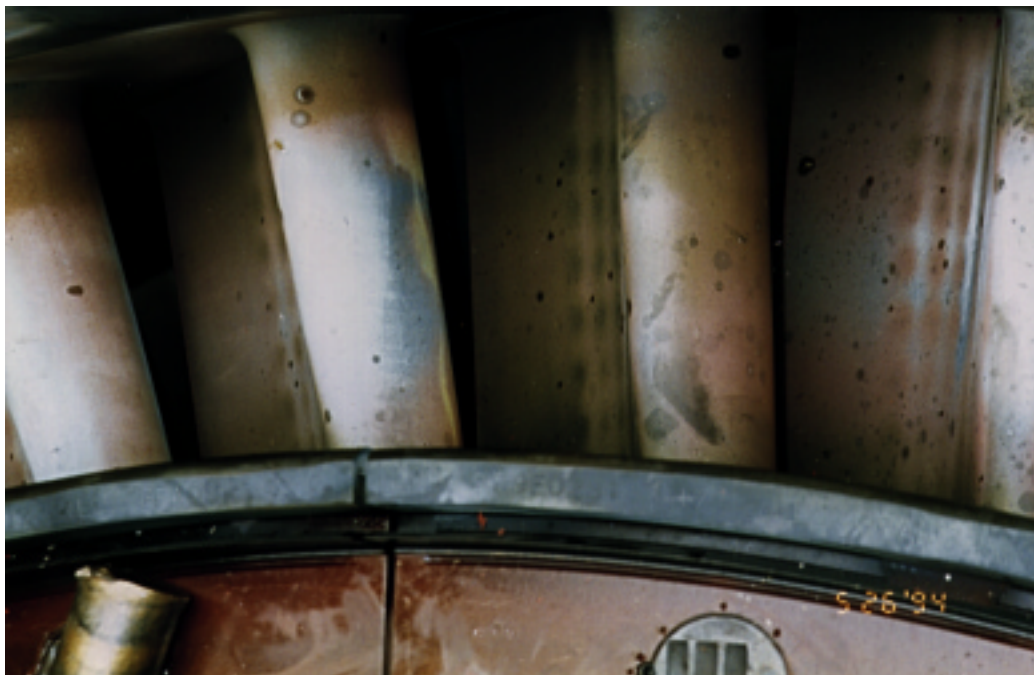
2nd stage nozzle showing good condition. Most spots are oil marks which occurred during the disassembly of the parts.

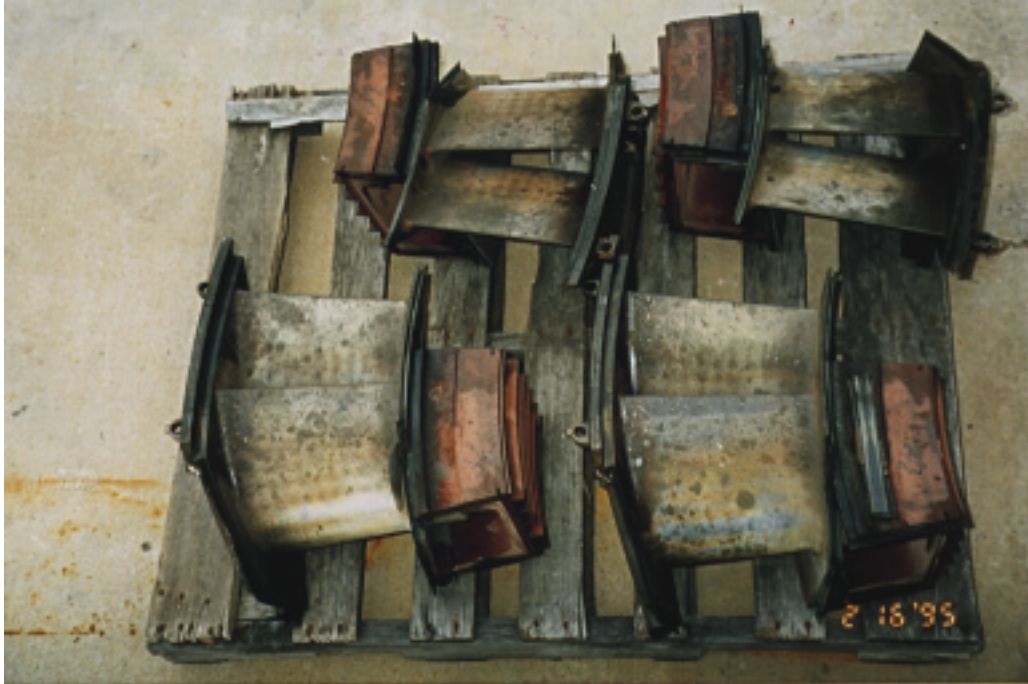
2nd stage nozzle showing minor damage from compressor blade impactions. Most large spots are oil marks from disassembly.

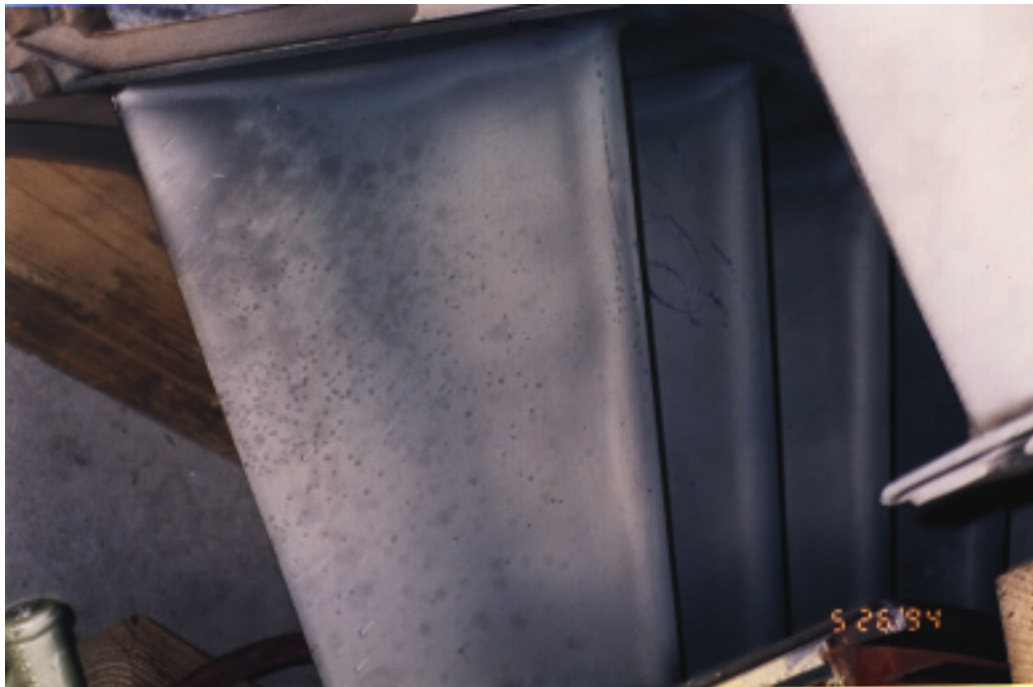
The 3rd stage nozzle is shown in good condition.

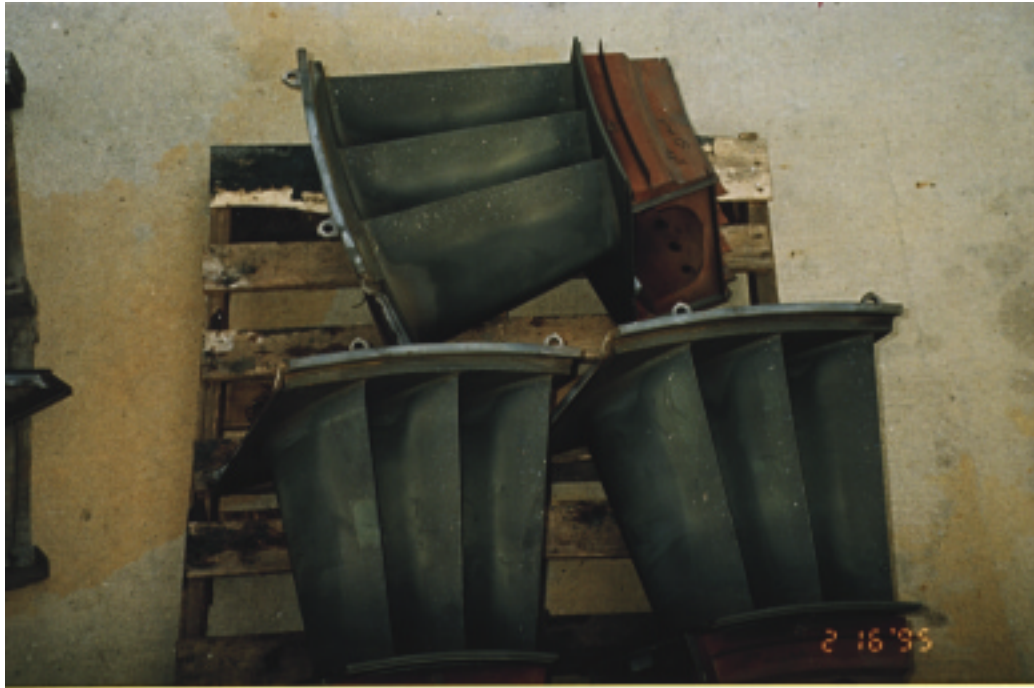
3rd stage nozzle showing minor damage from compressor blade impactions.
Figure 8.31 Unit 4A 2/95, 6,120 hrs. 3rd Stage Nozzle.
