Advanced Gas Turbine Guidelines: Hot Gas Path Parts Condition and Remaining Life Assessment for GE 7FA in Baseload Operation

TR-106329
3125-02

Final Report, December 1996

The Guideline on Hot Gas Path Parts Condition and Remaining Life Assessment provides results of monitoring and inspection of four General Electric (“GE”) MS 7221 FA Advanced Gas Turbines, in baseload service at Florida Power & Light’s (“FP&L”) Martin Station, Indiantown, Florida.

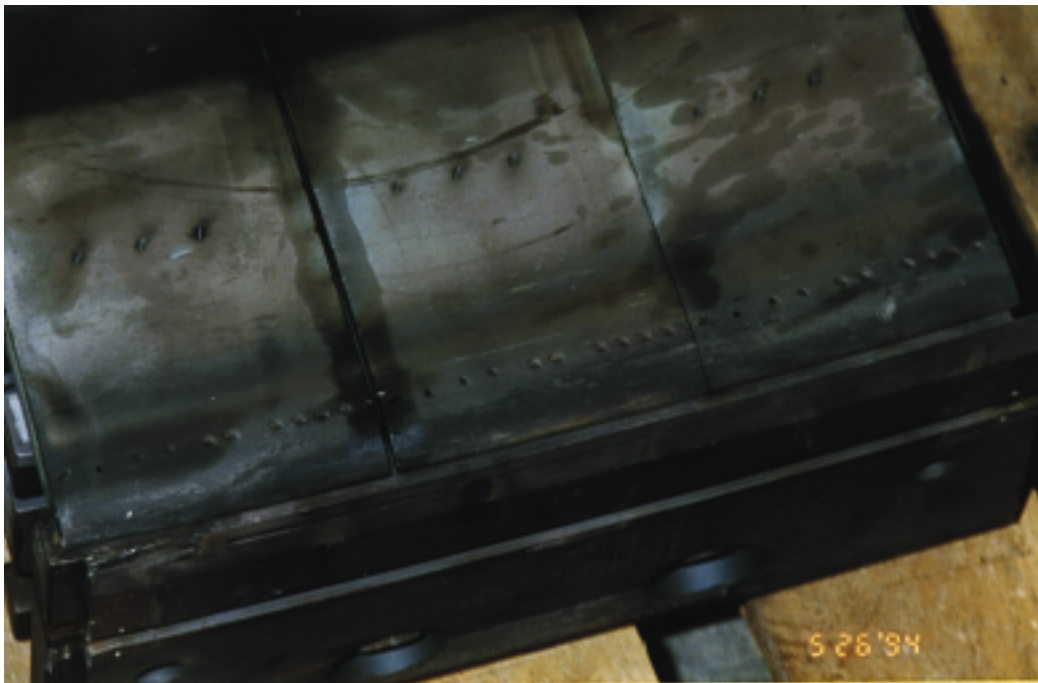
1st stage stationary shroud. good condition with no rubs.
Figure 8.32 Unit 3B 5/94, 4,082 hrs. 1st Stage Stationary Shroud.

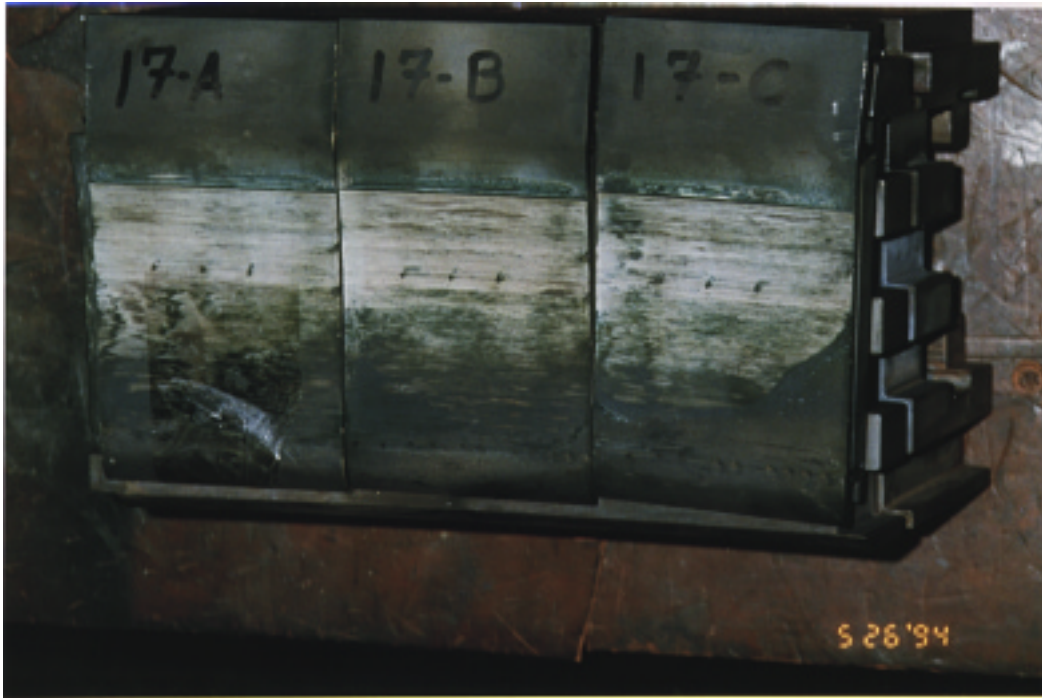
1st stage stationary shroud horizontal flange shows a substantial rub.
Figure 8.33 Unit 3B 5/94, 4,082 hrs. 1st Stage Stationary Shroud.

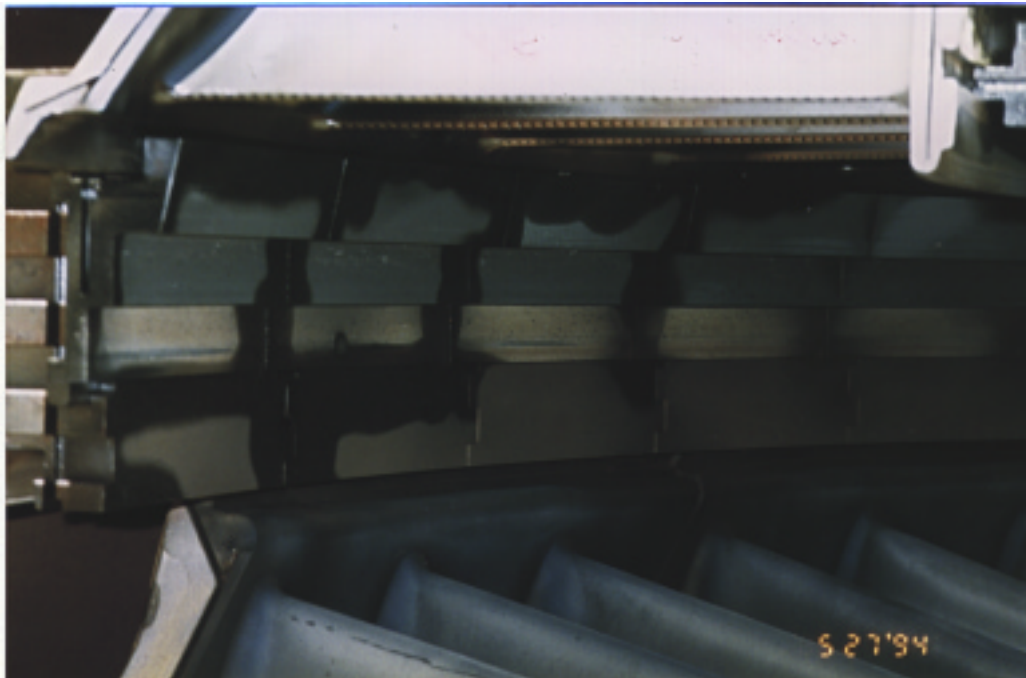
The 2nd stage stationary shroud appears to be in good condition. This is typical of others examined at the site.

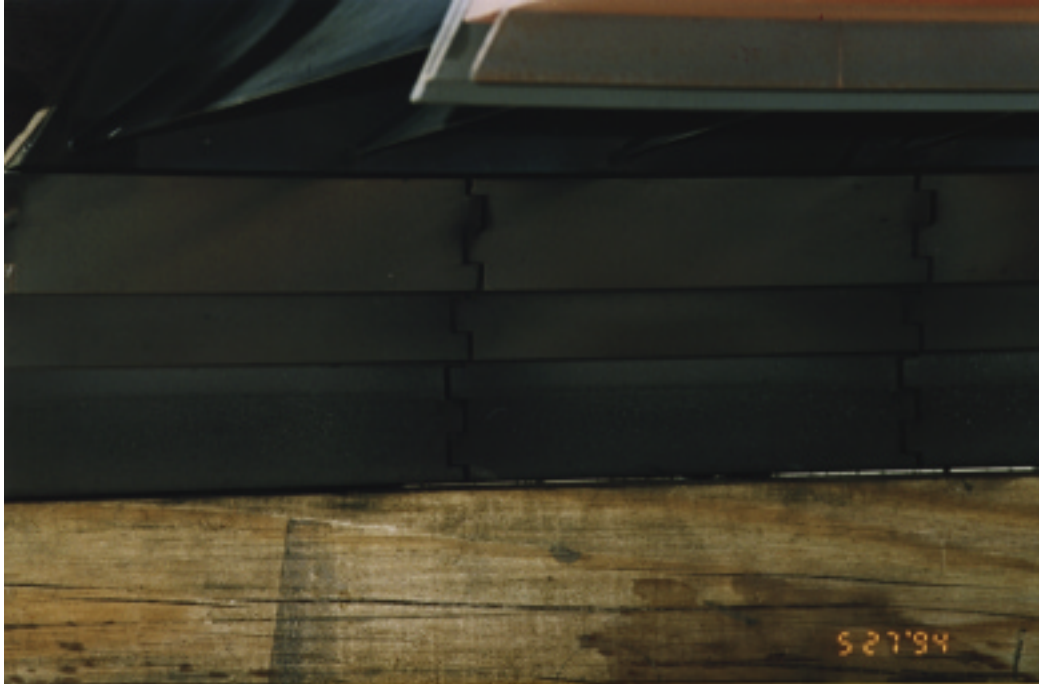
The 3rd stage stationary shroud appears to be in good condition. This is typical of others examined at the site.

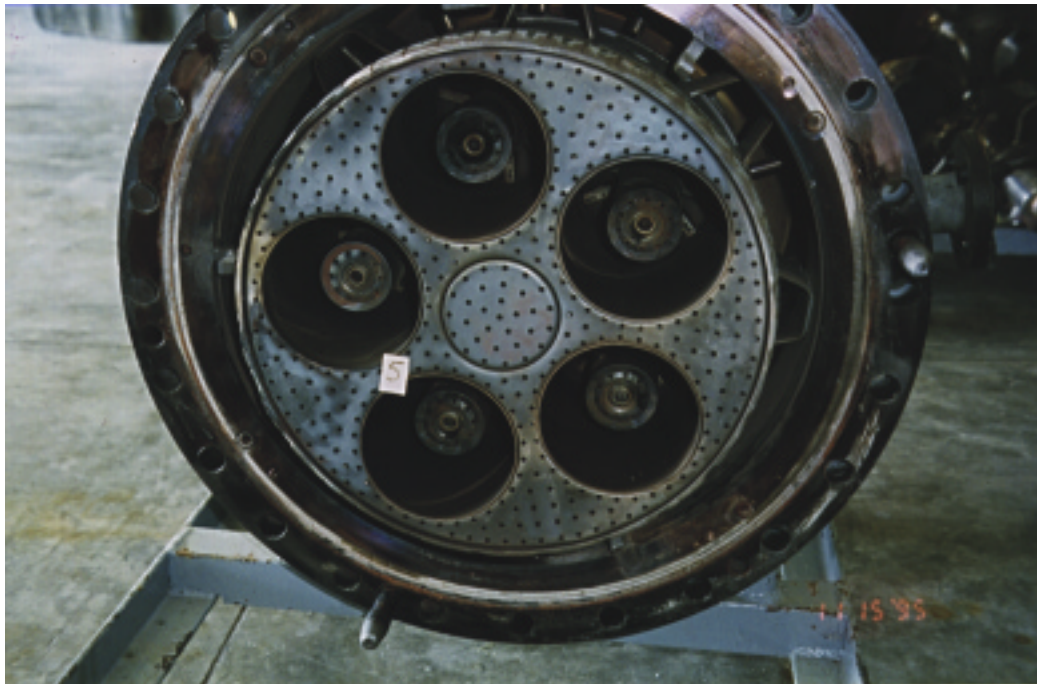
Typical condition of end cap and fuel nozzles, after 9,682 hours.

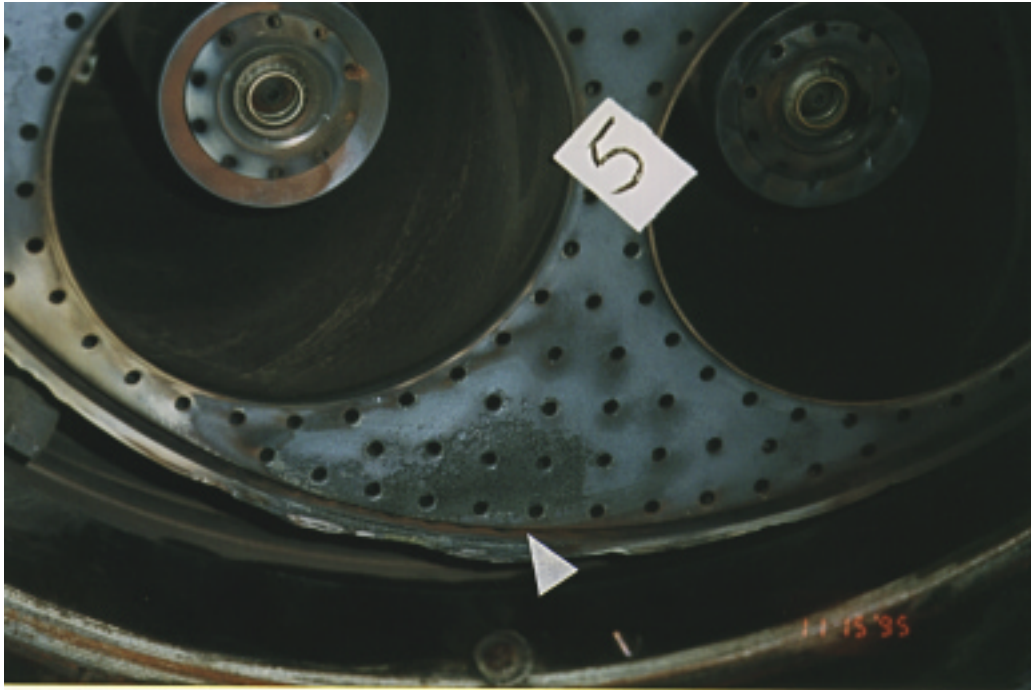
The end cap shows minor local oxidation and distortion. This degradation is seen occasionally at 9,682 hours of service.

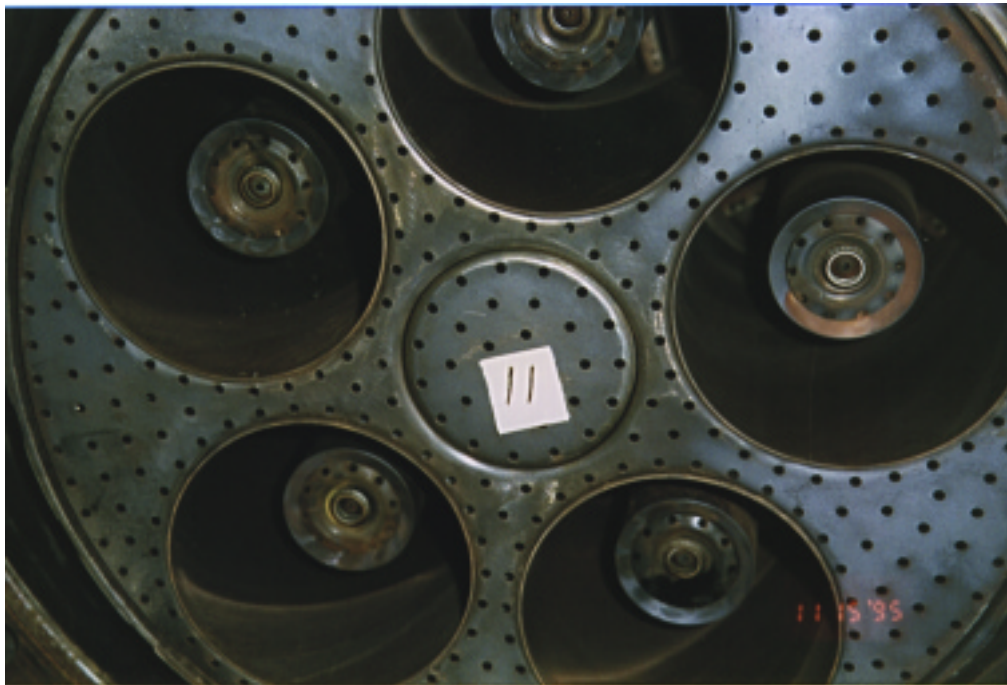
Typical condition of fuel nozzles, after 9,682 hours.

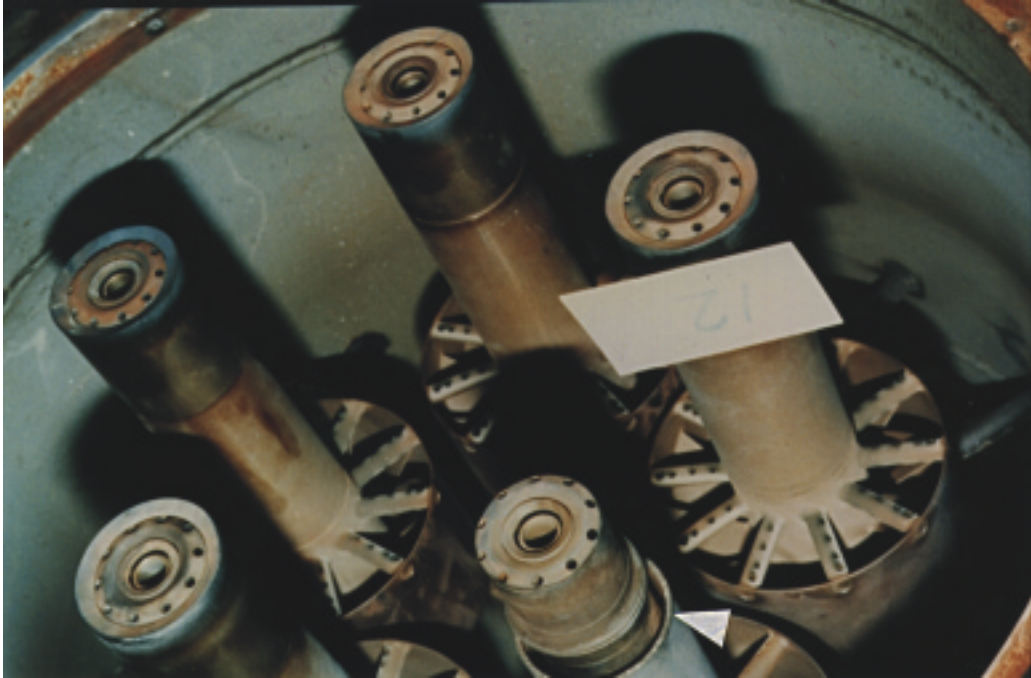
The fuel nozzle tip was lost after 2,500 hours. This failure was attributed to a fuel flashback.

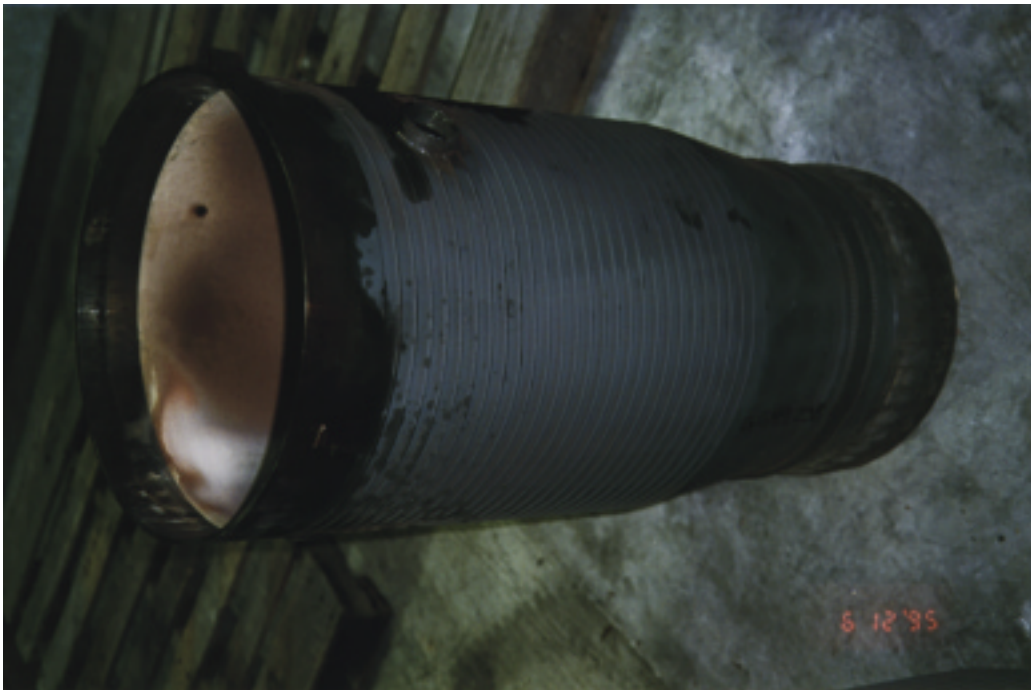
Combustion liner is in good condition, after 8,504 hours.

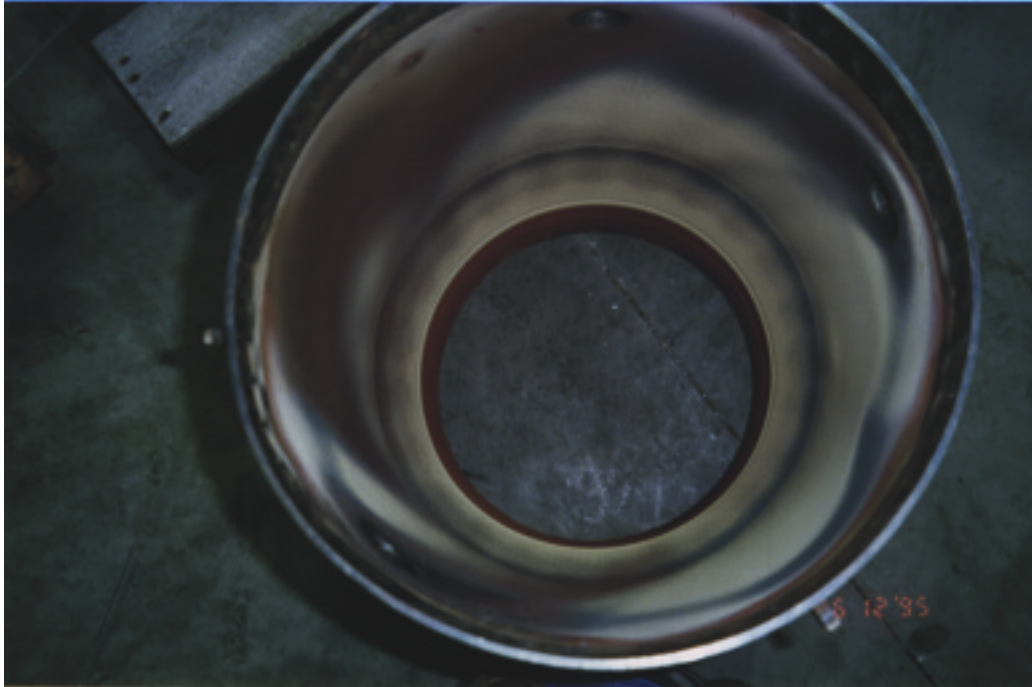
The combustor liner is in good condition. The coating is shown in good condition.
Figure 8.41 Unit 3B 6/95, 12,586 hrs. Combustor Liner.

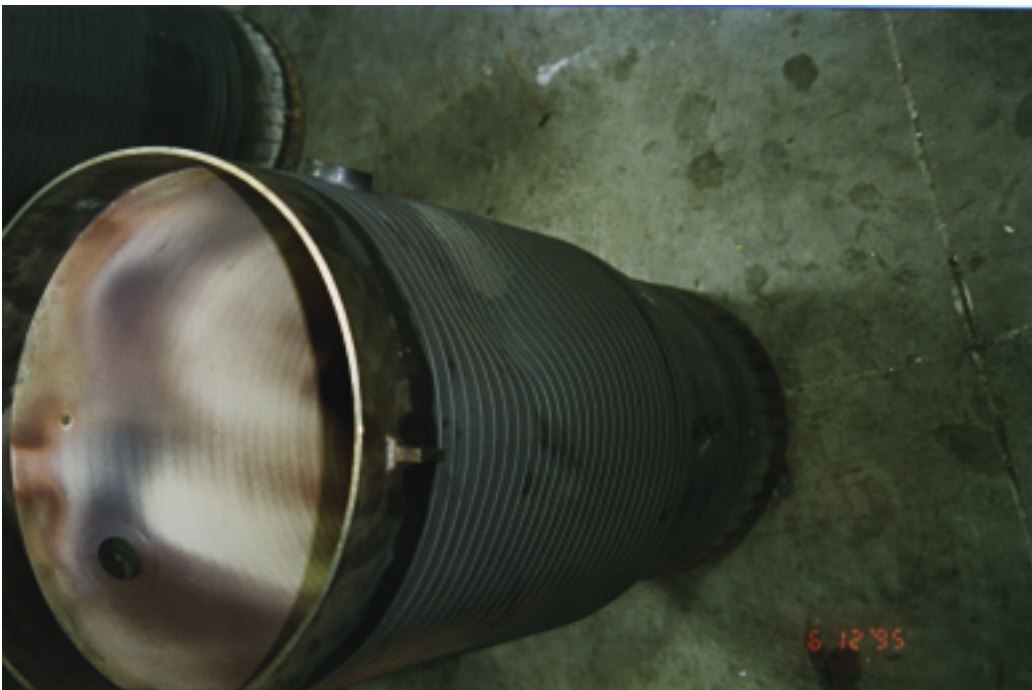
The combustion liner shows an inward bulging distortion after 8,504 hours of operation.
Figure 8.42 Unit 3B 6/95, 12,586 hrs. Combustion Liner.

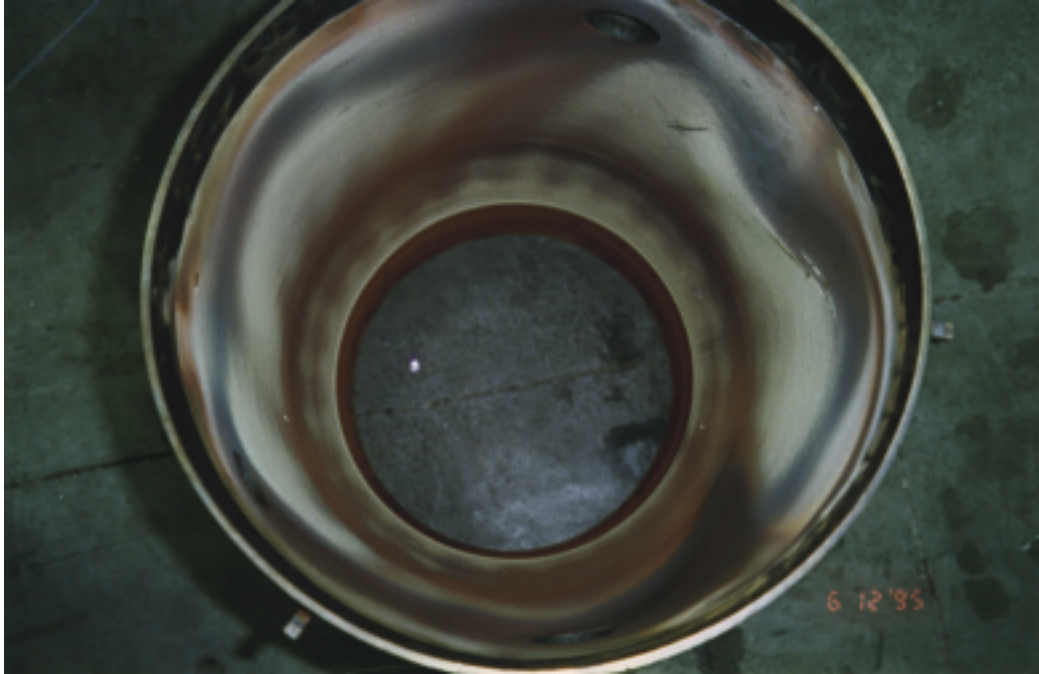
The combustion liner shows an inward bulging distortion after 8,504 hours of operation. There is a small coating deterioration in the immediate area of distortion.
Figure 8.43 Unit 3B 6/95, 12,586 hrs. Combustion Liner.

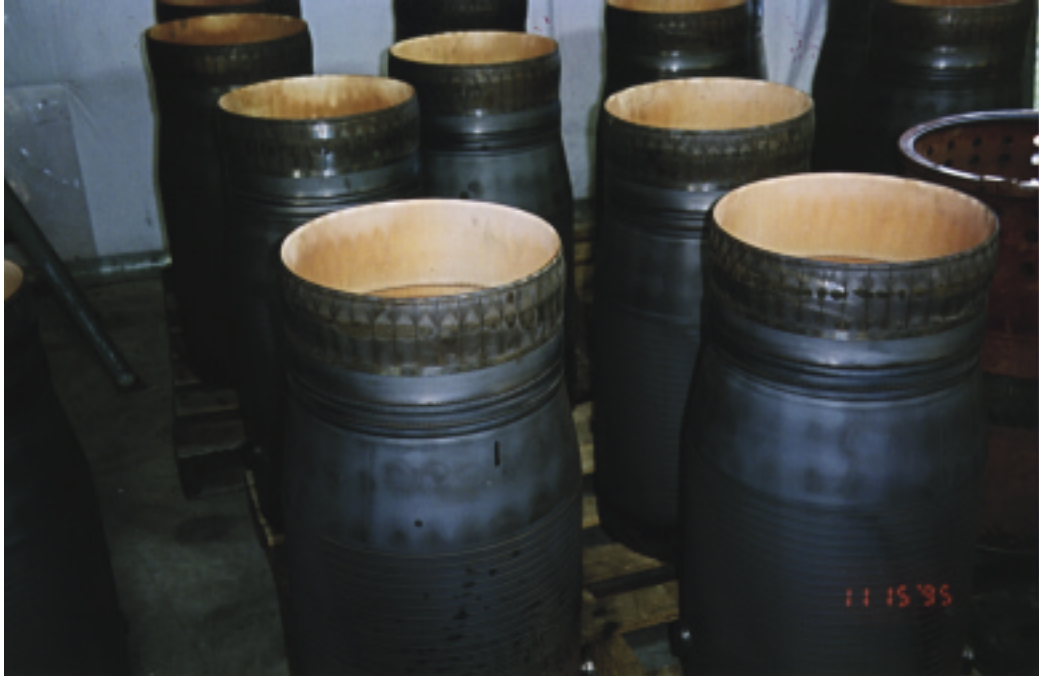
After 9,682 hours of operation the combustor liner appears in good condition.
Figure 8.44 Unit 4B 11/95, 14,264 hrs. Combustion Liner.

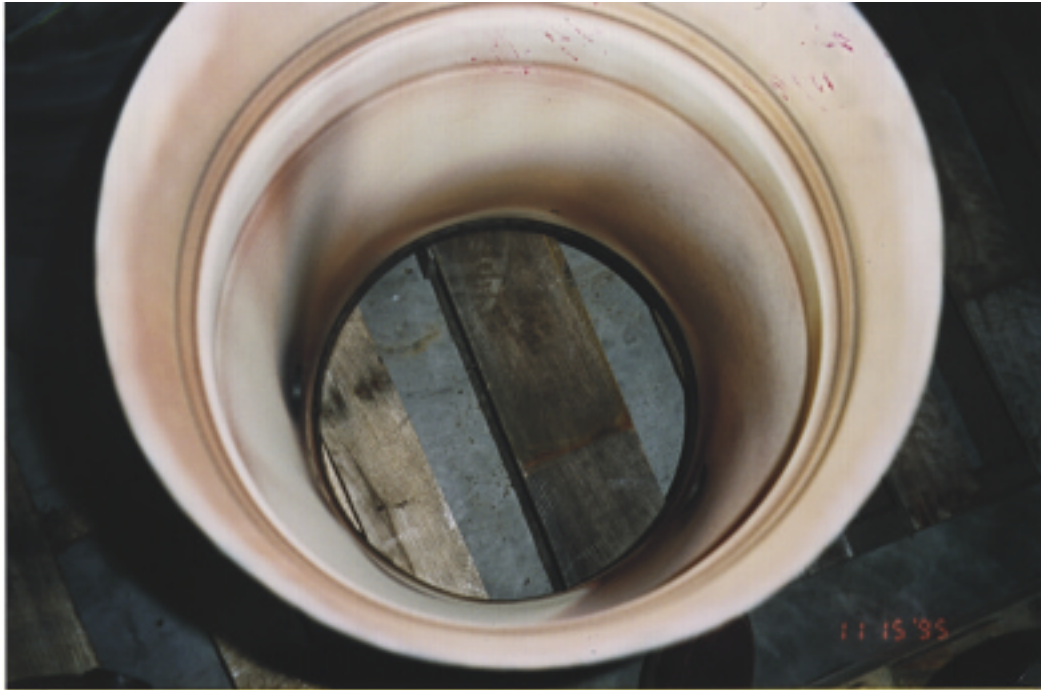
The interior view of the combustor liner shows the coating in good condition.
Figure 8.45 Unit 4B 11/95, 14,264 hrs. Combustor Liner.

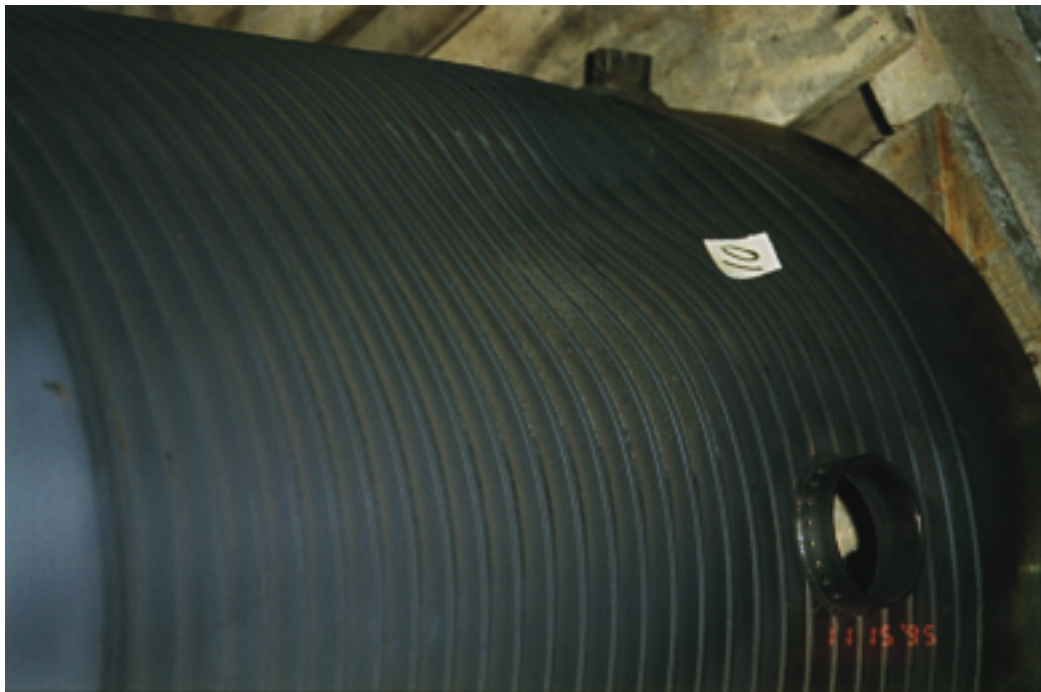
The combustion liner shows typical inward bulging distortion after 9,682 hours of operation. (seen on all liners.)

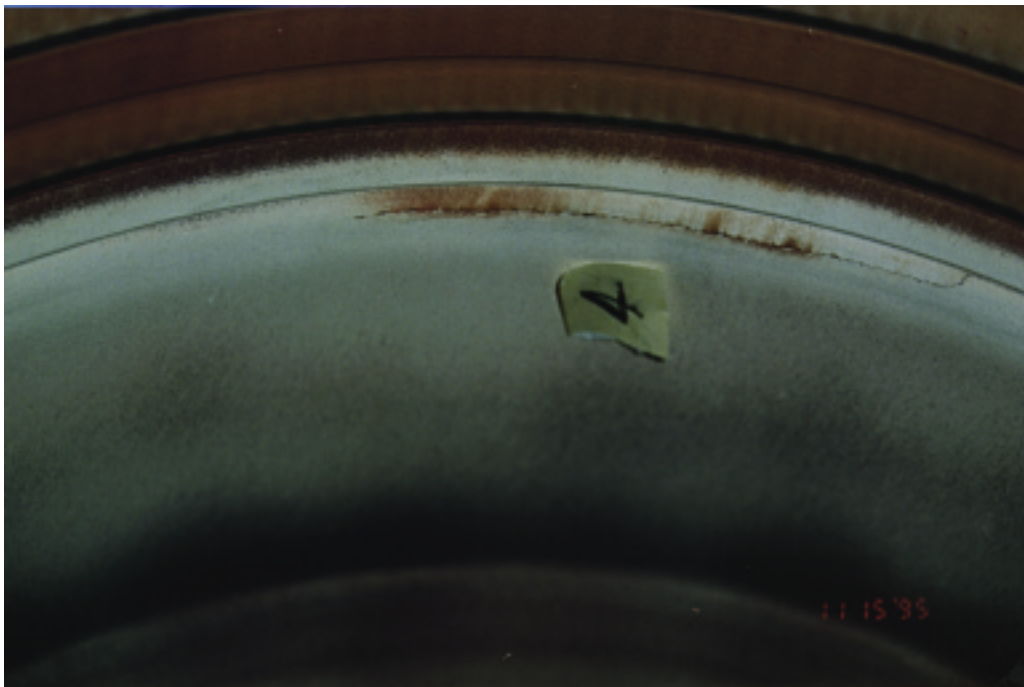
Combustion liner showing aft end crack, after 9,682 hours. (Seen in one liner only).
Figure 8.48 Unit 4B 11/95, 14,264 hrs. Combustion Liner.

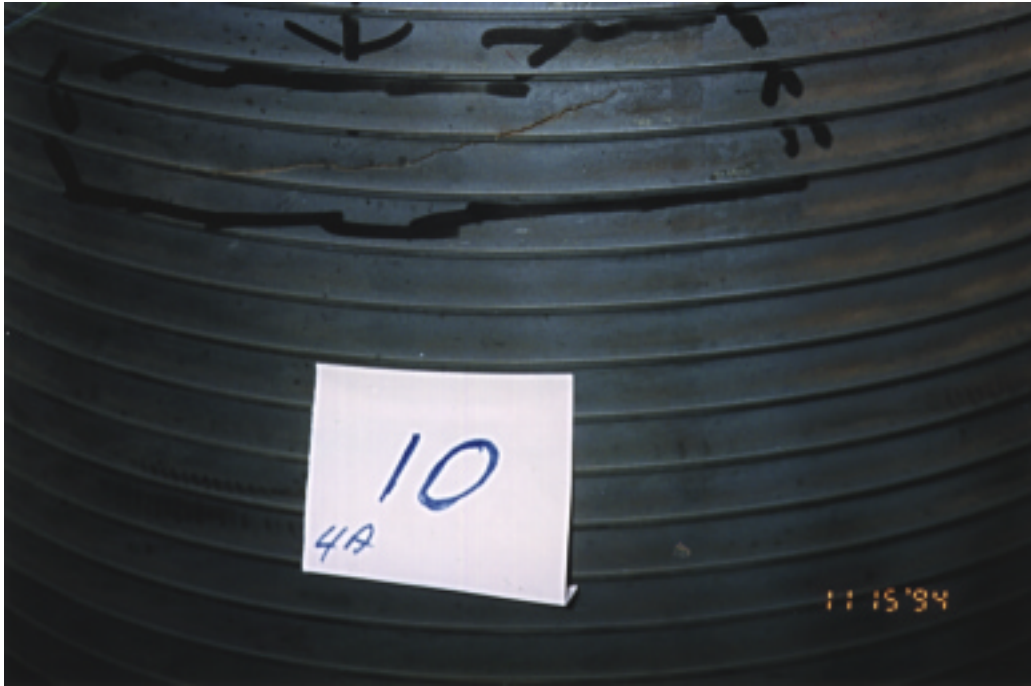
Combustion liner showing body crack, after 4,868 hours. (Seen in one liner only).
Figure 8.49 Unit 4A 11/94, 4,868 hrs. Combustion Liner.

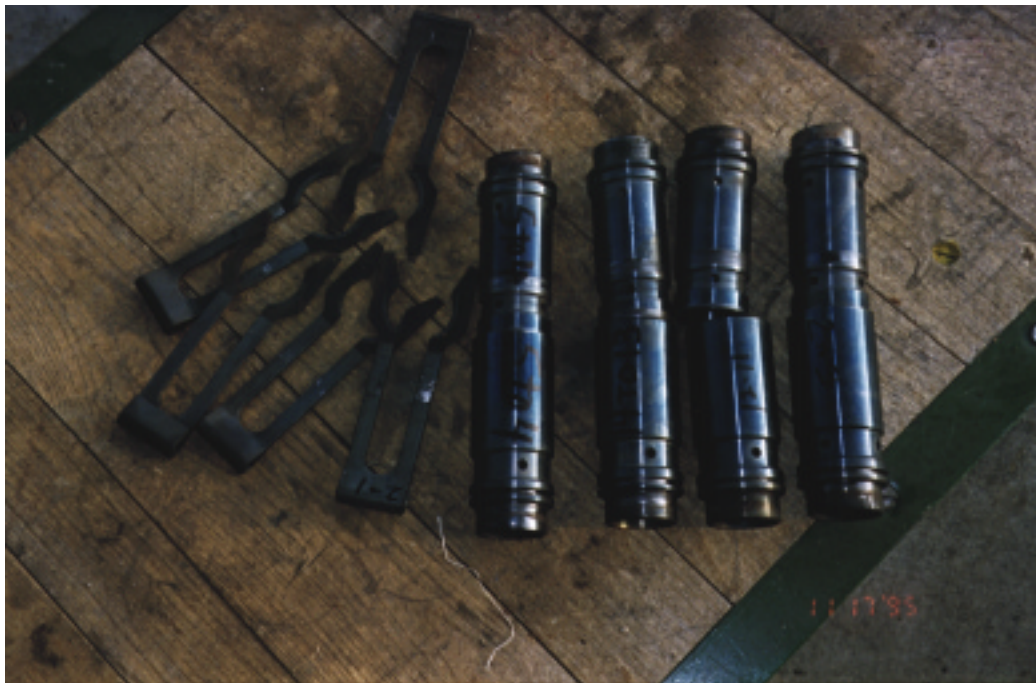
Cross fire tubes typical condition after 4,000-10,000 hours. These fire tubes had 9,682 hours of operation.
Figure 8.50 Unit 4B 11/95, 14,264 hrs. Cross Fire Tubes.

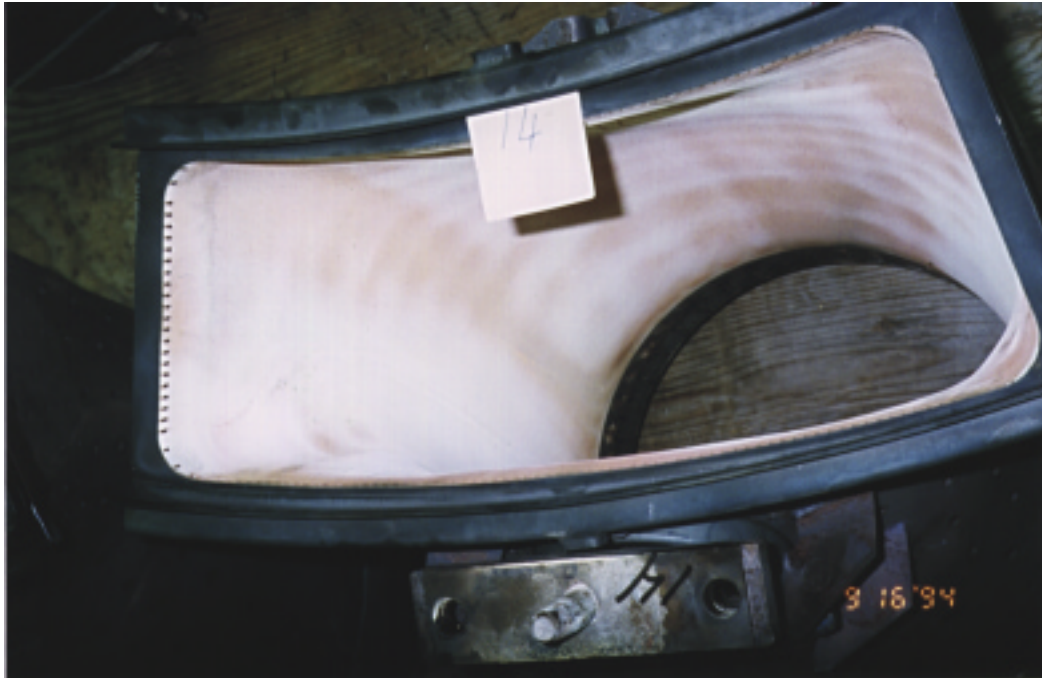
Transition piece in generally good condition after 4,402 hours, but with some wear on the end frame (without design modification).

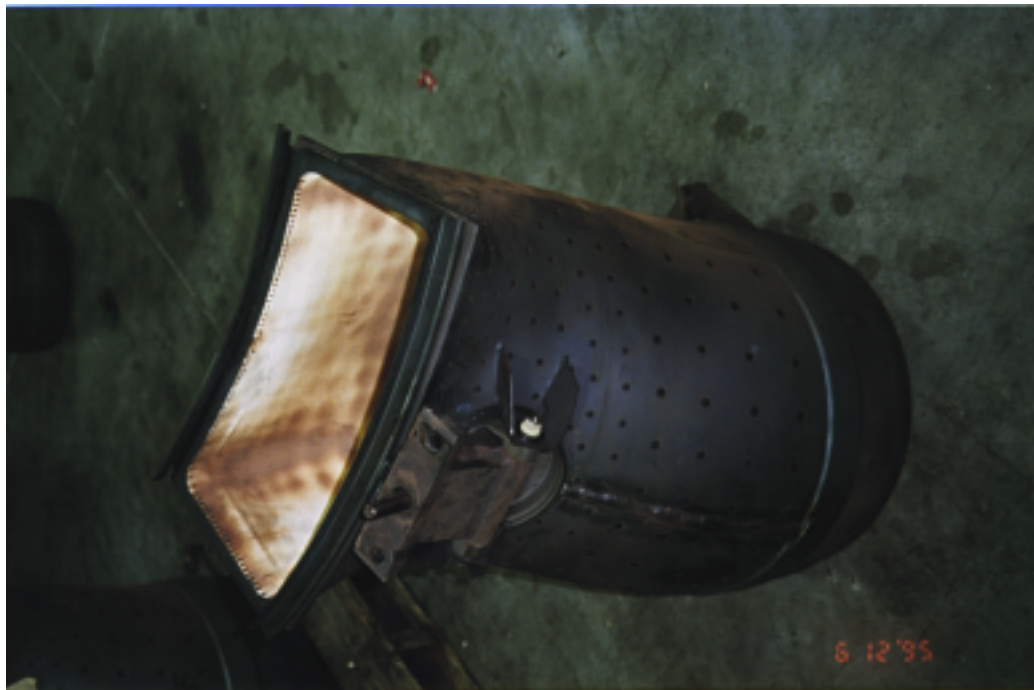
The transition piece is in good condition, after 8,504 hours.

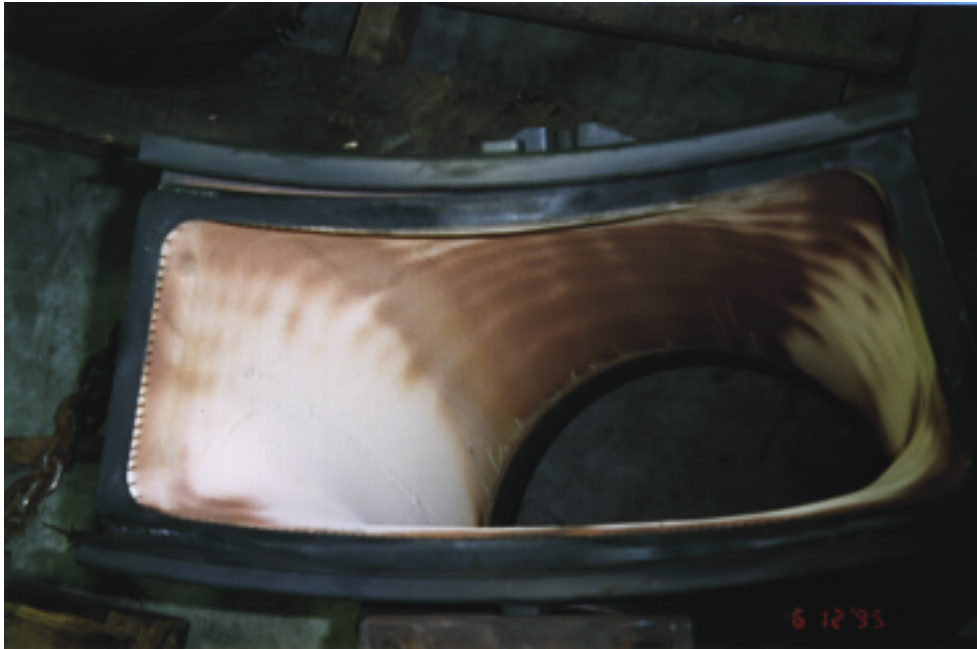
The transition piece and the coating are in good condition, after 8,504 hours of operation.

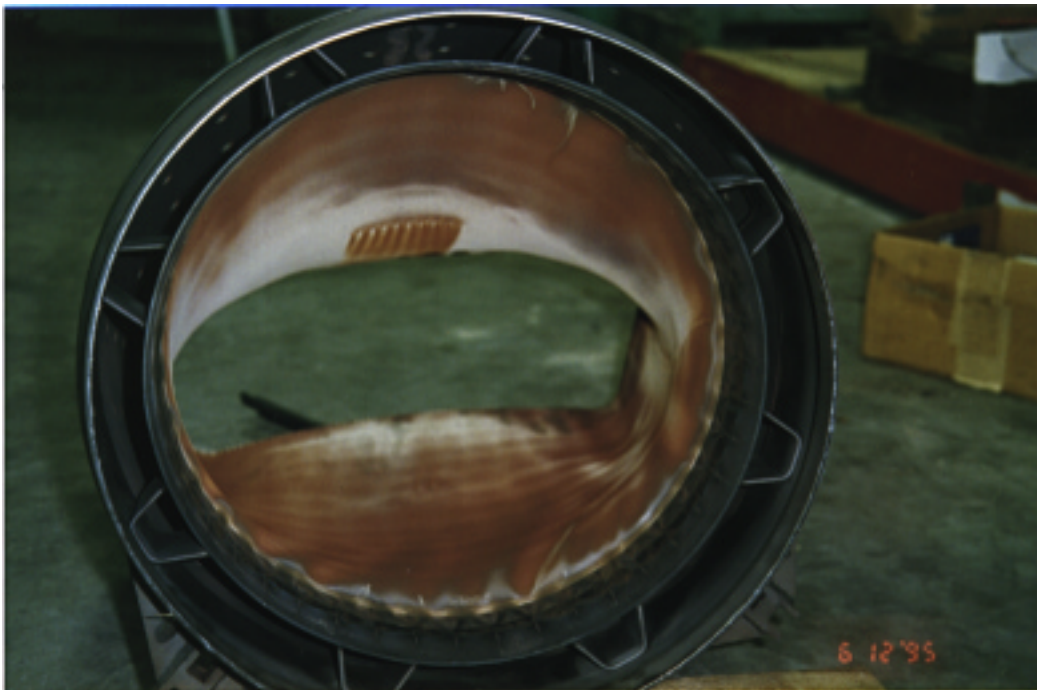
The transition piece is in good condition, after 8,504 hours.

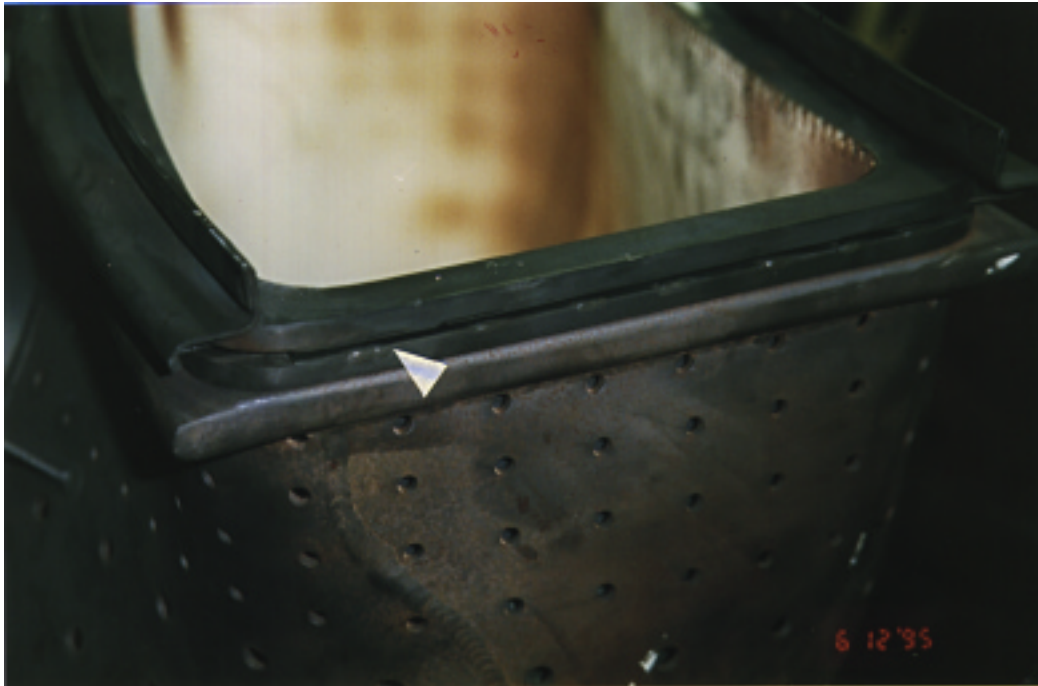
Transition piece showing design modification resulting in minimal wear.
Figure 8.55 Unit 3B 6/95, 12,586 hrs. Transition Piece.

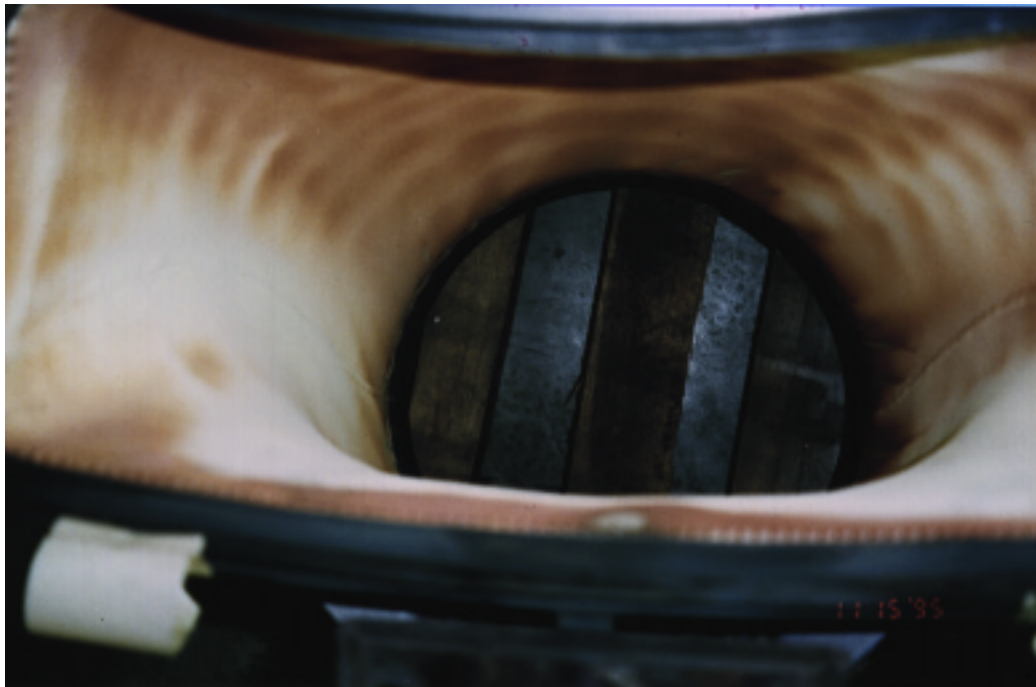
Transition piece in good condition, after 9,682 hours.
Figure 8.56 Unit 4B 11/95, 14,264 hrs. Transition Piece.

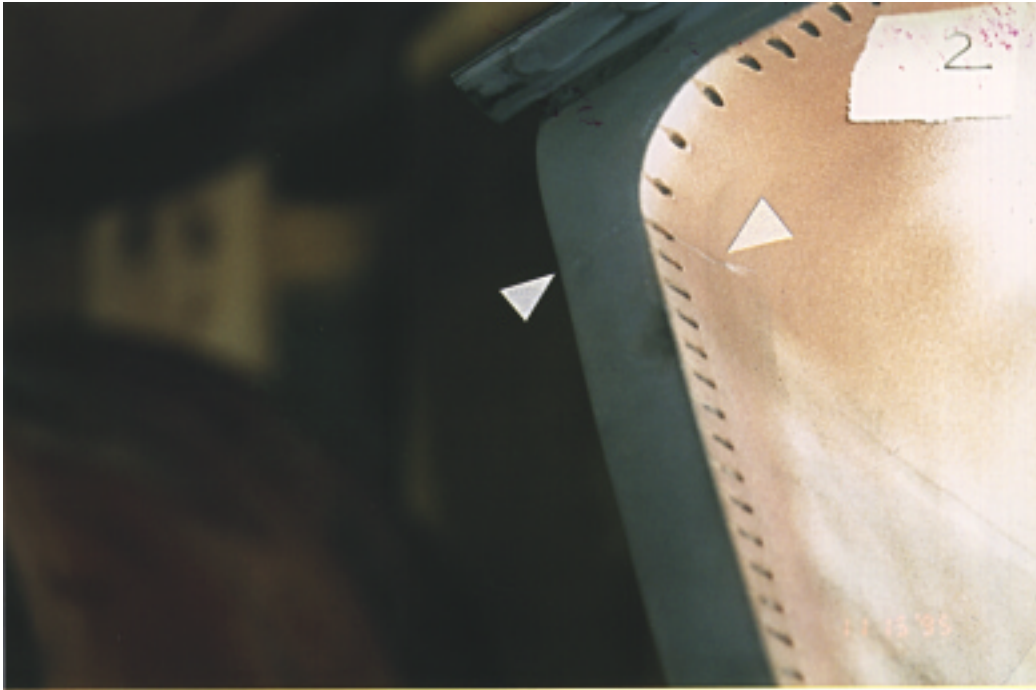
One machine with FSX-414 end frames (the same alloy used for the 1st stage nozzle) had even less wear. Two of the 14 end frames, however, developed 1-2" (25.4-50.8 mm) cracks - but in completely different locations. Propagation looked as if it was very slow.

Transition piece showing material modification to end frame (FSX-414), with no wear. There is a crack on two (of 14) transition pieces.
