Performance of NOREM Hardfacing in Plant Valves: In Situ Application and Leak Rate Testing of Feedwater Check Valves

In-Situ Application and Leak Rate Testing of Feedwater Check Valves

TR-107987

Final Report, September 1997

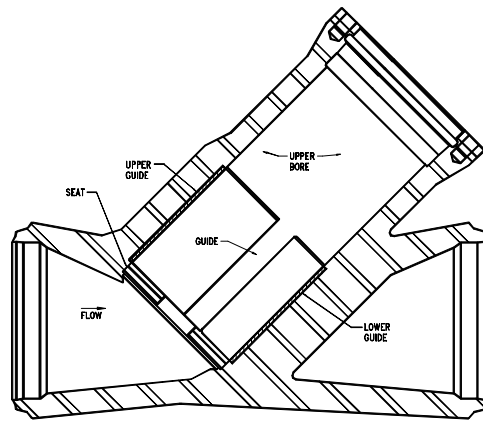
Figure 2-1 F010 Valve

The orientation of the F010 valves in the piping system causes the plug guide rings/ribs to wear unevenly. With these valves installed in a horizontal piping run, the plugs are oriented 45 degrees between horizontal and vertical. This orientation puts the weight of the plug on the lower guide ribs, causing friction and wear at the

guide ring/rib interface. Wear on the guide ring/ribs results in excess clearance, allowing the plug to cock and move off the upper edge of the valve seat. The ideal valve orientation would be for the centerline of the plug to be vertical, which would reduce friction/wear on the guides, and allow the weight of the plug to aid in seating.

Of the four guide ribs, the lower guide (rib #4, Figure 6-4) was the most difficult rib to weld. As shown in Figure 2-1 this rib spans the bottom bore of the valve and is not merely a built up area of the upper (plug) bore. As such, thermal gradients were a major concern during hardfacing the lower guide. Six thermocouples were utilized to monitor the bottom rib temperature during hardfacing. Care was taken to keep the thermal gradient along the rib to less than 100°F during NOREM welding.

In addition to returning the valve to original manufacture's design dimensions, several other modifications to the existing valve were considered including: (1) changing the guide material; (2) adding a disc/plug spring; (3) adding or modifying the plug upper stop; (4) re-orienting the valve; (5) lowering the plug weight; and (6) widening the bottom guide rib. Widening the lower guide rib to better support the disc/plug weight and improve seat approach geometry. Widening the bottom guide rib (see Figure 2-1) was the most feasible and effective modification in terms of eliminating the apparent source of wear by reducing the per-unit friction force on the plug/guide ribs and thus reducing the wear on both the guides and plug ring. Further analysis indicated that widening the bottom valve guide would not significantly effect the valve Cv and flow velocities. However, the project team realized the installation of wider guides did not address or solve the potential valve flutter problem. Additional analysis by William Powell showed the plug should be fully open (no flutter) at normal operating conditions. Based on this information, the project team did not pursue a modification for an upper stop on the plug.

Changing the guide material to a more wear resistant material would also increase the life of the disc/plug and body guides. However, the current guide material was Stellite™ #21, one of the industry's most wear resistant materials. While using a more wear resistant material, Stellite™ #6, was feasible, the increase in wear life would not be significant. If Stellite™ were used, increasing the guide width would have added to the cobalt inventory. As previously discussed, an engineering evaluation had concluded that EPRI's cobalt-free NOREM material would perform as good if not better than Stellite™. Therefore, the project team recommended utilizing NOREM hardfacing in the F010 valve modifications.

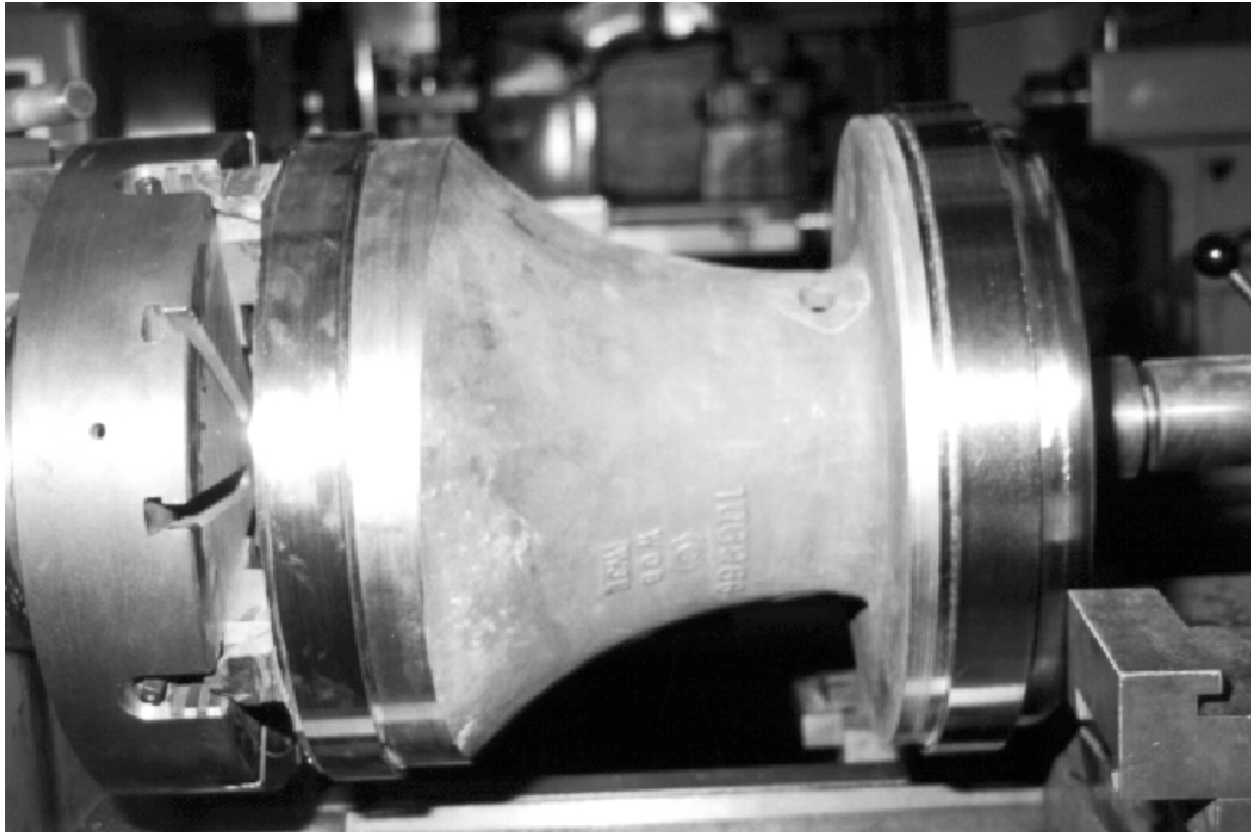
Figure 5-7 Finished Plug

Machining proceeded without incident until final machining on the last plug (F010A plug). The F010A plug seat and bottom guide were finished and the upper guide was nearing completion when a crack developed with the loud "ping" characteristic of hardfacing cracks.

This crack was removed by grinding and did not propagate into the 309L layer. After removing the flaw the plug was installed. An engineering evaluation determined the small transverse groove left after removing the indication would not hinder valve performance. However, a new plug was procured and installed during RFO8.

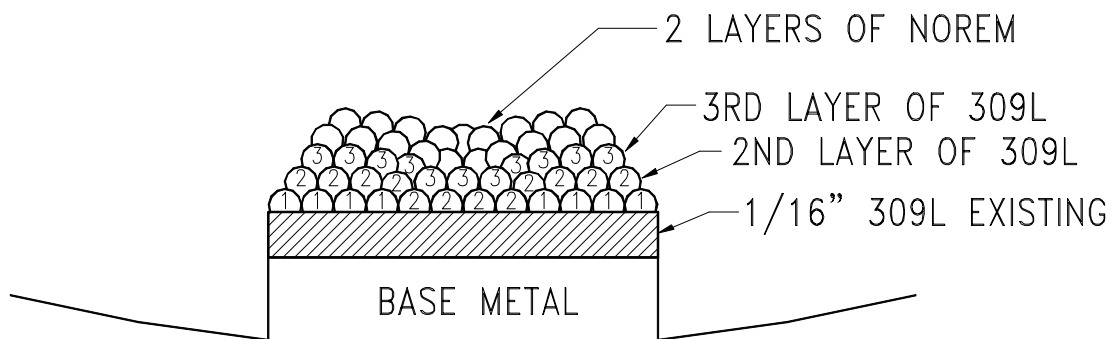
Figure 6-10 Alternate Weld Prep

Location	Rib 4	Rib 3
Top	93.8	90.8
Mid	93.1	95.8
Bottom	92.1	98.6

A RH_b in the range of 93 was taken to be acceptable, while the 98.6 was borderline high. Additional 309L was then applied as shown in Figure 6-10. This alternate 309L weld bead sequence re-established contour on the guide and served as the NOREM weld prep. Two layers of NOREM were welded on top of the 309L without an intermediate machining step. In addition to saving the time required for machining, this saved additional time since the welding equipment didn't have to be replaced with machining equipment and the valve didn't have to cool to allow machining.

After final machining, NDE revealed three small linear indications on the bottom guide. These indications were removed with a burring tool and all edges were sloped to a 4:1 slope.
