General Electric Electrohydraulic Controls (EHC) Electronics Maintenance Guide

Technical Report

TR-108146

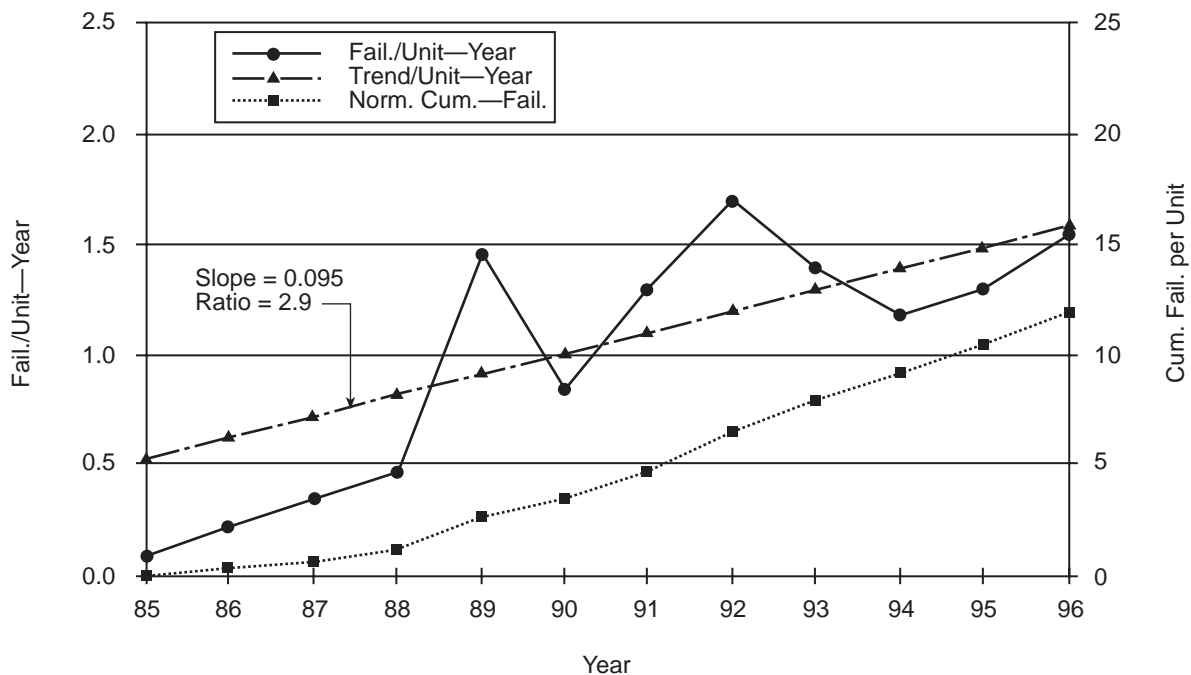
Figure 3-1
Event Frequency: BWR and PWR Mark I with Hydraulics and Test

The frequency of occurrence of events for Mark I systems is shown in Figure 3-1; Mark II systems are shown in Figure 3-2. The most striking feature of these two figures is that the failure rate for Mark II systems shows a definite downward trend, while the failure rate for Mark I systems shows a definite upward trend. Since Mark I systems are somewhat older than Mark II systems, the Mark I systems could be showing signs of aging. (As of the end of 1996, the average age of Mark I systems is almost 20 years; the average age for Mark II systems is about 10.5 years.) It is important to note, however, that the actual failure rate for Mark II systems was greater than for Mark I systems until about 1993.

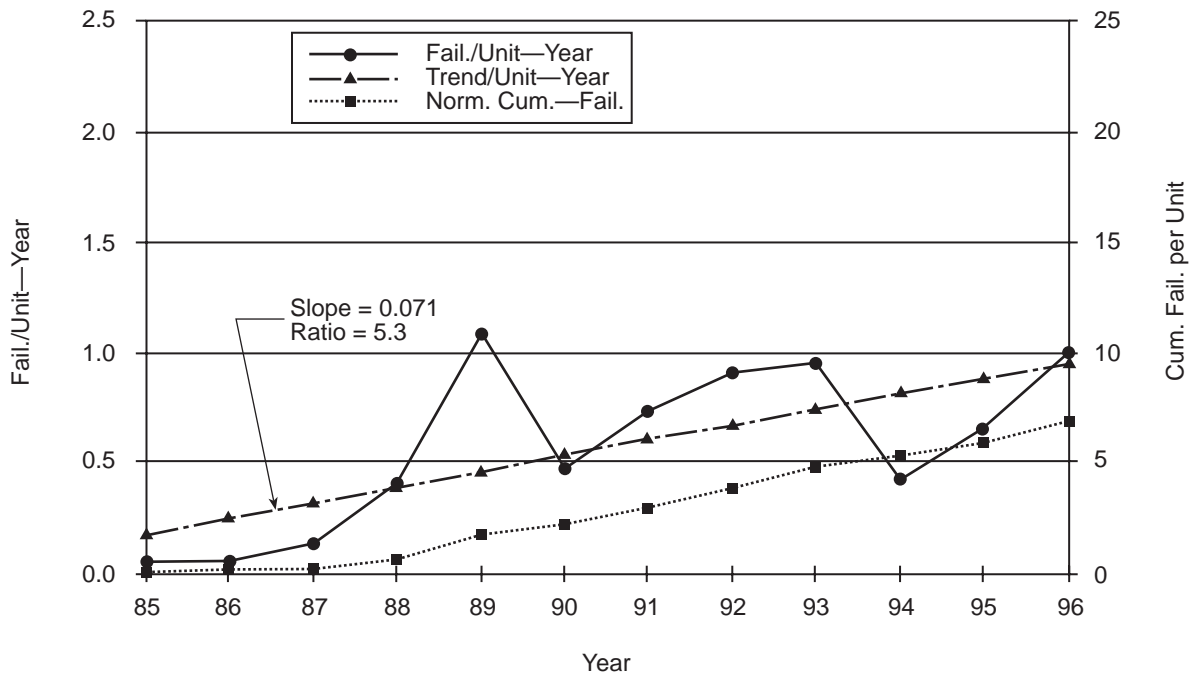
Figure 3-5
Event Frequency: BWR Mark I without Hydraulics and Test

The trends for BWRs with Mark I systems are shown in Figure 3-5. PWRs with Mark I systems appear in Figure 3-6. The trend lines for both show an increasing failure rate, but the slope for the PWR is significantly less than for the BWR.

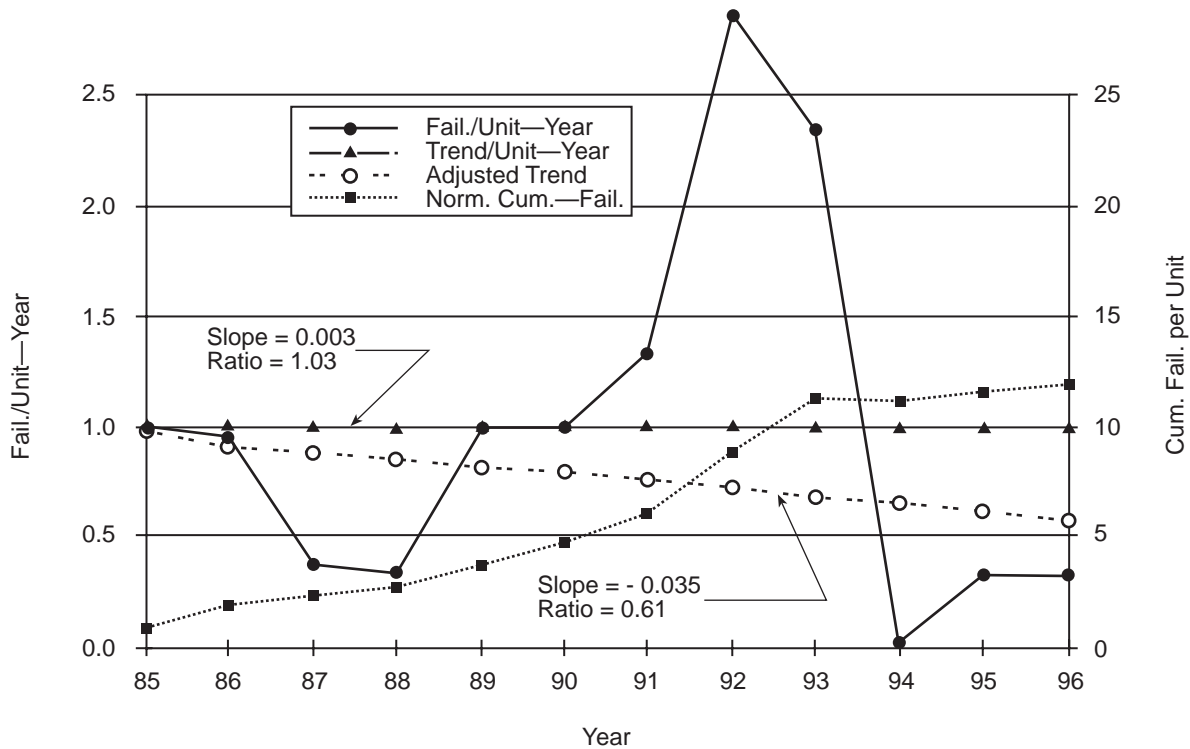
Figure 3-7
Event Frequency: BWR Mark II without Hydraulics and Test

The trends for BWRs with Mark II systems are shown in Figure 3-7; PWRs with Mark II systems are depicted in Figure 3-8. The PWR trend line shows a definite decreasing trend. The line for BWRs is almost flat. However, there are only three BWR Mark II units, so the trend is easily distorted. The bulge in failures in 1992 and 1993 is the result of several problems involving EHC during startups following refueling outages. If the relatively minor events in the 1992 to 1993 time frame are removed, then the trend becomes decreasing (see the Adjusted Trend line in Figure 3-7). Note that the slope of the cumulative failure line becomes flatter beyond 1993, which also indicates a decreasing failure rate trend.

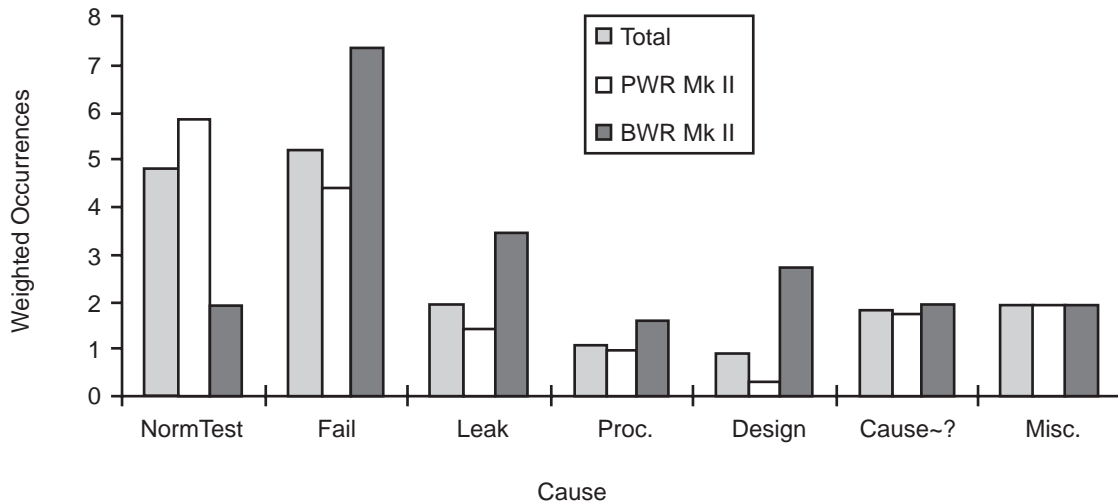
**Figure 3-10**
Causes of Events: Mark II

A graph of each of the items is shown in Figure 3-10 for Mark II and Figure 3-11 for Mark I. The values in these figures are normalized to the number of units. For causes that are not exclusively hydraulics problems or test operations, the biggest cause is failures of some sort. Note that the number of failures for PWRs is somewhat less than for BWRs. This is consistent with the greater complexity of the BWR EHC. The dominance of failures and hydraulic leaks are a significant maintenance concern.

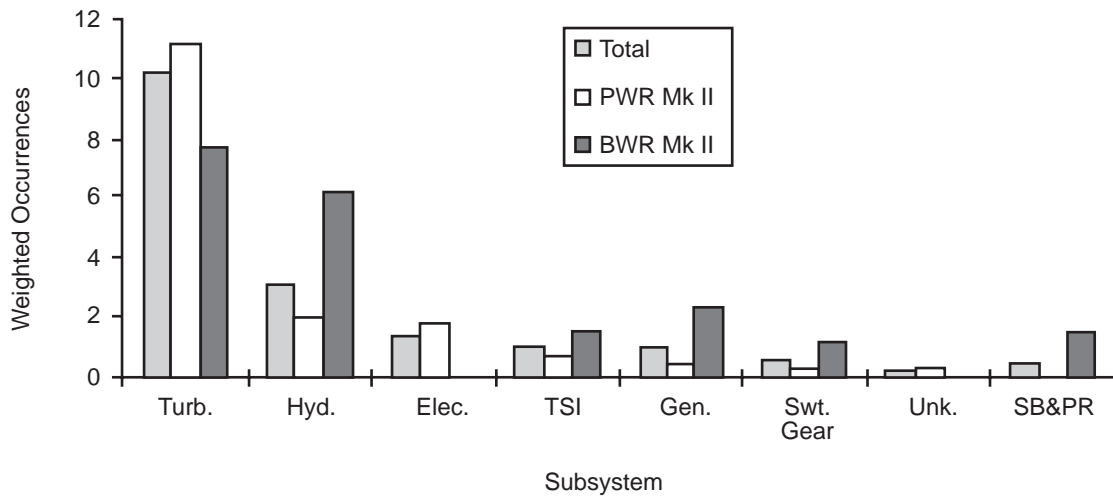
Figure 3-12
Event Occurrences by Subsystem: Mark II

A graph of each of the items is shown in Figure 3-12 for Mark II and Figure 3-13 for Mark I. The values in these figures are normalized to the number of units. The largest number is in the turbine subsystem, which would be expected. The larger number of hydraulic problems in BWRs is consistent with the more complicated BWR hydraulics because of the bypass valves. Note that, for BWR Mark II systems, the bypass valves typically have a completely separate hydraulic system. It is important to note that the number of problems in the TSI and MMI are probably underrepresented in the industry databases because many of the problems in these subsystems would not create the type of events that are reported.

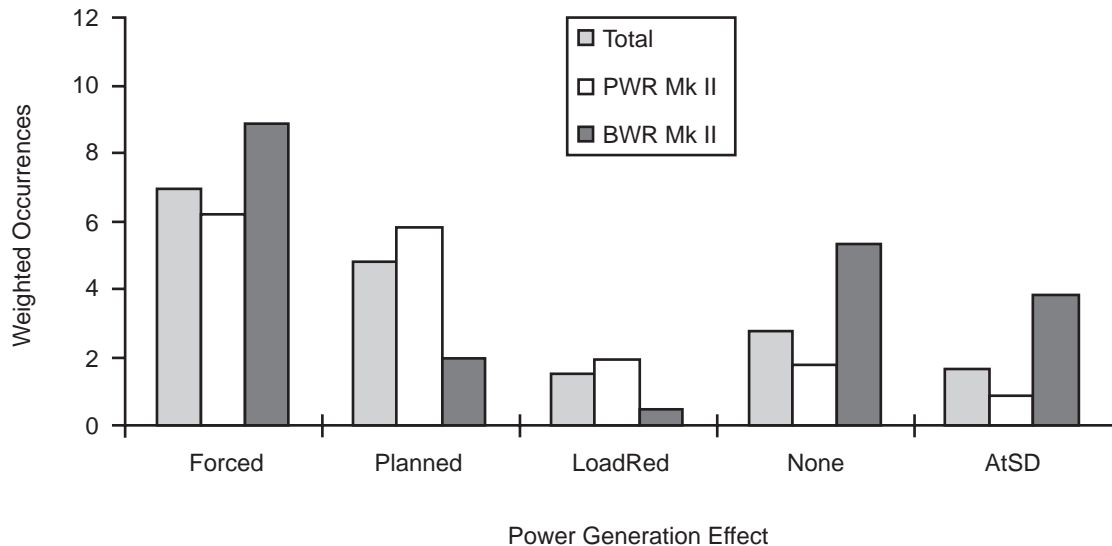
Figure 3-14
Event Occurrences by Effect on Power Generation: Mark II

A graph of each of the items is shown in Figure 3-14 for Mark II and Figure 3-15 for Mark I. The largest number of events that are reported, other than planned power reductions for normal testing, are for forced outages. This is basically consistent with the fact that the industry databases are biased toward events that cause plant shutdowns. The cases with no effect and those that occur during shutdown are undoubtedly underrepresented.
