technical brief

Pool Shocking—"Fun in the Sun" Can Be a Shocking Event

Power Quality Information Services and Support Target

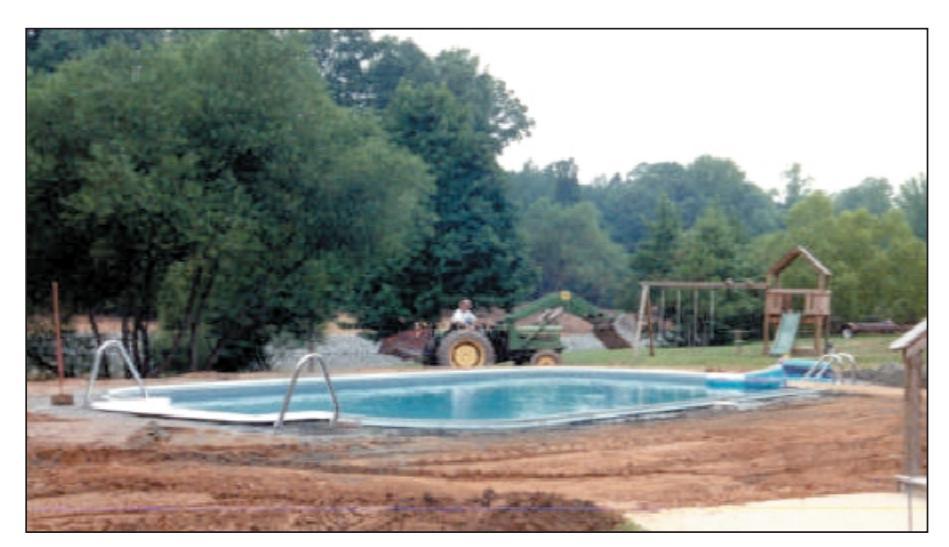
Figure 1. Swimming pool still under construction.

The customer was in the construction stage of a swimming pool, shown in Figure 1, and had experienced several incidents of shocking while working around the pool. The swimming pool cavity in the ground was 4" to 6" larger than the fiberglass pool shell. The 4" to 6" gap between the shell and the surrounding earth had to be back-filled with dirt before the concrete deck was poured. The customer indicated he was getting shocked while standing in the pool water and reaching out to pull dirt into the gap. Every time he came in contact with the earth, he experienced a shocking sensation.

The shocking voltage was measured to be $3.1V_{ne}$ ac from the pool's water to the soil around the pool. The potential difference was created by the pool's water being held at the elevated system neutral level (via the pool's grounded ladder and submerged light fixture) while the sur-

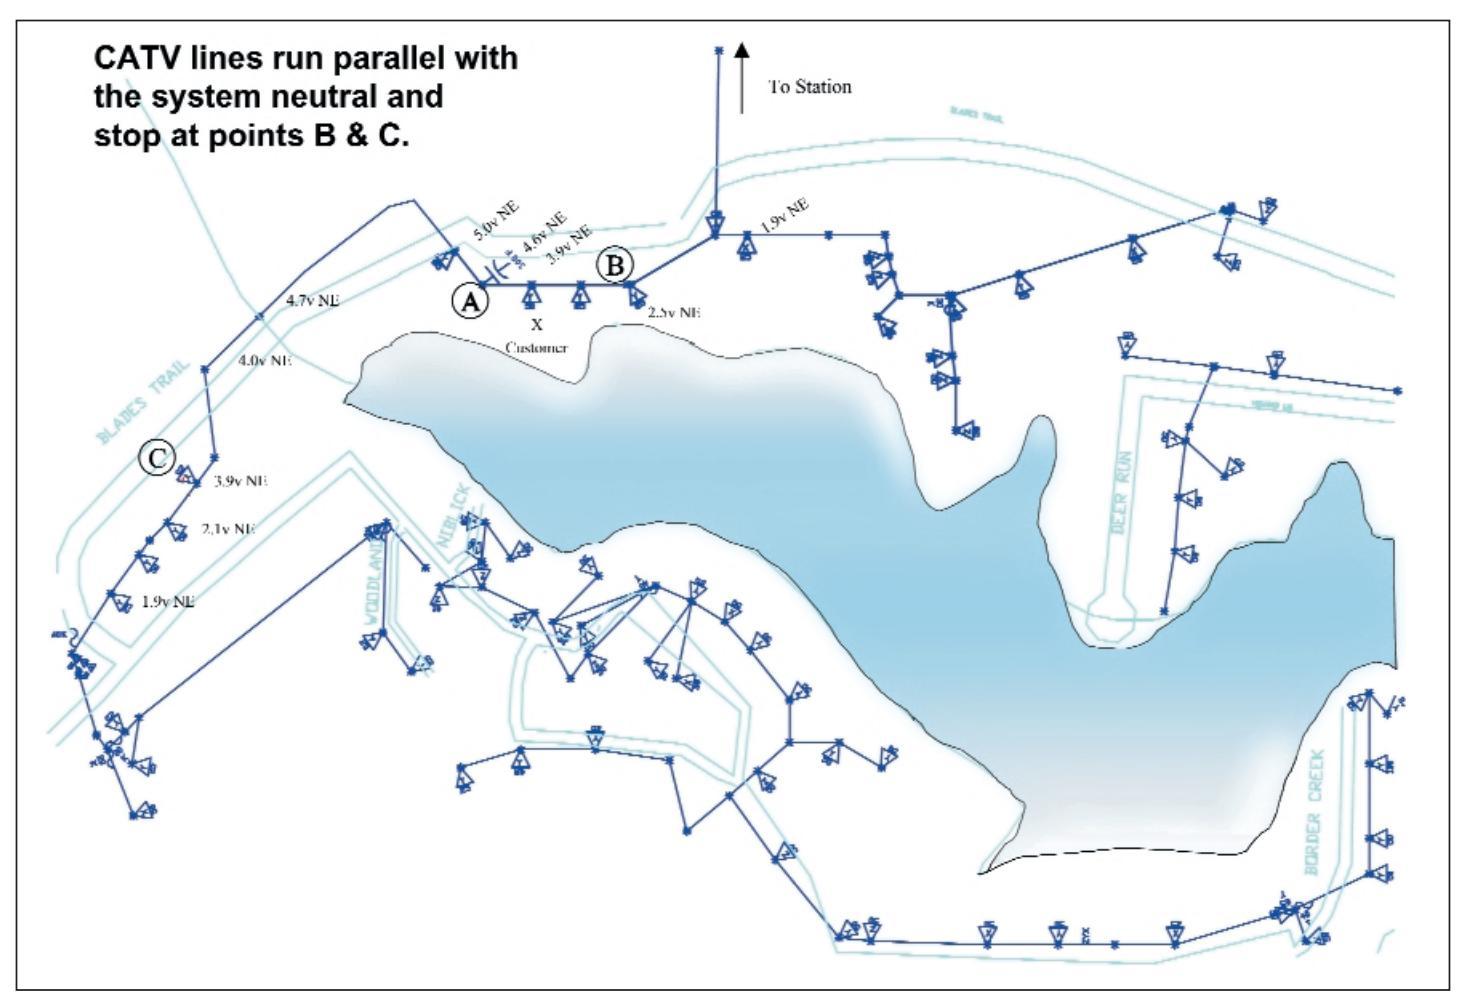
Figure 2. Distribution circuits and geographics in the area of inquiring customer.

The next step in the investigation was to take amp readings and neutral-to-earth voltage measurements on the circuit in the vicinity of the inquiring customer. The circuit construction was three-phase with 1/0 ACSR primary and 2 ACSR neutral. The values measured are indicated in Figure 2. There was no appreciable current on the grounding conductors along the circuit, therefore no current values are offered. This is an indication that the system neutral is intact having no open points in this area.

The increasing and decreasing magnitude of the neutral-to-earth voltages between points B and C is an indication that there is a relative increase in the neutral impedance in that region. A close inspection of the circuitry in this area reveals the culprit. The local cable company has installed CATV conductors in all regions around this part of the lake, with the exception of the circuitry between points B and C. The elevated neutral-to-earth voltages measured in this area are related to the increased neutral impedance resulting from the absence of CATV cables.

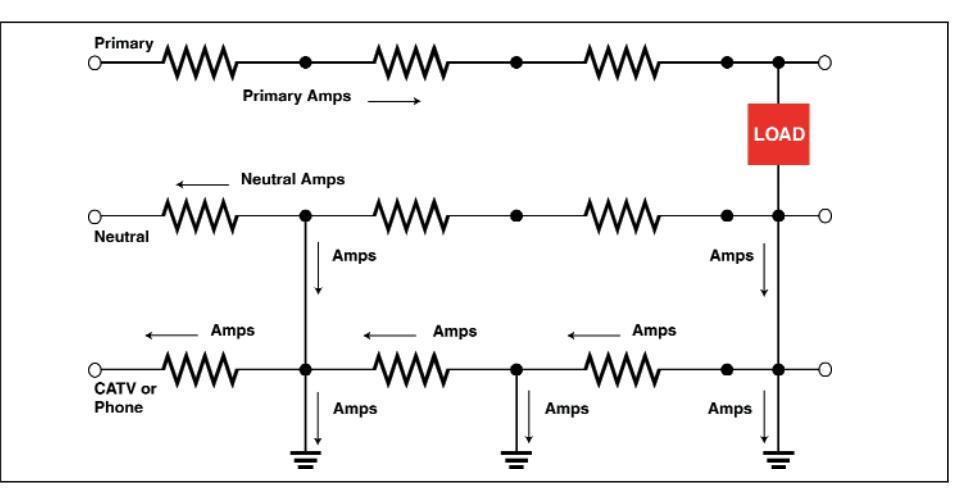
When evaluating the system neutral path, it is important to recognize that the return current path for system load is comprised of more than just the system neutral conductor. Investigations need to consider all parallel paths back to the source transformer. The following can be

Figure 3. Single-phase circuit with parallel paths for the system neutral.

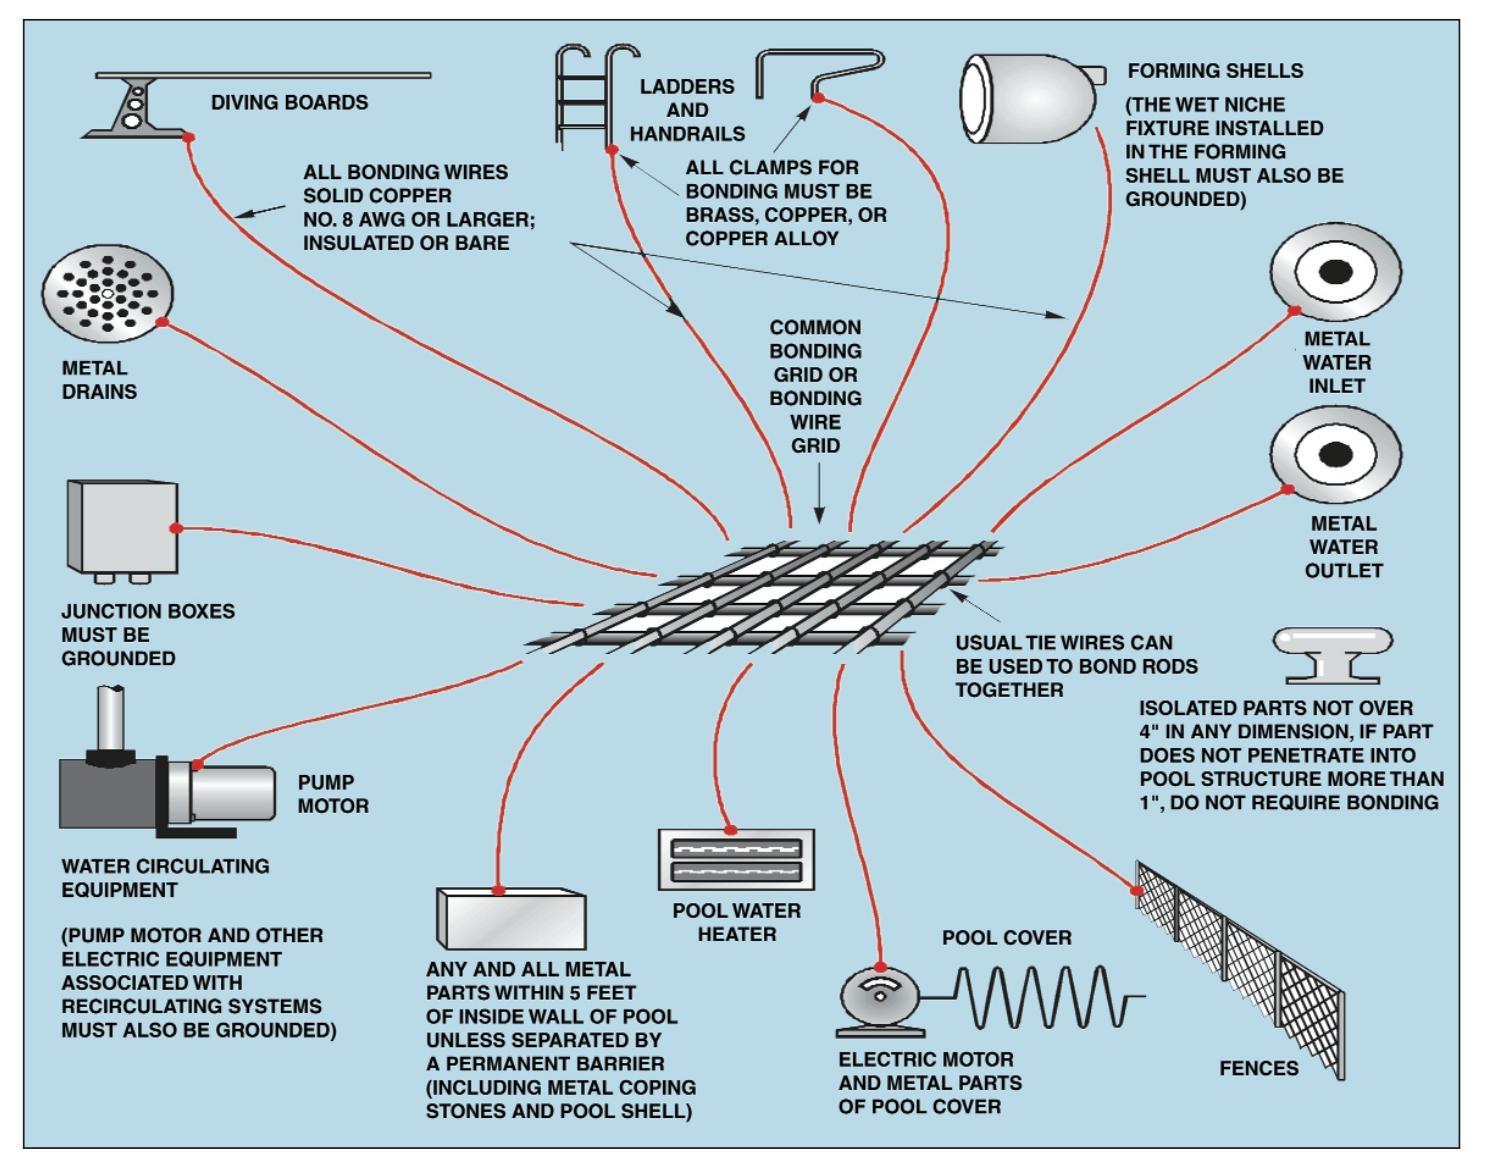
Figure 4. Bonding and grounding requirements of a swimming pool.

before the concrete deck is poured. For other safety reasons, **the swimming pool shall be bonded per Article 680-22 of the National Electrical Code (NEC).** Figure 4 illustrates the various components to be bonded together.

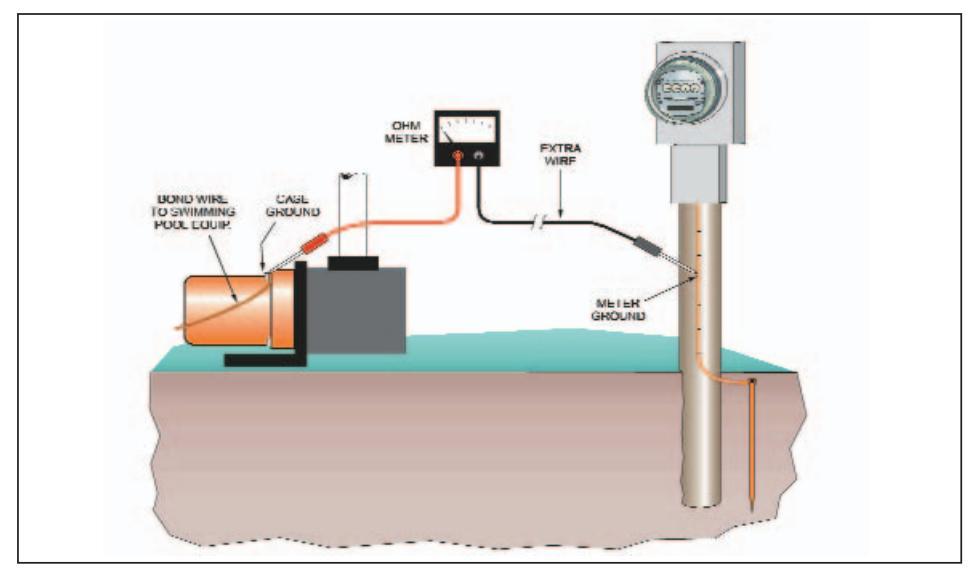
What Happens When All Is Not Bonded? Without proper bonding, a difference of potential can exist between the metal parts of the pool and the pool water or any wet surfaces around the pool. The result can be a slight, yet painful shock. All pool shocking investigations should evaluate the bonding between the pool's metallic components. A good way to do this is with the use of an ohmmeter, see Figure 5. Typical bonding ohm values are listed in Table 5.

Figure 5. Ohm measurements taken between the grounding electrode conductor at the meter and the pool pump motor.

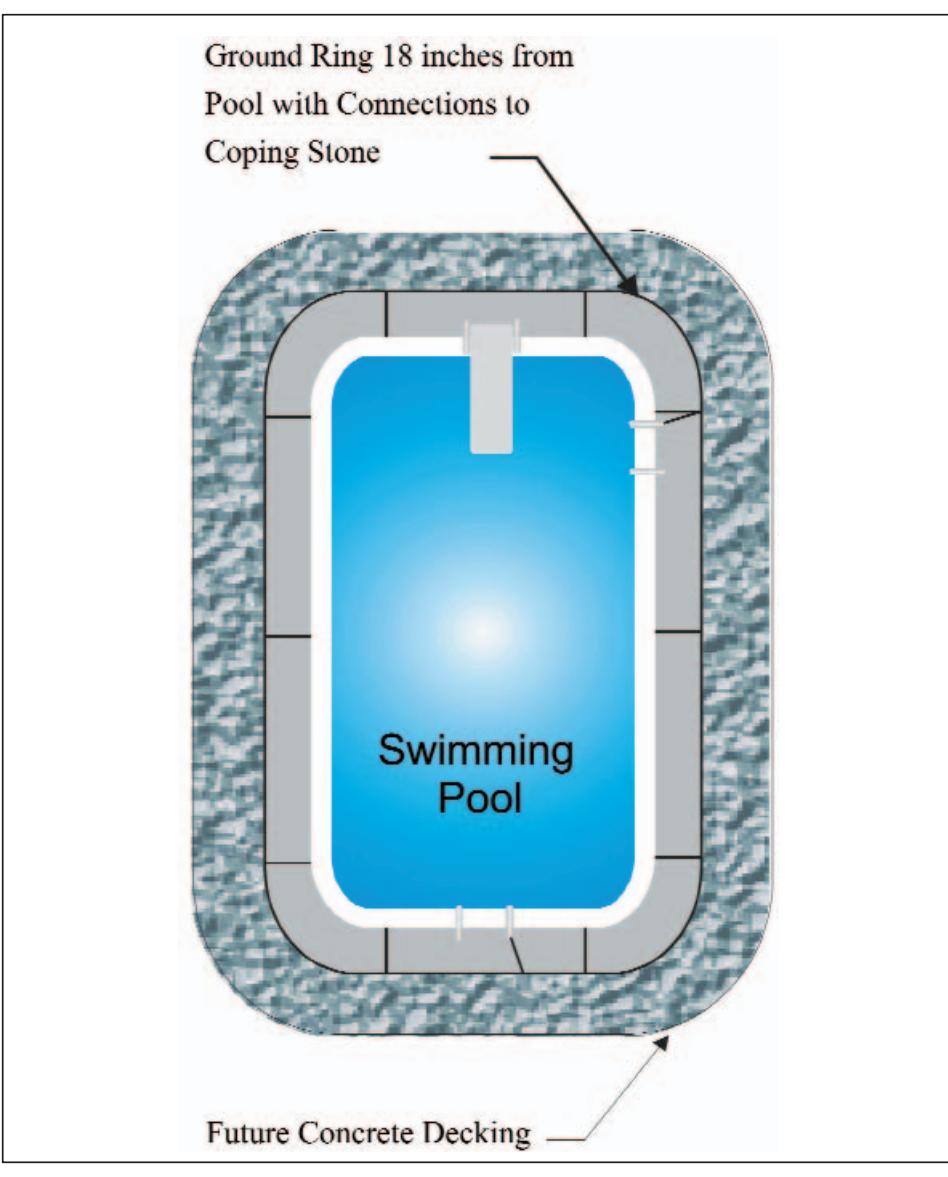
The ground ring held the concrete decking immediately above it at the neutral/grounding system potential. The 18inch gradient to the pool's edge was minimal such that there was very little potential difference between the pool water and the surface at the pool's edge. The customer has not experienced any incidence of pool shocking since the pool's completion.

Figure 6. Swimming pool with ground ring installed.

In this case study, there was an additional option because the construction of the concrete decking had not been completed. Although the contractor refused to install rebar in the concrete decking to be used as a grounding grid system, the customer was persuaded to employ a single conductor ground ring around the pool structure. The ground ring was installed approximately 18 inches away from the pool's edge and was bonded back to the coping stones, the ladder, and hand rail, as shown in Figure 6. The ground ring effectively becomes a single conductor grounding-grid around the pool structure.
