Dry Cask Storage Characterization Project

Interim Progress Report – June 2000

1000157

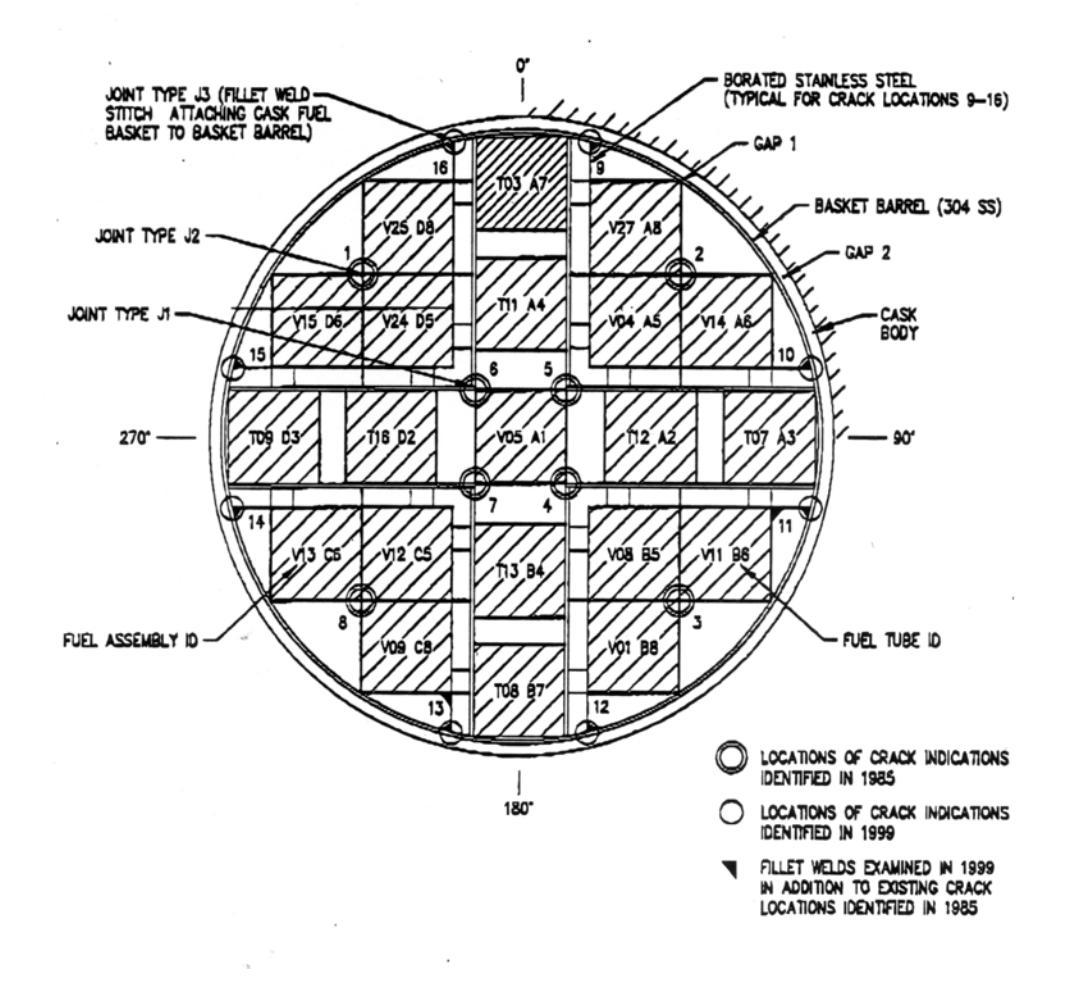
Figure 2-1. Castor-V/21 Basket Crack Indication Locations

The stitch welds in the triangular air channels at the perimeter of the basket were examined with the pencil camera system. The gusset- and strut-free channels were just large enough to permit insertion of the pencil camera for viewing the stitch welds attaching the fuel basket partition plates to the basket barrel.

The inspections found that all eight of the top stitch welds were cracked, and seven of the eight bottom welds. The intermediate welds did not appear to be cracked.

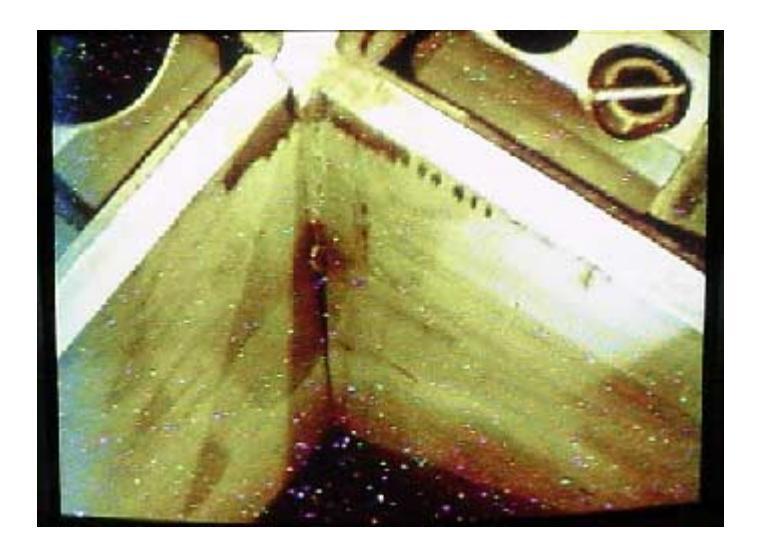
Figure 2-2. Cracks in basket welds

Additional cracks in basket welds (as shown in Figure 2-2.) were associated with stainless/borated steel junctions welds in fuel tubes.

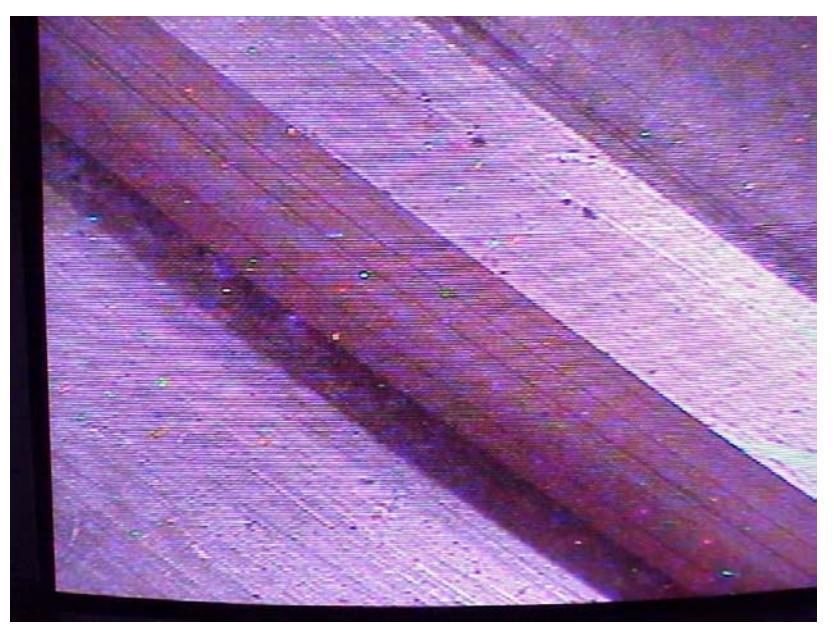
The assemblies were in a generally good condition, which had not changed since the 1985 inspection. The general visual survey revealed a dark gray oxide layer under ambient cell lights, and light tan by video. The inspection found no increase in the oxide layer thickness. There was no formation of a loose oxide scale or particles between the fuel rods of the grid spacers or on the bottom nozzles.

Fig 2-4. Close-up of rods via video.

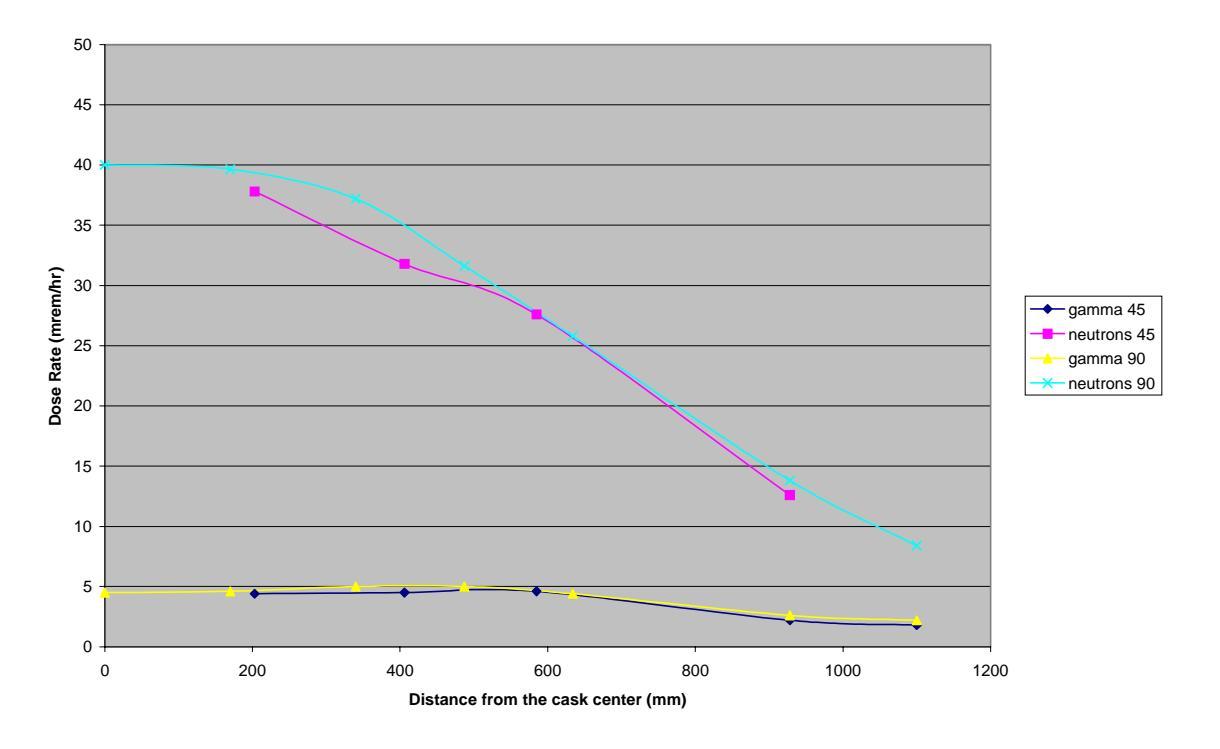
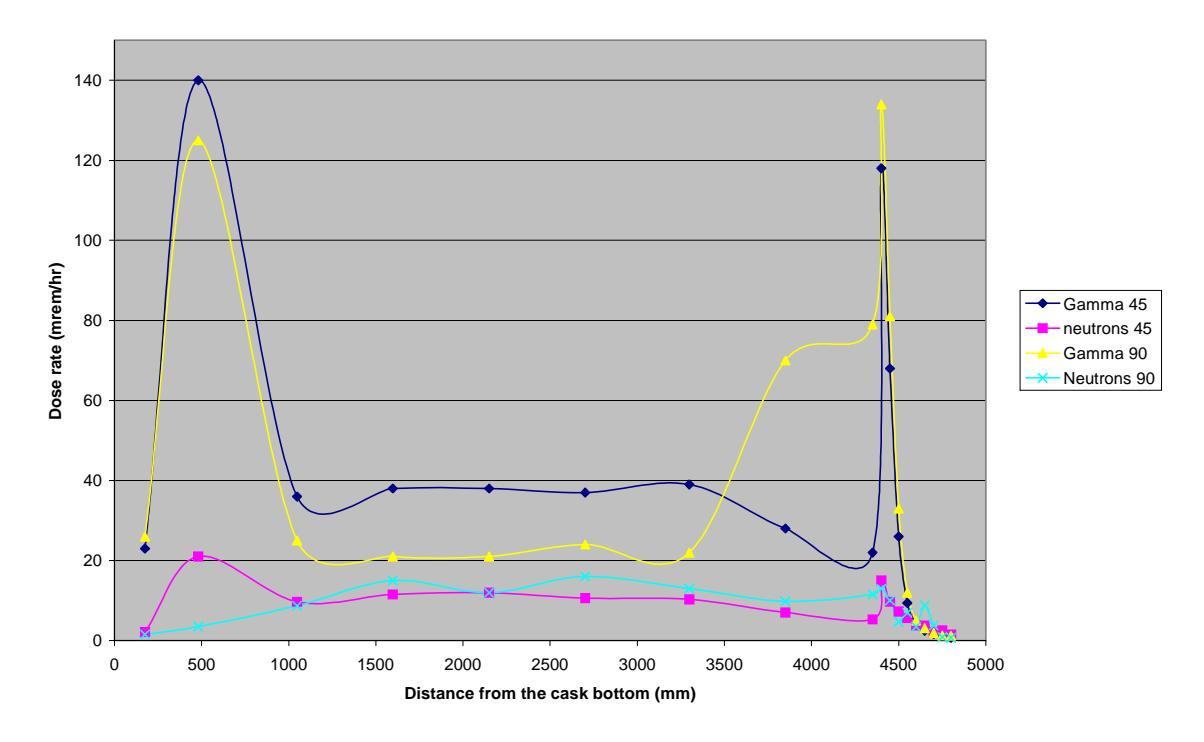
Figure 3-3 and 3-4 show the dose rates measured on the side of the casks in 1985 and in 1999, depending on the distance from the cask bottom.

Fig. 3-3. SIDE Dose rates 1985 (Dosimeter TLD and TED)

Fig. 3-4. SIDE Dose rates 1999 (Dosimeter TLD and TED)

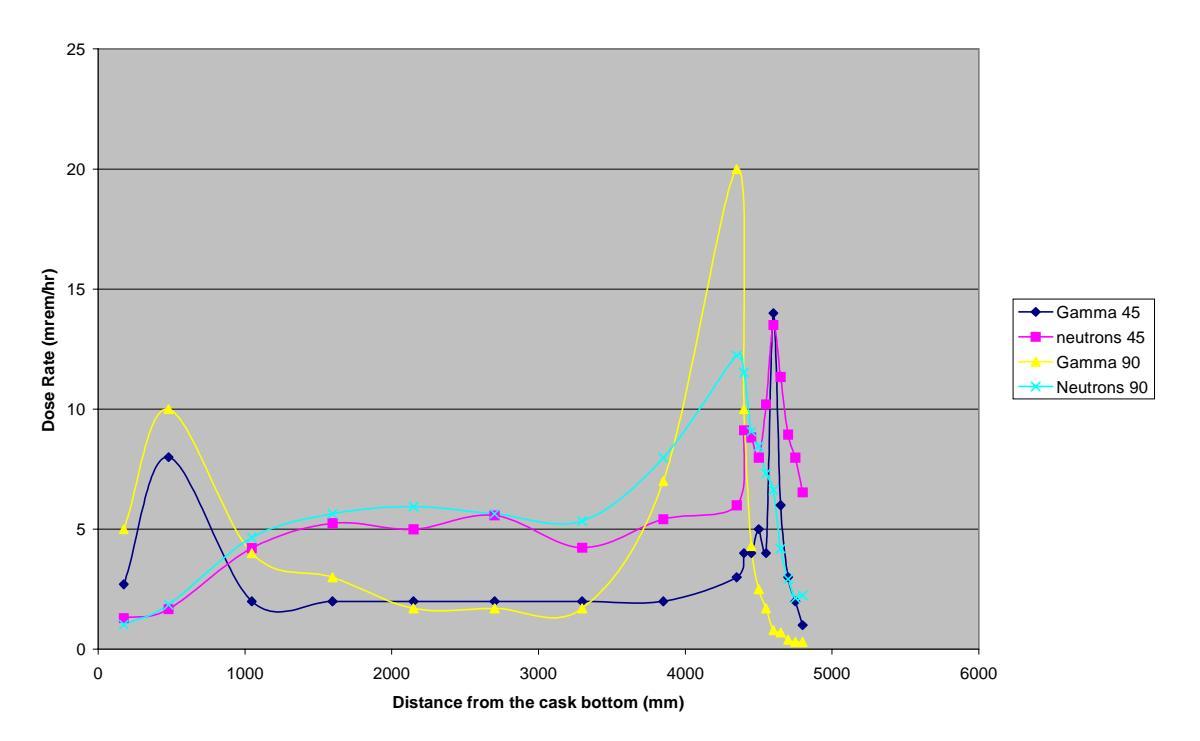
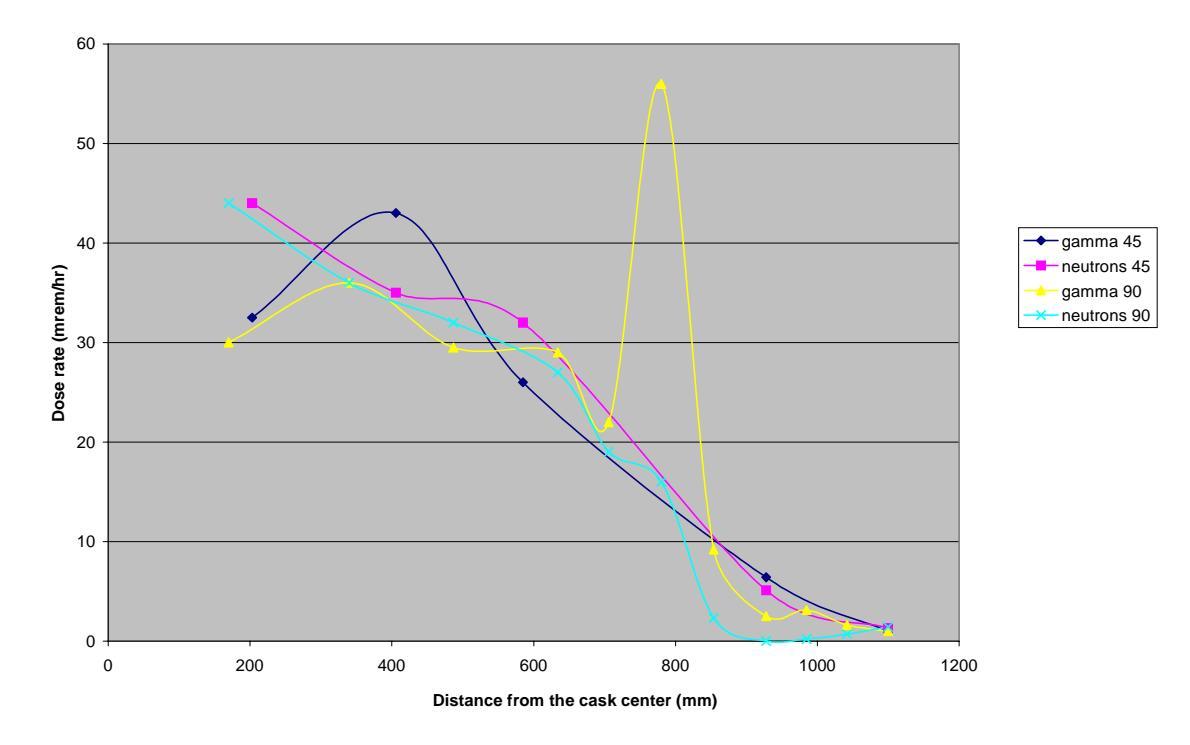
Figure 3-5 and 3-6 show the dose rates measured on the top of the cask in 1985 and in 1999, depending on the distance to the center of the cask.

Fig. 3-5. TOP Dose rates 1985 (Dosimeter, TLD and TED)

Fig. 3-6. TOP Dose rates 1999 (Dosimete, TLD and TED)
