Materials Reliability Program Evaluation of the Effect of Weld Repairs on Dissimilar Metal Butt Welds (MRP-114)

Technical Report

1009559

Final Report, September 2004

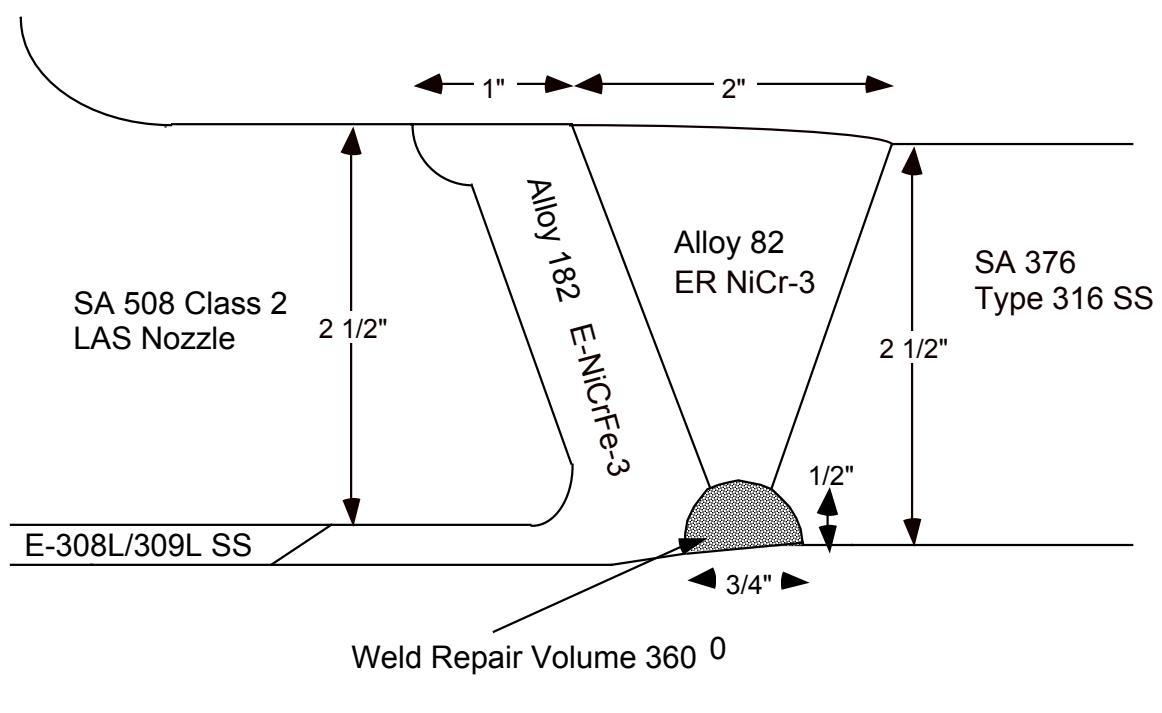
Figure 2-3 Schematic Cross-section of 360° ID Root Repair

This repair is particularly damaging because it enlarges the weld volume and finishes the weld on the surface exposed to the reactor coolant. In addition most of the deposited weld volume remains in-place to provide surfaces that are pulled in tension as the weld deposit solidifies and cools. Repair welding always alters the original residual stress distribution, but repairs applied directly to the ID are especially significant. This is because high residual tensile stresses are applied directly to the ID surface by contraction forces resulting from solidification and cooling on the ID surface. Thus, an ID root weld repair can be a particularly influential SCC damage mechanism. The completed weld repair will be ground to contour and smooth the weld root and newly welded interface. Figure 2-3 provides a schematic cross-section of the ID repair.

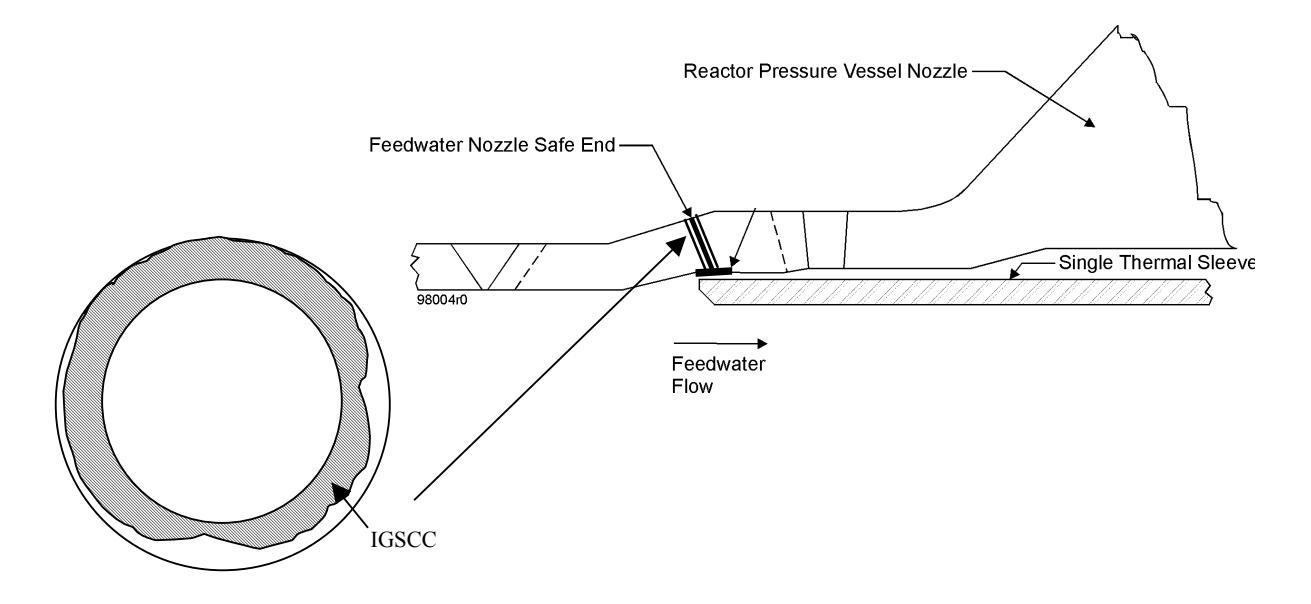
Figure 4-2 Schematic of the Circumferential IGSCC at Duane Arnold

- In addition several weld repairs and associated grinding were performed on the weld. This would have contributed to both the premature crack initiation and propagation of cracking by further reducing the corrosion resistance of Alloy 600 due to additional heating from the weld repairs and the increase the yield strength. The cold working of the Alloy 600 from the grinding would also reduce the creviced material's IGSCC resistance.
