Materials Reliability Program Fatigue Issues Assessment (MRP-138)

1011442

Final Report, February 2005

Structural Integrity Associates, Inc.

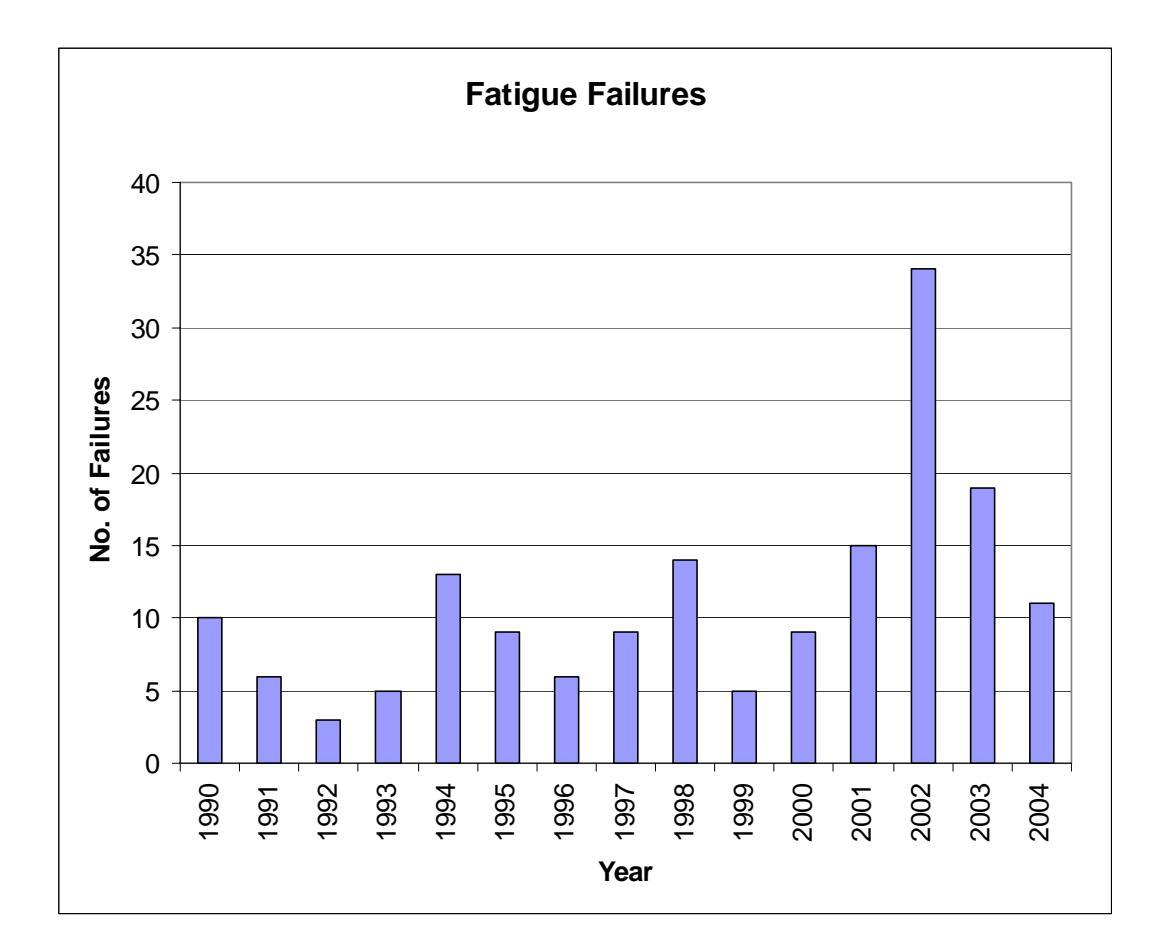
Figure 3-1 Fatigue Failures Sorted by Year

Figure 3-1 shows a plot of the failures versus time for all the nuclear plants and Figures 3-2 and 3-3 shows the number of fatigue failures by type of plant, BWRs and PWRs, respectively.

It should be noted that the number of reported fatigue failures for the year 2004 only include the first six months of the year, so the expectation is that the number of failures in 2004 will be greater than those that occurred in 2003. The trend of the fatigue failures appears to be increasing slightly, with a sudden increase in failures in 2002. The fatigue failures were relatively low until the year 2002 where the number of failures more than doubled from previous years. The increase in 2002 is due to small bore pipe fatigue failures which accounted for 13 of the 34 failures. The fatigue failures have been separated into BWR and PWR fatigue failures per year and are shown in Figures 3-2 and 3-3, respectively.

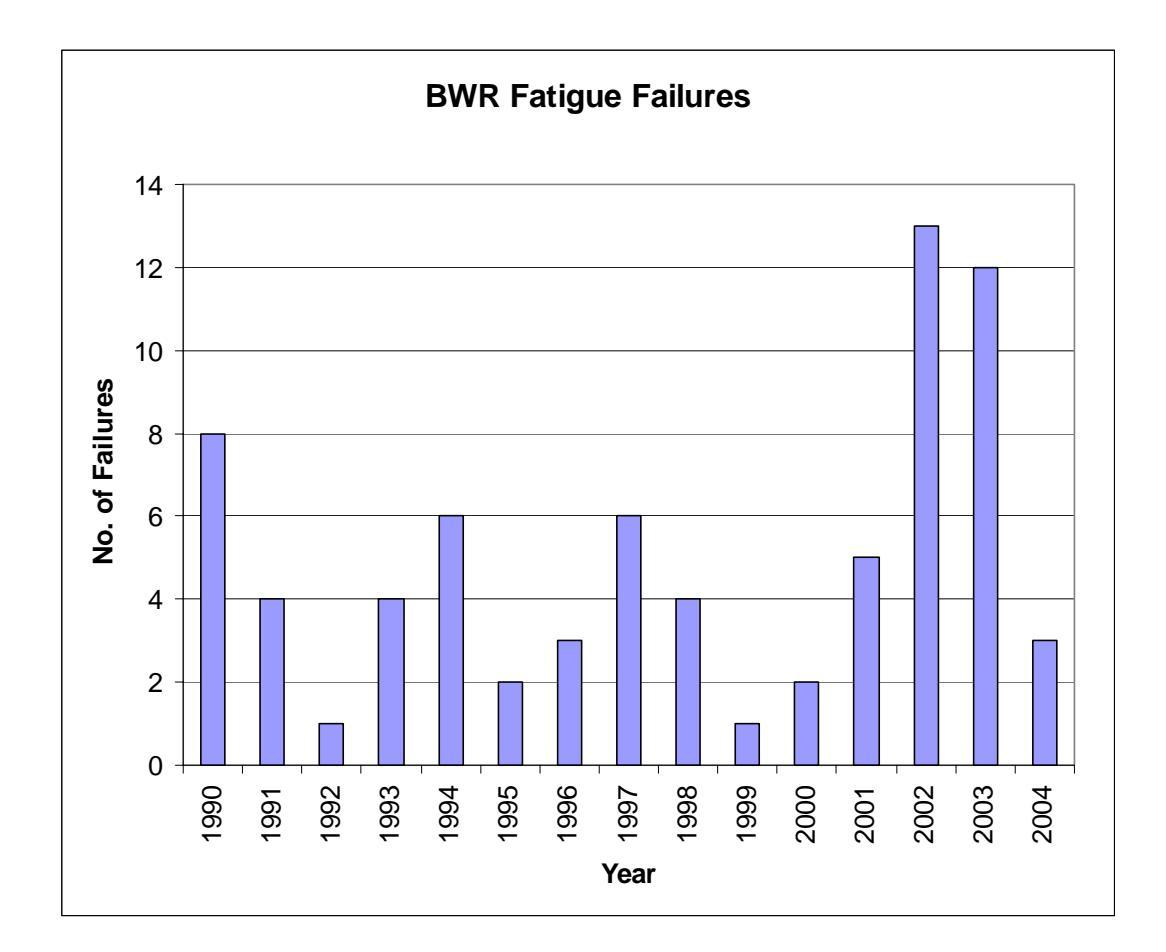
Figure 3-2 BWR Fatigue Failures Sorted by Year

A comparison of Figure 3-2 to Figure 3-3 shows that the trend in fatigue failures is similar between BWRs and PWRs. For BWRs, almost half of the fatigue failures in 2002 are due to small-bore pipe failures and the main cause of the failure was attributed to system/plant operation. The main forcing function that caused the failures in 2002 was flow induced vibration (FIV) loads. A portion of the more recent failures is related to EPU.

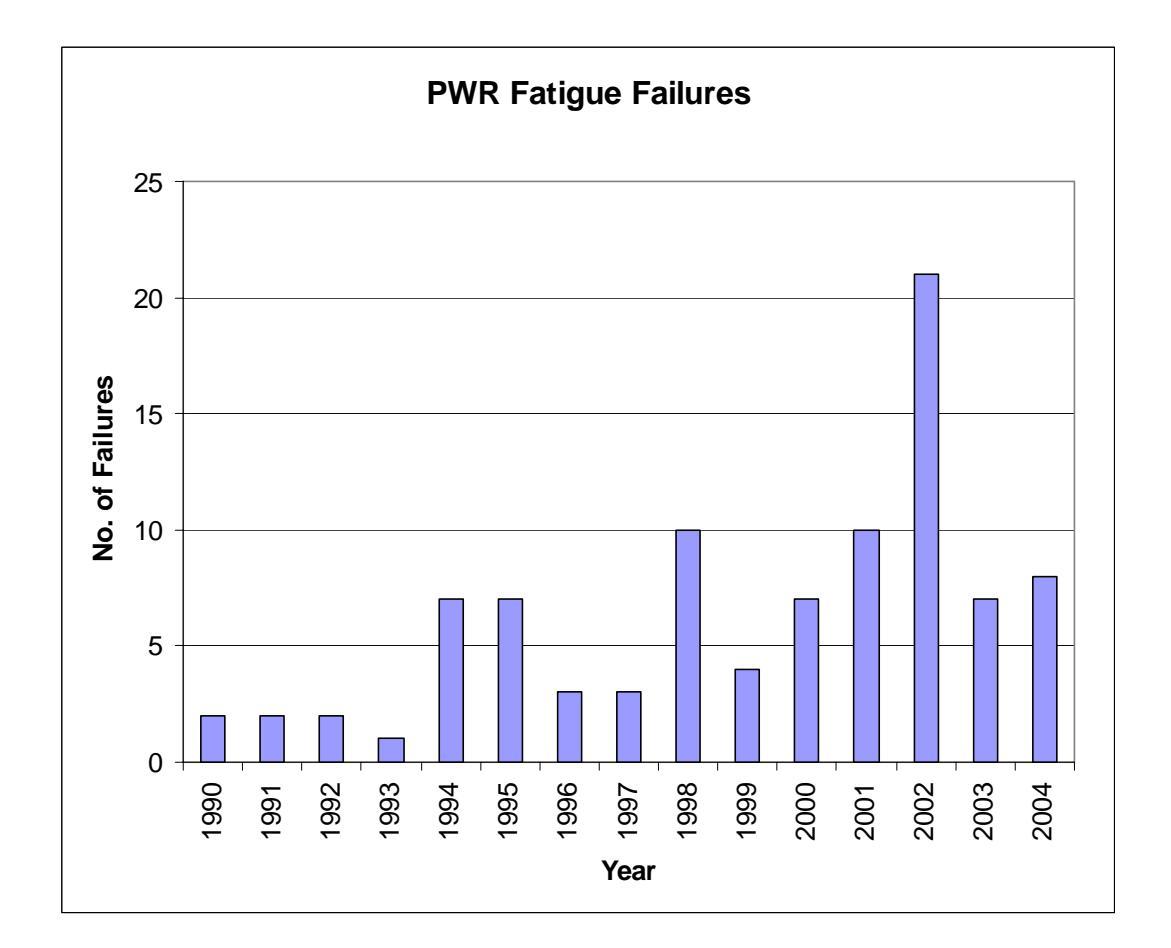
Figure 3-3 PWR Fatigue Failures Sorted by Year

In PWRs, small bore pipe fatigue failures average one to two a year with the exception of 2002 where eight fatigue failures occurred in small bore pipe. The main causes for the failures in 2002 were attributed to design configuration and aging.

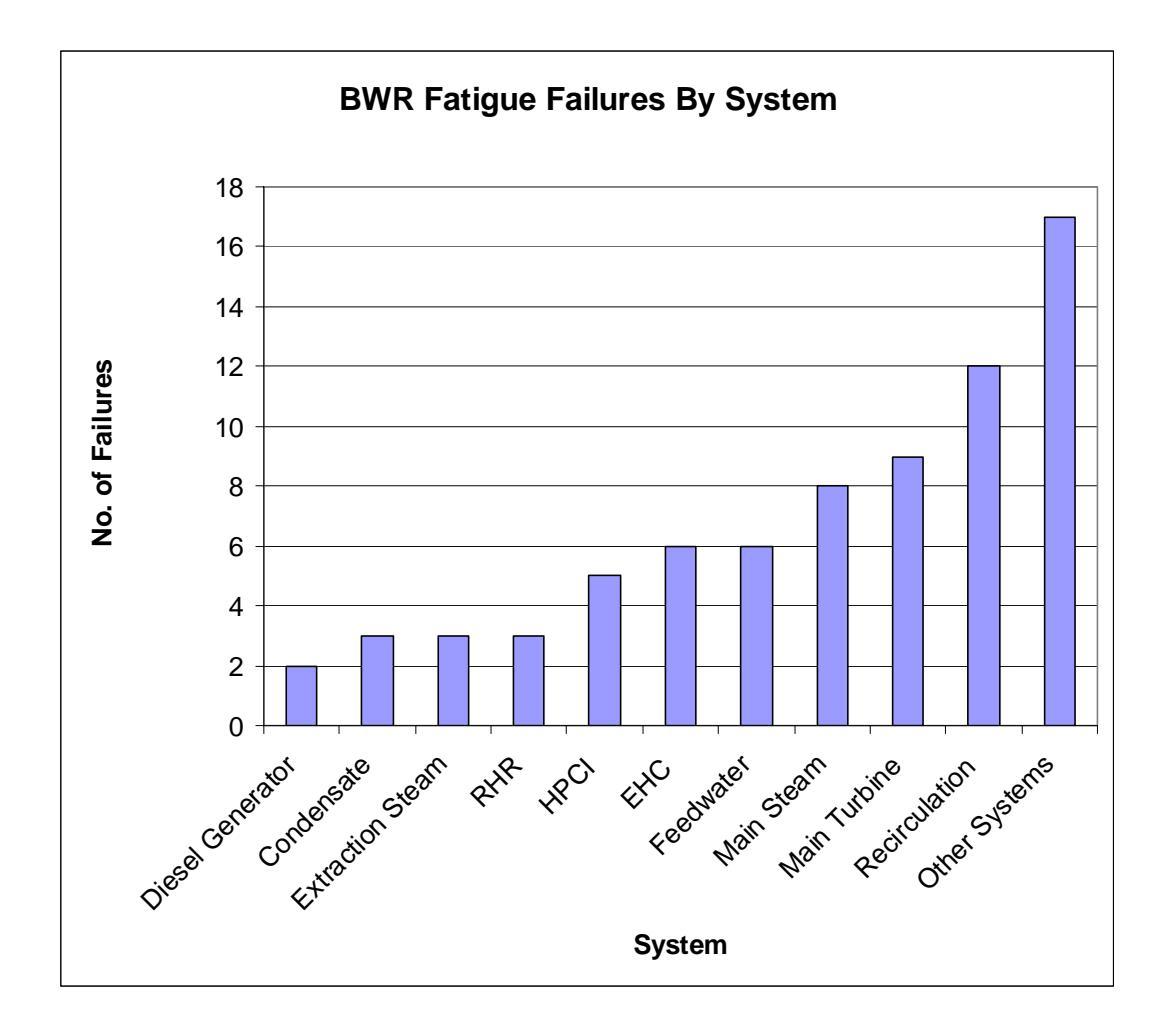
Figure 3-4 BWR Fatigue Failures Sorted by System

Figure 3-4 shows a breakdown by system of the total number of failures occurring in BWRs between 1990 and 2004. In the previous survey [1], the recirculation system had the most failures and remains a high contributor for the current survey period. The "Other Systems" include closed cooling water, HVAC, instrument air, main condenser, main generator, service water, and reactor internal systems.

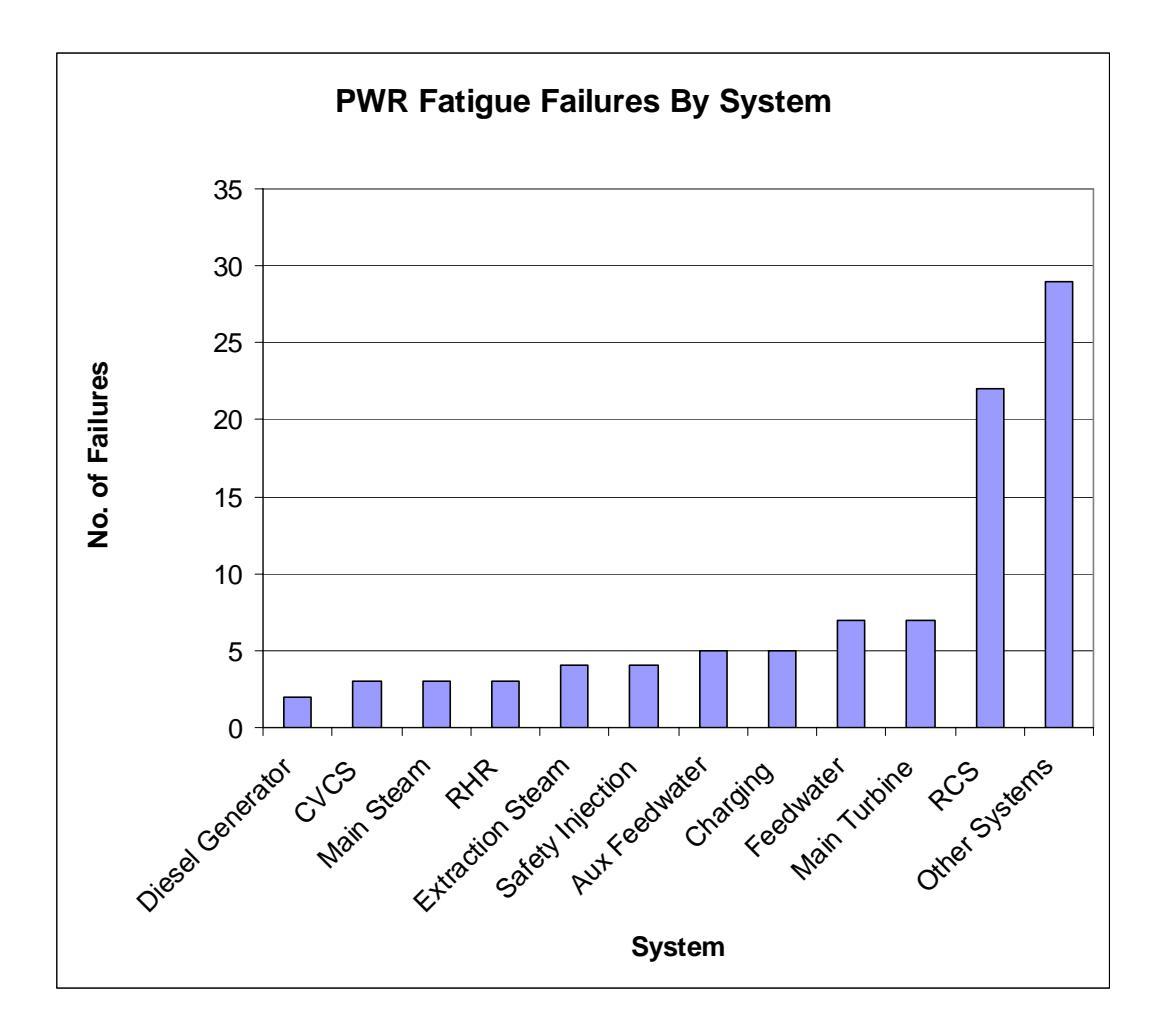
Figure 3-5 PWR Fatigue Failures Sorted by System

Figure 3-5 shows a breakdown by system of the total number of failures occurring in PWRs between 1990 and 2004. In the previous survey [1], the chemical and volume control system (CVCS), consisting of the letdown and charging (or make-up) systems, had the most failures by a large margin. This is not the case anymore; the reactor coolant system (RCS) has had the most fatigue related failures for the current survey period. The previous survey also reported that the next system with the most The "Other Systems" include closed cooling water, HVAC, instrument air, main condenser, main generator, service water, and the steam generator systems.

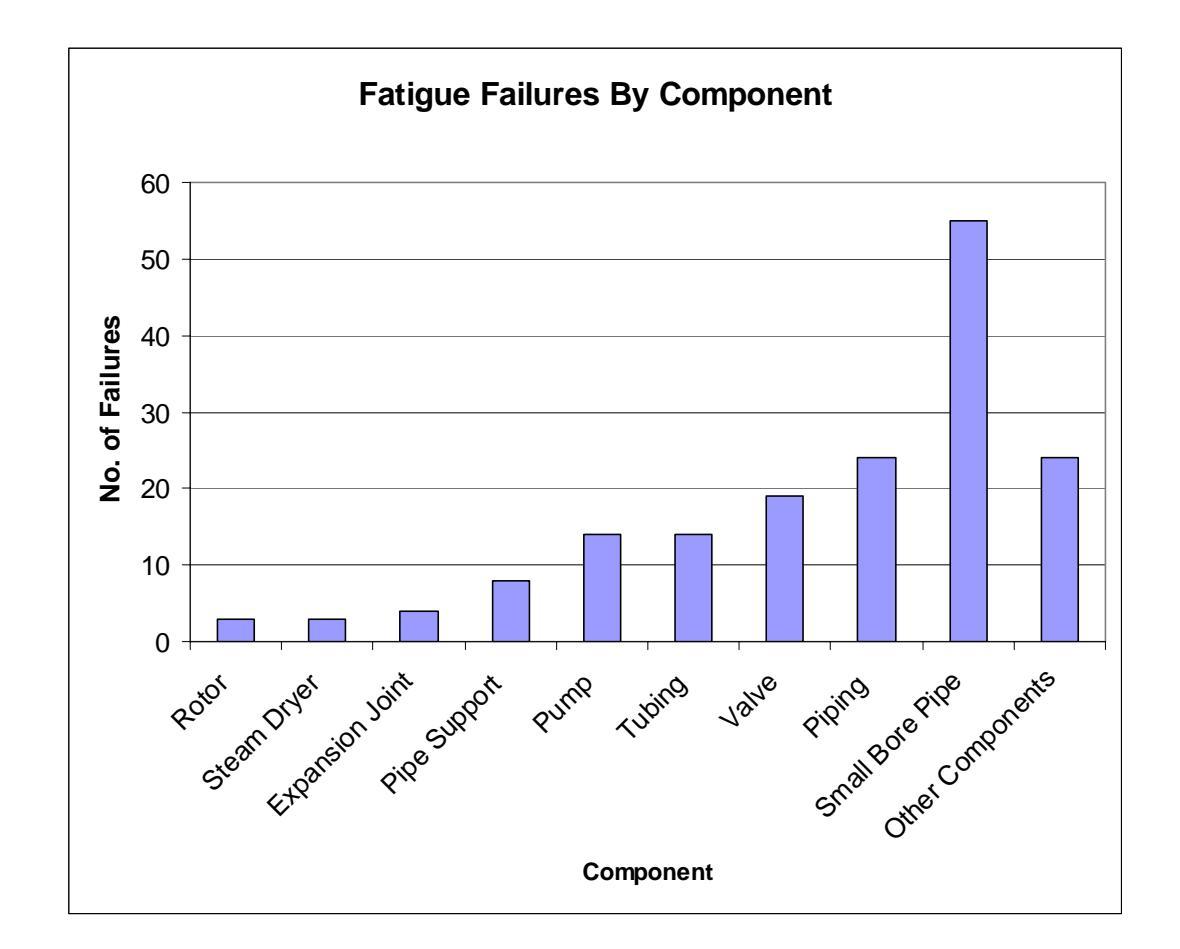
Figure 3-6 Fatigue Failures Sorted by Component

Figure 3-6 shows failures reported in the current survey sorted by component. Similar to the earlier survey, small bore pipe fatigue failures continue to affect plant availability. Some of the valve and piping fatigue failures are welds at valve to pipe connections. Most of the fatigue failures on valves, piping, and small-bore pipe occurred at welds. The "Other Components" include accumulators, bellows, fans, heat exchangers, condenser, and a diesel generator gear. With the exception of the steam dryer which is unique to BWRs, all other component failures occurred in both BWRs and PWRs.

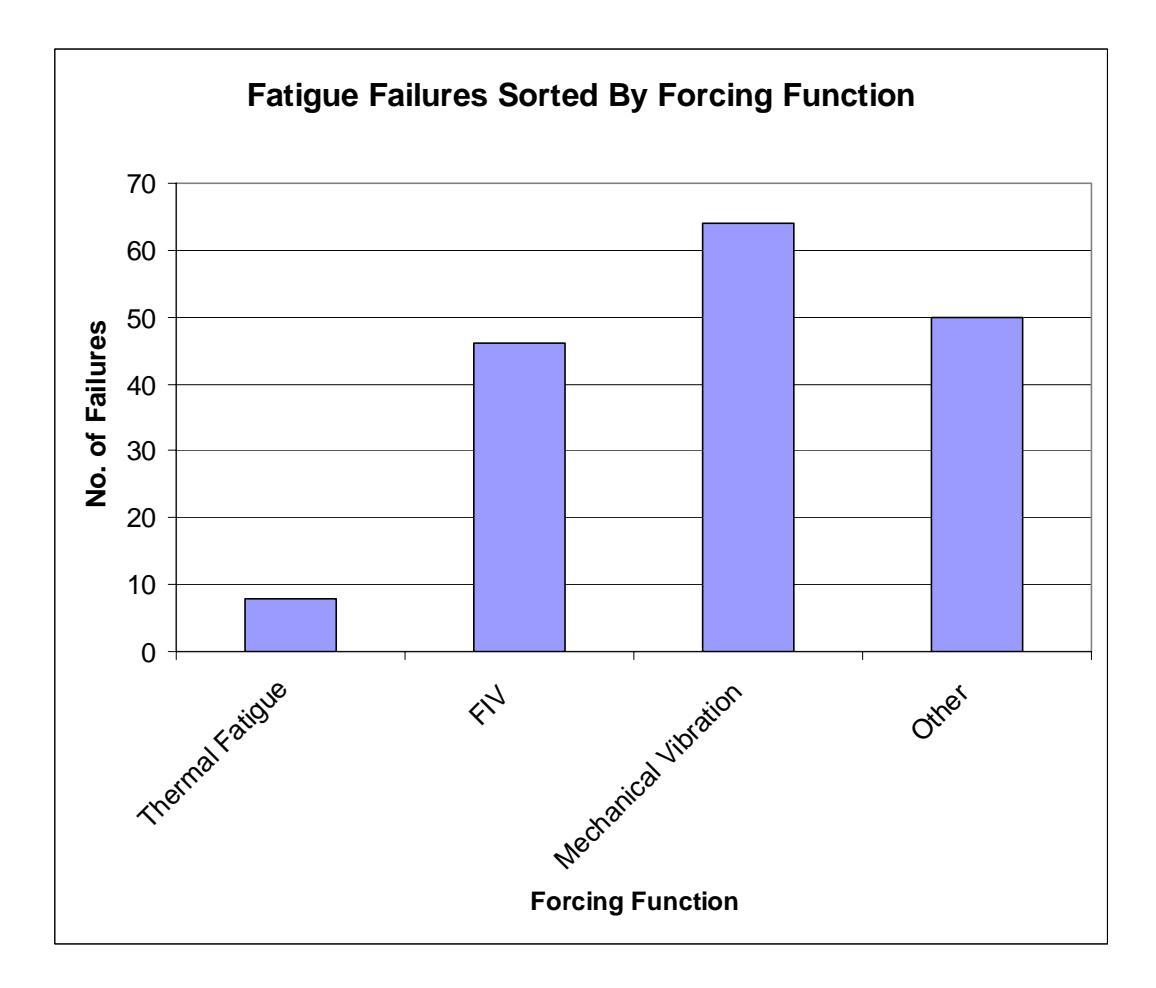
Figure 3-7 Fatigue Failures Sorted by Forcing Function

Figure 3-7 shows the failures sorted by forcing function. The main forcing functions of vibration fatigue failures are mechanical vibration and flow induced vibration loads. The "Other" forcing functions include torsional vibration, water hammer loads, cavitation loads, and forcing functions that otherwise could not be identified. A review of the mechanical vibration events shows that there has been a gradual increase over the years but twelve failures attributed to mechanical vibration occurred in 2002 while only three fatigue failures occurred in 2003. The fatigue failures due to FIV have remained fairly constant over the survey period at around two to three per year.

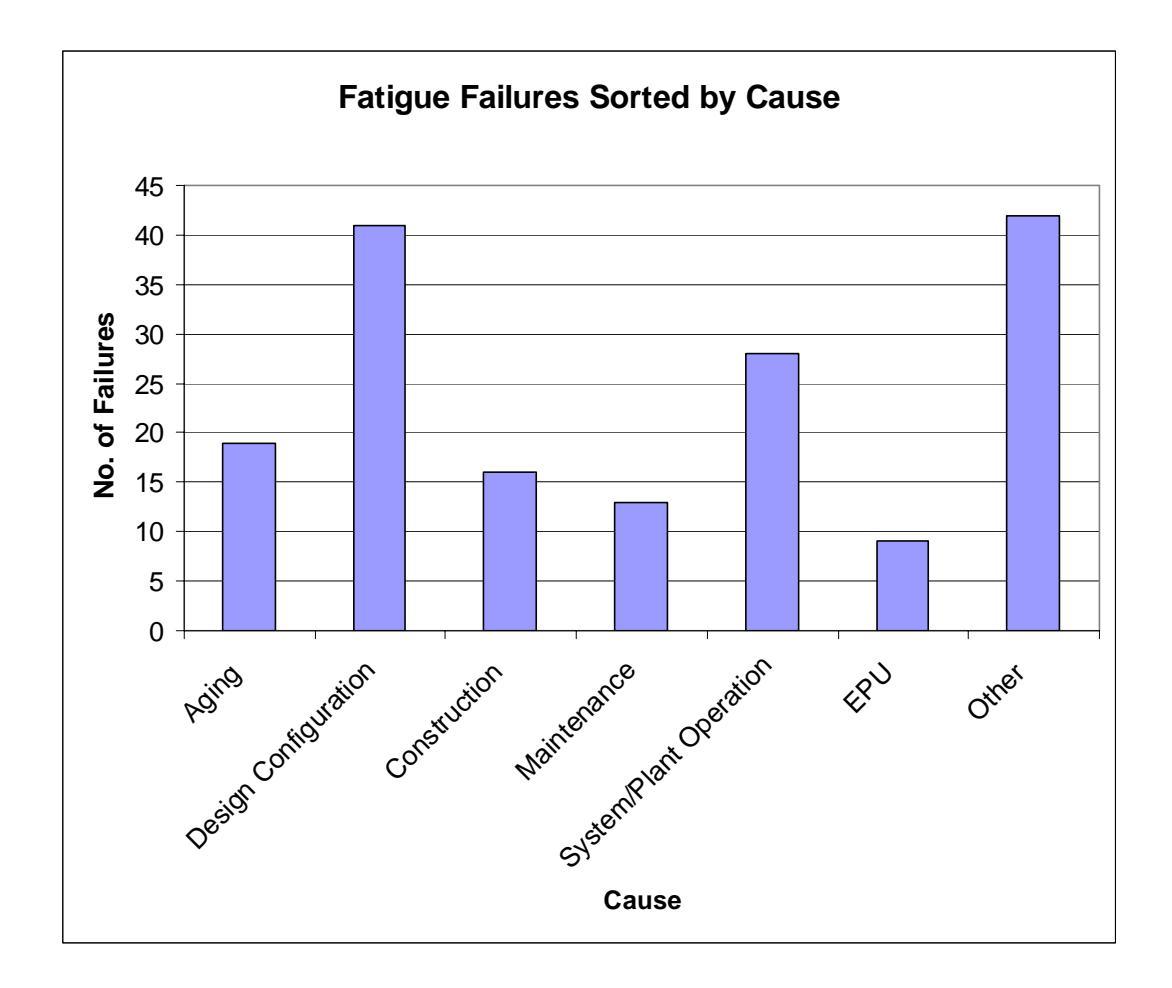
Figure 3-8 Causes of Fatigue Failures

The fatigue failures have been sorted by the cause of the failure in Figure 3-8. The main fatigue failure cause is due to the design configuration. This includes the original design of the system or component that did not properly account for steady state vibration loads. Design modifications to a system or component that result in a fatigue failure are also included in this category. While the number of failures due to design configuration has remained relatively constant over the survey period, design modifications have contributed to the fatigue failures in the recent years. Some of the design modifications are due in part to replacement of components that appear to be the same but have slight differences that change the natural frequency of the component or system. EPU, which is specific to BWRs, is shown as a separate category even though it is a subset of system/plant operation. The "Other" category includes equipment design, manufacturing defects, and unknown causes.
