Manhole Event Mitigation Strategies

Explosion Testing of Manhole Covers with Pressure Relief Mechanisms

1012305

Technical Update, December 2006

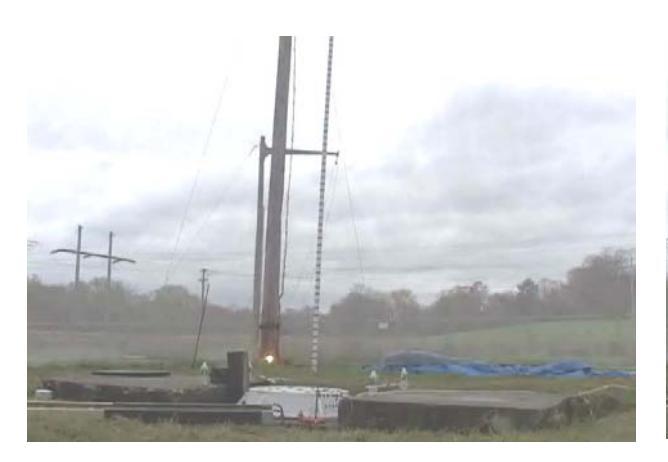
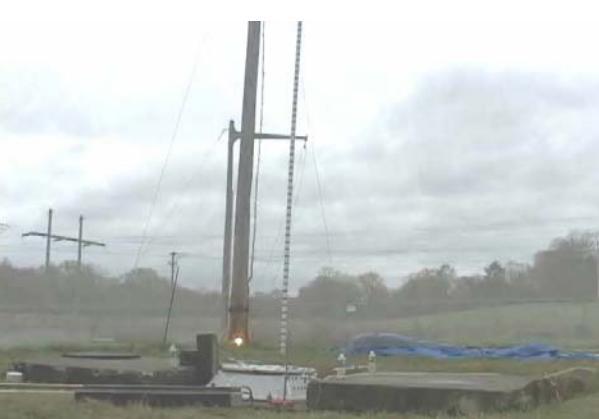
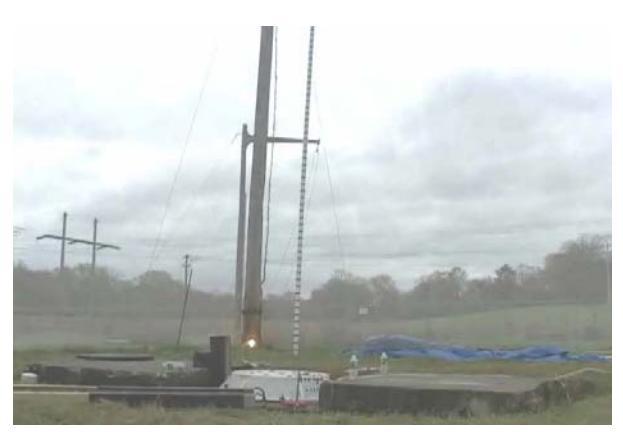
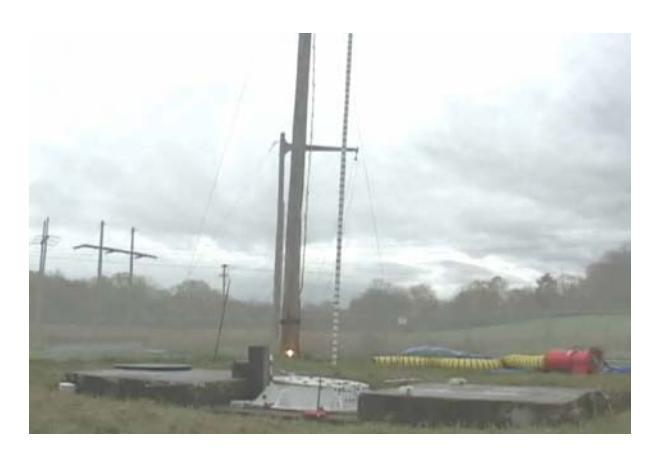
In those cases, the cover rose about 2 inches as allowed by the locking/restraining mechanism, fell back into the frame thus allowing internal pressure to increase again. Then toe cover rose and fell back, repeating this behavior several times until the internal pressure decreased below that value needed to lift the cover (overcome gravity). This is shown in Figure 4-1 in a sequence of frames copied from the video.

(a) Initiation of explosion. Cover still in its frame.

(b) Cover rose about 2 inches for the first time.

(c) Cover fell back into its frame.

(d) Cover rose again.

Cover relieves internal pressure by "bobbing" up-and-down about 6 times. Test with 6% hydrogen by volume (Event 4).

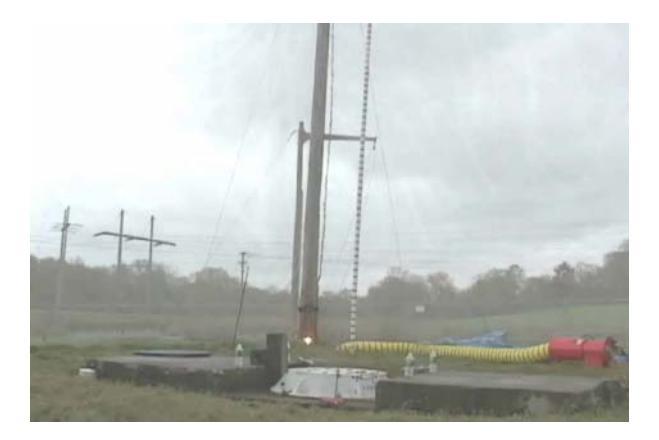
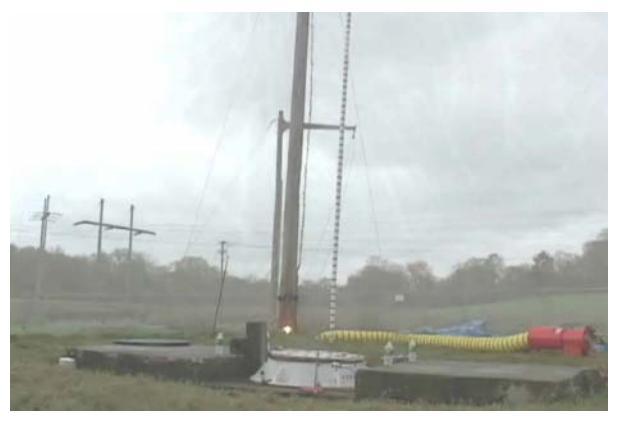
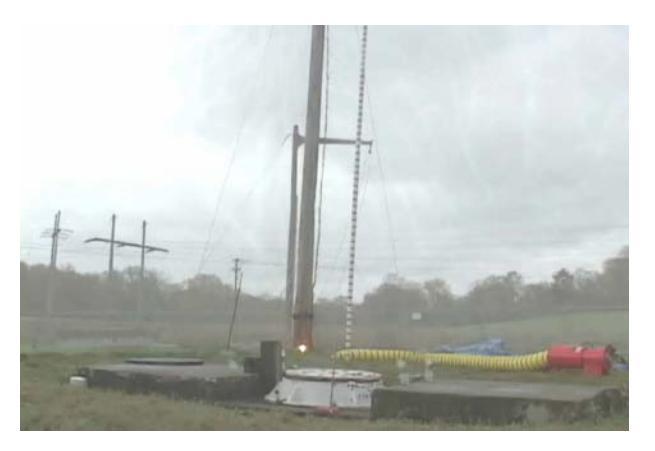
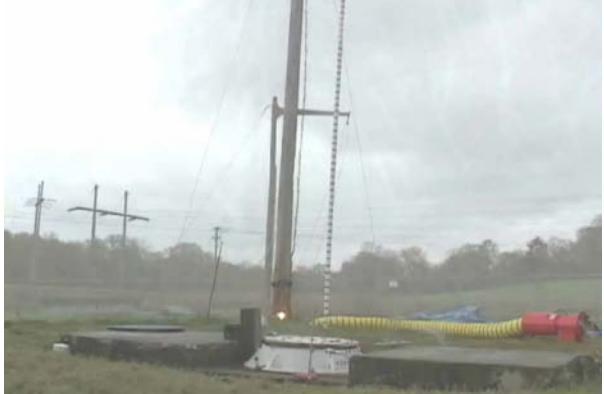
(a) Initiation of explosion. Cover still in its frame.

(b) Cover rose about 2 inches for the first time.

(c) Cover remains aloft. Note that the bottles are being "sucked" towards the frame.

(d) Cover remains aloft. Bottles are blown away from the cover.

Cover relieves internal pressure by rising and remaining aloft for a significant length of time. Bottles are initially "sucked" towards the frame, then blown away. Test with 8% hydrogen by volume (Event 5).

The sequence of frames in Figure 4-2 indicates the presence of a lateral pressure wave in the vicinity of the annulus between the rising cover and its frame.

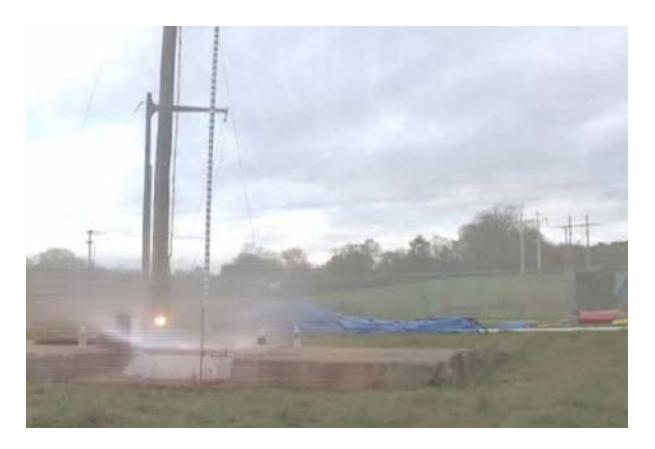
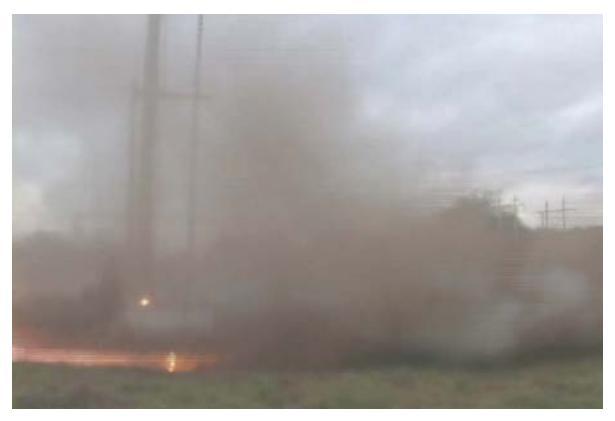
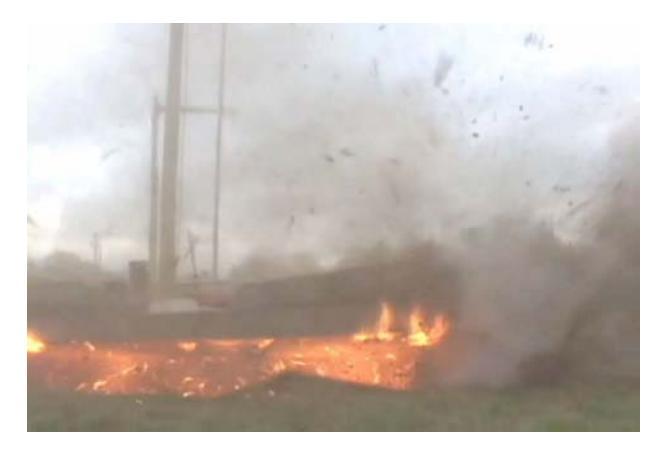
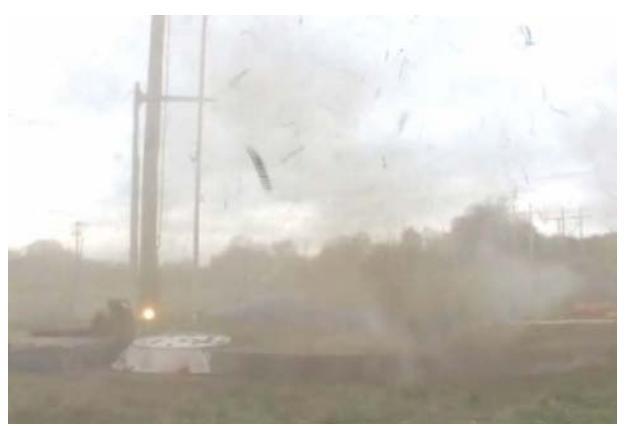
Figure 4-3

In major explosions, the entire roof slab of the M11 manhole, weighing 13,200 lbs (which approximately represents a roadbed) lifted because the pressure relieving action of the restrained cover was not adequate if the shear pin did not break. This is shown in Figure 4-2.

(a) Explosion. Cover rises and partially relieves pressure. Lateral pressure wave is visible.

(b) The roof slab begins to rise.

(c) Roof slab rises to about 1.5 ft. Cover remains restrained by the locking mechanism.

(d) Roof slab falls back down. Cover remains restrained by the locking mechanism.

Cover does not relieve the internal pressure. The entire roof slab is lifted to relieve the pressure. Test with 6% UL mixture by volume (Event 10).

The maximum internal pressure recorded in this test is about 5 psi by one internal sensor before the roof slab started to lift. Assuming that the internal pressure wave is spherical (internal sensors indicate that it is not spherical, so this assumption is a gross simplification), the external pressure around the frame when the cover is lifted but the roof slab has not started moving yet can be estimated roughly as the ratio of the area of the annulus to the area of the frame opening. Assuming the frame opening is 32 inches in diameter, the frame opening area is approximately 812 sq. inches. The area of the annulus is its height of about 2 inches times the circumference of the 32 inch cover, i.e., about 200 sq. inches. Then, the lateral pressure through the annulus is about 5 x 812/200 = 20 psi. The maximum pressure measured by one external sensor about 1 ft away from the annulus was about 6.2 psi. However, this maximum occurred much later in time.

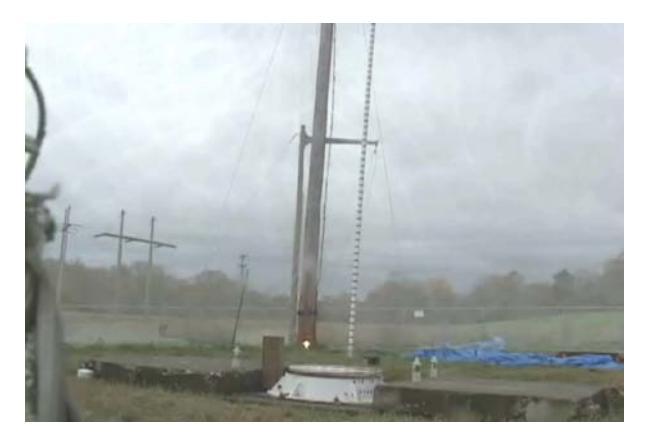
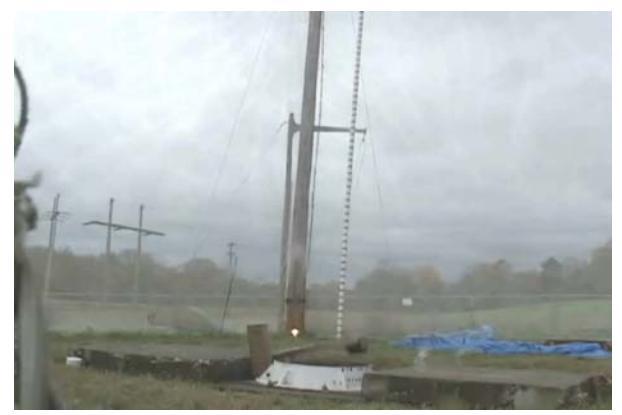
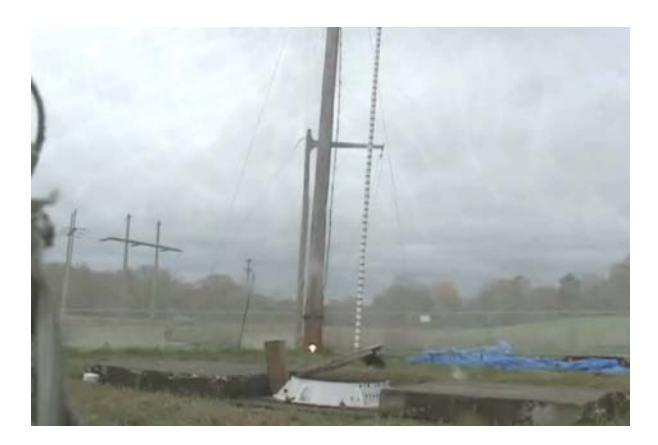
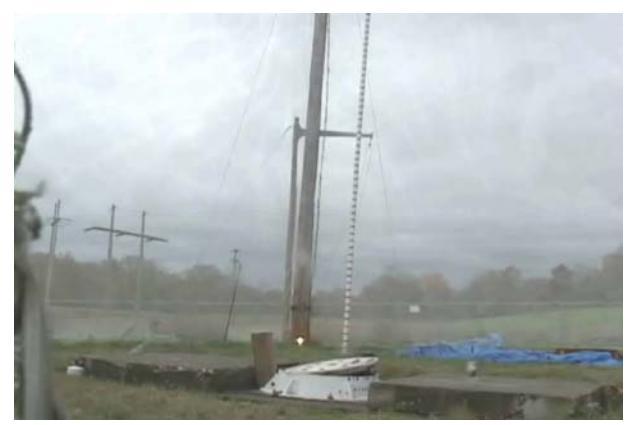
Figure 4-4

Tests were also performed on Cover #1 with the locking mechanism disengaged under test conditions similar to those in Event 5 in Figure 4-2. In this case, the cover rose to a height of about 8 inches, remained aloft for a period of time and fell back into its frame, see Figure 4-4.

(a) Cover begins to rise.

(b) Cover rises unevenly since the restraining mechanism is disengaged on one side.

(c) Maximum height reached. Cover remains partially restrained on one side by the passive lip.

(d) Cover falls back into its frame.

With the restraining mechanism disengaged, the cover lifts on one side, pressure is relieved and the cover falls back into its frame. Test with 8% hydrogen by volume (Event 6).

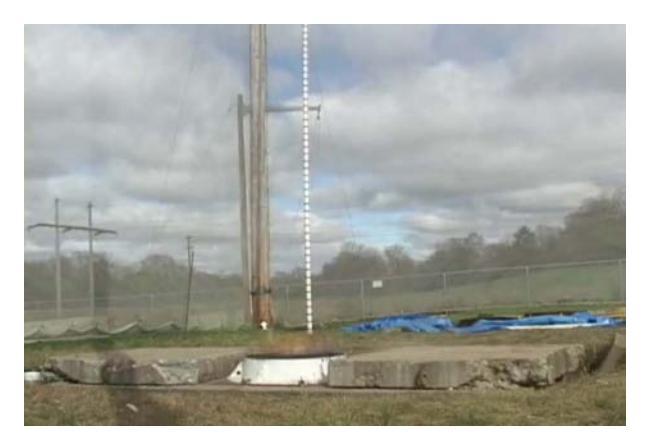
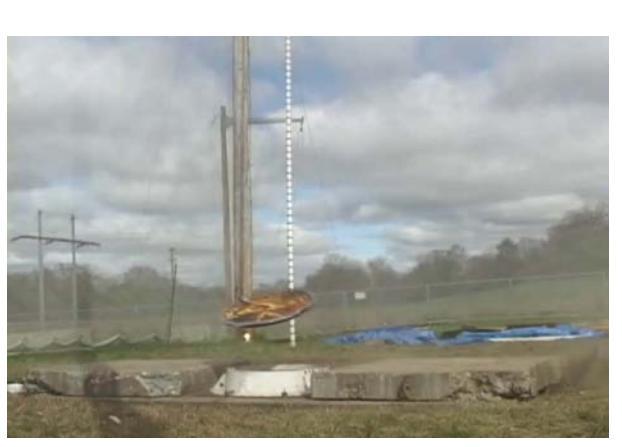
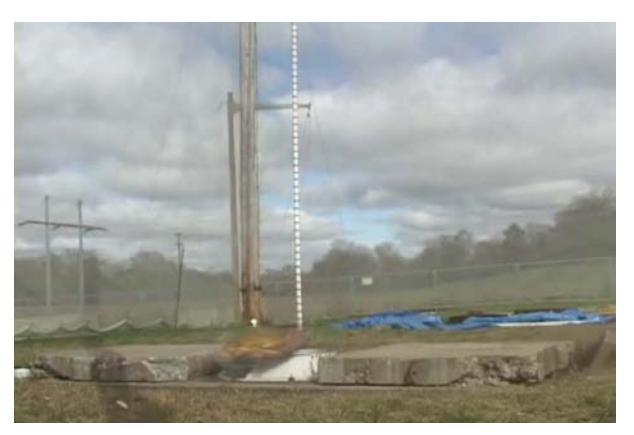
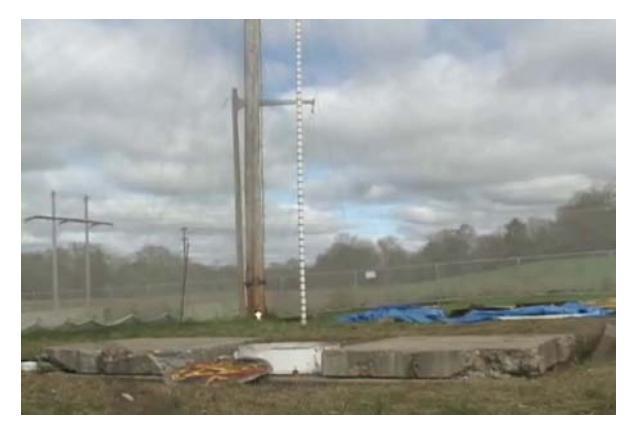
Cover #2 did not have a locking mechanism during tests. Figure 4-5 shows that in this case the cover is dislodged and hurled away. Significant collateral damage is possible.

(a) Cover begins to rise.

(b) Cover at maximum height.

(c) Cover falls.

(d) Cover lands on the ground near the M11 manhole.

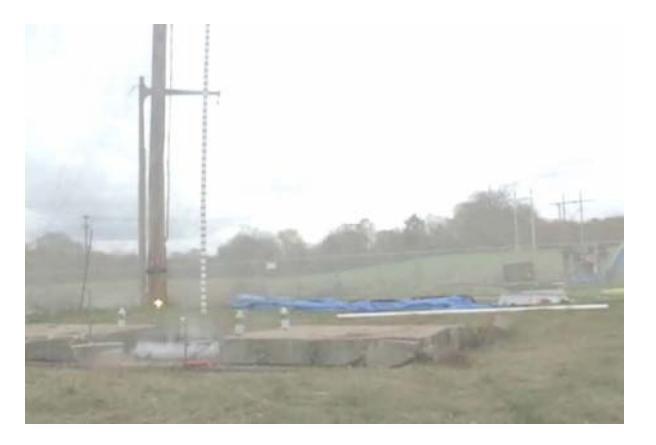
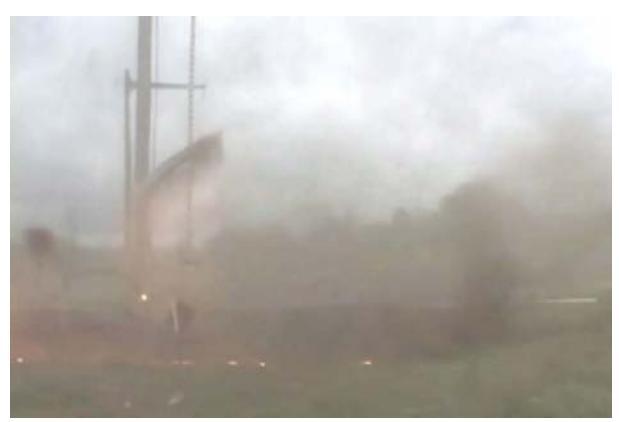
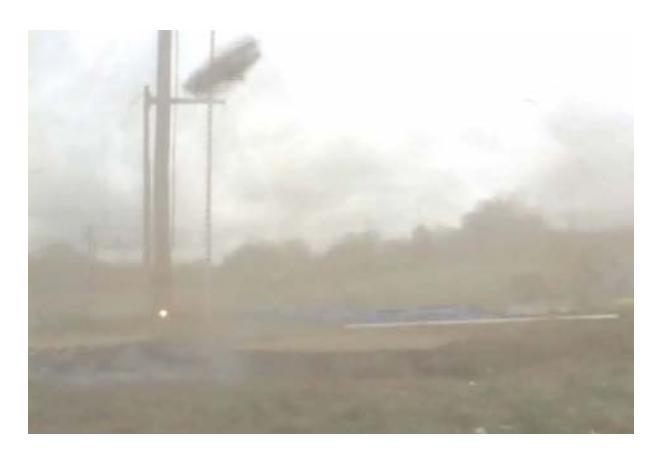
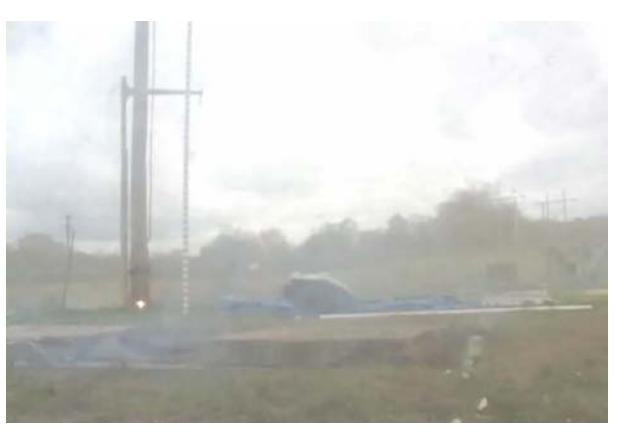
Figure 4-6

Cover #3 is a hinged cover. It was equipped with the Stabiloc restraining mechanism for these tests. The cover did not provide sufficient pressure relief. It and its frame were ripped off the M11 manhole and hurled to a height of about 14 ft in a test with 6% UL mixture, see Figure 4-6.

(a) Cover begins to open to relieve pressure.

(b) Cover and its frame are ripped off the M11 manhole roof slab and hurled upwards.

(c) Cover and frame at maximum height.

(d) Cover and frame land on the ground away from the M11 manhole.

The fourth objective – study of the hinged cover – was met and the results suggest that this approach requires further development as pressure relief was insufficient to prevent dislodgement of the entire cover frame. Hence, the results of this test are to a large extent inconclusive as to the capabilities of hinged covers to provide pressure relief. It is recommended to revisit this issue and re-design the attachment system of the frame to the roof slab, as this would further explore the possible advantages of hinged cover.

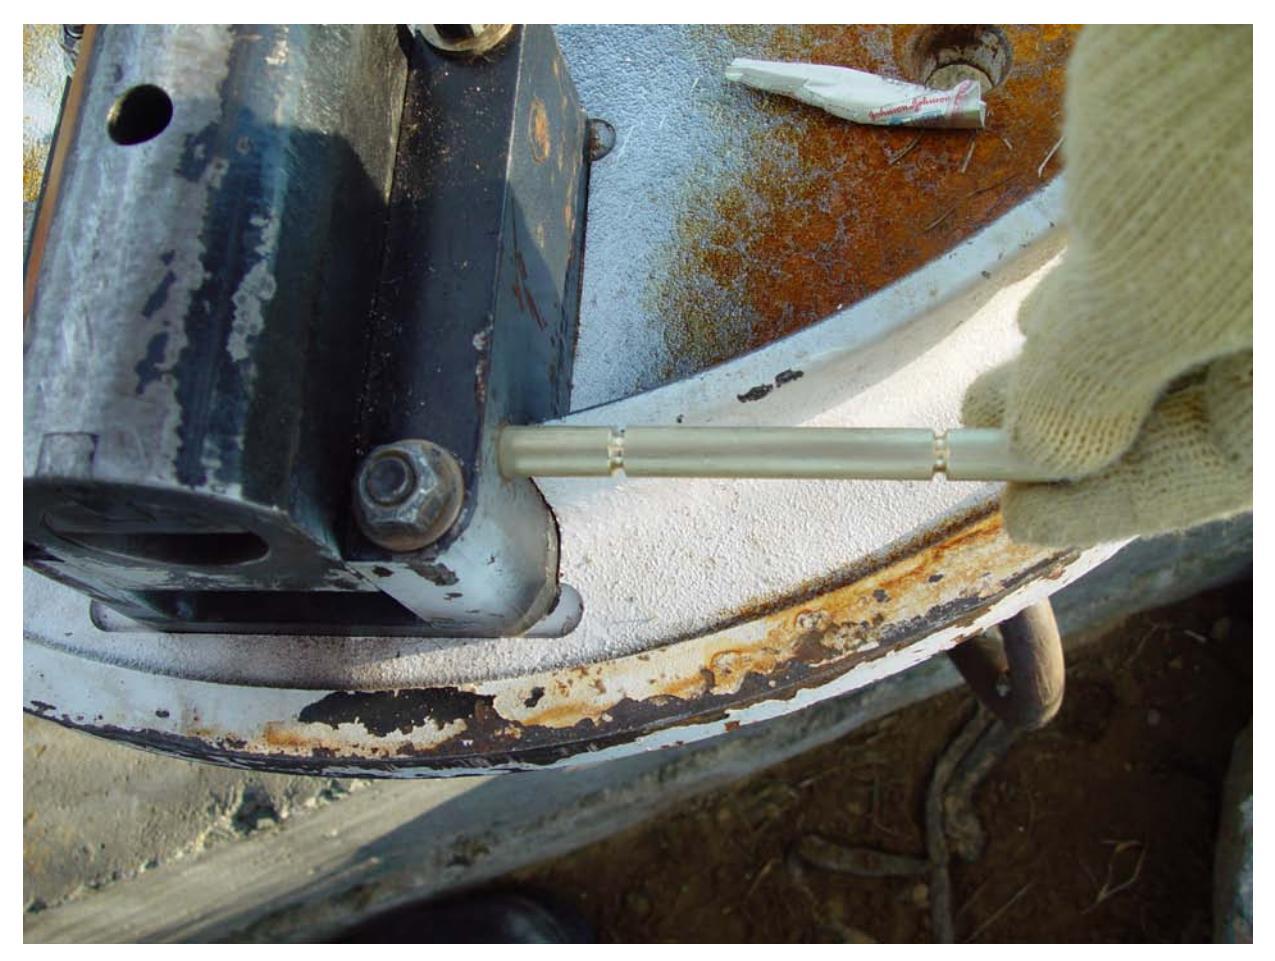
Figure 4-7 Shear pin with notches.

The shear strength of the pin was adjusted by beveling two notches as shown in Figure 4-7. This introduces controlled weak points in the pin. The amount of remaining material in the notch area determines the shear strength of the pin.

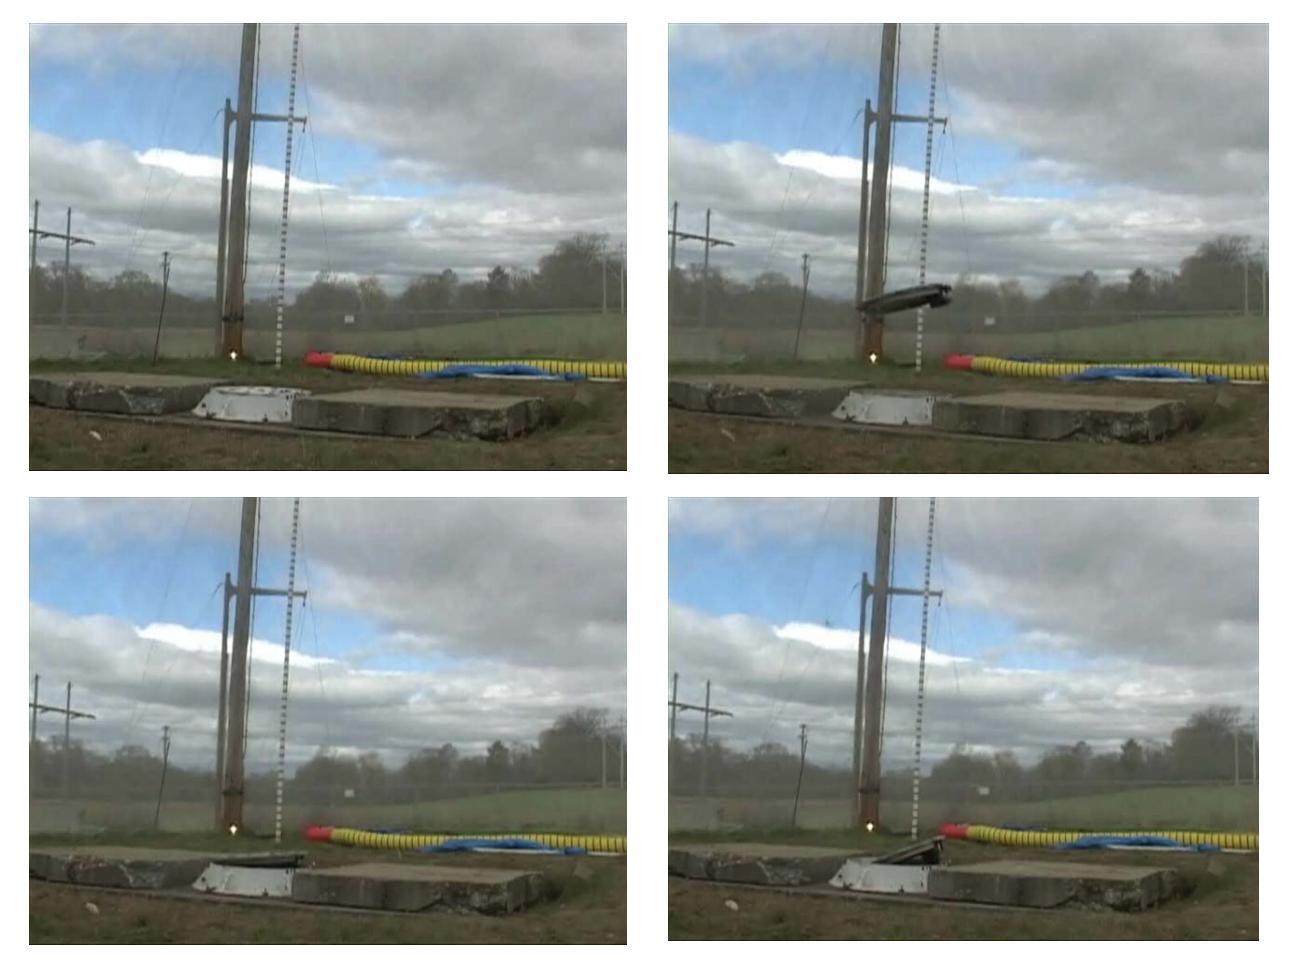
Figure A-1 Event 17. Pin size 0.275". Hydrogen concentration 13%.

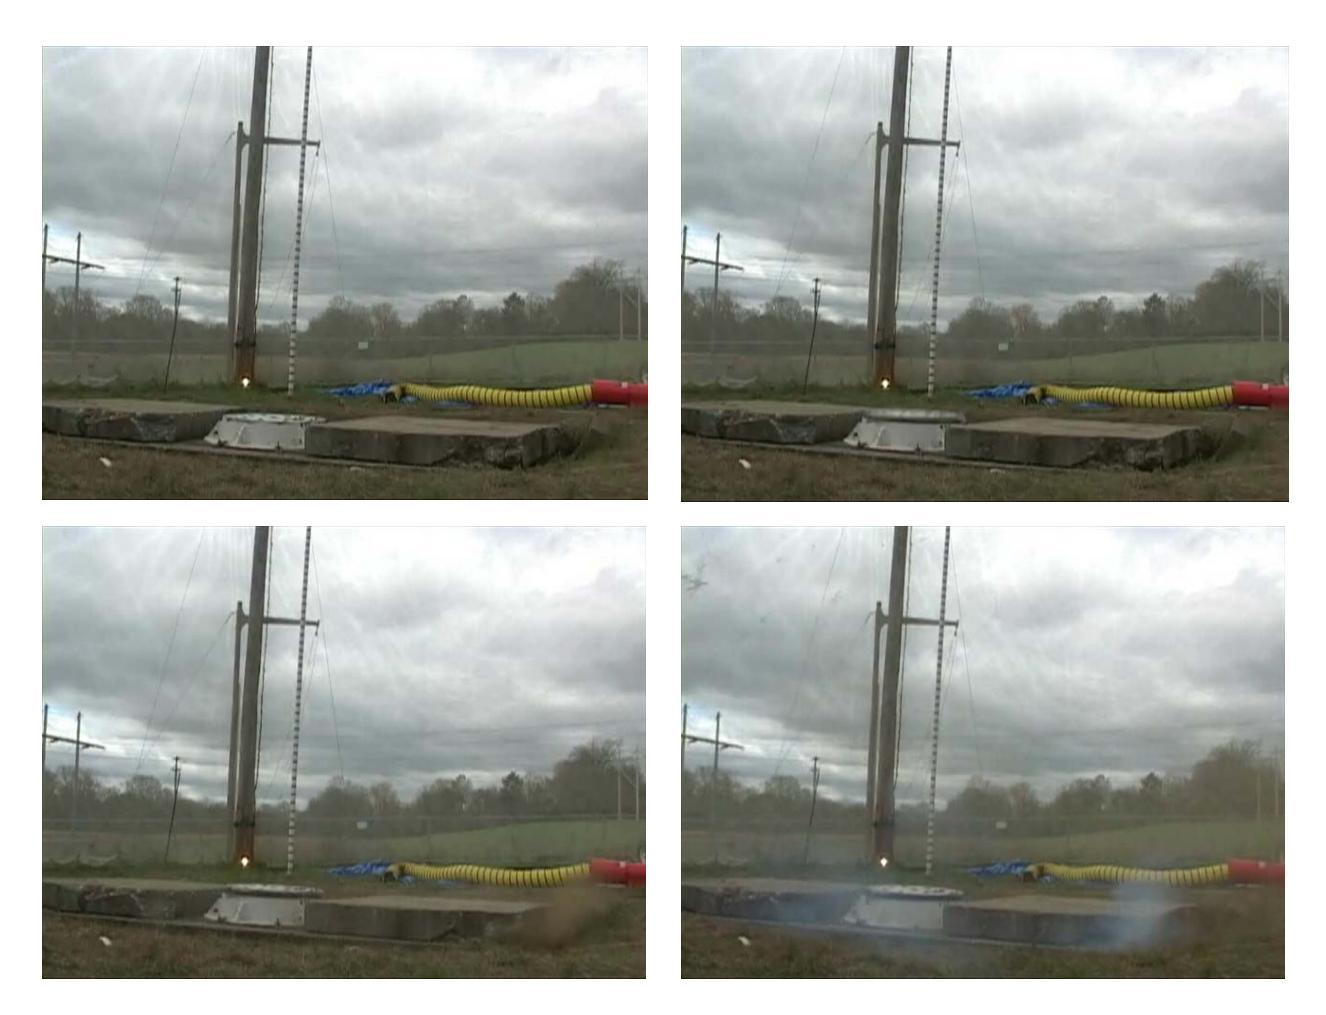
Figure A-2 Event 20. Pin size 0.350". Hydrogen concentration 13%.

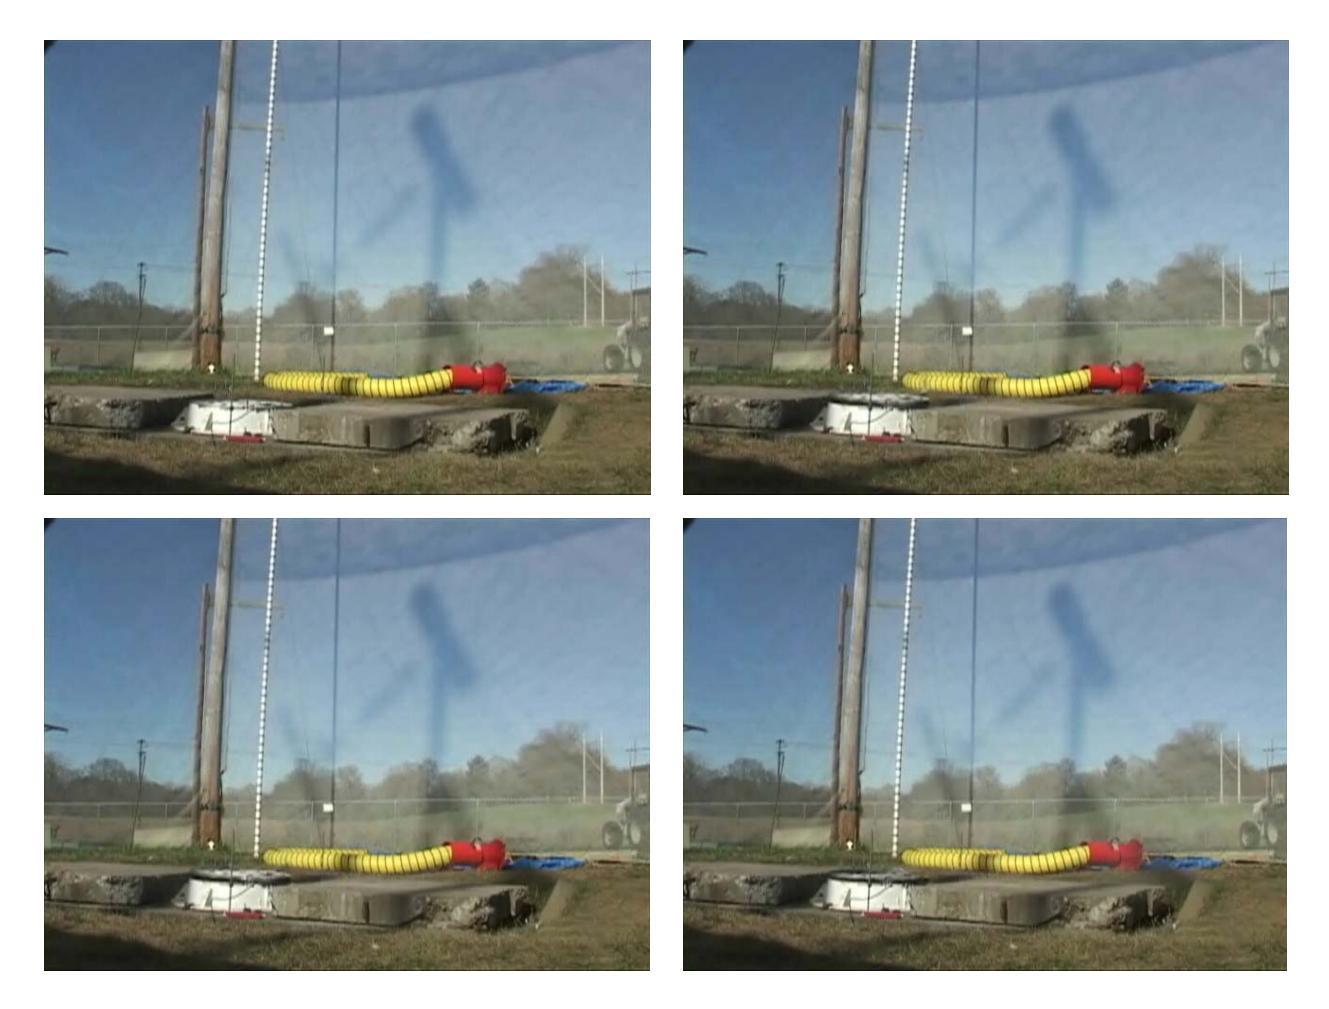
Figure A-3 Event 28. Pin size 0.250". Hydrogen concentration 10%.
