# **Turbine-Generator Topics for Power Plant Engineers: Motoring of a Synchronous Generator**

1022588

Technical Update, February 2011

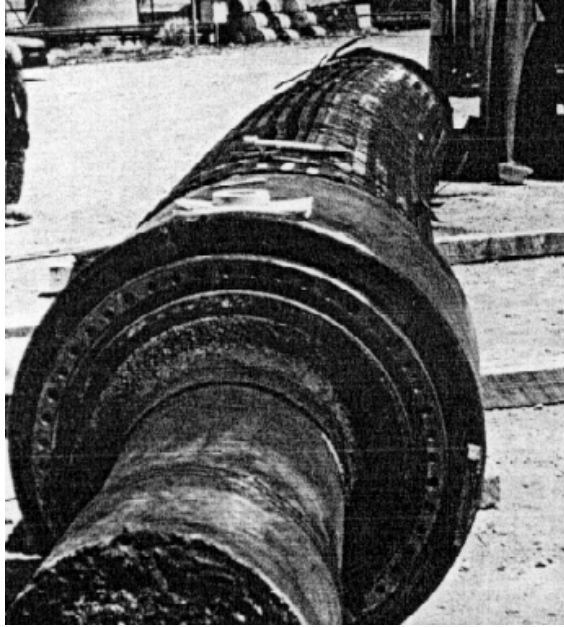
Both motoring currents and negative sequence currents will be discussed here. It is difficult to discuss one problem without the other; they both cause unwanted and harmful current to flow on the rotor forging. Like many maladies there are extremes. Operating with negative sequence currents near the design limit and motoring a unit from rest are both harmful to the rotor, in either case there was over heating of the rotor. One more severe than the other. Here is an analogy of walking and tripping. You can trip on the nap of a rug and fall, or you can trip off the top of the Sears Tower. In either case you fell, one more severe than the other. Photo 1 is an example of a Sears Tower rotor over heating event.

Damage evaluation is easy in some motoring situations, once the smoke has cleared. See the first photograph in the Photo Section. But, for a majority of motoring events, generator or turbine damage is not immediately clear; and in many cases no damage or insignificant harm occurs. If other than Synchronous Motoring takes place for tens of minutes, the generator casing may need to be opened for a visual inspection.

1. Worst case motoring

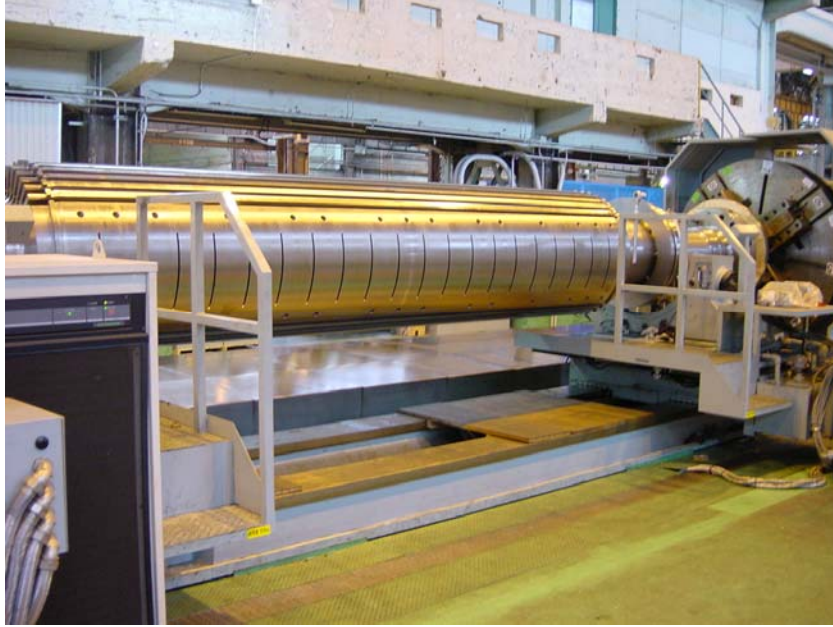
On the 2 pole forgings, pole face “cross slots”, also called body flex slots, are machined into the forging to balance out the stiffness of the forging. [Photo 2] Motoring surface currents can not bridge these slots; as the current flows axially along the forging it bunches up at the end of the cross slot causing heating. [Photos 3 and 4] This localized heating, if severe, will increase the forging steel material hardness which could become the source for a forging crack. All of the overheated areas on the forging must be checked for changes in hardness.

2. Pole forging with cross slots

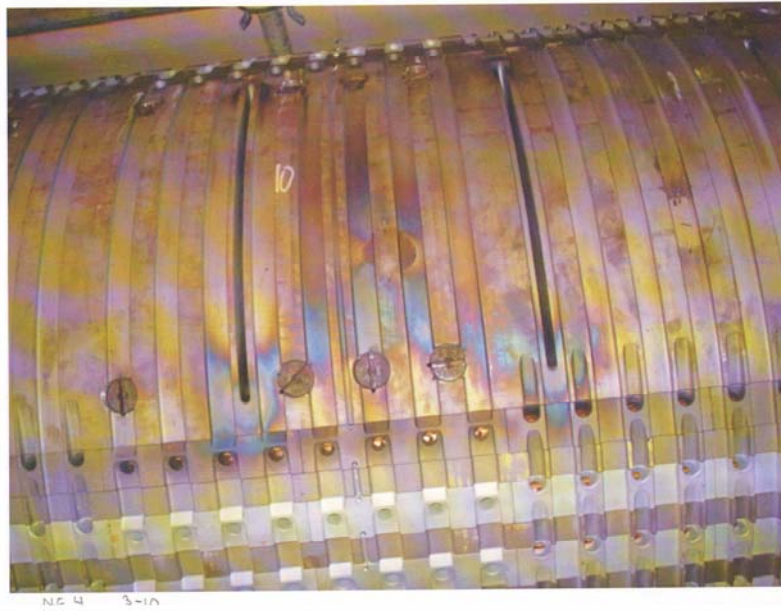
The major areas of concern are: 1) the forging at the ends of the cross slots. [Photos 3 and 4]; 2) the interface where slot wedges butt together [Photo 5]; 3) the interface between the retaining ring fit and the forging or the retaining rings and the wedges [Photo 6]; and 4) the slot wedge to body interface. See the sketch below from Reference 1.

3. Overheating at cross slot (You can almost see the current flow path)

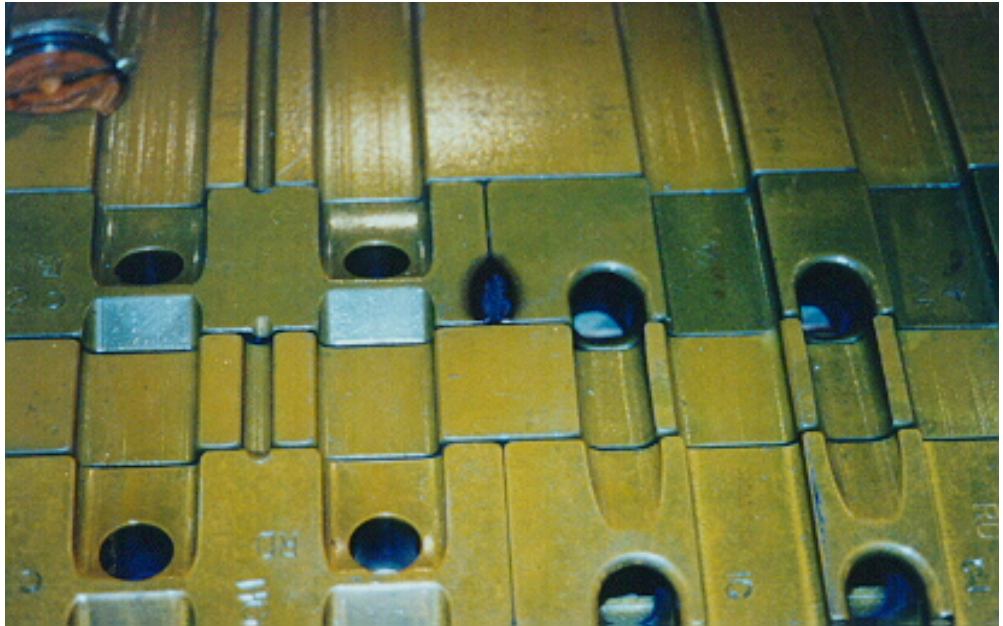
5. Overheating at wedges

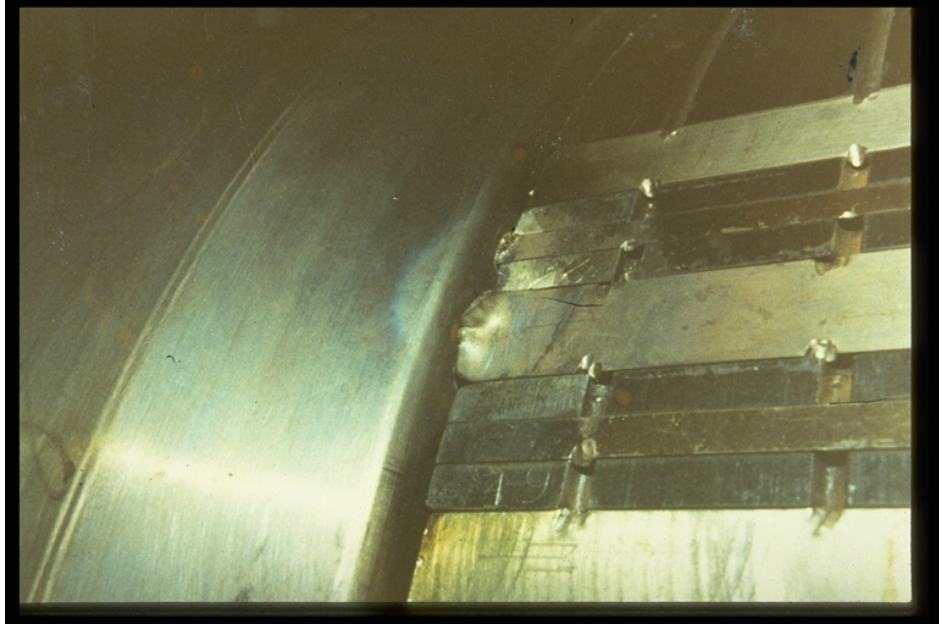
6. Overheating, welding, at the retaining ring
