Turbine-Generator Topics for Power Plant Engineers: Motoring of a Synchronous Generator

1022588

Technical Update, February 2011

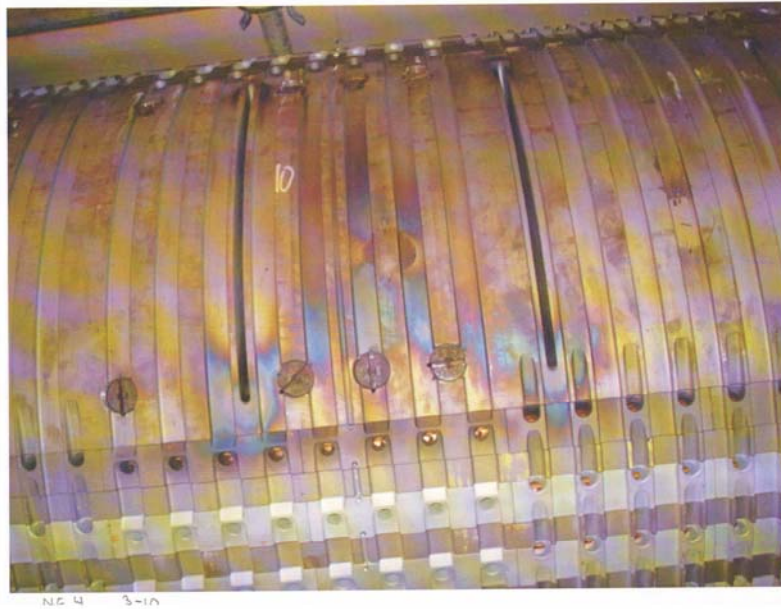
The major areas of concern are: 1) the forging at the ends of the cross slots [Photos 3 and 4]; 2) the interface where slot wedges butt together [Photo 5]; 3) the interface between the retaining ring fit and the forging or the retaining rings and the wedges [Photo 6]; and 4) the slot wedge to body interface. See the sketch below from Reference 1.

3. Overheating at cross slot (You can almost see the current flow path)

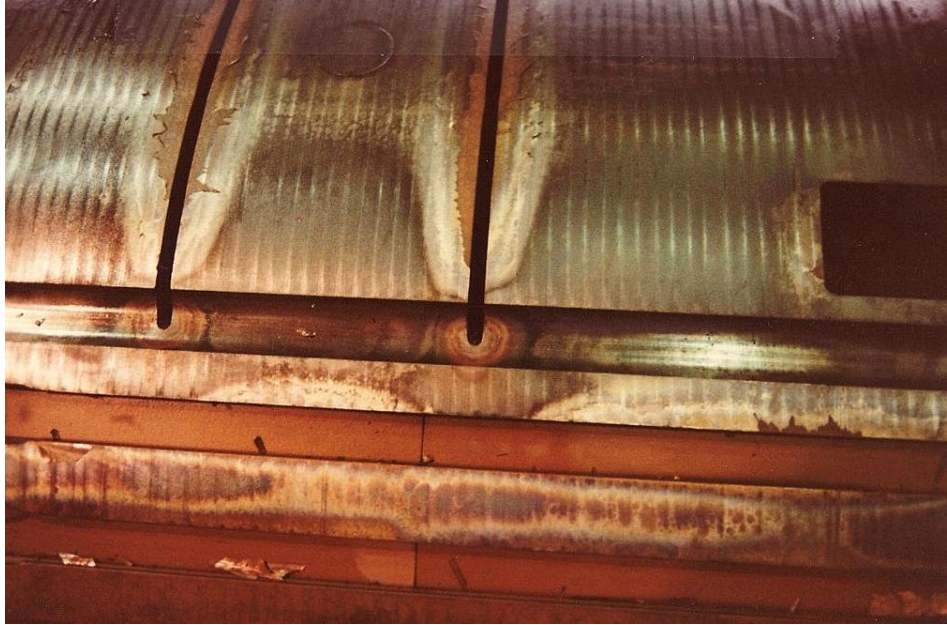
4. Overheating at cross slot
