An EPRI White Paper

## CARNEGIE ROAD ENERGY STORAGE SYSTEM FAILURE RESPONSE, RECOVERY, AND REBUILD LESSONS LEARNED

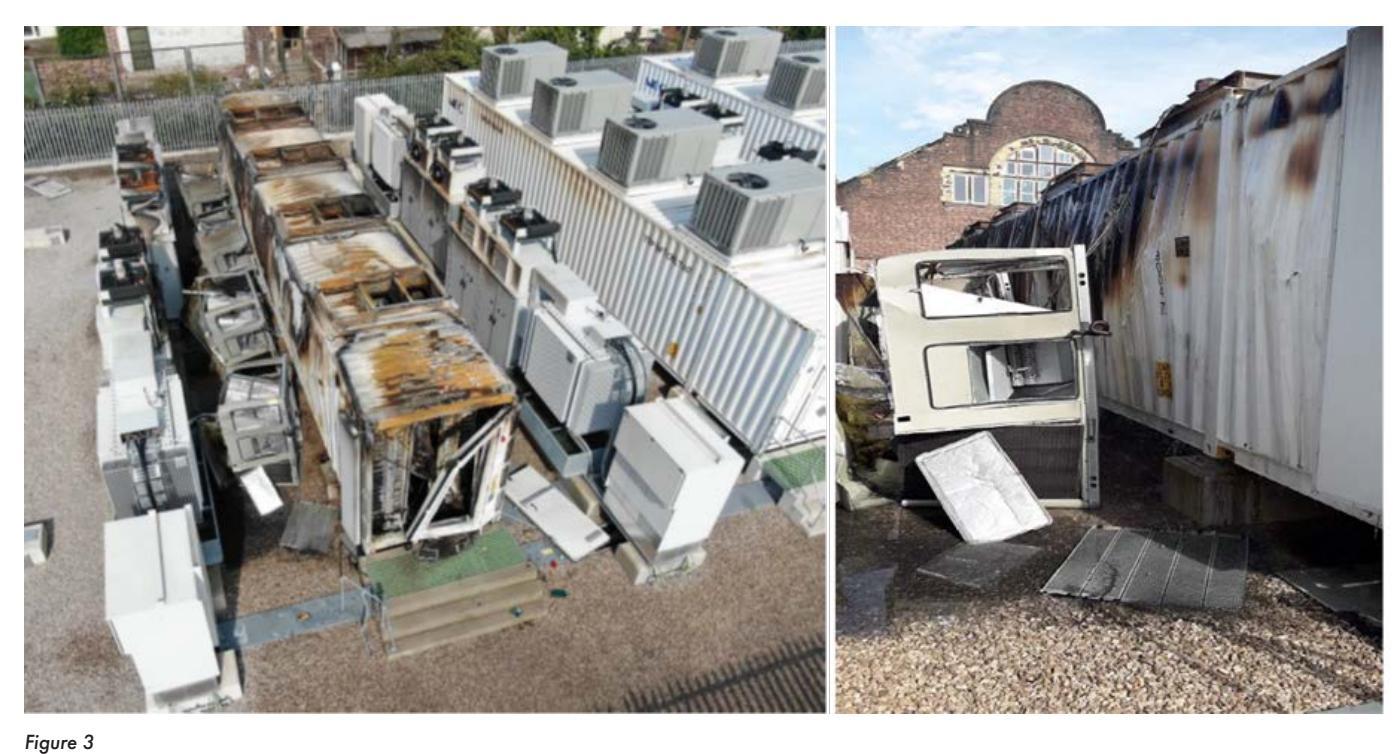
The failure occurred in Container 1 of 3. Figure 3 shows bowing of the container walls because of pressure buildup within, dislocation of the air conditioning units that were attached to the top of the container, and severe charring from the fire. The doors on both ends of the container had been blown open, seen in Figure 4. The door exiting to the yellow metal stairs had been torn off the hinges, further illustrating how powerful this explosion was. Bowing, sagging, and melting of the interior components are the result of extreme temperature exposure. Pools of hardened aluminum were found at the base of the racks and below the container, suggesting that the fire temperatures exceeded 660°C (1221°F).

Aerial photo of Carnegie Road BESS after incident (left) and side view of Container 1 (right); source: MFRS

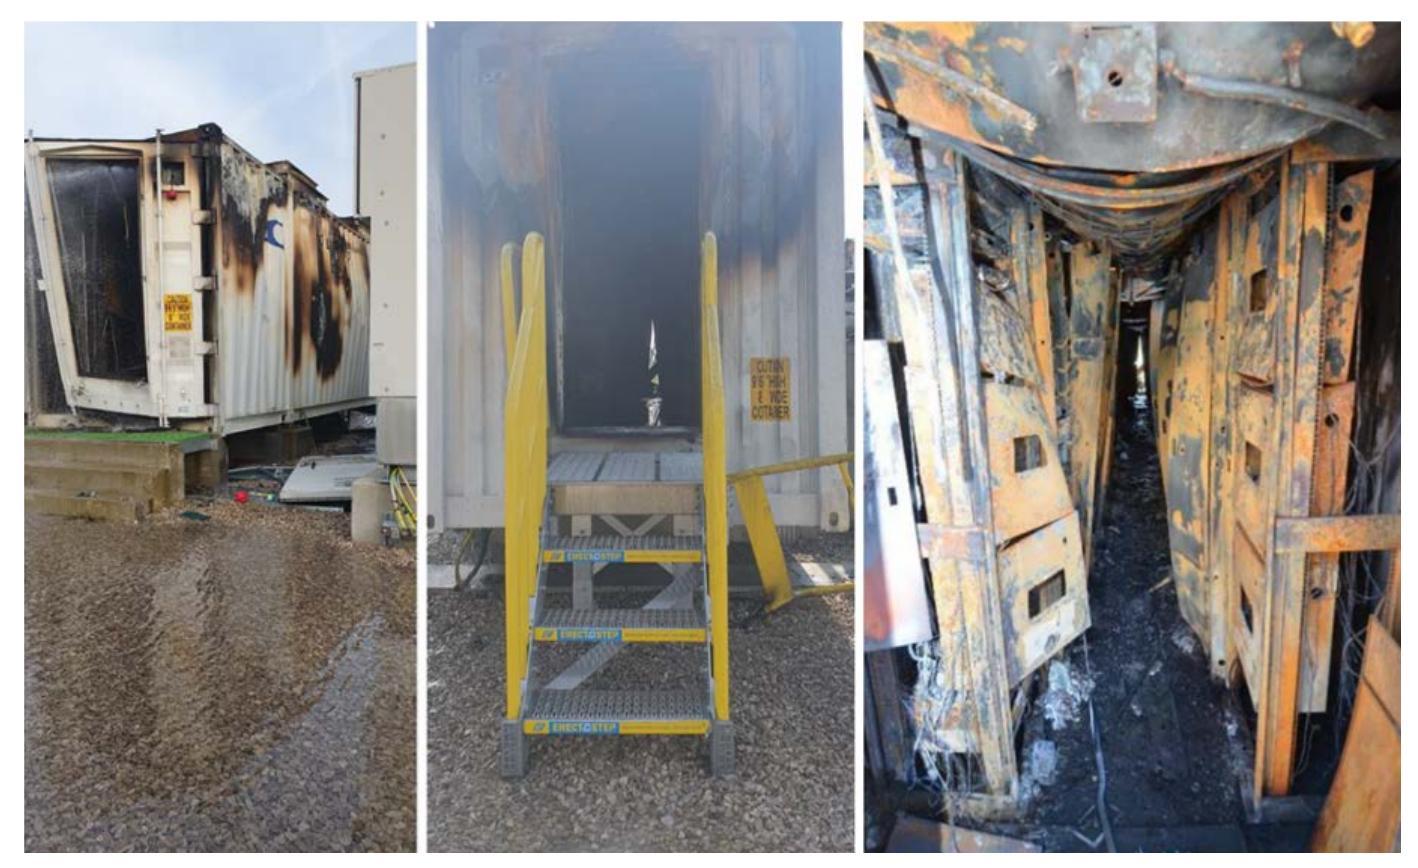
Figure 4 Image of doors blown open (source: NEC) and inside the container; source: MFRS

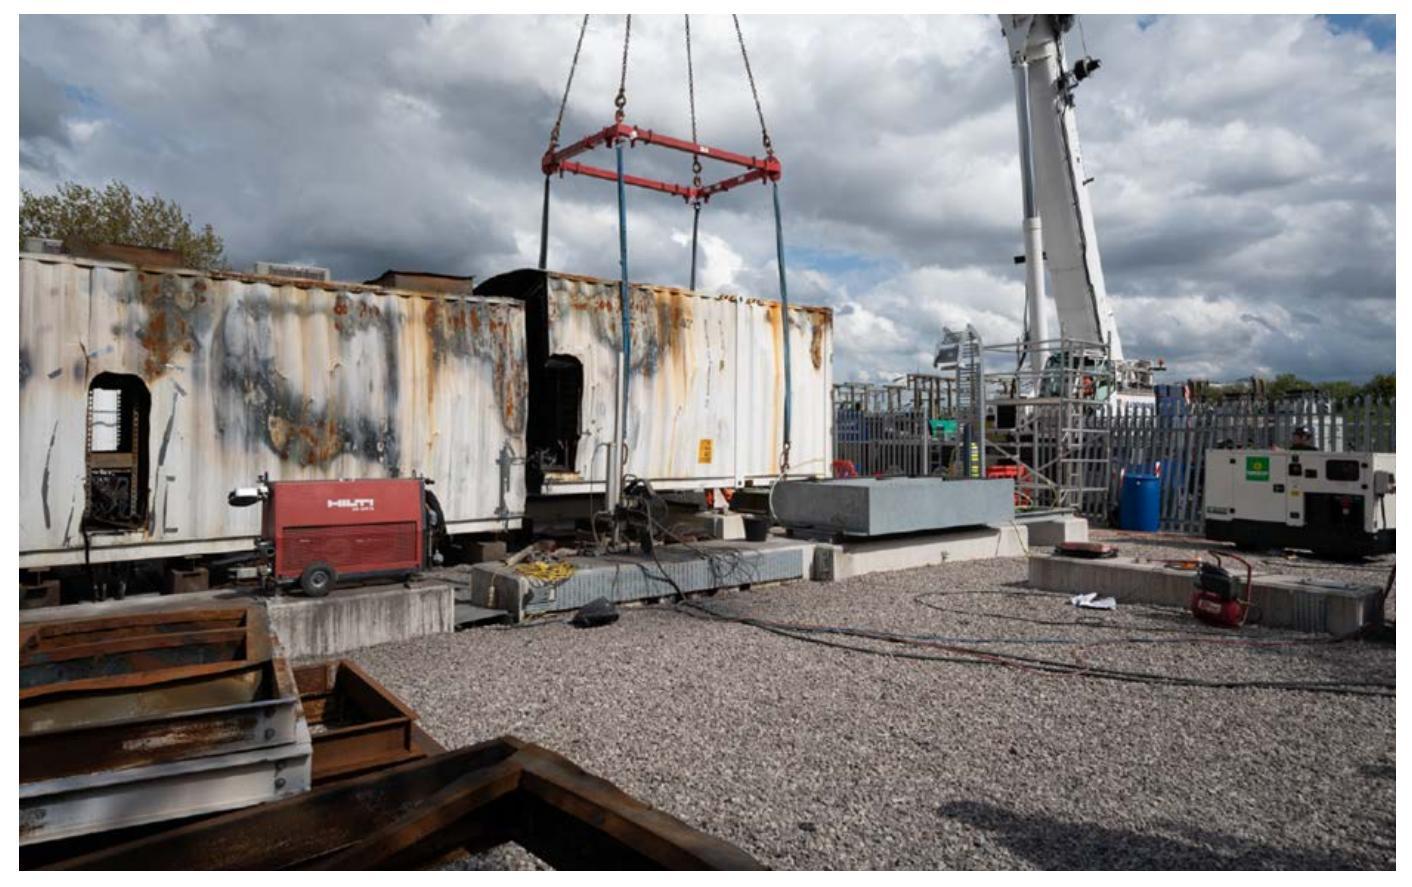
Disassembly and removal of Container 1 commenced in May 2021. The container was cut into three sections and craned into a staging area where further investigation of the system could occur. This allowed a more comprehensive assessment of the container and target rack without risk to health and safety. Retrieval of the batteries for further inspection was difficult because they were extremely brittle and not easily separated. Some sections of the modules needed to be sawed apart and removed from the racks. See Figure 5.

Figure 5 View of Container 1, Section 1 being removed (source: SAFE Laboratories and Engineering Corp.)
