PWR Steam Generator Sleeving Assessment Document Revision 1

TR-105960-R1

Final Report, December 1997

Prepared by Steam Generator Sleeving Review Committee 3412 Hillview Avenue Palo Alto, California 94304

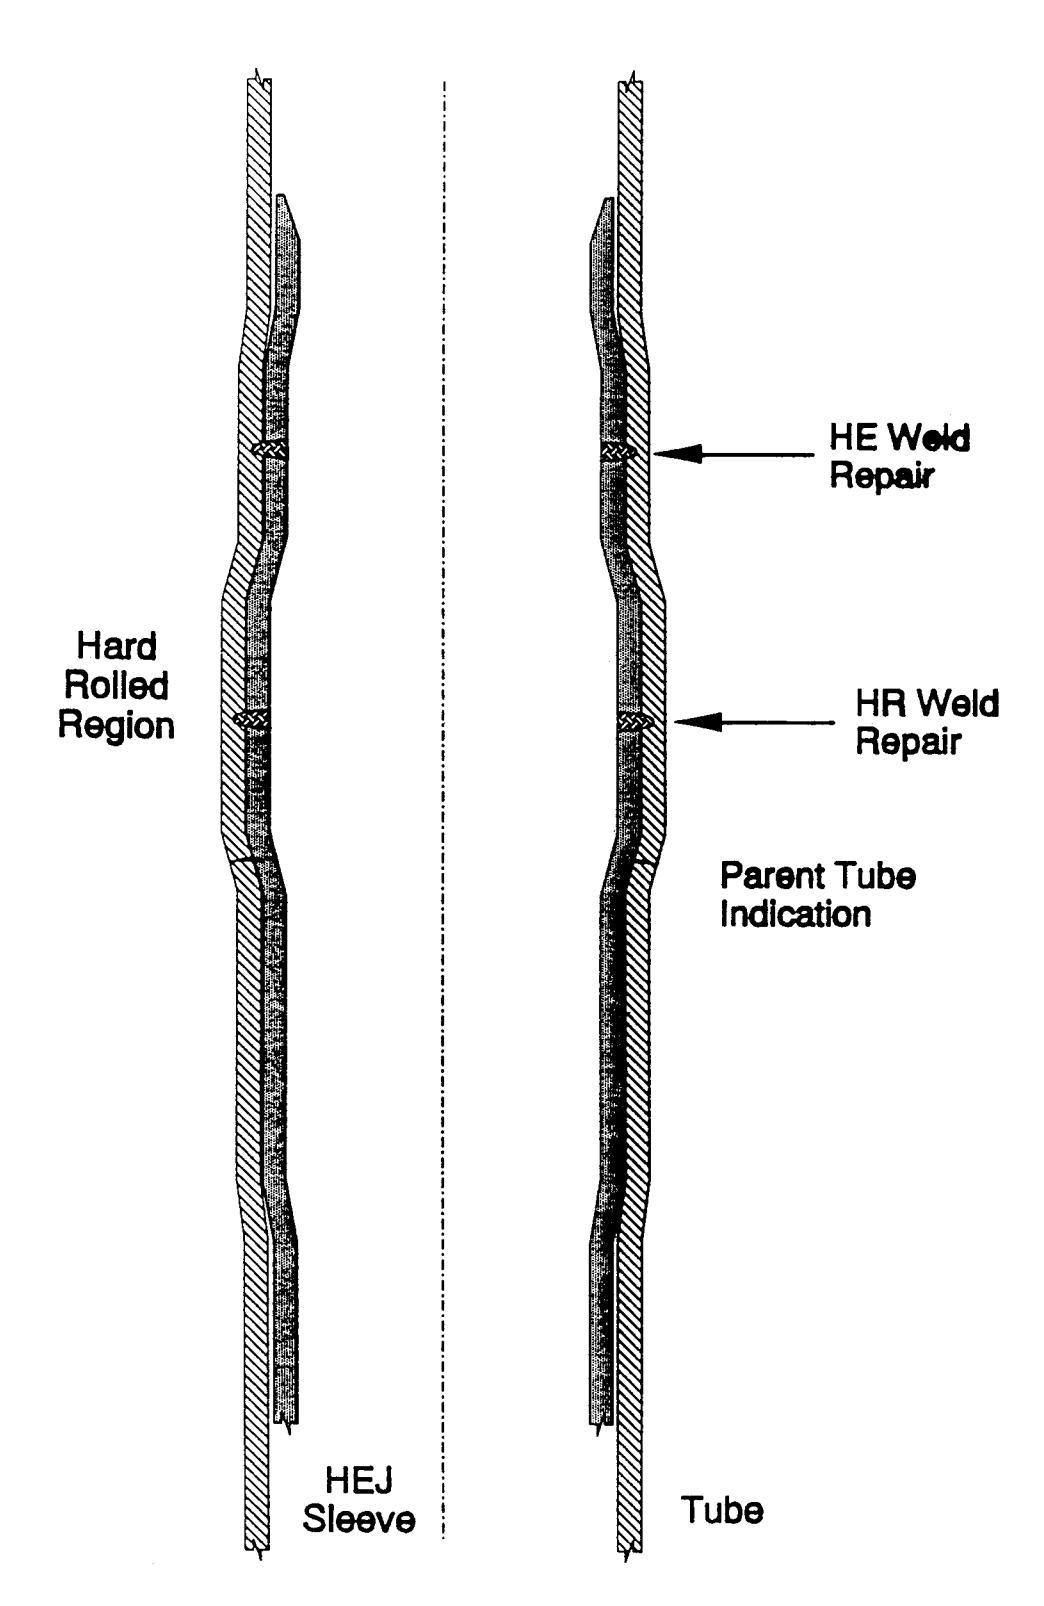
Figure B-1 Location of Welds in HEJ Sleeved Tubes

Due to the significant number of parent tube indications detected during the 1996/1997 outage, a method was required to repair the sleeve joint in order to keep tubes in service and return the plant to operation. The first repair technique attempt was to place a laser weld in the center of the existing hardroll joint, see Figure B-1. This repair method had a very low success rate. Of approximately 650 welds attempted only 198 were determined to be acceptable following UT and eddy current inspection. The cause of the weld failure was two-fold. First, due to the confined geometry of the hardroll, there was not a vent path for hot weld gases and contaminants volitized during the welding to escape. This resulted in a significant number of blowholes forming on the weld inner diameter. Therefore, as allowed by the welding procedure, subsequent re-weld passes were made. This then resulted in hot weld cracks forming on the inner

diameter of the weld due to too much heat input. All welds with hot cracks or blowholes were either plugged or re-sleeved.

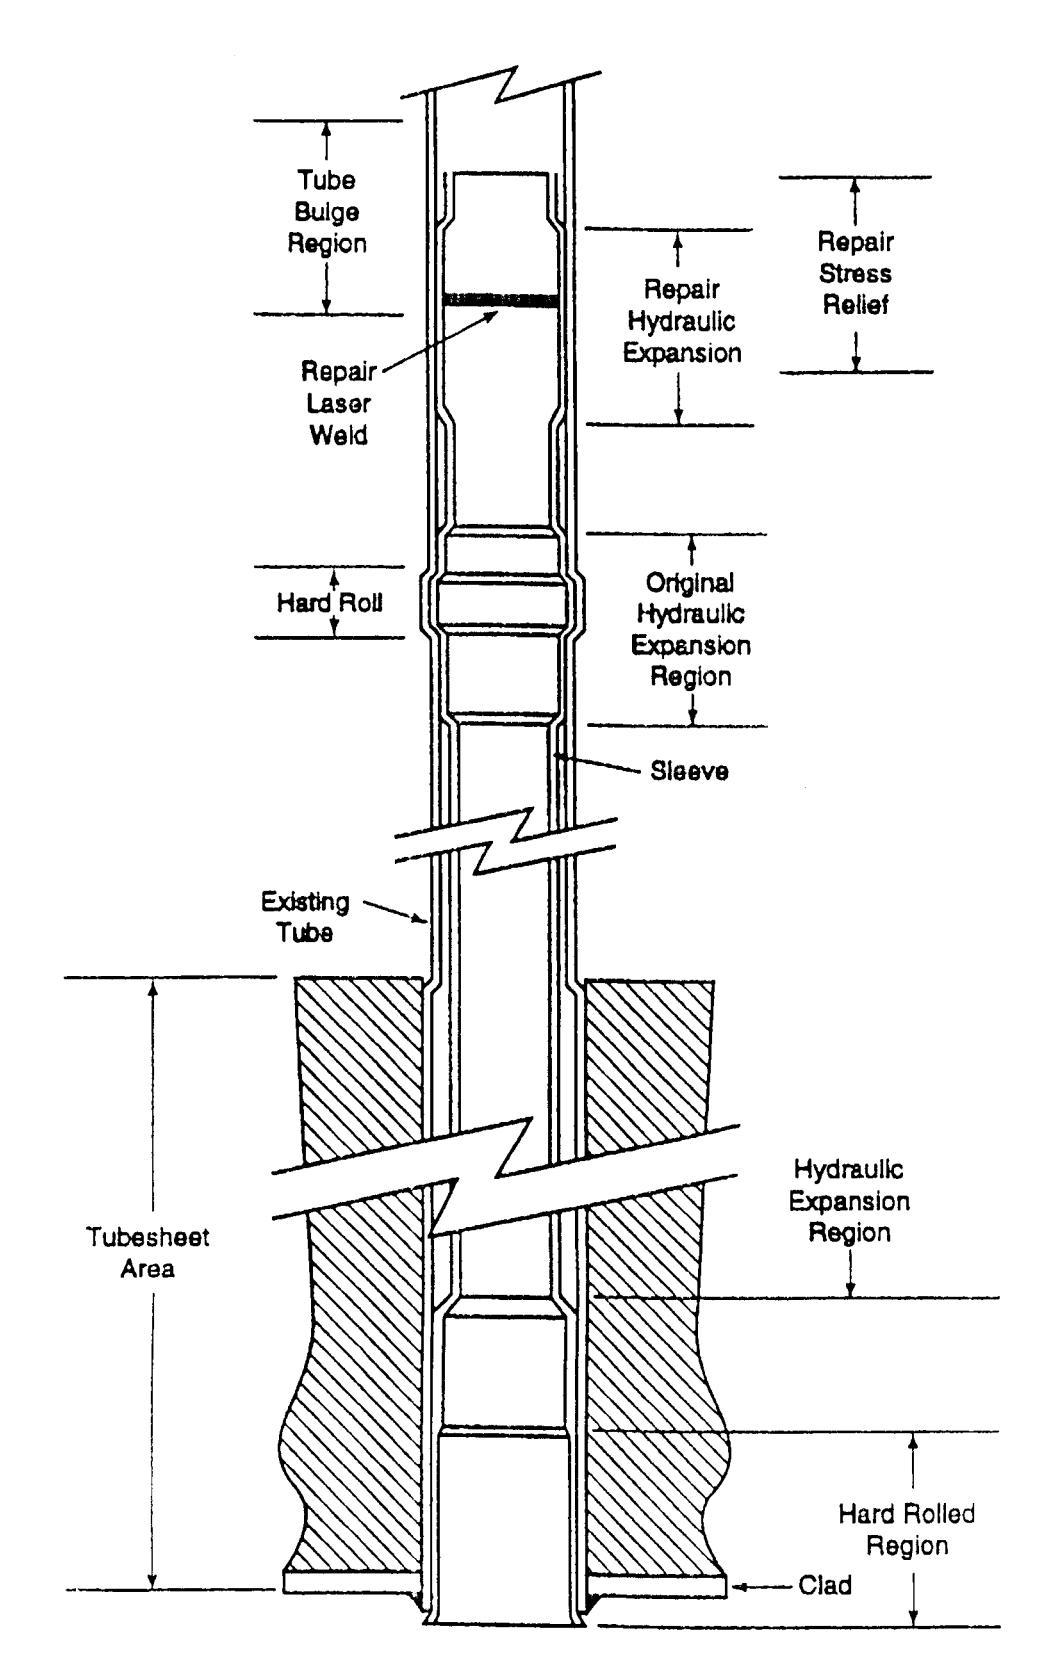
Figure B-6 Doel 4 HEJ Sleeve Repair

In June of 1995, both the laser welded and repaired HEJ sleeves were inspected with CECCO-3 and Plus-Point probes, and ten samples (six repaired HEJs and four LWSs) were pulled for laboratory examination and testing. The following observations were made from the pulled tube examination (see Figure B-6):

- A bulging, or outward expansion of the parent tube, was discovered in the region just above the welded joint. The degree of bulging ranged between 0.1 mm to 0.7 mm for the ten pulled sleeved tube samples. Bulges in the range of 0.4 to 0.7 mm were seen in the HEJ sleeves, and bulges in the range of 0.1 to 0.25 mm were seen on the laser welded sleeves. The bulging was caused by the stress relief treatment of the weld. Two stress relief cycles were performed using an oscillating heater to obtain coverage on the upper hydraulic expansion as well as the laser weld. The stress relief cycles were performed consecutively without allowing the joints to cool to room temperature. Based on the observation of bulging, it is now concluded that tubing was locked at support plates when the repairs were performed.
