# **Weld Overlay of Waterwall Tubing, Alternative Filler**

**1001268**

Technical Review, March 2001

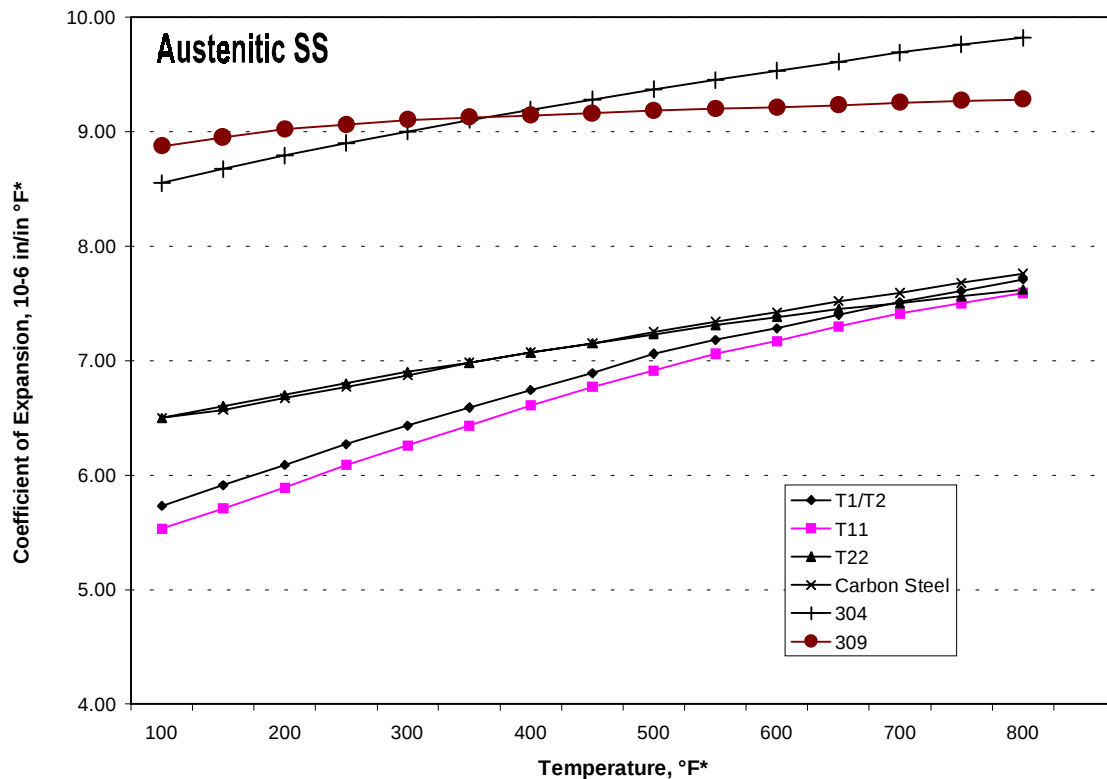
**Figure 3-1**  
**Thermal Expansion of Base Metals and 300 Series Austenitic SS from ASME Section II, Part D**  
*\* Conversion Factors — To convert inches to centimeters, multiply by 2.54. To convert Fahrenheit temperature to Celsius, subtract 32 and divide by 1.8.*

Various families (ferritic, austenitic, and duplex stainless steels) of alloys were considered solely from a thermal expansion standpoint. Several austenitic SS materials were plotted against the tubing alloys: T1/T2, T-11, T-22, and carbon steel. Two of the more common austenitic SS alloys, Types 304 and 309, are shown in Figure 3-1. As can be seen, the pure austenitic SS alloys do not match the tubing alloys very well in terms of thermal expansion characteristics. As mentioned above, it is important to note that Type 309 has seen some use as an overlay material.

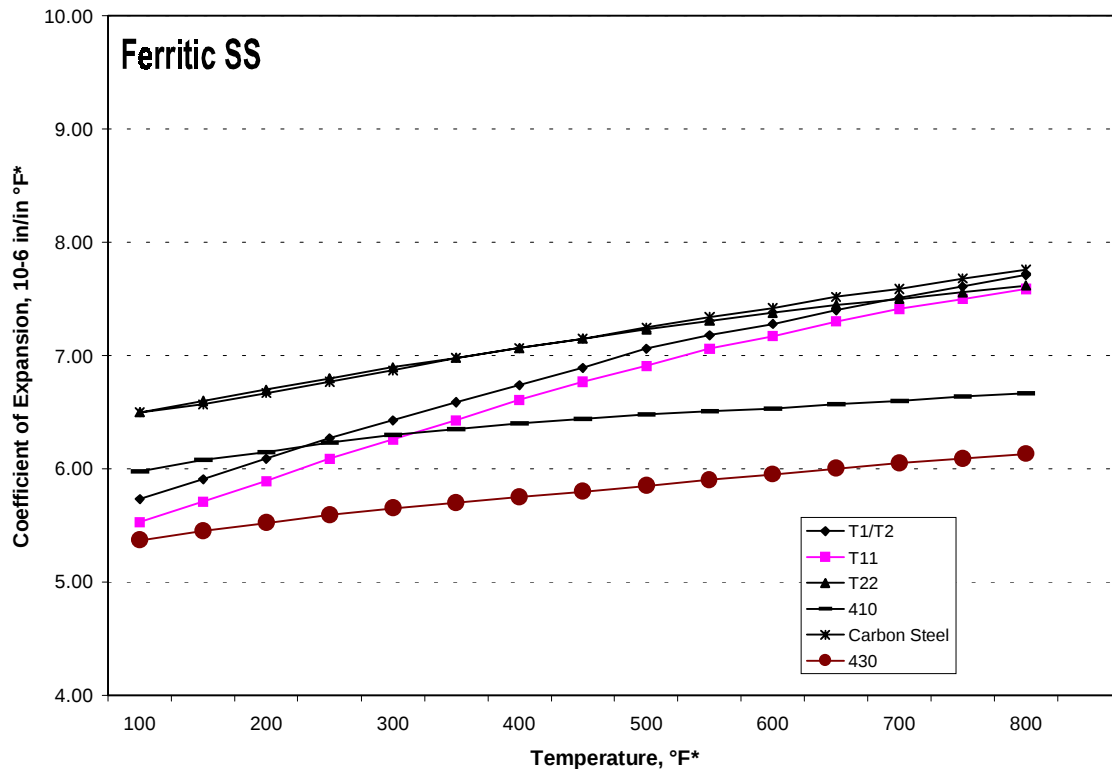
**Figure 3-2**  
**Thermal Expansion of Base Metals and 400 Series SS from ASME Section II, Part D**

Next, several ferritic SS alloys were plotted against the currently used tubing alloys. Two representative ferritic alloys are provided in Figure 3-2 for comparison. Again, as with the austenitic SS (though to a lesser degree), one can easily see that the ferritic SS alloys do not match the tubing alloys in terms of thermal expansion characteristics. Particularly at high temperatures, the ferritics tend to deviate from the tubing alloys by a rather wide margin.

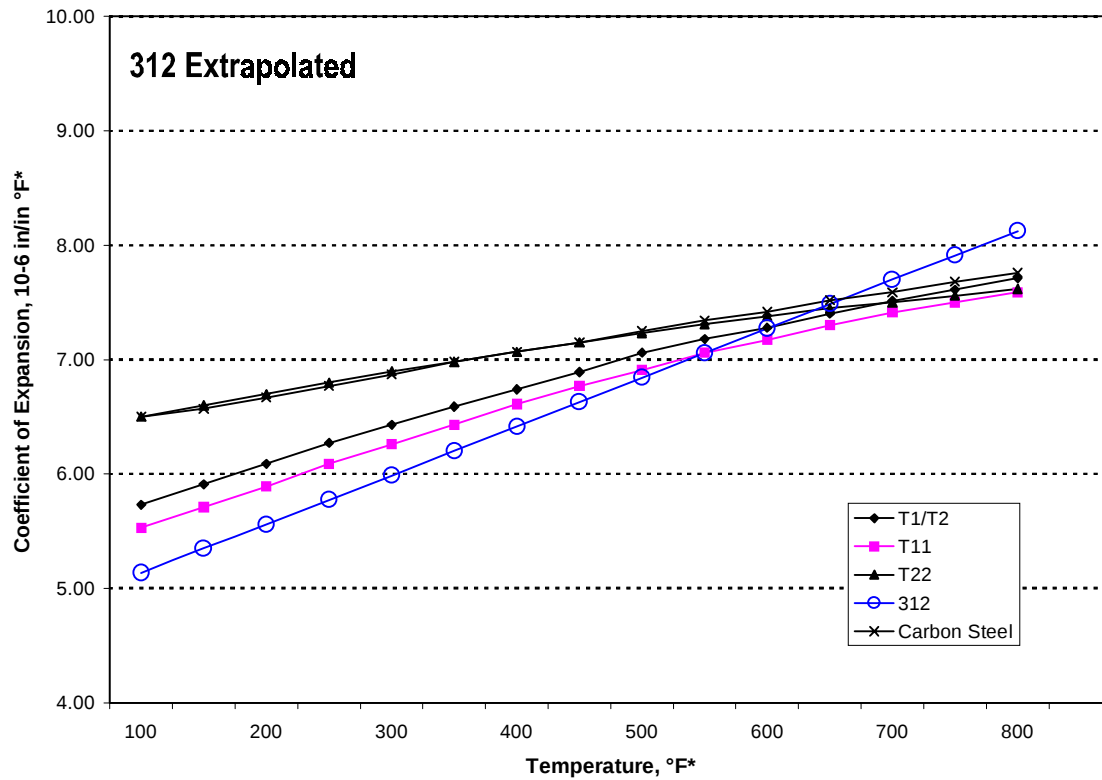
**Figure 3-3**  
**Thermal Expansion of Base Metals from ASME Section II, Part D and Type 312 SS**  
 (Type 312 SS properties were provided by Euroweld)

One of the duplex alloys that provided reasonably good thermal expansion characteristics was Type 312 SS. Only two data points for Type 312 SS were available from the filler-metal vendor. A straight-line curve was extrapolated from these two points. The alloy was then plotted versus the tubing alloys and is shown in Figure 3-3. At lower temperatures, the alloy matches the expansion characteristics of the T-11 and T-22 materials fairly well; however, it deviates from the T1/T2 and carbon steel by a sizable margin. Above 500°F (260°C) and up to 800°F (426.7°C), which is incidentally the operating temperature for waterwall panels, Type 312 SS corresponds quite well with all of the tubing materials currently used in boilers. As a result, further attention and investigation, which included actual thermal expansion testing to better define these curves, were targeted toward the Type 312 SS alloy. Discussion of the investigation is provided in the following subsections.

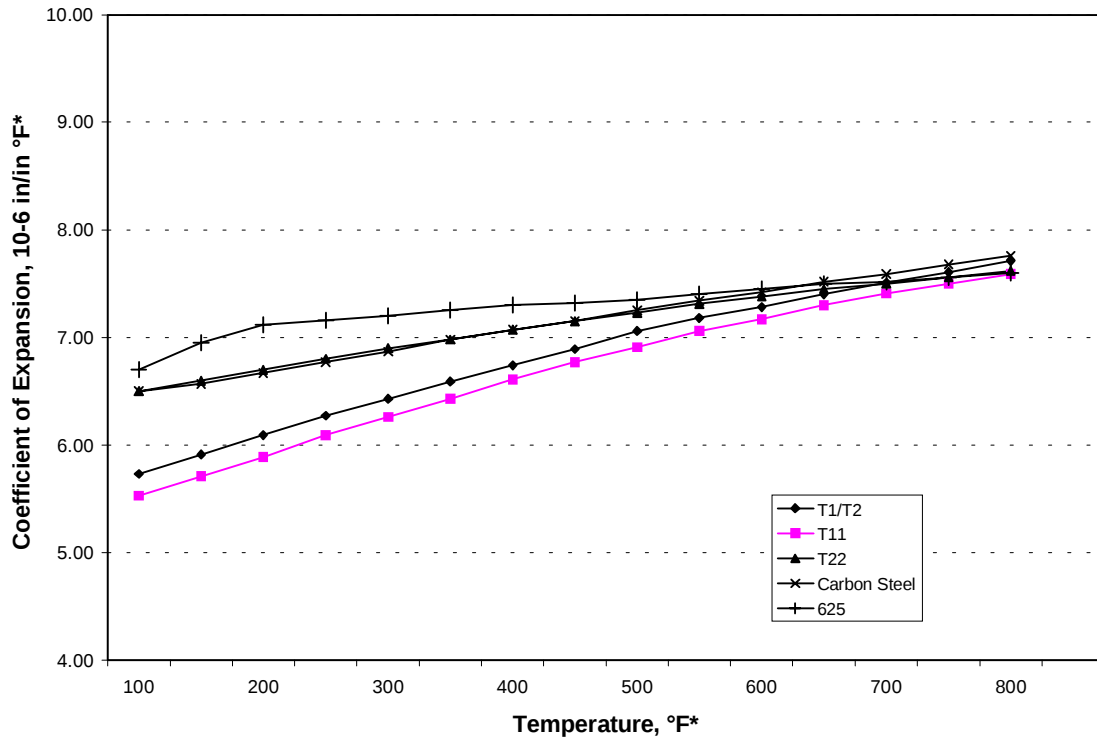
**Figure 3-4****Thermal Expansion of Base Metals and In 625 from ASME Section II, Part D**

One final plot (Figure 3-4) is provided here solely for informational purposes. The plot compares the currently used In 625 alloy with the tubing alloy materials. As shown, In 625 meets the expansion characteristics well over the entire range of temperatures from 100–800°F (38–427°C).

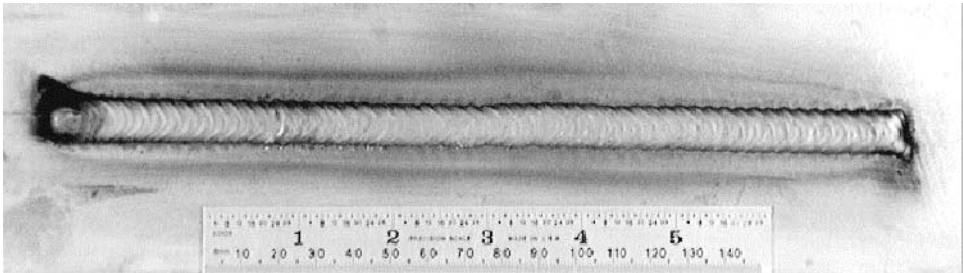
Figure 3-5  
Dilution Measurement Coupon After Welding

Dilution samples were prepared by applying single welding passes on a carbon steel test block. The samples were sectioned, mounted, polished, and evaluated metallurgically. Results for the various fillers can be found in Table 3-2. Pictures of the dilution test samples are shown in Figures 3-5 and 3-6. Dilution was measured on a percentage basis using the areas in Figure 3-7 and the formula:

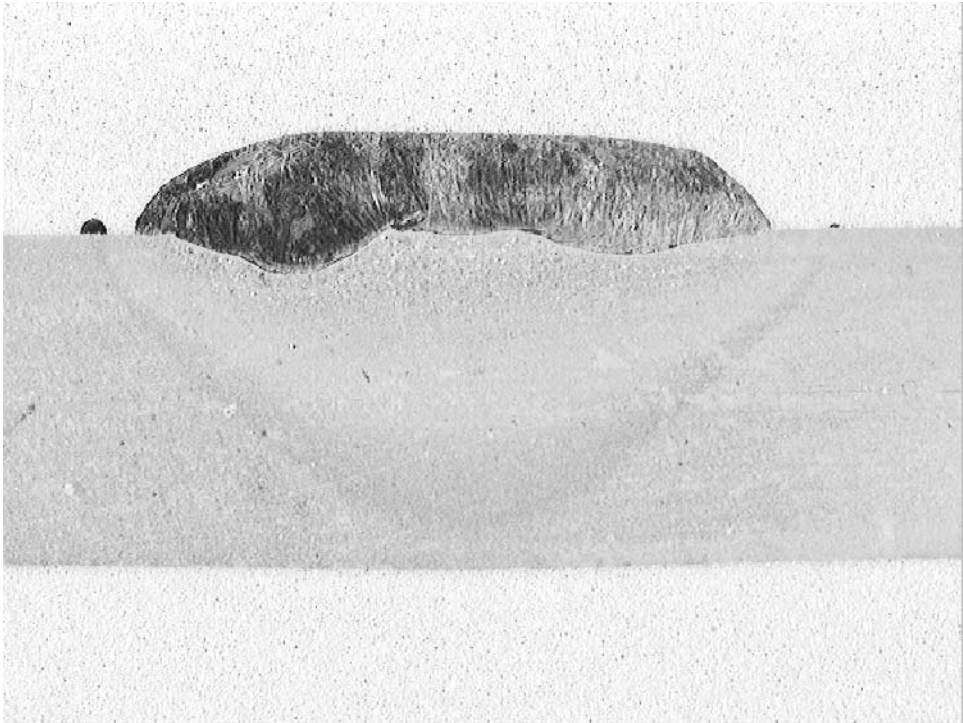
Figure 3-6  
Dilution Measurement Coupons After Mounting and Polishing

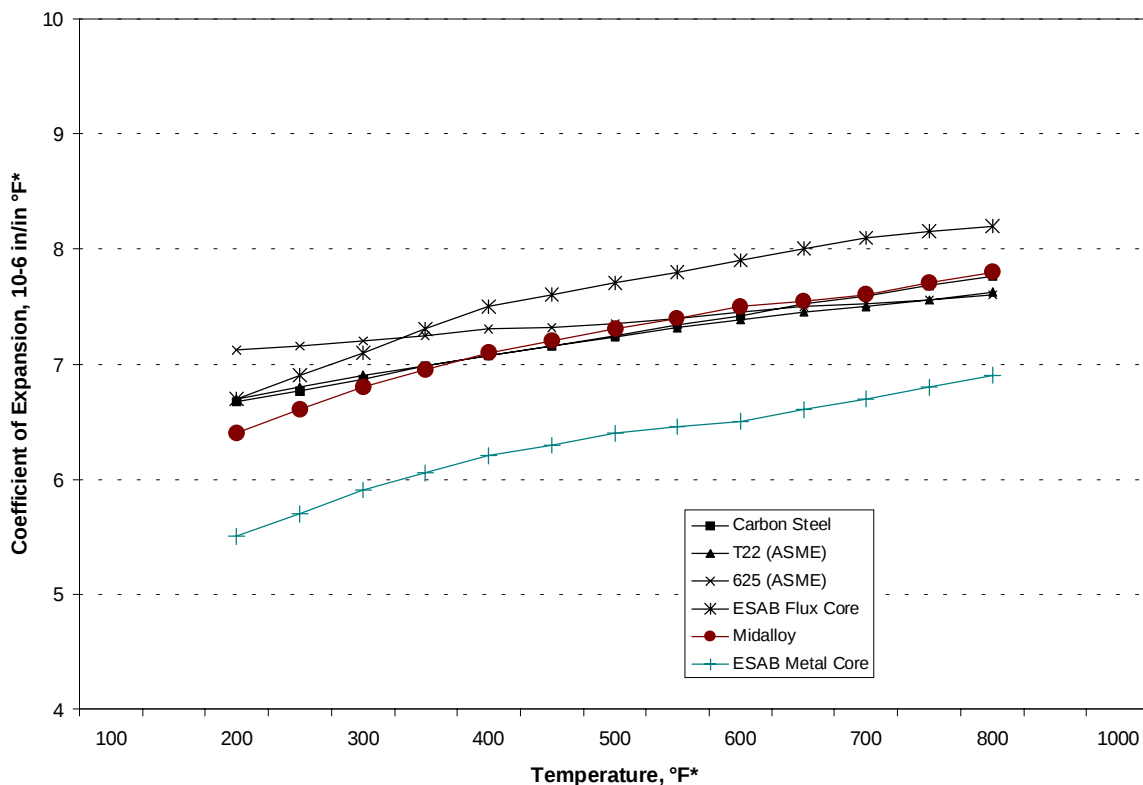
**Figure 3-10**

#### Thermal Expansion of Type 312 SS Filler Metals and Base Metals

Since there was no complete thermal expansion data for Type 312 SS in the ASME Code, samples were prepared for testing. The effect of ferrite on thermal expansion also needed to be investigated. All weld metal samples were prepared using the ESAB flux core, Midalloy, and ESAB metal core filler wires. These fillers were selected because of the different levels of delta ferrite they developed in the as deposited condition. The samples were sent to Materials Innovations, Inc., for testing. The samples were 1" (25.4 mm) long by 3/8" (9.5 mm) diameter. The results of this testing are plotted in Figure 3-10. **As can be seen from this figure, delta ferrite had a large influence on thermal expansion properties.** The Midalloy filler metal was found to have thermal expansion properties that closely match the carbon steel or T-22 base materials and was selected for further testing.

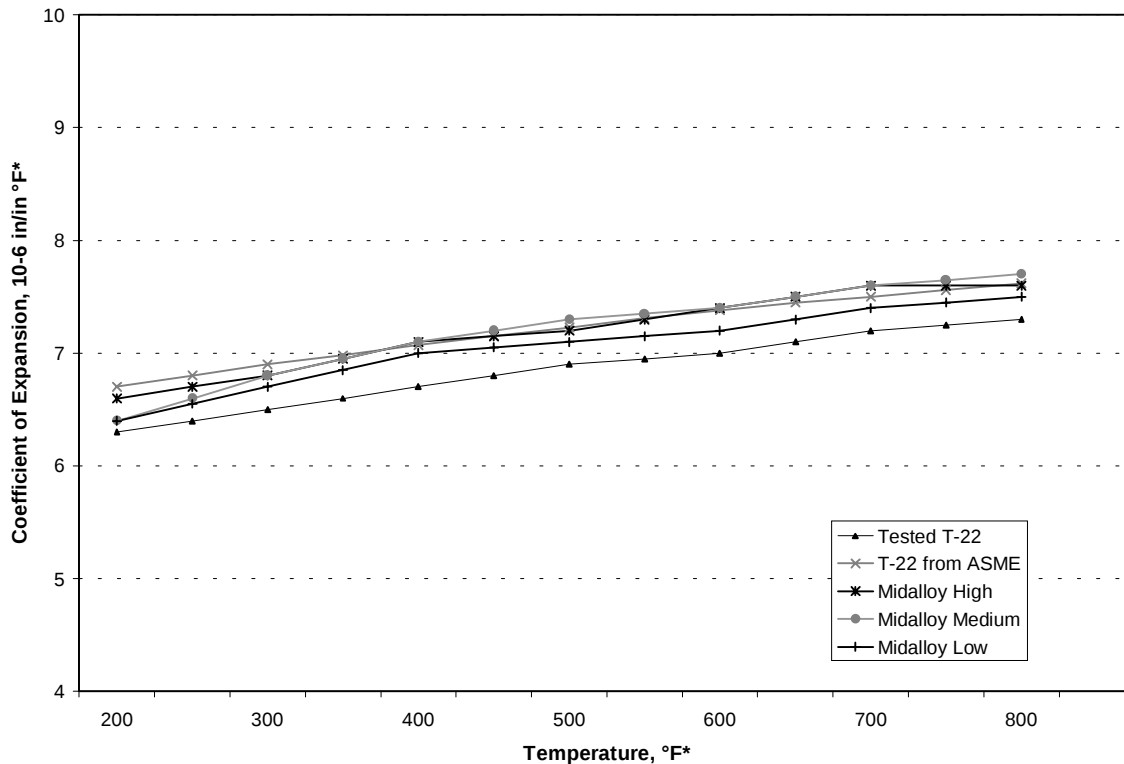
**Figure 3-11**  
**Heat Input Effect on Thermal Expansion, Type 312 SS**

The results are shown in Figure 3-11. Very little effect on thermal expansion rate was measured between the three samples. It is believed that the machine settings required to achieve sound welds limit the heat input to a range that has little effect on delta ferrite formation.

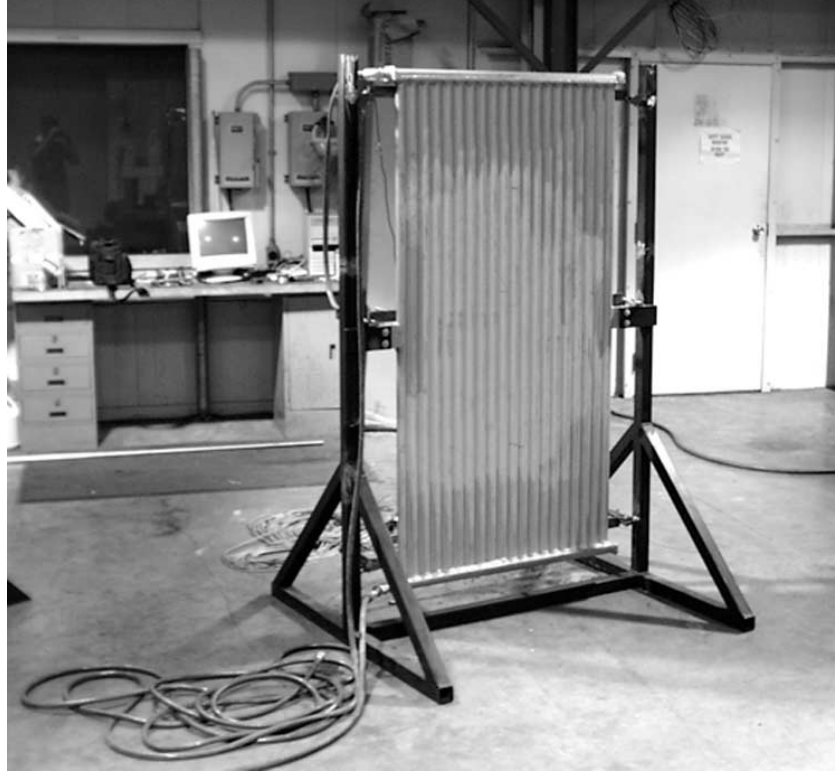
**Figure 4-1**  
**Waterwall Panel Mockup – Front View**

A mockup of a small waterwall panel was constructed to allow welding trials to be performed in the FRAC facility. Panels were manufactured from SA-213 T-22 tubing that was 1 ¼" OD (31.8 mm) X ¼" wall (6.4 mm). The tubes were on 1 ¾"(44.5 mm) centers with a membrane between. The panels were 20 tubes wide and measured approximately 34" (0.86 m) wide by 65" (1.7 m) tall. A fixture was built to hold the panels in the vertical position, and headers were added to the top and bottom to allow water to be circulated through the panels to simulate water backing. A sample mockup panel can be seen in the fixture in Figures 4-1 and 4-2.

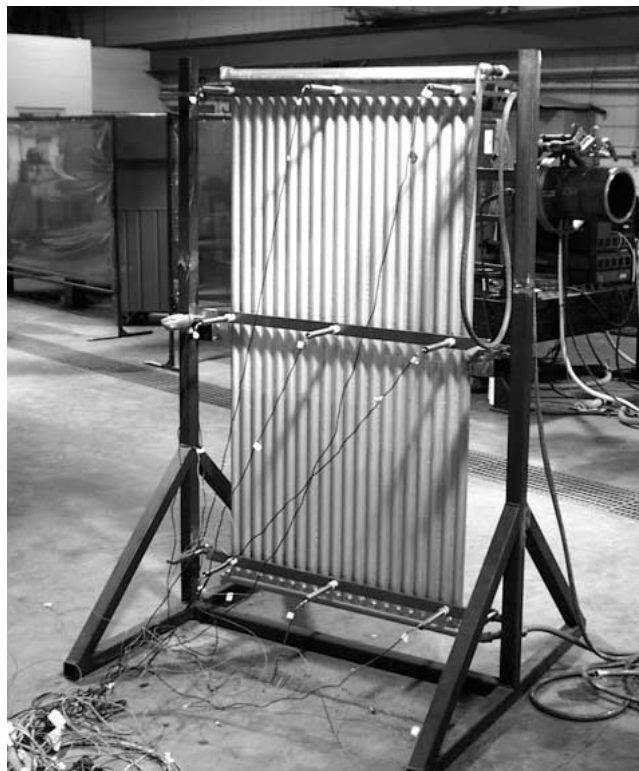
**Figure 4-2**  
**Waterwall Panel Mockup - Back View**

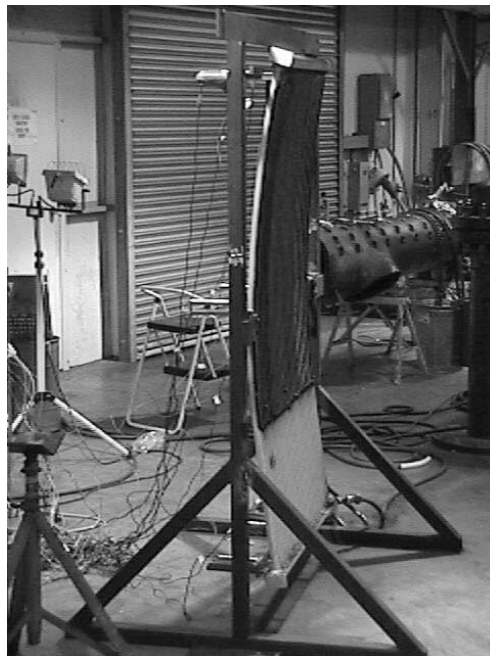
**Figure 4-3**  
**View of Panel as Welded**

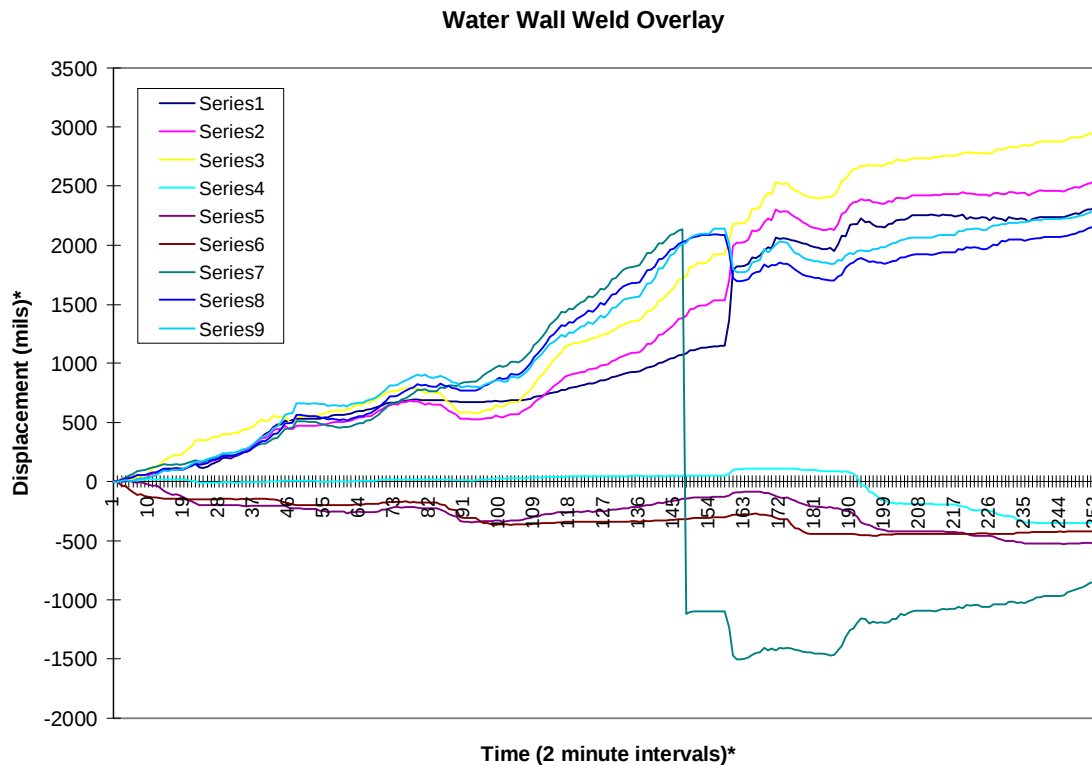
**Figure 4-4**  
**Typical Waterwall Distortion**

There is a tradeoff between welding speed and distortion. A welding contractor can slow down the welding process and decrease the distortion. There should be a balance between production and distortion. One typical distortion achieved by these tests can be seen in Figures 4-3 and 4-4. The jump in the graph in Figure 4-4 at the 160-minute range was caused by running out of travel on the LVDT's, which necessitated repositioning of the instrumentation before additional welding.

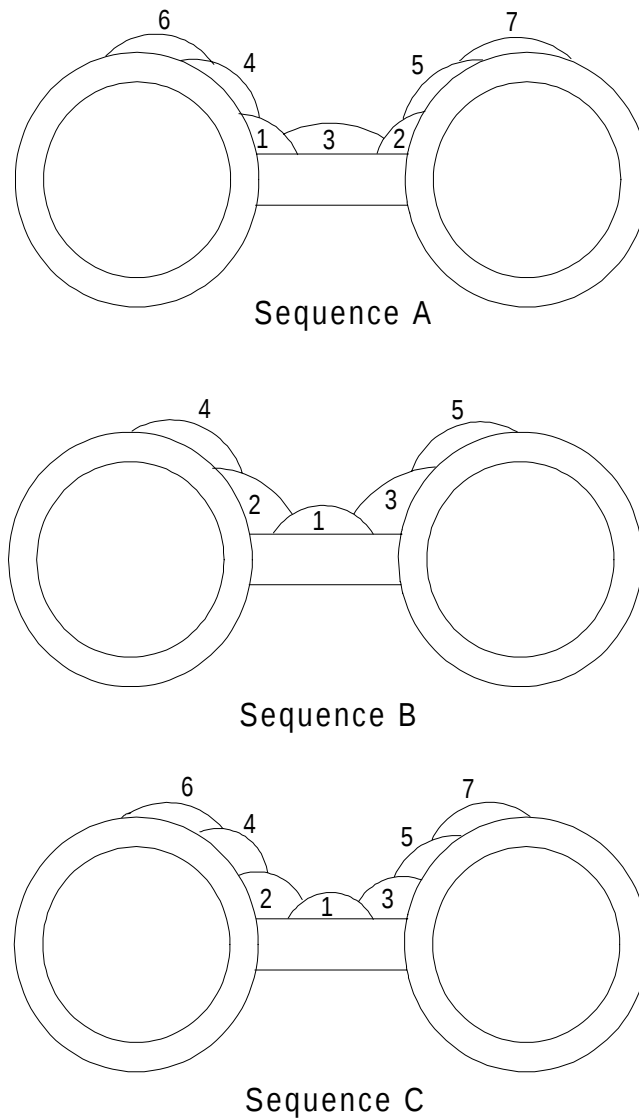
**Figure 4-5**  
**Weld Bead Placement Scenarios**

It was learned that the best results were achieved when the membrane areas of the panel were covered with weld metal first, as opposed to the tube. Some of the bead placement sequences that were experimented with are shown in Figure 4-5. Of these different scenarios, sequences B and C, which placed the first weld bead in the center of the membrane web, provided the best overall welding characteristics.

If the corners were welded first, as is shown in sequence A, lack of fusion was noted in the corners of the third bead. The stick-out changes of the filler metal during the welding process were also minimized by this bead placement, allowing better voltage and amperage control. It should also be noted that these are weld bead sequences for one pair of tubes. During the actual weld overlay operation, the welding head should be moved around on the waterwall to keep from curving the panels sideways.

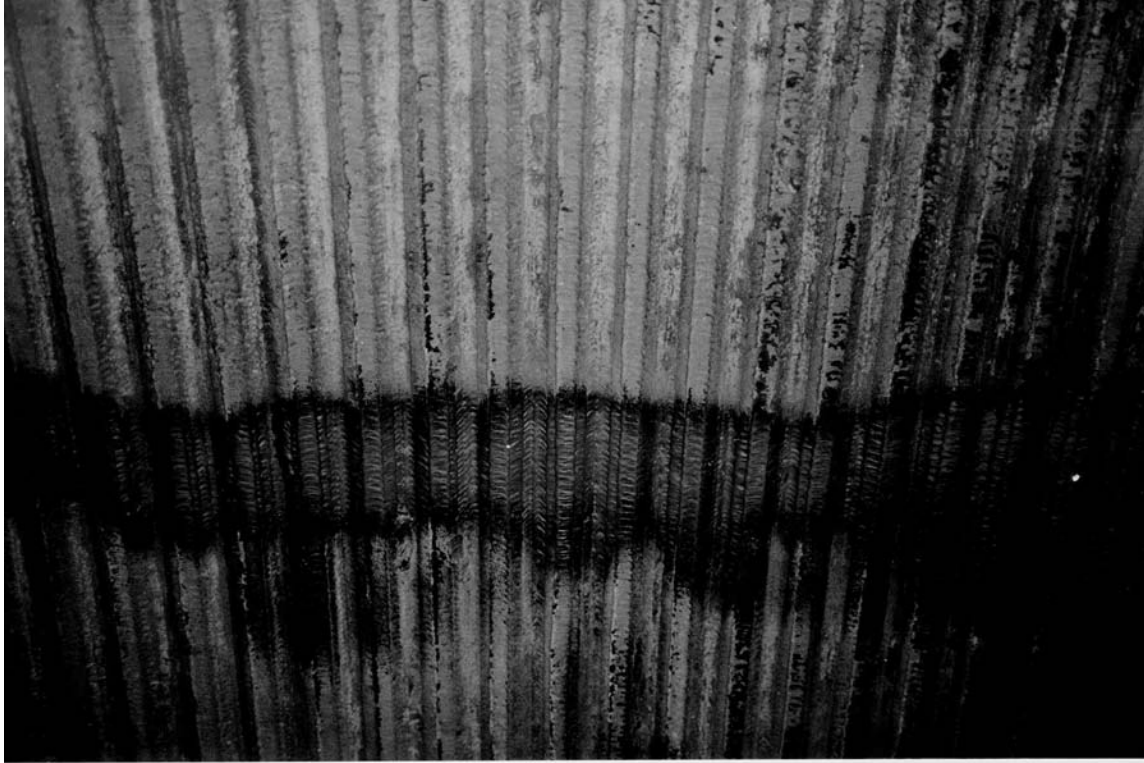
**Figure 5-1**  
**View of overlay after 5 months of service**

The unit was returned to service and subsequently removed from service after five months to replace the thin tube panel that was left in service and perform inspection of the overlay. In general the overlay looked very good. Scaffolding was erected in the boiler and one foot bands were blasted at each scaffold elevation to allow for ultrasonic thickness measurements. Virtually no wastage was noted. Visual inspection of the original weld ripples indicated no wall loss. A typical section of the waterwall overlay can be seen in Figure 5-1. The weld ripples can be seen clearly in the blasted areas.

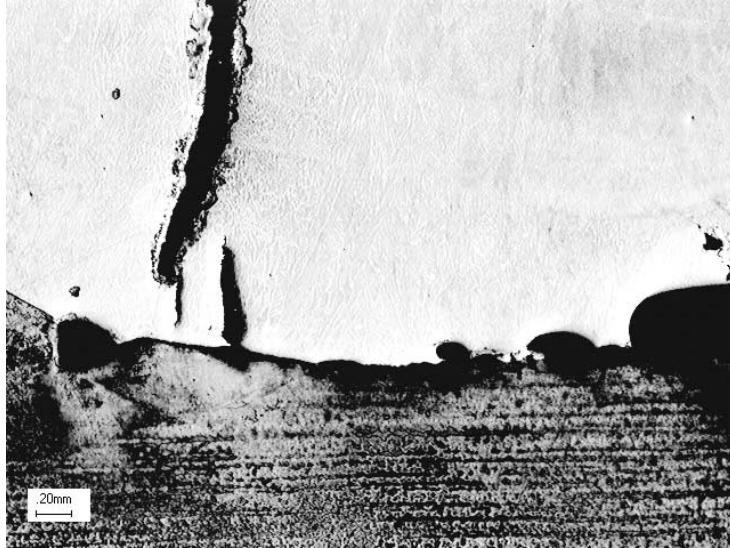
**Figure 5-2**  
**Photomicrograph of crack indication showing underbead deposits**

The overlaid panel containing the cracks was shipped to the EPRI Charlotte Facility for metallurgical evaluation. While the depressed delta ferrite content is thought to have been a contributing factor in the cracks, all of the cracks contained underbead deposits. Most were at the start or stop of an ER80S-B2 welding bead. No cleaning was performed between the weld buildup with the ER80S-B2 filler and application of the Type 312 SS filler. The underbead deposit could possibly have been caused from deposits on the tubing that were not originally

blasted off before repair welding with ER80S-B2 was performed that floated to the surface of the repair weld. When the Type 312 SS overlay was applied, the deposit acted to cause the cracking. No analysis was performed of the deposit chemistry. A typical crack and underbead deposit can be seen in Figure 5-2.

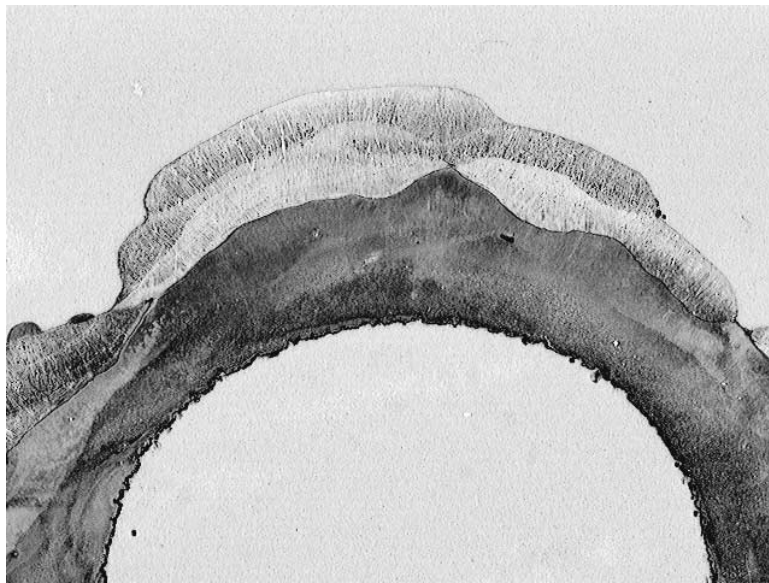
**Figure 5-3**  
**Cross section of overlaid tubing with incomplete coverage**

Additionally, some areas of tubing were found to have not been completely covered with Type 312 SS weld metal. This can be seen in Figure 5-3. Care must be performed during the welding and inspection stage of waterwall overlays. Any area that is not completely covered will result in a tube failure in a short duration.

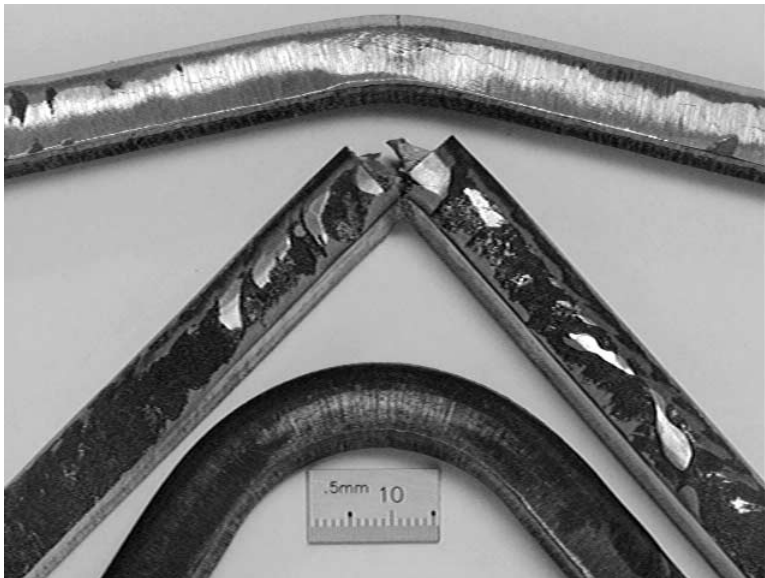
**Figure 7-1**  
**Weld overlay tests after tempering and bending**

Literature indicated that the effects of the embrittlement could be reversed by heating the embrittled weld metal to 1020°F (549°C). Investigation of this ability to reverse the embrittlement was performed on 3/8" side bend coupons from the tubing. Coupons were heated to 1100 °F and 1200 °F for one hour. These coupons were then subjected to side bend testing. The coupons subjected to 1100 °F demonstrated improved ductility over the serviced aged samples but still failed. The 1200 °F samples passed bend tests. Sample bend test coupons can be seen in Figure 7-1. The top coupon was tempered at 1100 °F, the middle coupon was as removed from the boiler, and the bottom coupon was tempered at 1200 °F.

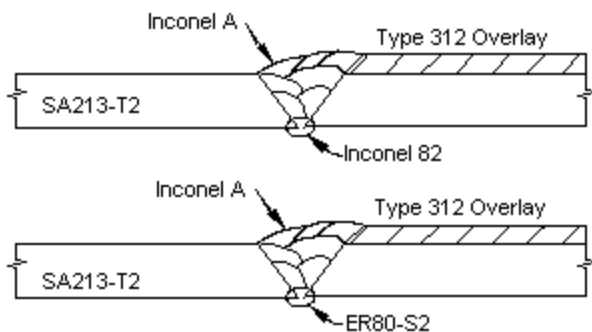
**Figure 7-2**  
**Typical joint geometries for tubing replacement**

Evaluation of preliminary repair welding procedures was completed on weld coupons prepared from the Big Sandy Unit 2 waterwall panel. These tubes were machined to a standard  $37\ 1/2^\circ$  welding bevel. Coupons were also machined as above only the overlay was machined back approximately  $3/8"$ . This was performed to demonstrate a standard tube replacement then addition of a localized corrosion resistant overlay over the repair weld. Inco A, Inco 82, ER 80-S2, E8018-B2, and ER312 fillers were utilized. Figure 7-2 shows the joint geometries and fillers that might typically be utilized in the replacement of a damage tube section. The first weld joint in Figure 7-2 utilized a GTAW root with Inco 82 filler followed by an Inco A fill using the SMAW process. Side bends of this procedure failed in the root pass. Next a procedure was tried using the bottom weld joint in Figure 7-2. The weld joint passed bend tests in the weld region but failed about  $3/16"$  out into the Type 312 SS overlay. As indicated earlier, some softening of the embrittlement was accomplished in the HAZ. This is indicated because the overlay did not crack adjacent to the replacement weld.

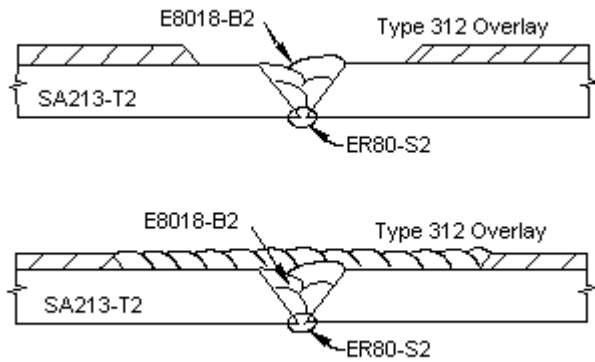
**Figure 7-3**

**Possible procedure for repair welds using matching filler metal followed by corrosion resistant overlay**

Figure 7-3 shows a typical overlay technique that could be applied to a field weld to protect the pressure retaining joint weld metal. In this demonstration, the damaged tube was replaced with a piece of tubing that had previously been overlayed with Type 312 SS to about  $1/2"$  of the pressure retaining weld joint. The circumferential pressure retaining weld joint would be completed using typical welding procedures that require a GTAW root pass followed with SMAW fill passes utilizing filler metals that match the base metal chemistry. A Type 312 SS overlay would then be applied to protect the low alloy steel tubing and weld from the products of combustion.
