# **Training Aids for Visual/Tactile Inspection of Electrical Cables for Detection of Aging**

**1001391**

Final Report, March 2002

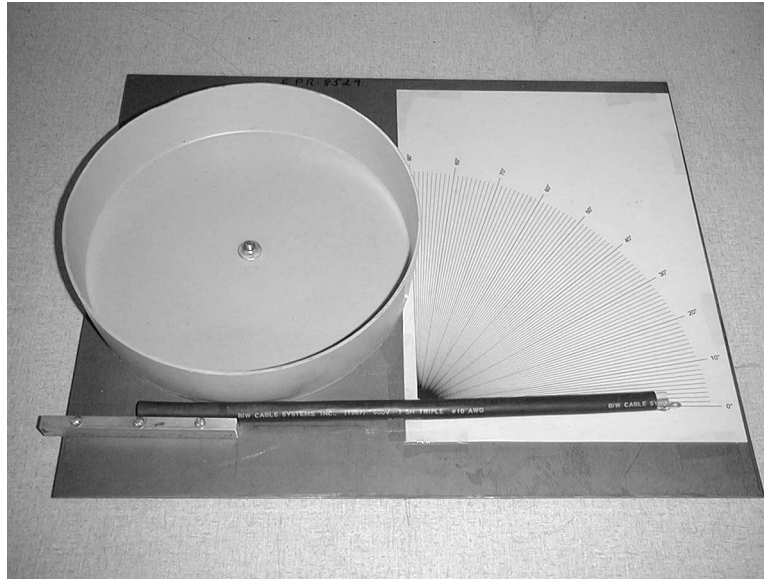
**Figure 1-1**  
**Bend Test Fixture with BIW Cable**

The bend test after the initial thermal aging period was performed according to Nutherm's "Engineering Instruction 8529-EI-3, Rev. 0 included in Appendix IV." Prior to testing, each specimen was visually inspected for signs of cracking or other abnormalities. The mandrels used for each cable and wire type during the bend tests are shown in Table 1-3. Figure 1-1 shows a bend test in progress.

After a third thermal period of thermal aging, no visible cracking occurred as well, and testing was then performed with smaller diameter mandrels to determine if cracking would occur. Mandrels as small as 19.05-mm (0.75-in.) diameter were used; however, cracking was observed only in the jacket of the BIW cable from aging step 4.

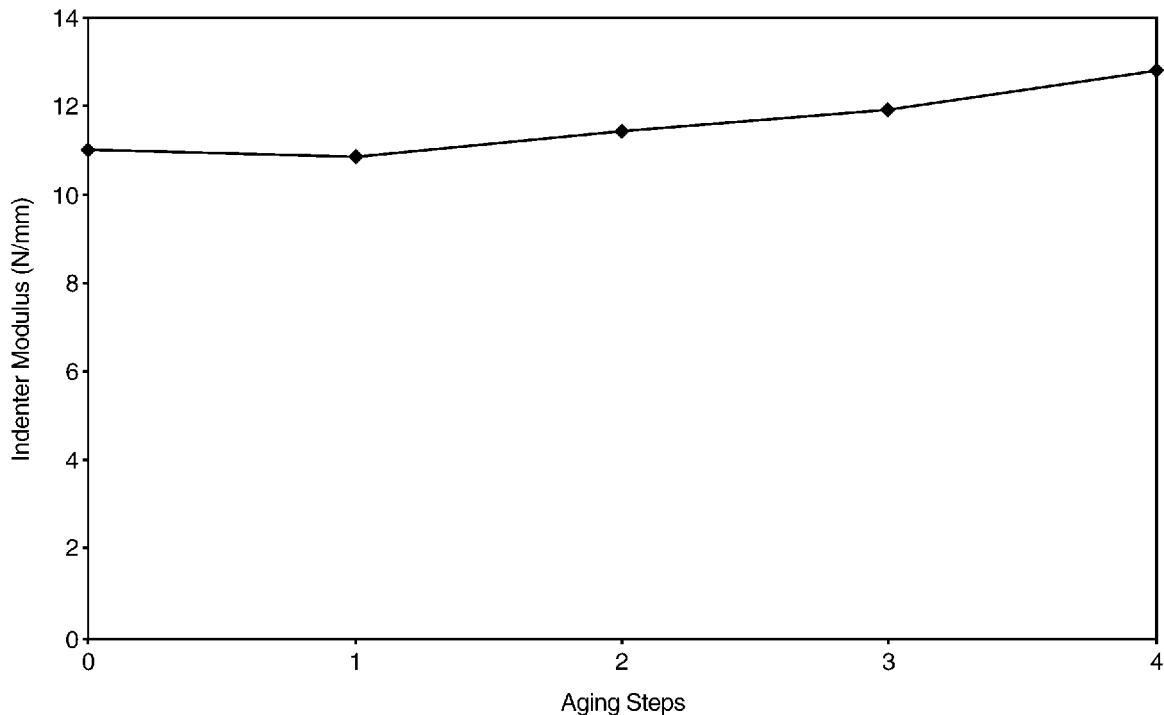
**Figure 2-5**  
**BIW Wire Indenter Modulus versus Aging Steps**

The indenter data presented in Table 1-4 of Section 1 provides a more refined definition of the degree of aging of the insulations and jackets than visual or tactile evaluation. The indenter modulus versus the aging steps is shown in Figure 2-5 for the BIW wire. While there is a gentle increase in indenter modulus, the aging of this EPR/CSPE insulation has been very limited with respect to the capability of this particular composite. The aging has not shifted the indenter modulus significantly from the unaged condition of 11 N/mm. From other tests of the BIW wire, significant hardening of the CSPE jacket of the composite insulation will ultimately occur.

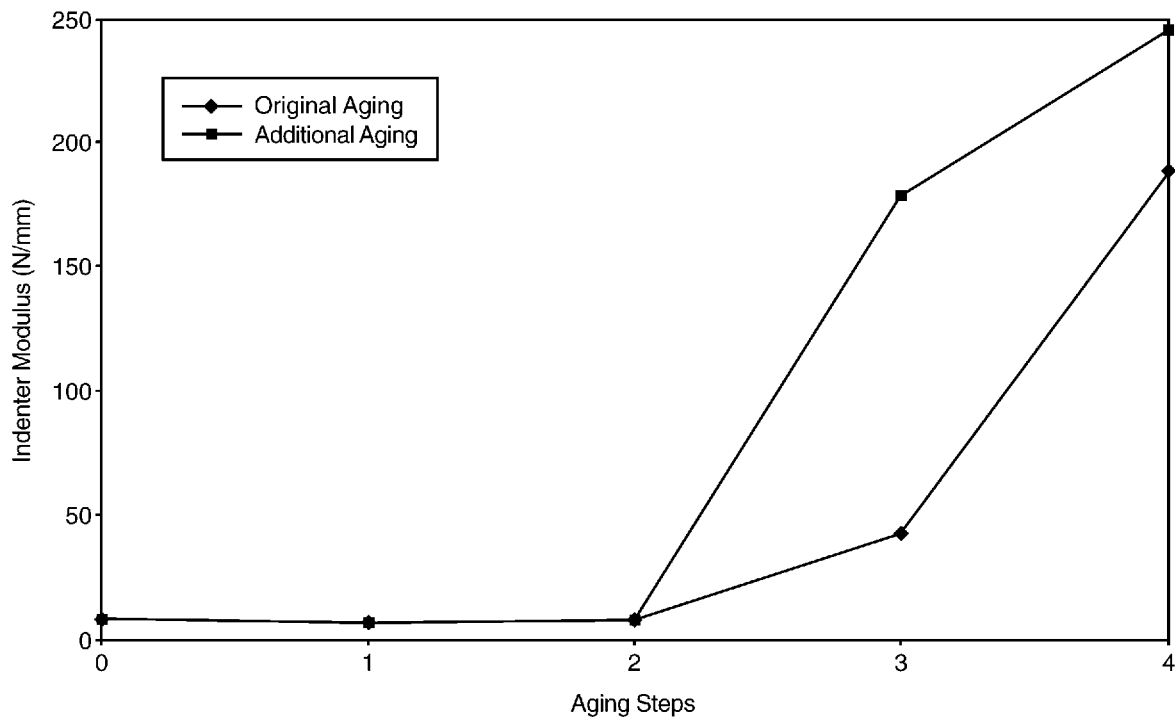
**Figure 2-6**  
**BIW Cable Indenter Modulus versus Aging Steps**

Figure 2-6 provides the indenter modulus for the BIW cable overall CSPE jacket. As described in Table 2-2, the hardening between aging steps 3 and 4 is severe. The condition of these cables has resulted from additional thermal aging by comparison with other cables in the program. Figure 2-6 shows two different indenter plots for aging steps 3 and 4. The less severe of the two is for the original aging. The more severe is with the additional aging that is representative of the jackets in the training aids. An indenter modulus of 100 N/mm or greater for CSPE indicates severe aging. A modulus of 219.6 N/mm indicates extreme aging for this cable.

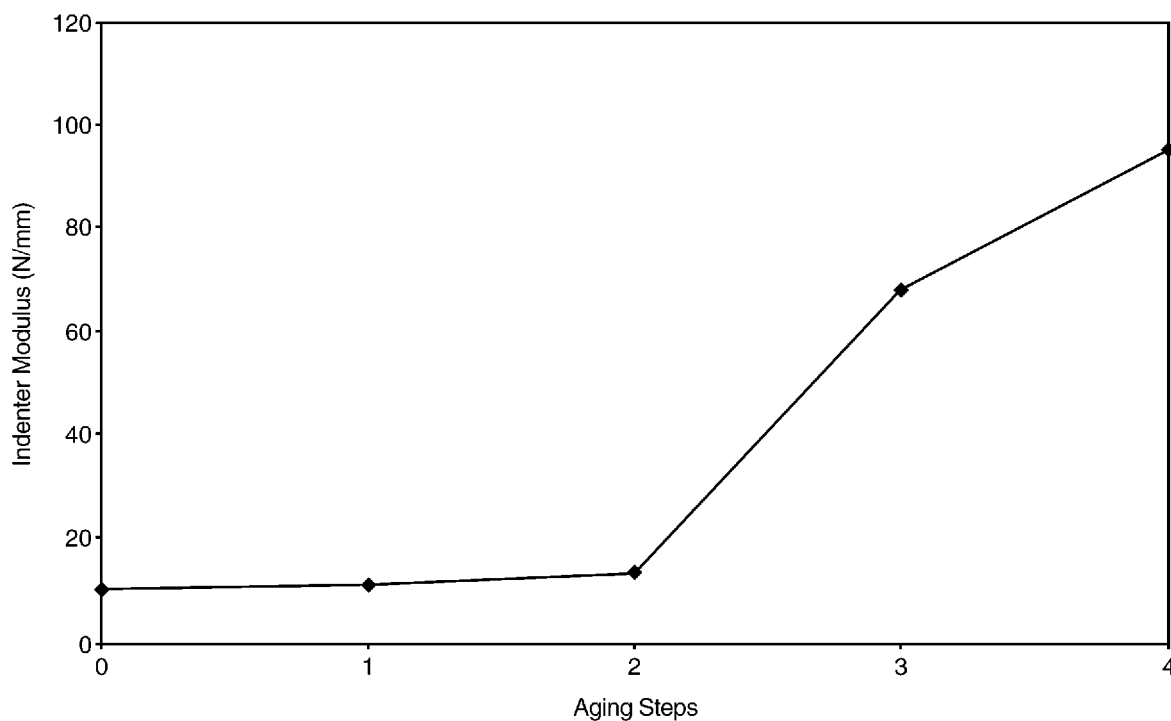
**Figure 2-7**  
**Okonite Wire Indenter Modulus versus Aging Steps**

Figure 2-7 provides the indenter modulus for the Okonite wires. Between aging steps 2 and 3, significant hardening occurs so that the jacket of the composite insulation becomes brittle. The hardening is extreme for aging step 4 on the Okonite wires so that no flexibility is available and cracking occurs immediately under manipulation. The indenter modulus of the composite insulation is shown in Figure 2-7 with 70 N/mm for step 3 and 95 for step 4.

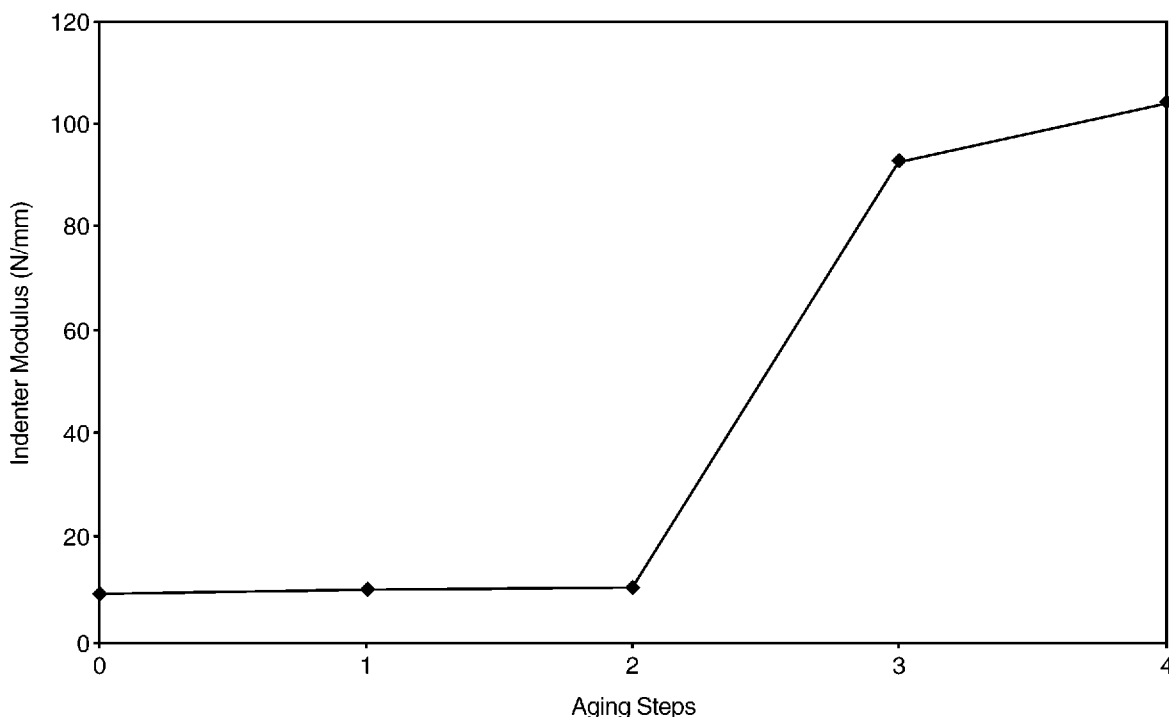
**Figure 2-8**  
**Okonite Cable Indenter Modulus versus Aging Steps**

As described above, the Okonite cable does not appear to have aged significantly upon initial inspection. However, Figure 2-8 indicates that severe hardening of the CSPE occurred between aging steps 2 and 3 and further hardening occurred at step 4. Careful manipulation of the specimens proves that the aging of steps 3 and 4 has caused significant hardening and loss of elongation properties. Sharp bending of the cable causes cracking at steps 3 and 4.

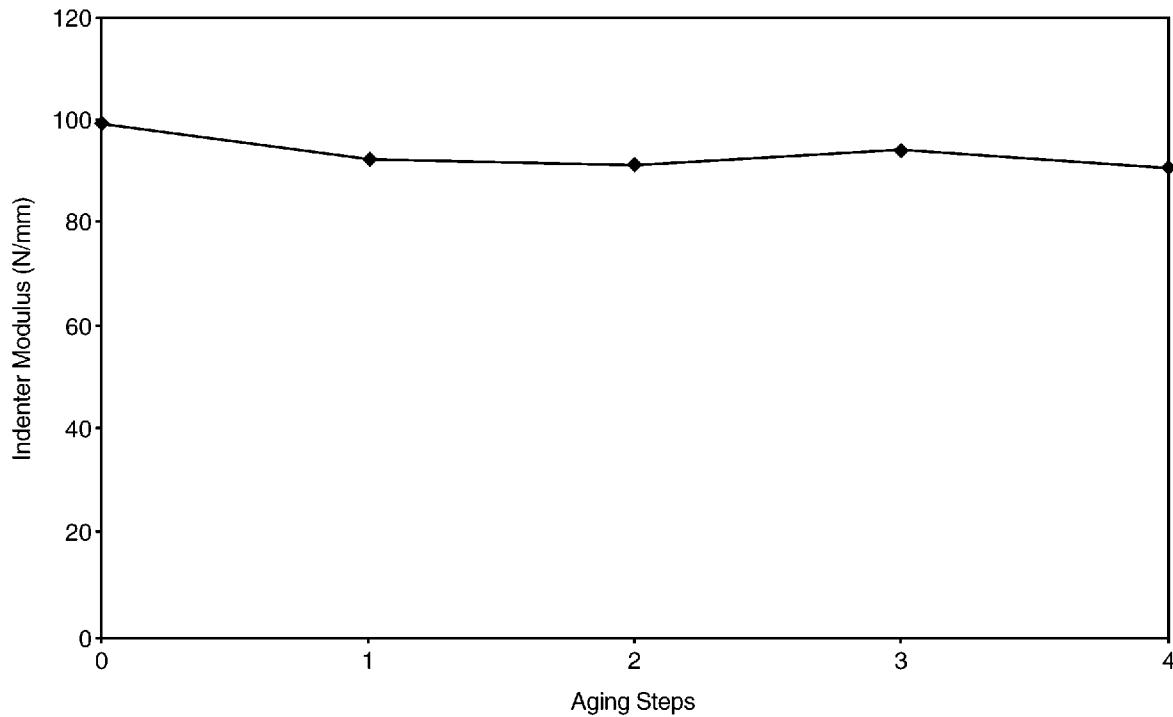
**Figure 2-9**  
**Rockbestos Wire Indenter Modulus versus Aging Steps**

Figure 2-9 shows the indenter modulus for the XLPE insulation of the Rockbestos wires. There is a very limited softening trend in the data; however, this trend is probably more related to changes in the crystalline melt curve from heating and cooling during the oven exposure than to actual aging. The differences in indenter modulus are not significant in this curve. Severe aging, well beyond that in the program, would ultimately lead to severe, sudden hardening. However, the aging of these specimens is not significant with respect to overall aging. The specimens have been provided to show that XLPE material is hard at room temperature and remains that way during aging.

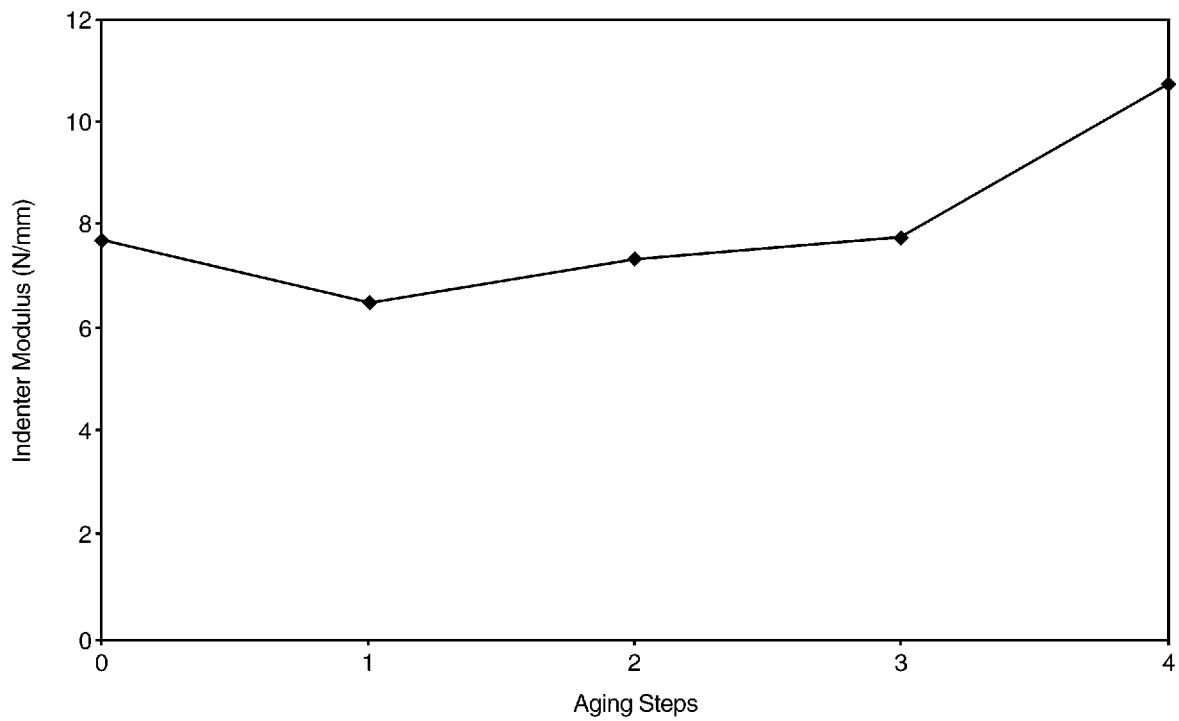
**Figure 2-10**  
**Rockbestos Cable Indenter Modulus versus Aging Steps**

The CSPE overall jacket has not been significantly aged in the development of the specimens. A small increase in the indenter modulus is noted for aging step 4, as can be seen in Figure 2-10. More aging would cause this jacket to age as did the Okonite overall jacket. Further aging, as occurred for the BIW cable in steps 3 and 4, would cause the jacket to harden severely.
