# Impact of Emergency Operating Temperatures on the Integrity of XLPE Transmission Cable Systems

**1001859**

Final Report, December 2003

**Powertech Labs Inc.**

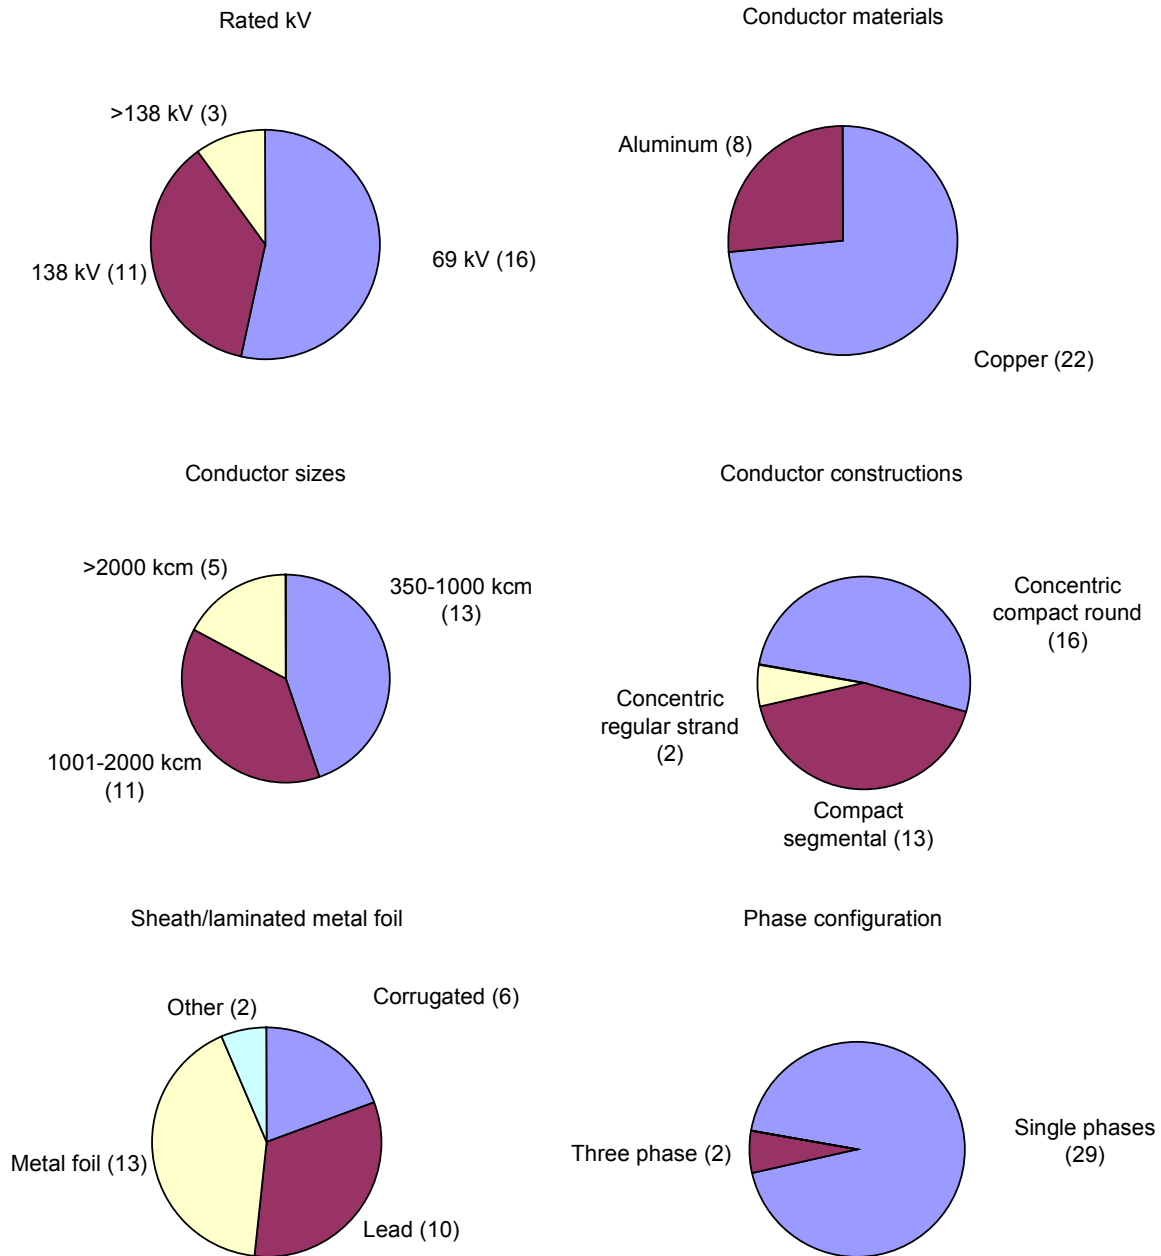
**Figure 2-1**  
**Pie Charts Showing Survey Results Breakdown**

The mechanical behavior of the cables depends on the type of sheath, so the survey results have been further broken down by sheath type in Tables 2-2 through 2-4. The overall results are shown graphically in Figures 2-1 and 2-2.

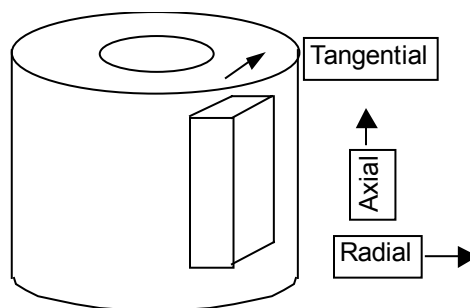
**Figure 3-1**  
**Orientation of XLPE Block Samples Cut from Cable Insulation**

The two cable segments were cut to about 10 cm long and both ends turned smooth on a lathe. One segment (S) had the aluminum sheath and jacket removed, and the other (F) was tested as a complete cable segment. Two XLPE block samples were cut to smooth rectangular blocks about 7 x 1 x 2 cm, with the long dimension along the axis of the cable. A sketch of the block samples is shown in Figure 3-1.

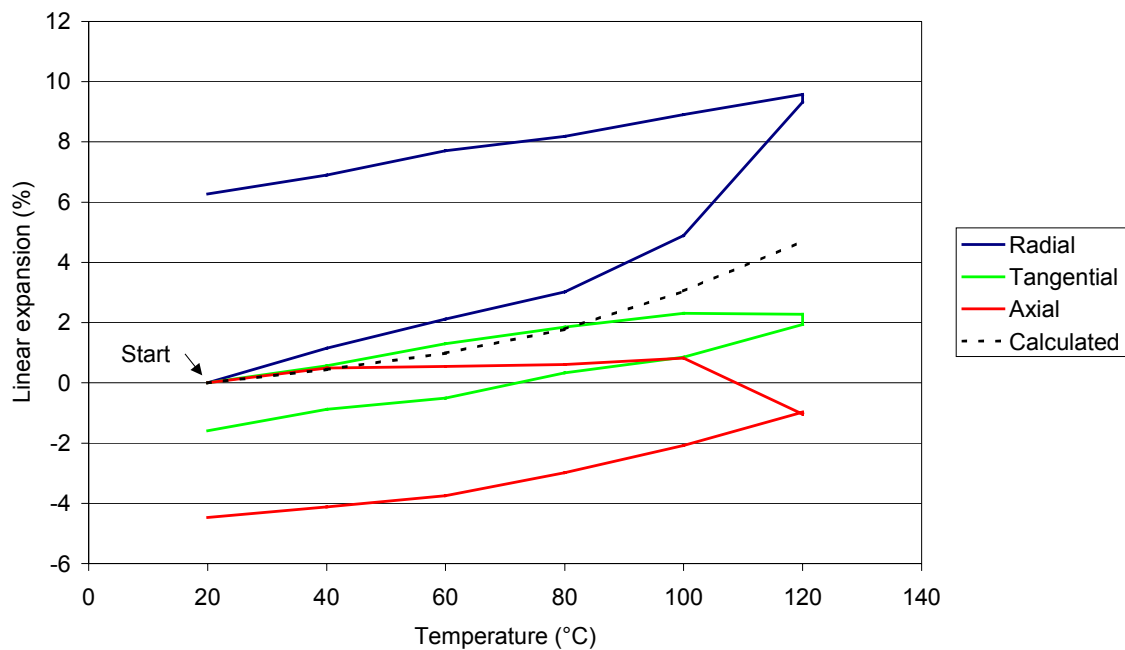
**Figure 3-2**  
**Linear Expansion of XLPE Block Samples During the Oven Heating Test**

The lengths of the cable samples were measured at 6 locations each and the diameters over the extruded XLPE semicon insulation shielding at 3 locations with a digital caliper or micrometer at room temperature. The three dimensions of the XLPE blocks were also measured at two locations each with a digital caliper. All four samples were heated in an oven at 40°C for 2 hours, then removed from the oven one at a time and measured as quickly as possible. The oven temperature was raised to 60°C, and after two hours the measurement was repeated. This process was continued in 20°C increments to 120°C. The samples were left for 2 additional hours at 120°C, then cooled and measured in 20°C decrements down to room temperature. The measured dimensions (averaged over duplicate measurement locations) are listed in Table 3-2. The changes in measurements for the XLPE blocks are plotted in Figure 3-2. Each curve starts at zero at room temperature, and shows the expansion during heating followed by the contraction during cooling. There is significant distortion and hysteresis in the XLPE at high temperature, and at 120°C the material was observed to soften and change color. On examination of the results it was observed that the curves during cooling are much more consistent with the theoretical coefficients of linear thermal expansion than during heating. When the contraction measured during cooling was plotted beside the calculated curves, as shown in Figure 3-3, satisfactory agreement was obtained.

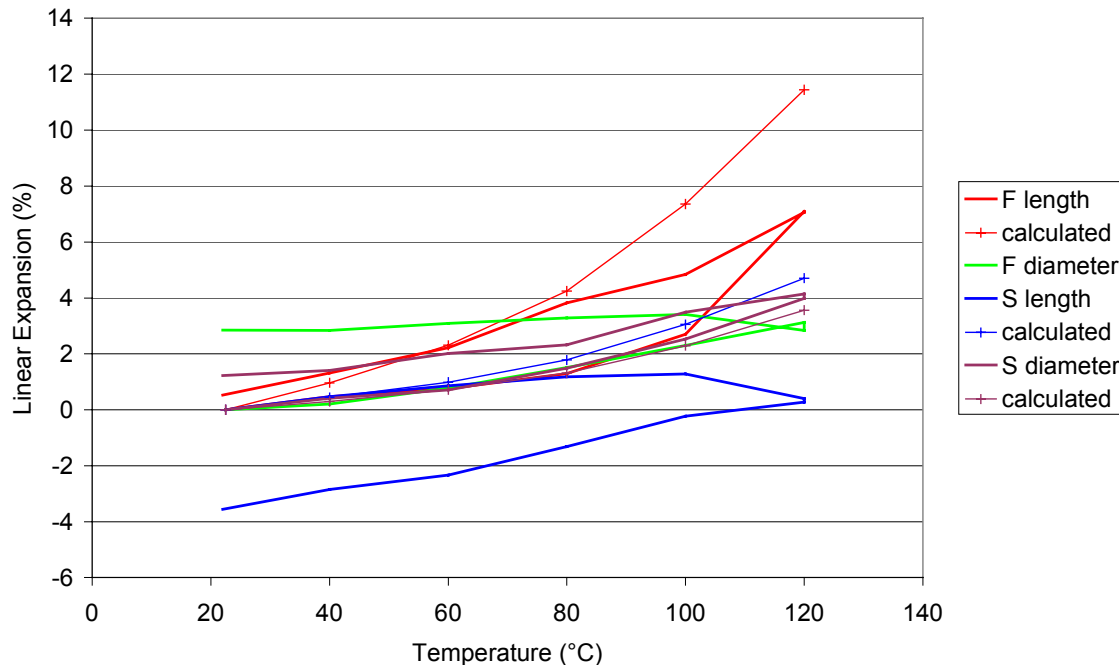
**Figure 3-4**  
**Linear Thermal Expansion of Cable Samples. Curves Labeled F Relate to the Complete Cable and Curves Labeled S Relate to the Cable with Jacket and Sheath Removed**

Analysis of the changes in dimension of the cable segments is more complicated, since the effect of the conductor and sheath must be taken into account. These measurements were used to check the finite element model that was later used to calculate mechanical movement and stresses in the complete cables. A finite element model was constructed using the Cosmos program to simulate each of the cable segments used in the oven test. For the complete cable segment (F), the axial expansion as constrained by a corrugated aluminum sheath was calculated. For the segment with the jacket and sheath removed (S) curve, the unconstrained axial expansion was calculated. For the diameter modeling, the unconstrained expansion in the diameter was calculated. As with the XLPE block samples, there were large differences between the heating and cooling curves, indicating hysteresis and an effect that could be called ‘slumping’, in which the hot polyethylene flows under the effect of gravitational force and expansion, and then hardens in the new shape. These effects are evident in Figure 3-4. These curves illustrate the complicated behavior of this material during heating and cooling. The diameter of the complete cable, constrained by the aluminum sheath, showed a large hysteresis, while the relatively unconstrained length showed less hysteresis. The cable with the jacket and sheath removed behaved very differently, as gravity caused the material to slump, reducing the expansion in length, and a large hysteresis occurred in the length, while the hysteresis in diameter was much less. As before, the linear expansion during cooling (except for the diameter of the complete cable, where the heating curve was used) was more consistent and produced the best match with the finite element model calculations, as shown in Figure 3-5.

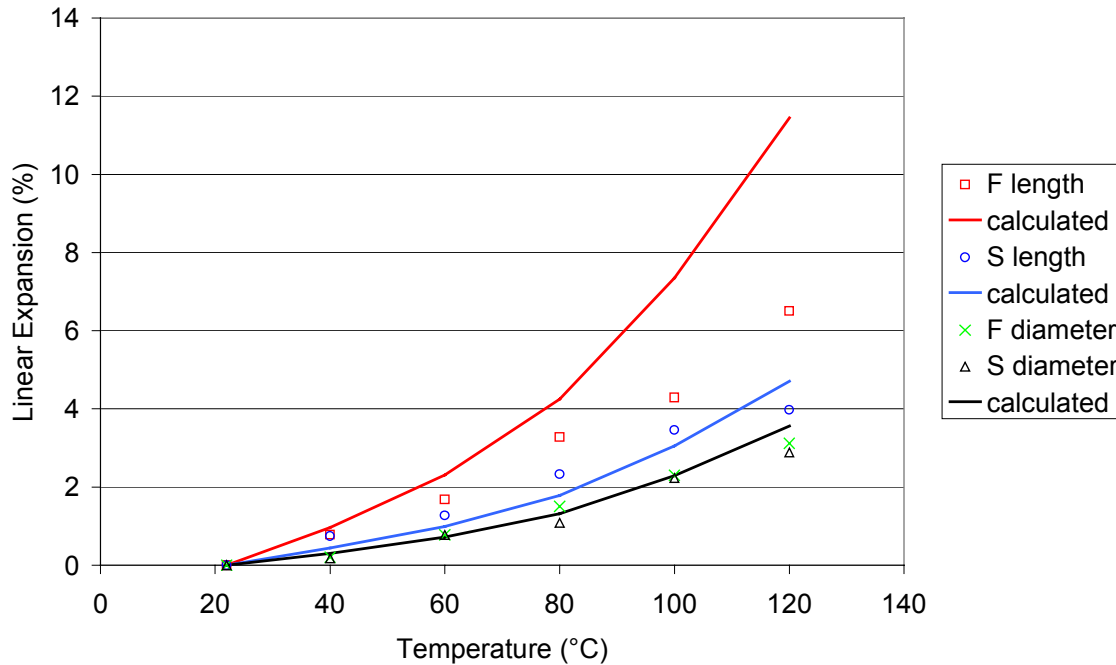
**Figure 3-5**  
**Cable Sample Linear Expansion During Cooling from the Oven Expansion Test.**  
**Curves Labeled F Relate to the Complete Cable and Curves Labeled S Relate to the Cable with Jacket and Sheath Removed**

When the calculated and measured curves are plotted together in Figure 3-5, there are obvious discrepancies. The core diameter of the complete sample (from heating), and the length and diameter (from cooling) match the finite element curves reasonably well, but the measured length of the sample with jacket and sheath removed does not fit the model curve. If the actual heating and cooling curves are considered, the discrepancies are even worse. These discrepancies illustrate one of the major lessons of this project, that the tools of conventional finite element analysis are insufficient to model the observed hysteresis effects in XLPE insulation. The finite element program did not have any tools capable of modeling the irreversible temperature and force dependent distortions that were observed, nor do we have the theoretical understanding to model these forces even if we had the tools. Attempts to duplicate this behavior in a computer model were unsuccessful, and it must be left to a future research project to study and develop an understanding of hysteresis effects in XLPE. While one of the goals of this project was to develop tools for modeling the behavior of cables at high temperatures and mechanical stress, this information appeared to move that goal out of reach. Before the modeling tools can be developed, some fundamental research is required on the irreversible distortion, or hysteresis that occurs in XLPE after cycling to high temperatures.

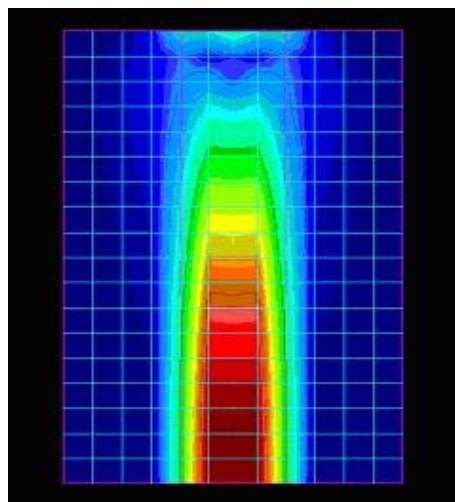
**Figure 3-6**  
**Color Contour Plot of the Stresses in the Constrained Finite Element Model**

Figure 3-6 shows a color contour map of the internal stresses in the constrained finite element model, with the bottom end fixed and the upper end allowed to expand. This illustrates the finite element techniques that were used to calculate the expansion of the cable segments as a function of temperature.

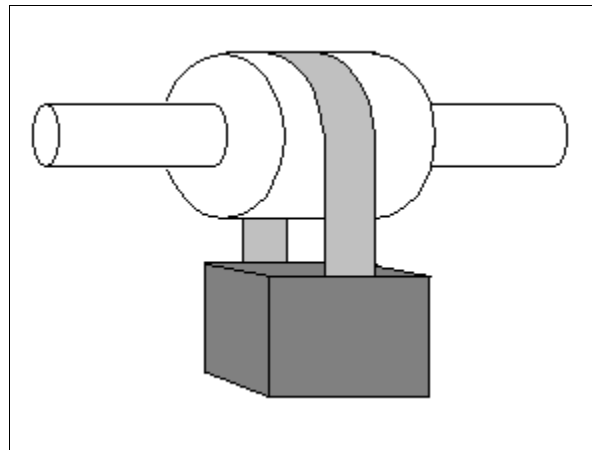
**Figure 4-1**  
**Diagram of Loaded Temperature Cycling Tests**

the width of the support strap. Preliminary tests showed elastic deformation as expected, but no long term creep or plastic failure. After the first hour or two, no further deformation occurred, even at temperatures up to 200°C with the stress maintained continuously for several days. The preliminary tests did reveal hysteresis that occurred when the temperature was cycled, so additional tests were performed to investigate this phenomenon.

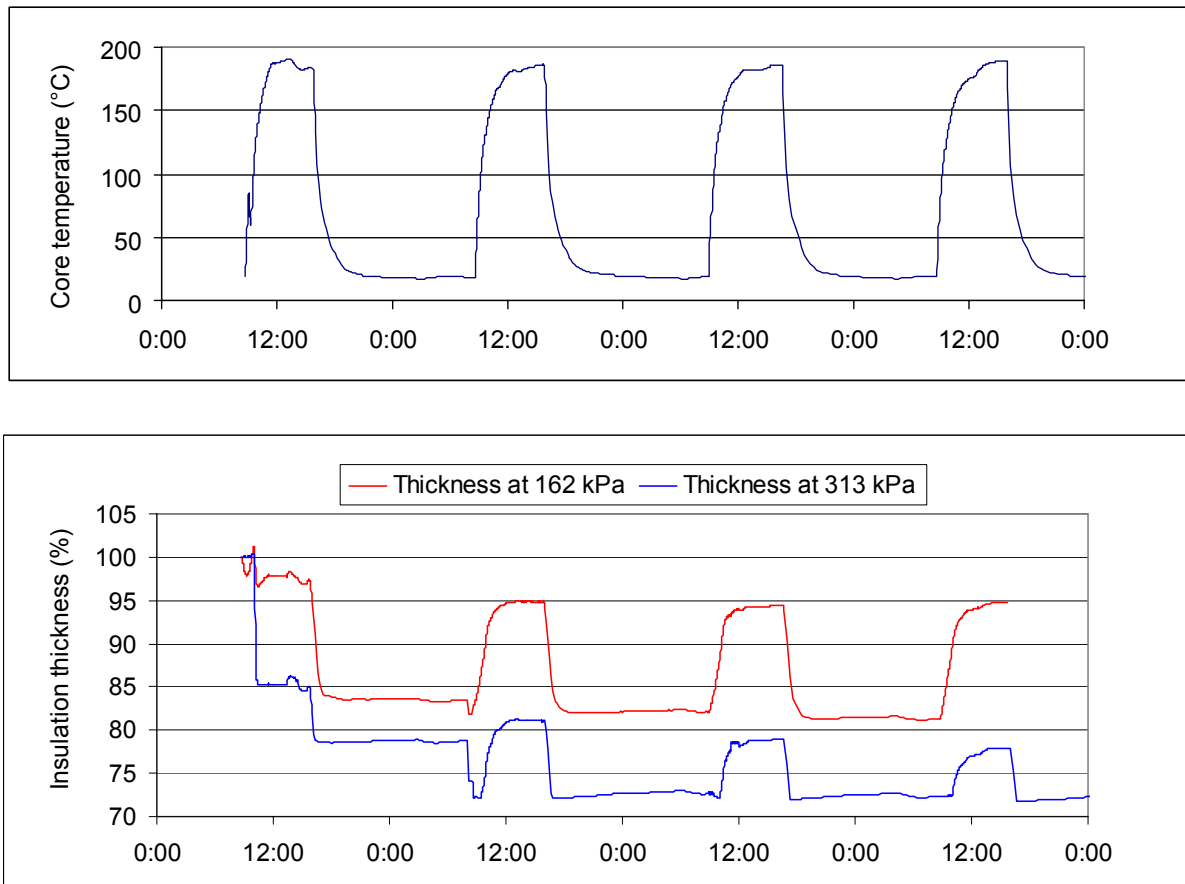
**Figure 4-2**  
**Variation of Thickness During Loaded Temperature Cycling**

At room temperature loads of this magnitude will cause a compression of less than 0.5% in the thickness. During the first heating interval, two opposing forces are at work. The XLPE has a large coefficient of thermal expansion and will therefore tend to expand, but the elastic modulus drops with heating, and so the softer material is compressed by the load. During the first heating interval, the deformation depends mainly on the stress. When the material is unloaded, it expands

substantially, consistent with the high thermal expansion coefficient, which was predicted at a free expansion of 5% to 10%. When a moderate compression stress is applied (162 kPa), the amount of increased compression is roughly equal to the thermal expansion, so there is very little change in thickness (red curve in Figure 4-2). When a higher compression stress is applied (313 kPa), the increased compression is greater than the thermal expansion, and there is a substantial net compression of the material as it is heated (blue curve in Figure 4-2). During the subsequent cooling interval, in which the stress was maintained constant, both samples contracted by the expected 5 to 10% as they cooled under load. In the next heating, both samples showed a relatively small compression followed by thermal expansion. In subsequent heating and cooling cycles, there was no more hysteresis, and samples showed a fairly consistent behavior of expansion during heating and contraction during cooling, with a magnitude in the 5 to 15% range. At the end of the process the samples were allowed to cool and the weights were removed. The measured insulation thickness had decreased by 10% at low stress and 25% at high stress under the support straps, as shown in Figure 4-3.

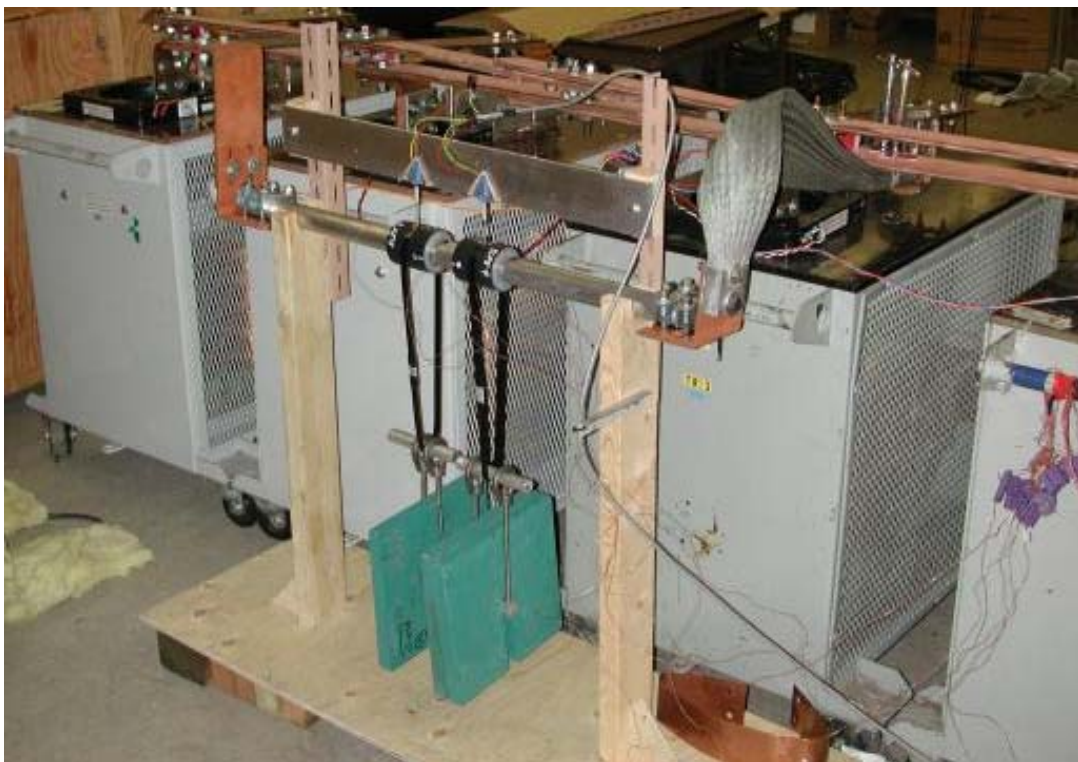
**Figure 4-4**  
**The Test Setup for Loaded Temperature Cycling**

In the second round of tests, two samples were tested, one loaded at 162 kPa (23 psi) and the other at 313 kPa (45 psi). These stresses were selected based on the maximum load that could be applied using the test stand, and were well above the expected stresses in an installed cable. The samples were mounted on a conductor that could be heated to 195°C. The outside was wrapped in thermal insulation to obtain a maximum temperature difference across the XLPE of about 25°C. The samples were subjected to four cycles, each comprising 8 hours of heating and 16 hours of cooling, to investigate inelastic distortion and hysteresis. The measured temperatures and the movement of the top surface of the samples are shown in Figure 4-2. A photograph of the test setup (with the insulation removed) is shown in Figure 4-4.

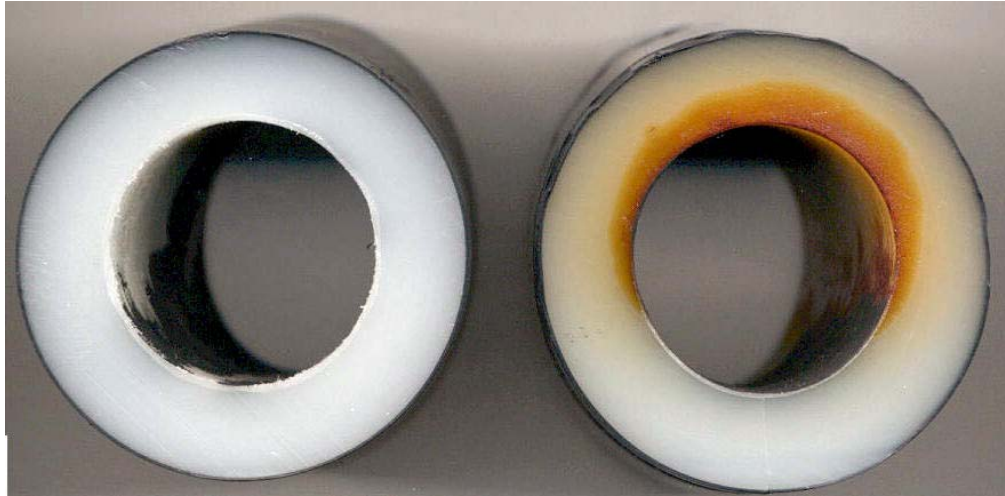
**Figure 4-5**  
**Insulation Color Before and After Loaded Temperature Cycling Test**

The loaded temperature cycling tests demonstrated that the physical properties of XLPE can change with time at high temperature. After several days of heating to almost 200°C the samples showed discoloration as shown in Figure 4-5, and some hardening. This suggested the possibility of a failure mechanism in which the insulation becomes brittle as a result of heating over long periods. The brittle insulation might then be subject to failure when stressed by cable movement or expansion and contraction. It should be noted that the conditions were unusual, since these samples were exposed to the air during the heating, while in normal operation air is excluded from the interior of the cable.

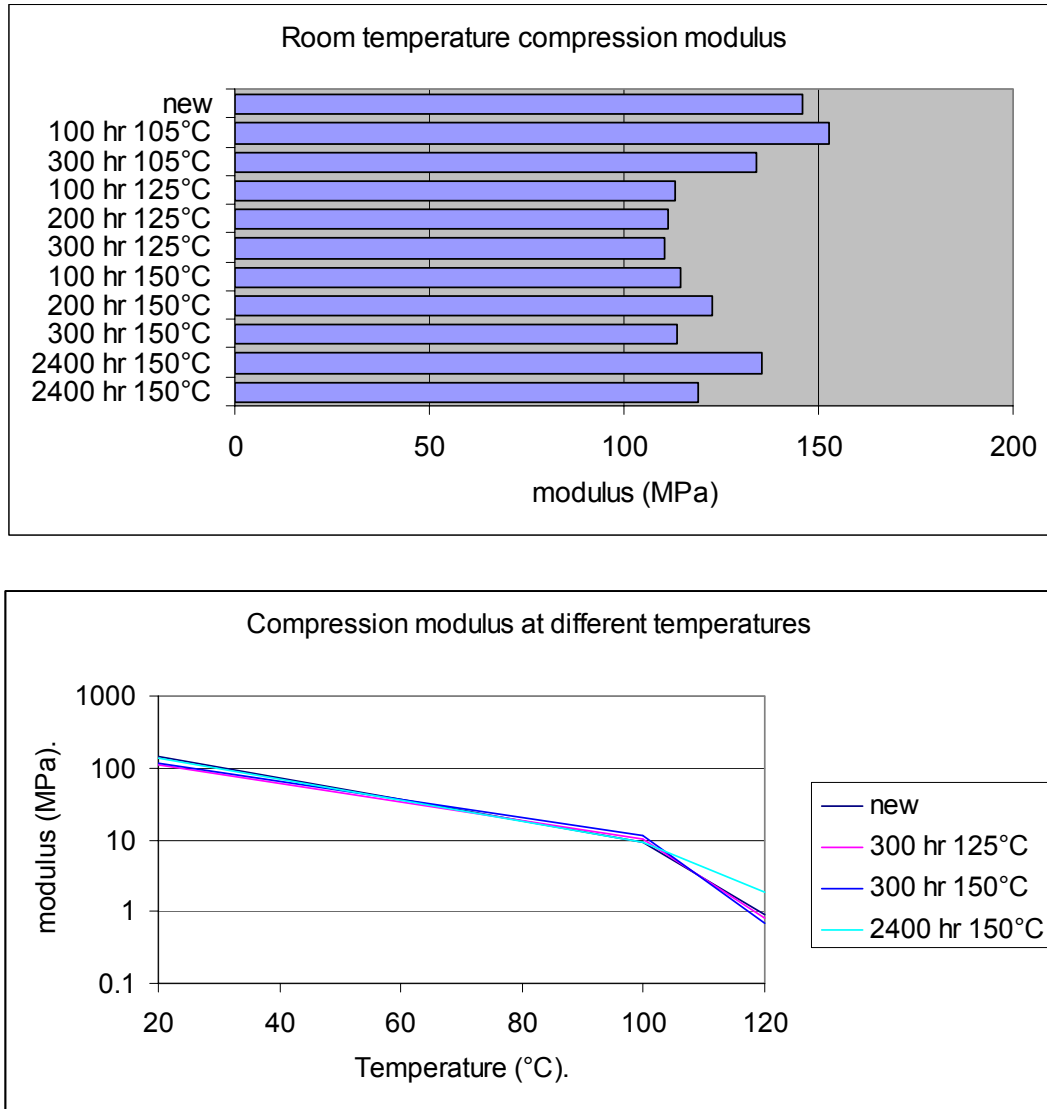
**Figure 4-6**  
**Compression Modulus of XLPE After Aging for the Time and Temperature**  
**Shown on Y axis**

To investigate this possibility, a series of oven heating tests was carried out at different combinations of temperature and duration up to 150°C and 300 hours, and a long term aging test was carried out for 2400 hours (see next chapter). Cylindrical shell samples were baked in an oven for times ranging from 100 to 300 hours, and then the compression modulus of each sample at room temperature was measured to determine whether the elasticity had changed. Additional modulus measurements were made on some of the samples at 100 and 120°C to look for changes to the elasticity at higher temperature. The results of the testing are listed in Table 4-1 and shown graphically in Figure 4-6. Aging caused minor changes in the modulus at a given temperature, including a slight decrease in room temperature modulus on initial aging and a slight increase in the high temperature modulus after 2400 hours of aging, but the changes were not large enough to suggest any threat to the insulation integrity. From these tests we concluded that the mechanical properties of the XLPE do not deteriorate significantly at temperatures and durations of interest for this project.

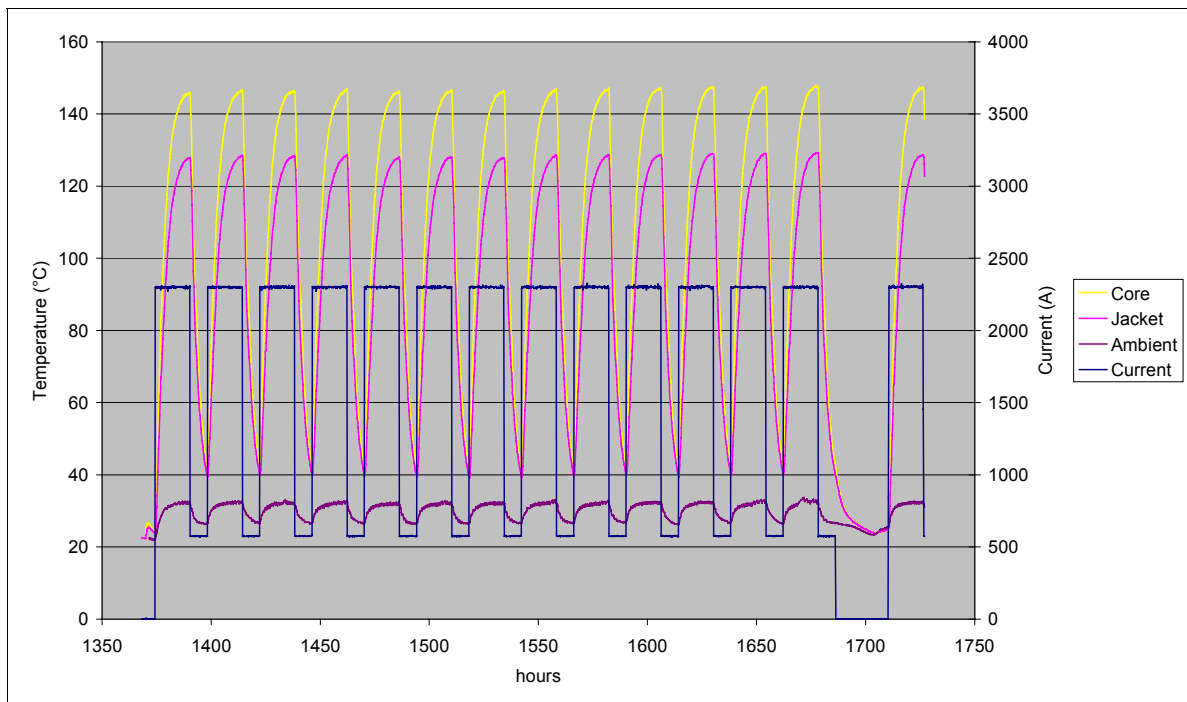
**Figure 5-1**  
**A Typical Two Week Cycle of the Long Term Aging Test**

During the early stages of this test the observations confirmed the effects of hysteresis that were measured during the loaded temperature cycling test as shown in Figure 4-2. Figure 5-2 shows the current and temperatures measured during the first few cycles of the test.

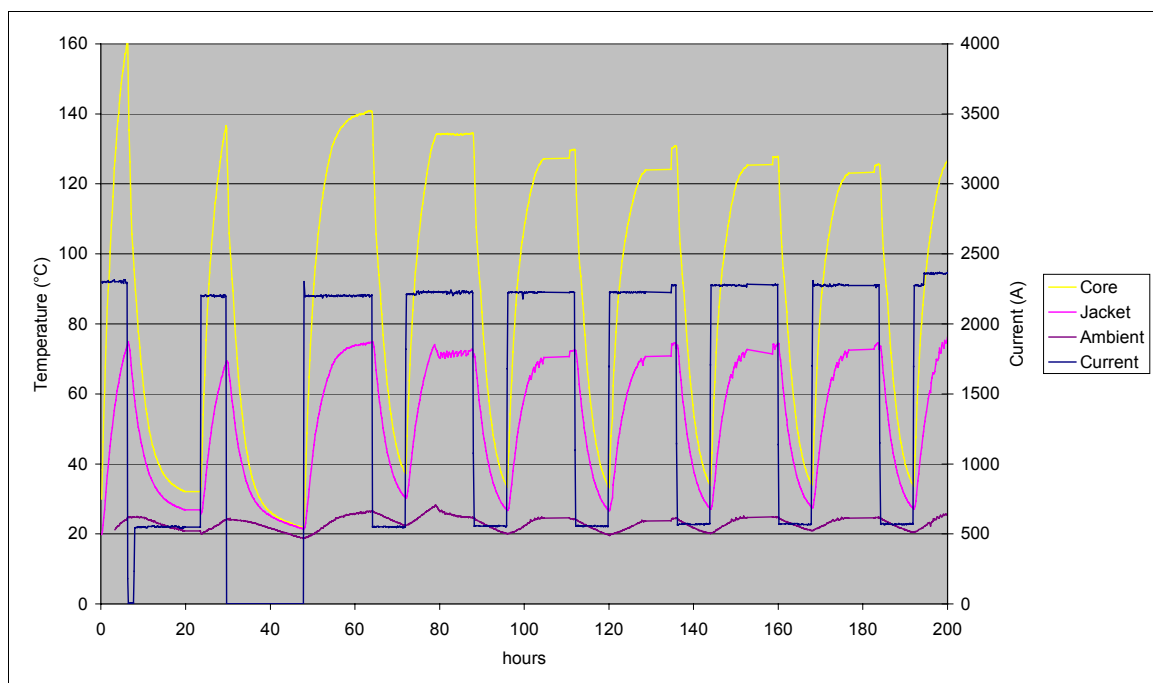
**Figure 5-2**  
**The First 200 Hours of the Long Term Aging Test**

In the first cycle the current was set at 2300 A, but the cable quickly overheated and the test was shut down automatically on over-temperature. The current was reduced to 2220 A, but over the next few cycles the peak temperature dropped steadily. After 8 cycles the current was restored to 2300 A, and the temperature approached the target of 150°C.

The best explanation for this phenomenon is that in the first few thermal cycles the XLPE insulation deforms to make better thermal contact with the sheath, and then settles permanently in that shape. The result is much improved heat transfer to the sheath and the ambient air, so that the conductor temperature drops, and the cable is subsequently able to carry higher current at a given peak temperature. This has interesting implications on ampacity rating calculations for this type of cable, and should be investigated further, since it is clear that thermally cycled cable may have rather different thermal properties than cable that has never been heated above the softening point. The change in thermal properties will likely depend on the mechanical construction of the cable, in particular the type of sheath and the details of the interface between XLPE and sheath. This is probably only a factor in cables with a corrugated aluminum sheath in which the heat transfer properties of the XLPE/sheath interface may change substantially on thermal cycling. Lead sheathed or foil covered cables would probably be affected much less, if at all.

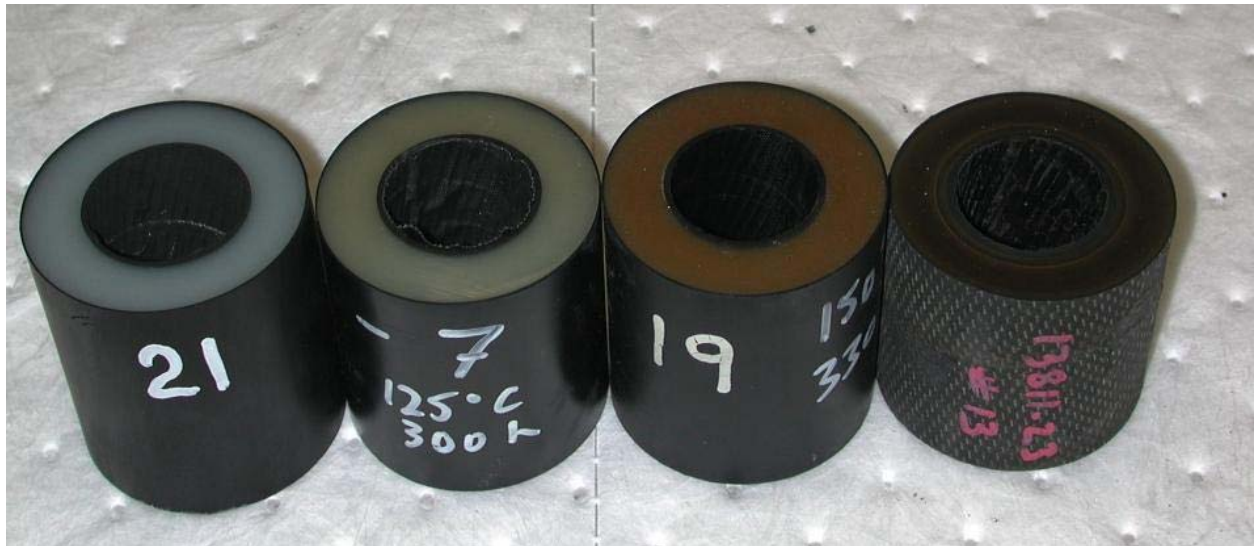
**Figure 5-3**  
**Progressive Darkening of Thermally Aged XLPE Samples (Left to Right):**  
**Not Aged, Oven Aged 300 Hours at 125°C, Oven Aged 330 Hours at 150°C,**  
**and Cycled for 2450 Hours at up to 150°C**

The long term aging test was actually carried out for 8 weeks, logging 2450 hours with current on plus 237 hours of cooling with current off. At the end of the test several XLPE samples were cut from the center of the cable for examination and elastic modulus testing, as described in the previous chapter. The material had darkened visibly, but did not show enough change in elastic properties to raise concerns for the insulation integrity in normal service, as shown in Figure 4-6. The progressive darkening of the material during aging is shown in Figure 5-3 below.

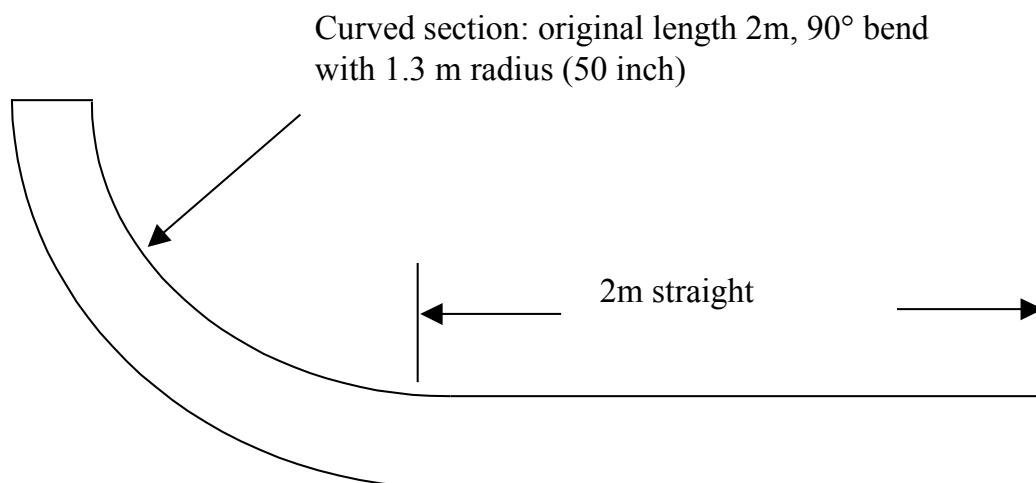
**Figure 6-1**  
**Drawing of the Duct Design for the Minimum Bending Radius Test**

The first test, the minimum bending radius test, involved maximum axial stress in a cable with a corrugated aluminum sheath constrained in a duct bent at the minimum allowable radius. A major unexpected failure occurred 6 days into the test when the PVC duct softened and failed under the applied stress, causing the cable to extrude through the side of the duct. The test cable and much of the test equipment were severely damaged by the failure. A decision was made to rebuild the test setup and repeat the test using aluminum duct and a fresh cable sample, thus adding a fourth validation test to the list.

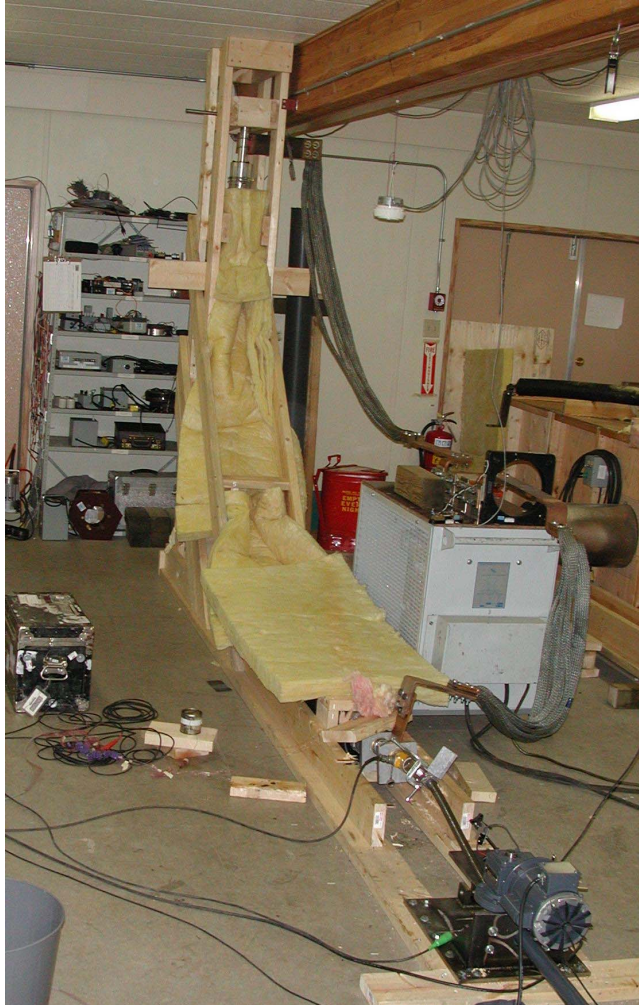
**Figure 6-2**  
**Photograph of the Minimum Bending Radius Test Setup**

Fittings were fabricated to hold the cable ends, fixing the relative position of conductor and sheath by clamping both in the same aluminum end fitting. The upper end was fixed in place, while force was applied to the lower end (the straight section) with a motorized screw jack, similar to a bench vise. The whole structure was supported by a wooden support bolted to the floor and ceiling of the test laboratory. Figure 6-2 shows a photograph of the complete assembly.

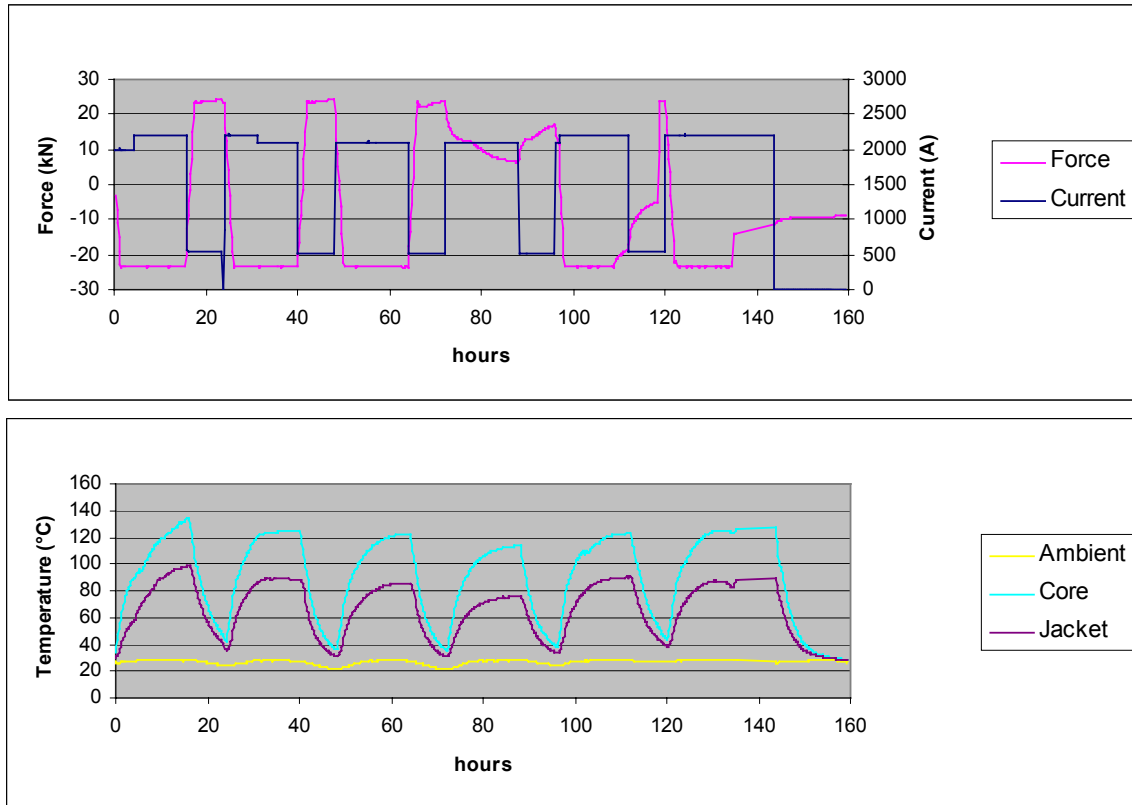
**Figure 6-3**  
**Temperature and Force Measurements from the Minimum Bending Radius Test**

a tension force. For the test, the axial force was monitored with a load cell, and a computer was used to drive the screw jack in and out to maintain the target force. A force profile was programmed to match the heating profile based on a 24 kN maximum force.

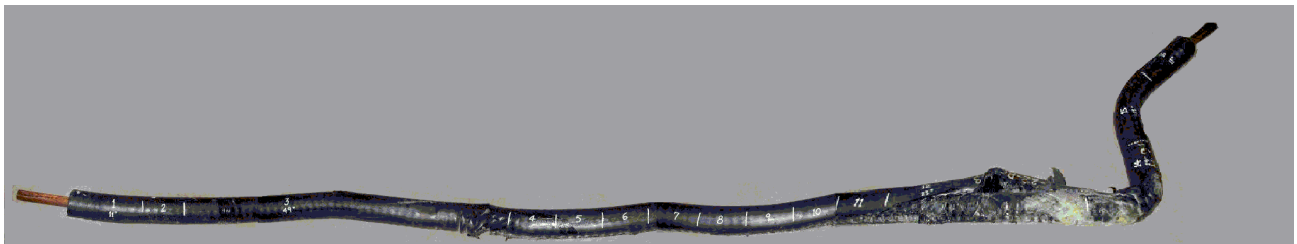
**Figure 6-5**  
**A Composite Photograph of the Damaged Cable**

Much of the cable was undamaged, but the section that pushed through the duct was bent at an acute angle. A composite picture of the test cable is shown in Figure 6-5. The cable was cut in sections as shown in Figure 6-6 and the insulation thickness was measured at each cut to determine how much the insulation had been deformed during the test and failure. While there was significant deformation at the two sites that had pushed through the duct, the bulk of the cable was in relatively good condition and showed no change in insulation thickness. Figure 6-7 shows a photograph of the most heavily damaged section of cable after it was cut along the axis for examination. This section is heavily damaged and would be very likely to fail, but this is far more severe bending than would be experienced in service, even during a heavy overload.

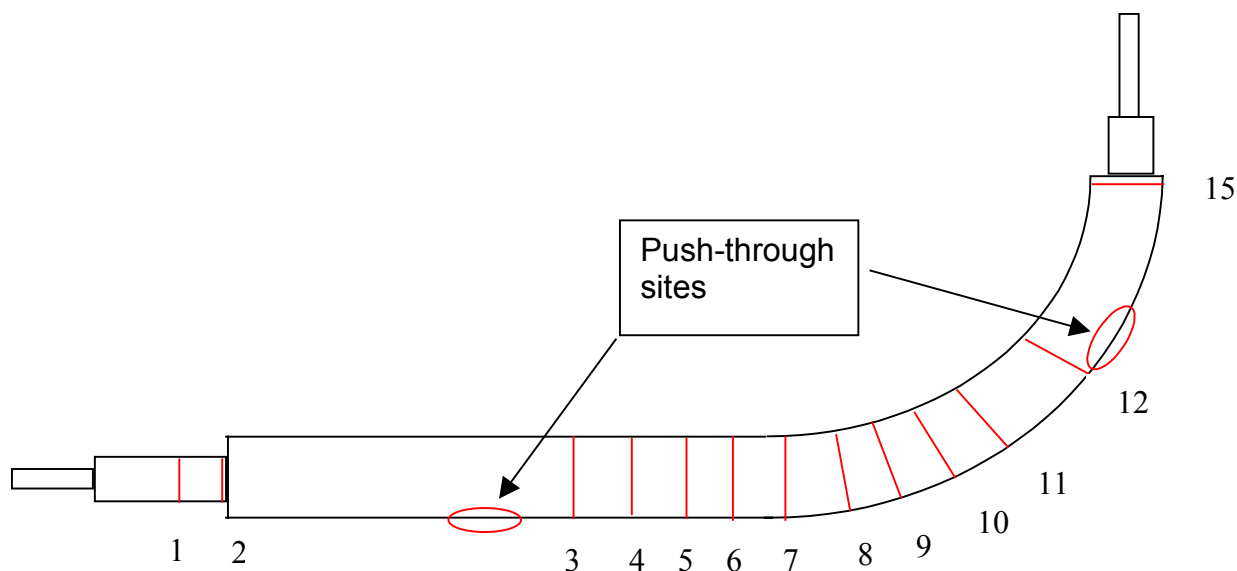
**Figure 6-6**  
**A Drawing of the Damaged Cable and Duct Showing Dissection Locations and Push-Through Sites**

Insulation thickness measurements were made at the top, bottom, right and left side of each cross-sectional cut. There was significant distortion at location 1, where the cable was highly stressed as it left the duct, and at location 3, where it pushed through the bottom of the duct, as well as in the highly bent region shown in Figure 6-7, but in the areas away from duct failure sites the insulation shows no sign of deterioration or distortion, and the thickness remains within measurement error of the nominal 13.3 mm. Based on the results of this test, there is no suggestion that the insulation integrity would have been impacted by the stresses if the duct failure had not occurred. Clearly the duct failure raises an important issue, and the impact of over-temperature operation on ducts, jackets and supporting structures must be considered when

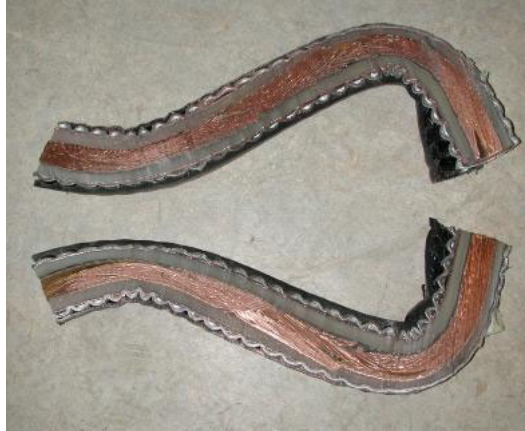
**Figure 6-7**  
**A Photograph of the Dissected Cable at the Sharp Bend**

deciding on a maximum emergency operating temperature. In this case, the duct temperature reached 90°C to 100°C, and the duct was unable to support the loading at that temperature. As might also be expected in service, the duct is hidden from view, and can easily be overlooked when analyzing the ability of the cable to survive high temperature operation. It should be noted that PVC duct would normally be buried in concrete or similarly supported in service and it would behave differently from that used in the test. Temperature limitations related to duct operating temperatures should be investigated further before final recommendations are made on emergency operating temperatures.

As illustrated by the failure in the minimum bending radius test, thermoplastic materials such as PVC and non-crosslinked polyethylene with low melting temperatures are often used for cable jacket and duct material, and are sometimes forgotten in the analysis. Any determination of maximum operating temperature must take into account the presence of these materials, and must ensure that their maximum operating temperature is not exceeded. This requires an accurate prediction of the jacket and duct temperature. For cables with corrugated aluminum sheaths we have learned that this prediction must take into account the hysteresis effect as well as the initial cable properties.

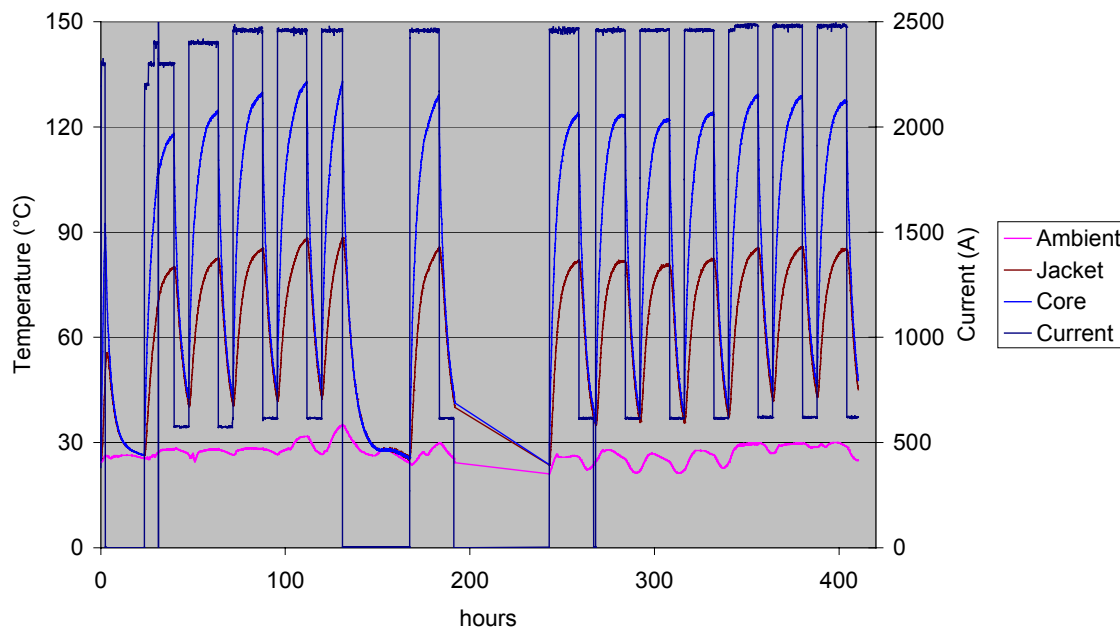
**Figure 6-8**  
**Current and Temperature Profile for Lead Sheathed Cable**

The lead sheathed cable, sample B in Table 6-1, 230 kV class with 27 mm insulation thickness, was the largest of the cables tested. It was set up for the clamp test as described above, and as usual there was some trial and error involved in adjusting the current level to achieve a peak conductor temperature of 130°C. This test ran at a significantly higher current level than previous tests due to the larger copper cross-section, and there were problems controlling the ambient temperature. The weather at the time was unusually hot, and the lab air conditioner was unable to cope with the heat dissipation and iced up, causing the ambient temperature to run away and the test to trip on over-temperature. The test was delayed while an air bypass was installed to relieve the loading on the air conditioner. The test was restarted, but the next day a computer problem shut down the test during the weekend. It was restarted without incident, but ambient temperature control continued to be a problem, and it took several days before the peak temperature could be stabilized at 130°C. Despite the problems, the cable was eventually subjected to 13 cycles with peak temperatures between 120°C and 133°C. The record of temperatures and currents during the test is shown in Figure 6-8.

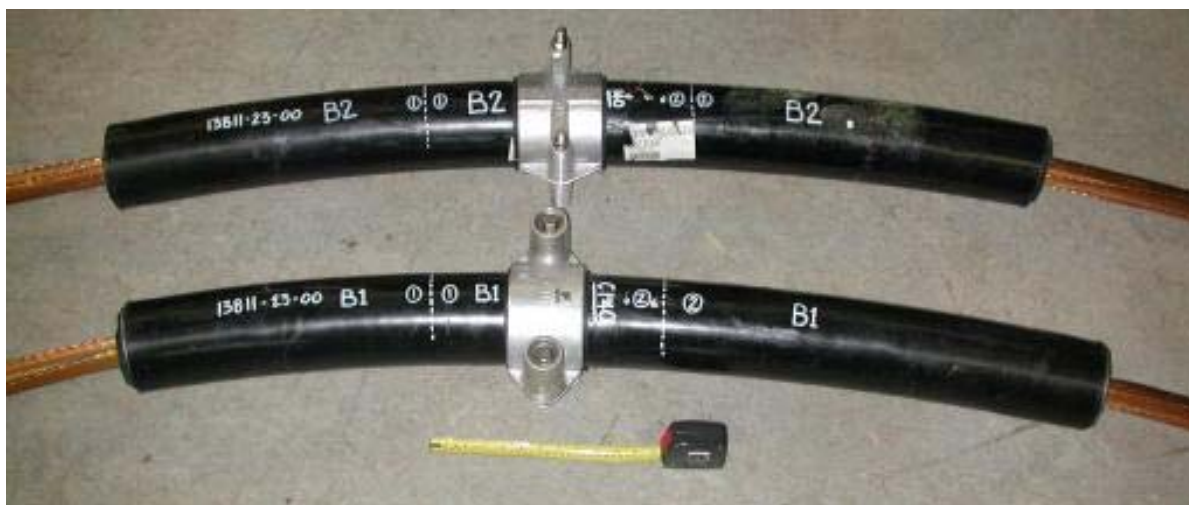
**Figure 6-9**  
**Lead Sheathed Cable Samples After the Test, Ready for Dissection**

When the clamps were removed, slight indentations could be observed where they had been, but the exterior of the jacket did not show any other signs of damage or deterioration. A section of cable around each clamp was cut out, and a cross-section cut through the center of where the clamp had been. One half of the clamped section was then cut axially to look for signs of deformation, gaps in the insulation, or any other changes that might impact the insulation performance. The XLPE showed no visible indentation or deformation, and no sign of anything to suggest that the electrical or mechanical performance might be impaired. Photographs of the cables after the test, whole and dissected, are shown in Figures 6-9 to 6-11.

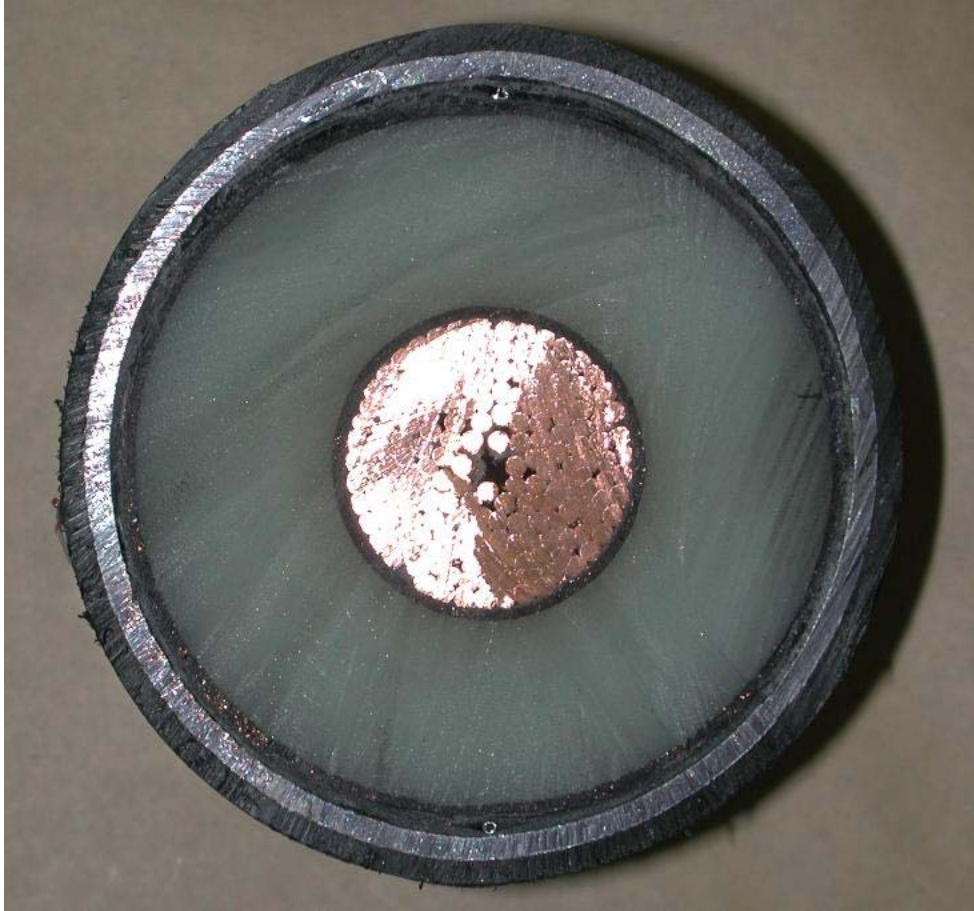
**Figure 6-11**  
**Cross-Section Photo of Cable B1 Under the Center of the Clamp After the Test**

To confirm the qualitative observation that the XLPE was unaffected by the clamping test, measurements were made of the cable overall diameter in two directions and of the insulation thickness at four points around the perimeter. The measurements were made under the center of the clamp and at the outer cut, about 10 cm away from the clamp. Both cables showed a 3-4 mm compression in the overall diameter, but there were no significant differences in the insulation thickness under the clamps. It should be noted that the insulation thickness varied by about 1-2 mm at different points around the circumference, and there was some uncertainty in identifying the edges of the insulation as well. The measured dimensions are shown in Table 6-3.
