# Impact of Emergency Operating Temperatures on the Integrity of XLPE Transmission Cable Systems

**1001859**

Final Report, December 2003

**Powertech Labs Inc.**

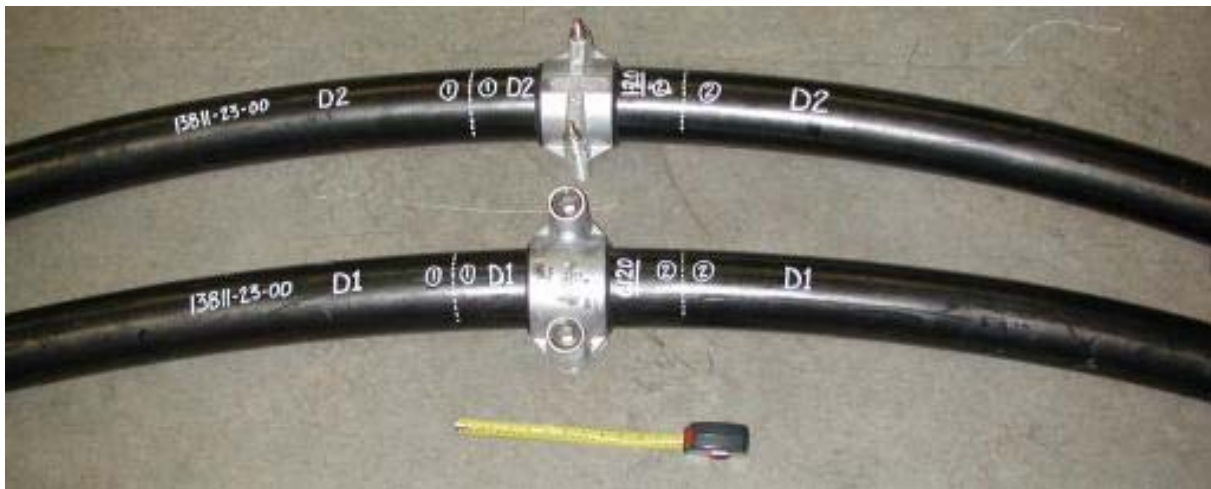
**Figure 6-13**  
**Copper Foil Sheathed Cables After the Test, Ready for Dissection**

When the clamps were removed, the imprint on the cable jacket was less than had been observed on the lead sheathed cable, and there were no indications of damage or deterioration on the cable jacket. A section of cable around each clamp was cut out, and a cross-section cut through the center of where the clamp had been. One half of the clamped section was then cut axially to look for signs of deformation, gaps in the insulation, or any other changes that might impact the insulation performance. The XLPE showed no visible indentation or deformation, and no sign of anything to suggest that the electrical or mechanical performance might be impaired. Photographs of the cables after the test, whole and dissected, are shown in Figures 6-13 through 6-16.

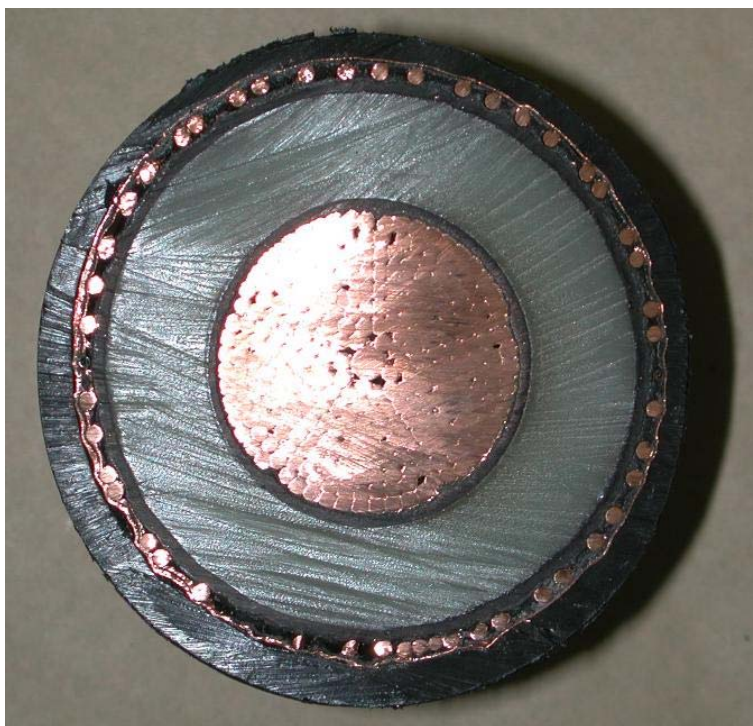
**Figure 6-16**  
Cross Section Photo of Cable D2 Under the Center of the Clamp After the Test

Measurements were made of the cable exterior and the XLPE insulation thickness, as listed in Table 6-4. Unfortunately, the jacket of sample D1 was removed before external diameter measurements had been made, so those measurements are missing from the table, but the results should be very similar to sample D2. The dissected samples were examined to see if the neutral wires had pushed into the insulation, but they did not shift from their normal position, and the integrity of the cable insulation did not seem to have been impaired in any way by the test.

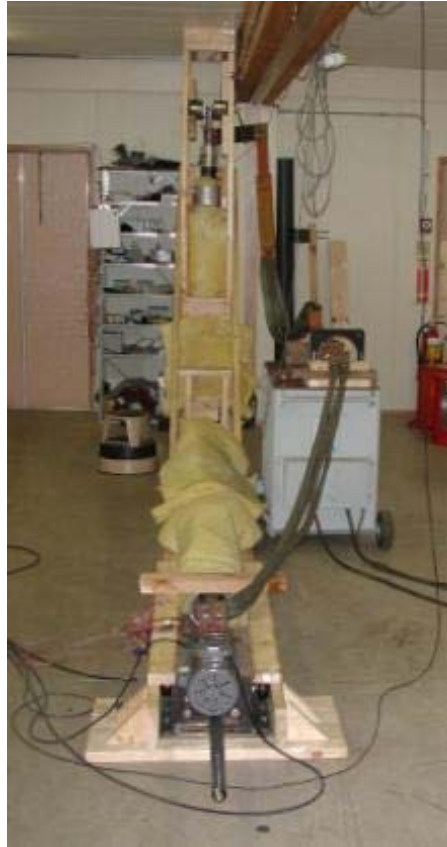
**Figure 6-17**  
**Setup for Repeat Minimum Bending Radius Test**

After repair of the test bed and drive motor, the minimum bending radius test was repeated with an aluminum pipe in place of the plastic duct, as shown in Figure 6-17. As before, the plan was to apply 13 heating and cooling cycles with a peak temperature of 130°C. During heating, a compression force of 24.5 kN was applied to simulate cable expansion, and during cooling the same force was applied in tension. The control software was modified to provide software limits that prevented excessive movement of the screw drive by limiting the maximum travel in both directions.

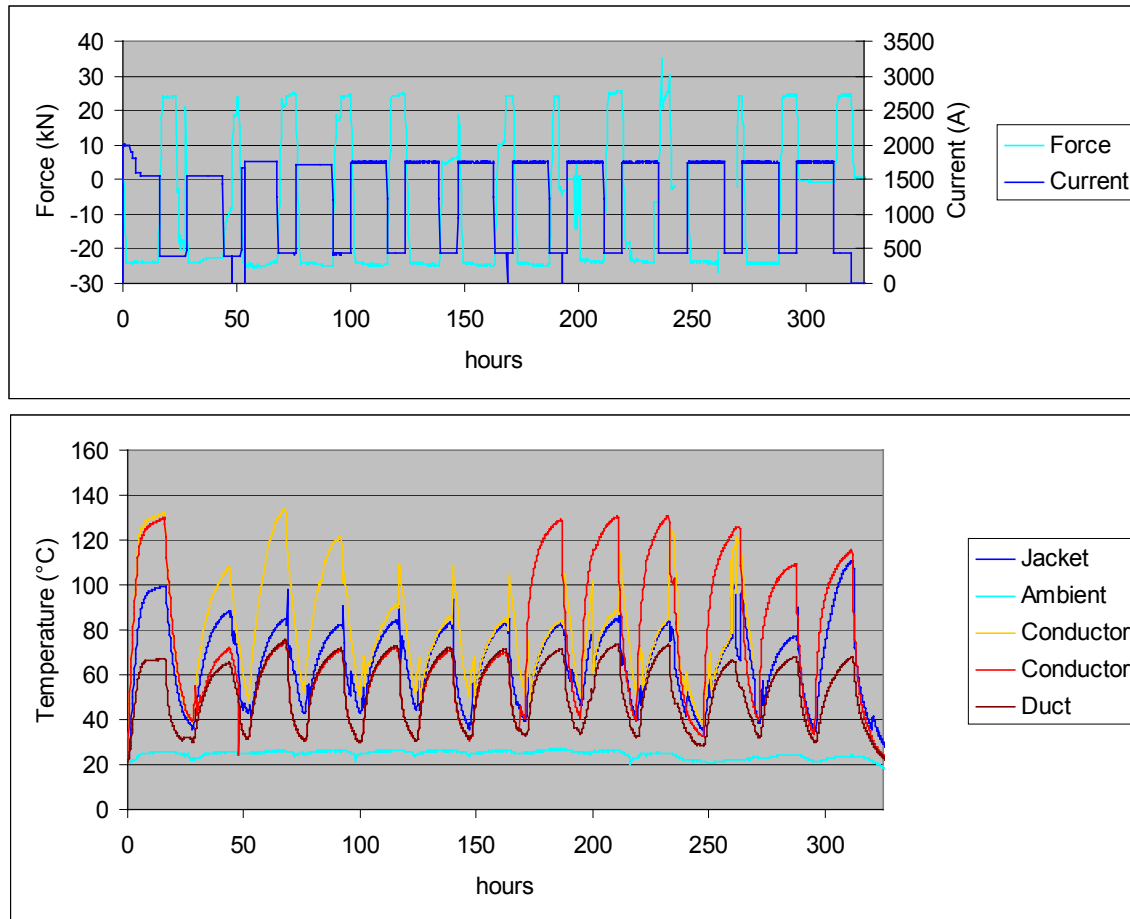
**Figure 6-18**  
**Logged Data from Repeat Minimum Bending Radius Test**

Two thermocouples were inserted into the conductor near the middle of the cable, and thermocouples were mounted on the jacket, the aluminum duct, and in ambient air. As before, the thermal conductance of the cable changed during the first few cycles, so the current values had to be adjusted to achieve the target maximum temperature of 130°C. The logged values of current, force, and temperature are shown in Figure 6-18 below.

Despite a number of problems, the test provided thermal and mechanical stresses close to planned levels. Thirteen heating and cooling cycles were run over 320 hours, and on all but the second cycle, the peak conductor temperature was between 122°C and 134°C, although thermocouple problems caused some low readings. The target compression force was applied in all but the last cycle, and the target tension force was applied during every cycle, although in half the cycles the full tension force was only applied for part of the cooling stage.

Relative movement of the core and sheath caused one thermocouple to fail during the first cycle, and the second one to fail during the fourth cycle. A new thermocouple was installed after the seventh cycle, and it survived the balance of the test. Although the core temperature was not recorded for cycles 5-7, and the indicated temperatures were low for the last few cycles, we believe that peak conductor temperatures were within a few degrees of 130°C for the last 9 cycles.

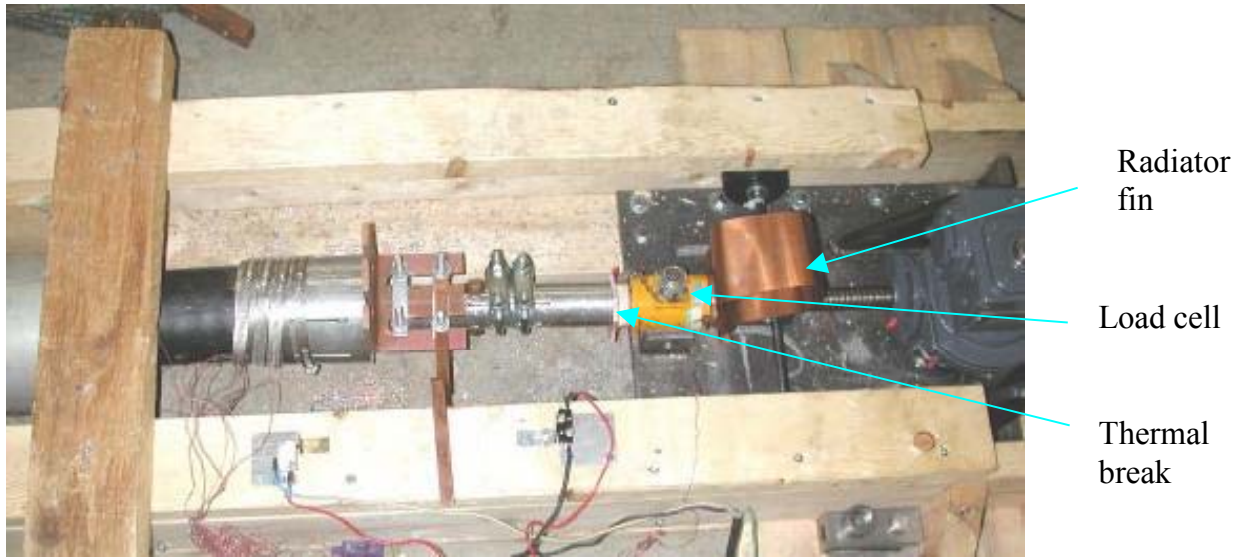
**Figure 6-19**  
**The Load Cell with Thermal Break and Radiator Fin Installed**

Problems with software limits and end fittings caused some deviations in the planned force. Near the end of the tenth heating cycle, the load cell that was used to monitor and control the force failed. The failure was such that an error of 20 kN was introduced in the measurement, so that the controller reduced the load to near zero during the heating stage, then attempted to apply 44 kN of tension for the cooling stage, nearly twice the design force. At a tension of approximately 40 kN, the fixed end support broke, relieving the tension. The software limiter controlled the damage. The structure was repaired, and the load cell was removed and examined. It was determined that a solder joint had failed, and the load cell was repaired and judged fit for service. It was reinstalled by the end of the day, and the test was continued. The next night the load cell failed again, and this time the readings went to very large values, causing the controller to apply tension until the software limiter stopped it. The force was close to normal judging by the cable end position, although the exact value could not be determined. The load cell was again removed and examined, and it appeared that another solder joint had failed. After analyzing the failures we found the problem. Some improvements that had been made to the end grips to reduce slip had also improved the thermal contact, and the load cell was now overheating, causing the solder joints to fail. A thermal break was inserted, and a radiator fin and cooling fan were attached to the load cell for the last two cycles, as shown in Figure 6-19. This solved the problem, but an incorrect software limit prevented compression from being applied during the last cycle.

The changes to the load cell reduced the measured peak temperatures during the last two cycles. It is likely that the conductor temperature in the middle of the test sample would not have been affected much by this change. The replacement thermocouple was close to the end of the cable, and the changes would have had considerably more effect on the temperatures near the end of the cable than in the bent section far from the load cell.

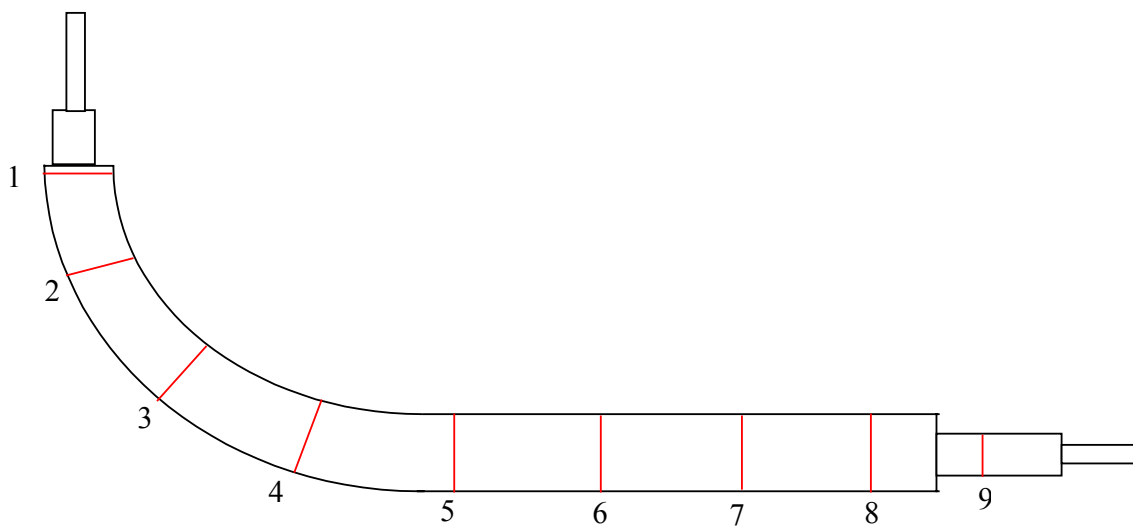
**Figure 6-20**  
**Dissection Cut Locations After Bending Test**

Some deformation of the cable occurred during the test; the top insulation thickness (inside edge of the bend) was reduced throughout the bent part of the cable by an average of 1.7 mm and the side thickness was increased by an average of 0.9 mm. The bottom thickness was unaffected. There were no gaps or defects that might affect the performance of the cable. The thinnest top wall thickness found, the inside wall near the center of the bend, was 11 mm, 1.6 mm less than the thinnest wall thickness in the straight section.

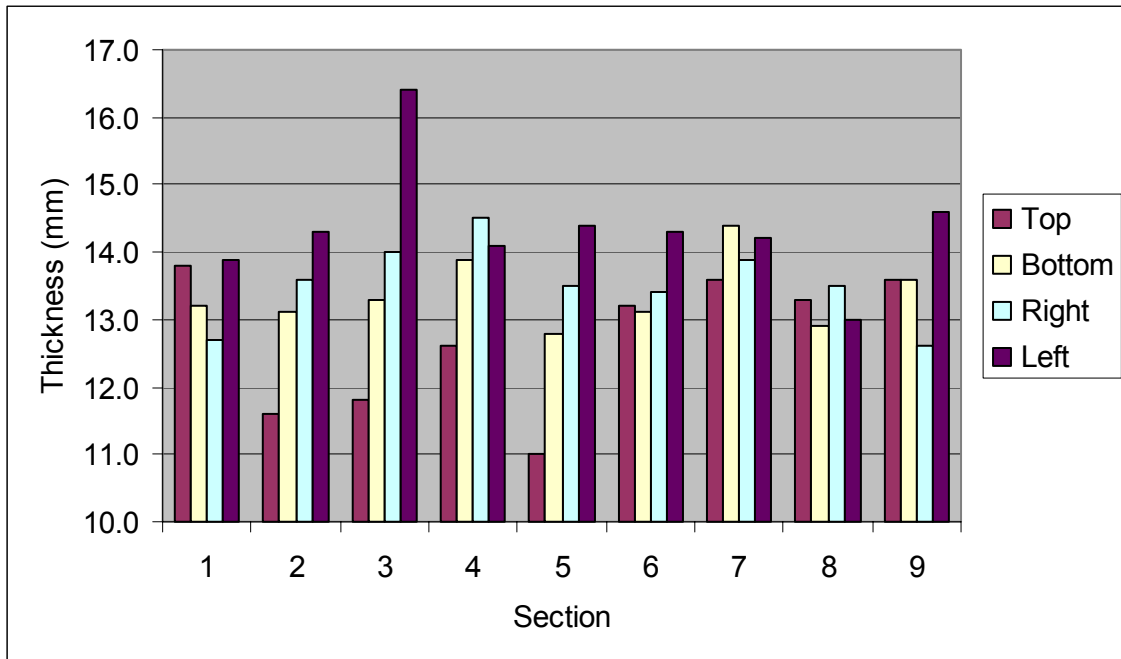
**Figure 6-21**  
**Variations in Insulation Thickness at Different Sections**

The impact of this worst-case test on the insulation thickness was a 1.7 mm (13%) reduction in insulation thickness in the most highly stressed area. There were no electrical stress enhancements observed that might lead to any further reduction in electrical strength. Previous tests have showed that this deformation occurs in the first few thermal cycles and that the material does not undergo long term deterioration from operation in this temperature range.
