The Use of Weld Overlays to Extend the Life of Seam Welded High Energy Piping in Fossil Power Plants

Common PQR and Thinner Piping Evaluation

1004616

February 2002

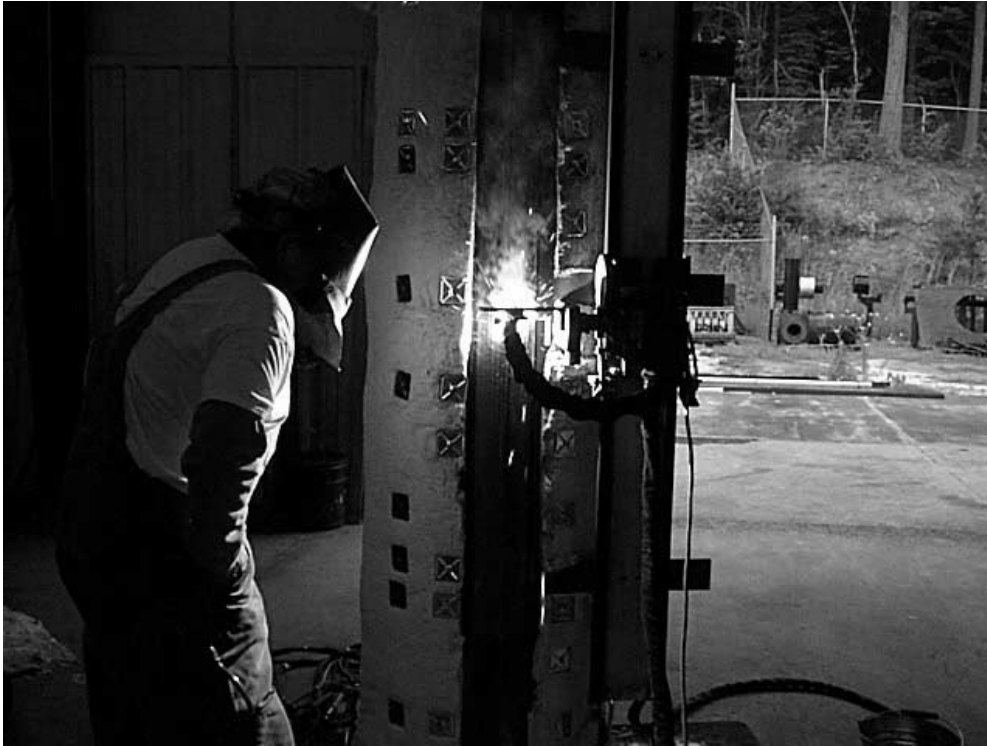
Figure 2-1. Procedure Qualification Welding Operation

Wachs Energy Services volunteered to assist with the welding part of the procedure qualification. Through their participation in the welding procedure, they now have a qualified procedure and the capability to assist utilities in this type of repair. The pipe mockup was shipped to the Wachs Facility in Charlotte, North Carolina. Thermal Solutions of Columbus Ohio volunteered to provide equipment for preheat and post weld bake out. Figure 2-1 below was taken during the welding process. The track for the Pipeliner semi-automatic welding head is located on the right of the picture. Welding is progressing uphill in the center of the overlay.

A 450F preheat was applied to the pipe before welding operations were started and maintained until welding was completed. Preheat was applied with strips of resistance heating pads located on either side of the original weld. The pads were located about 4" from the center of the original weld. This would allow for clearance between the completed 5" wide weld and the heating pads. The same pads were utilized for the temperbead post weld bake.

Three welding layers were applied to the pipe which resulted in an overlay of about $\frac{1}{2}$ " thickness. The overlay was about 5" wide and 57" long. The welding process took 11 hours actual arc time and the entire weld required 35 lbs of filler material. The filler metal utilized was supplied by Metrode and conformed to ER 81T1-B2M. As can be seen from the low amount of total weight added to the piping, there should not be a requirement to readjust hangers for this type of repair. Actual parameters utilized in the welding process can be seen in Table 2-1.

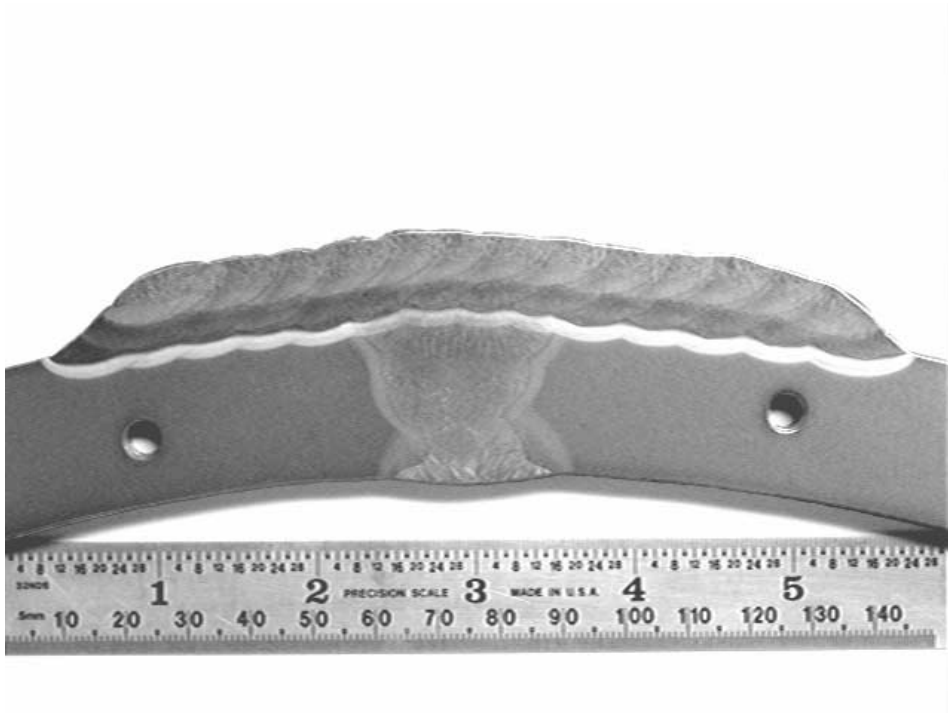
Figure 2-2. Cross section of Weld Overlay

Upon completion of residual stress work discussed later in Chapter 3, the pipe was sectioned and coupons were removed for bend tests, impact tests, and metallurgical evaluation to qualify the welding procedure. A sample cross section of the weld is shown in Figure 2-2. The original weld can clearly be seen in this figure as well as the new weld overlay.

Metallographically, the weld overlay was a sound weldment. Figure 2-3 above clearly shows the original weld and the weld overlay. No weld discontinuities were detected. A good bond was achieved with no lack of fusion or other welding defect. All tests required by ASME for qualification of a welding procedure were performed according to ASME Section IX, QW-450. Bend, tensile, hardness and impact strength were all acceptable. Tensile strength was above ASME minimums. Toughness, while not outstanding, was higher than the base metal. It also must be pointed out that toughness is only a problem at low temperatures. The fracture appearance transition temperature (FATT), the temperature above which failures occur in a ductile manner instead of a brittle manner, is well below the operating temperature for these materials. All tests indicated that the FCAW temperbead welding procedure is an excellent choice for this type of repair.

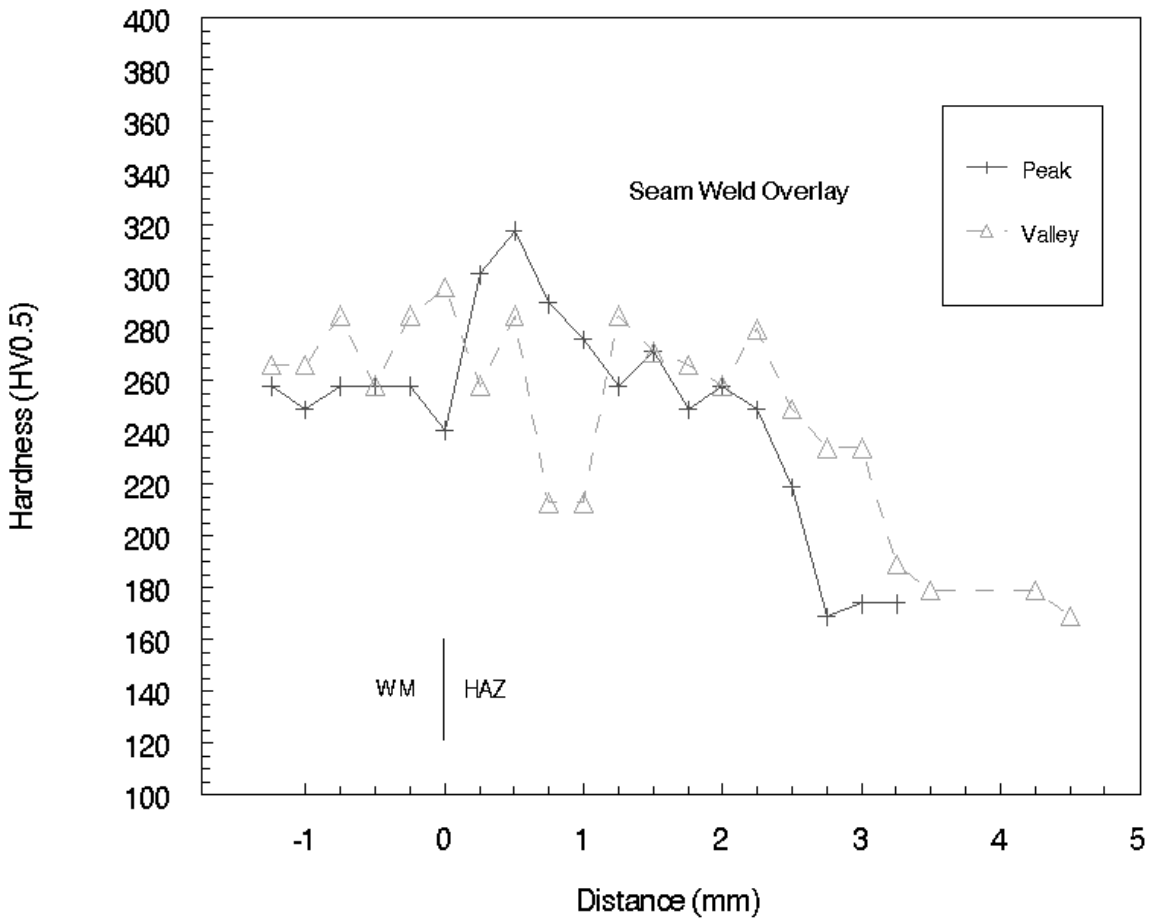
Figure 2-5. Hardness of weld.

Hardness traverses were performed across the base metal, HAZ, and weld metal. Results are shown in Figure 2-5. A maximum hardness of 320 Hv was measured in the peak of a weld bead in the HAZ.
