PWR Materials Reliability Program Response to NRC Bulletin 2001-01 (MRP-48)

1006284

Final Report, August 2001

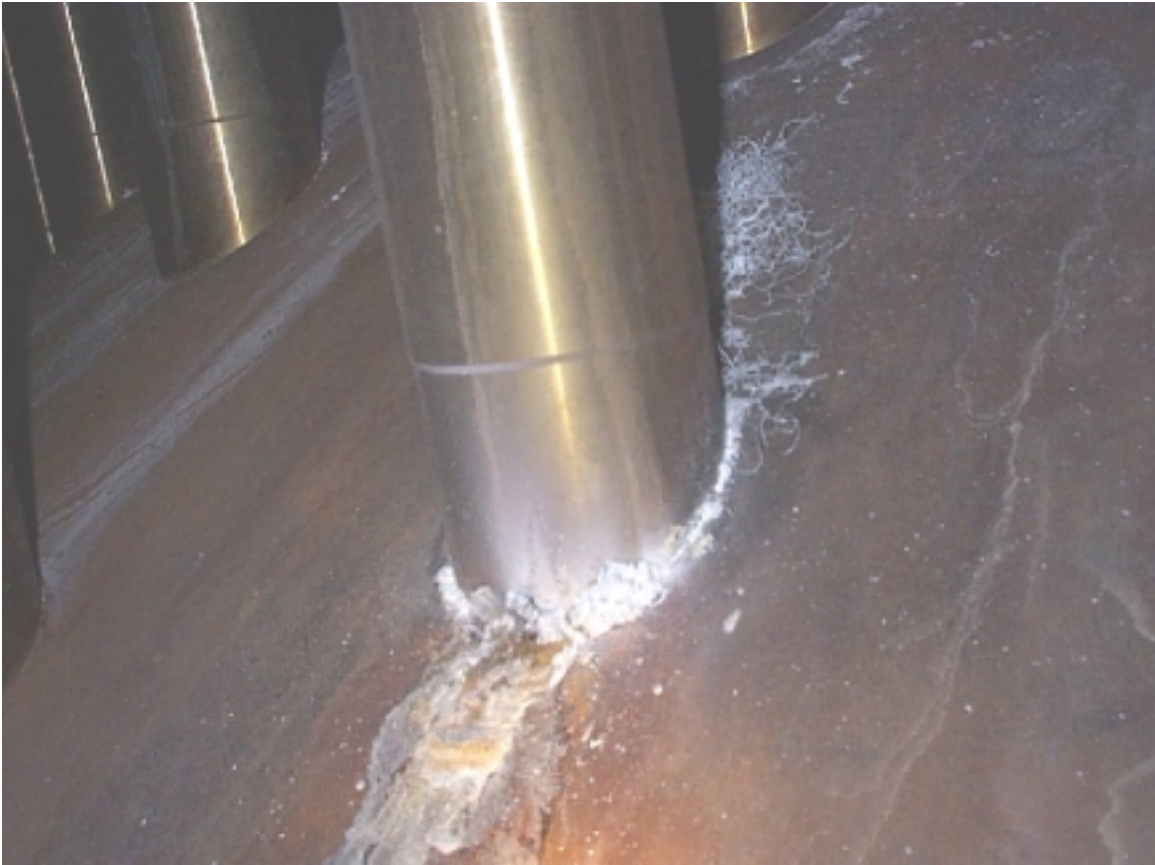
Figure 1-3
Leaking CRDM Nozzle at Oconee 3

In addition, five of the eight smaller diameter thermocouple nozzles at Oconee 1 were discovered to have leaks. All of these leaks were first detected during visual inspections of the top surface of the vessel heads for boric acid crystal deposits (see Figure 1-3). In all cases the quantity of boric acid crystals at each nozzle location was small ($<1 \text{ in}^3$).

- Destructive examinations of several specimens from cracked Oconee 1 and 3 nozzles showed that the leaks were the result of primary water stress corrosion cracking (PWSCC).
- Non-destructive examinations of the leaking CRDM nozzles showed that most of the cracks originated on the outside surface of the nozzles below the J-groove weld, were axially oriented, and propagated primarily in the nozzle base material to an elevation above the top of the J-groove weld where leakage could then pass through the annulus to the top of the head where it was detected by visual inspection. In some cases the cracks

initiated in the weld metal or propagated into the weld metal, and in a few cases the cracks propagated through the nozzle wall thickness to the inside surface.
