# Large Butterfly Valve Maintenance Guide

**1007908**

Final Report, December 2003

EPRI Project Manager  
L. Loflin

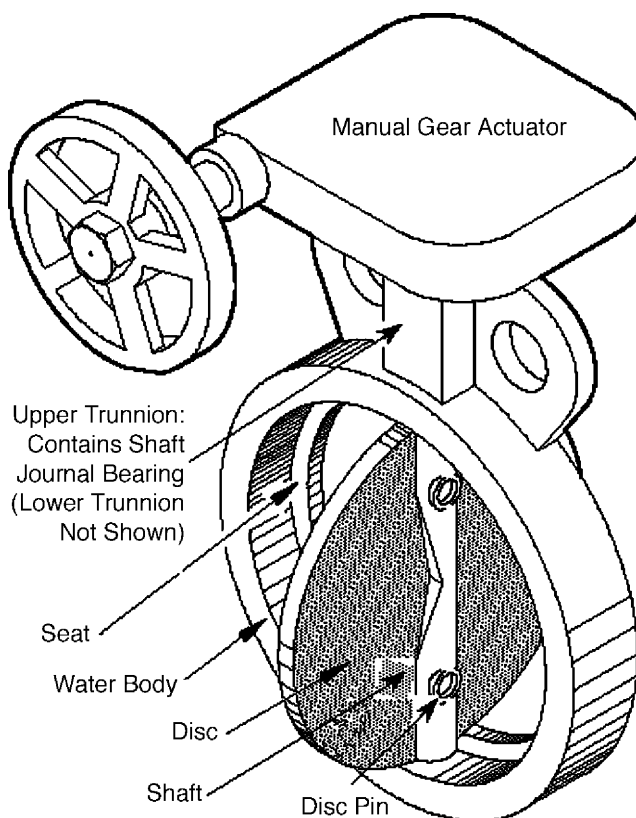
**Figure 2-1**  
**Typical Butterfly Valve with Manual Gear Actuator**

Figure 2-1 shows an overall assembly of a butterfly valve with a manual gear actuator with the principal parts identified. The body is usually carbon steel or stainless steel. The disc, disc pin, and shaft are stainless steel or some other high alloy material. The bearings are normally an elastomer such as polytetrafluoroethylene (PTFE). For nuclear power plants, the seat is normally rubber or some other elastomer. Some designs (for example, triple-offset) are commonly metal-to-metal seated.

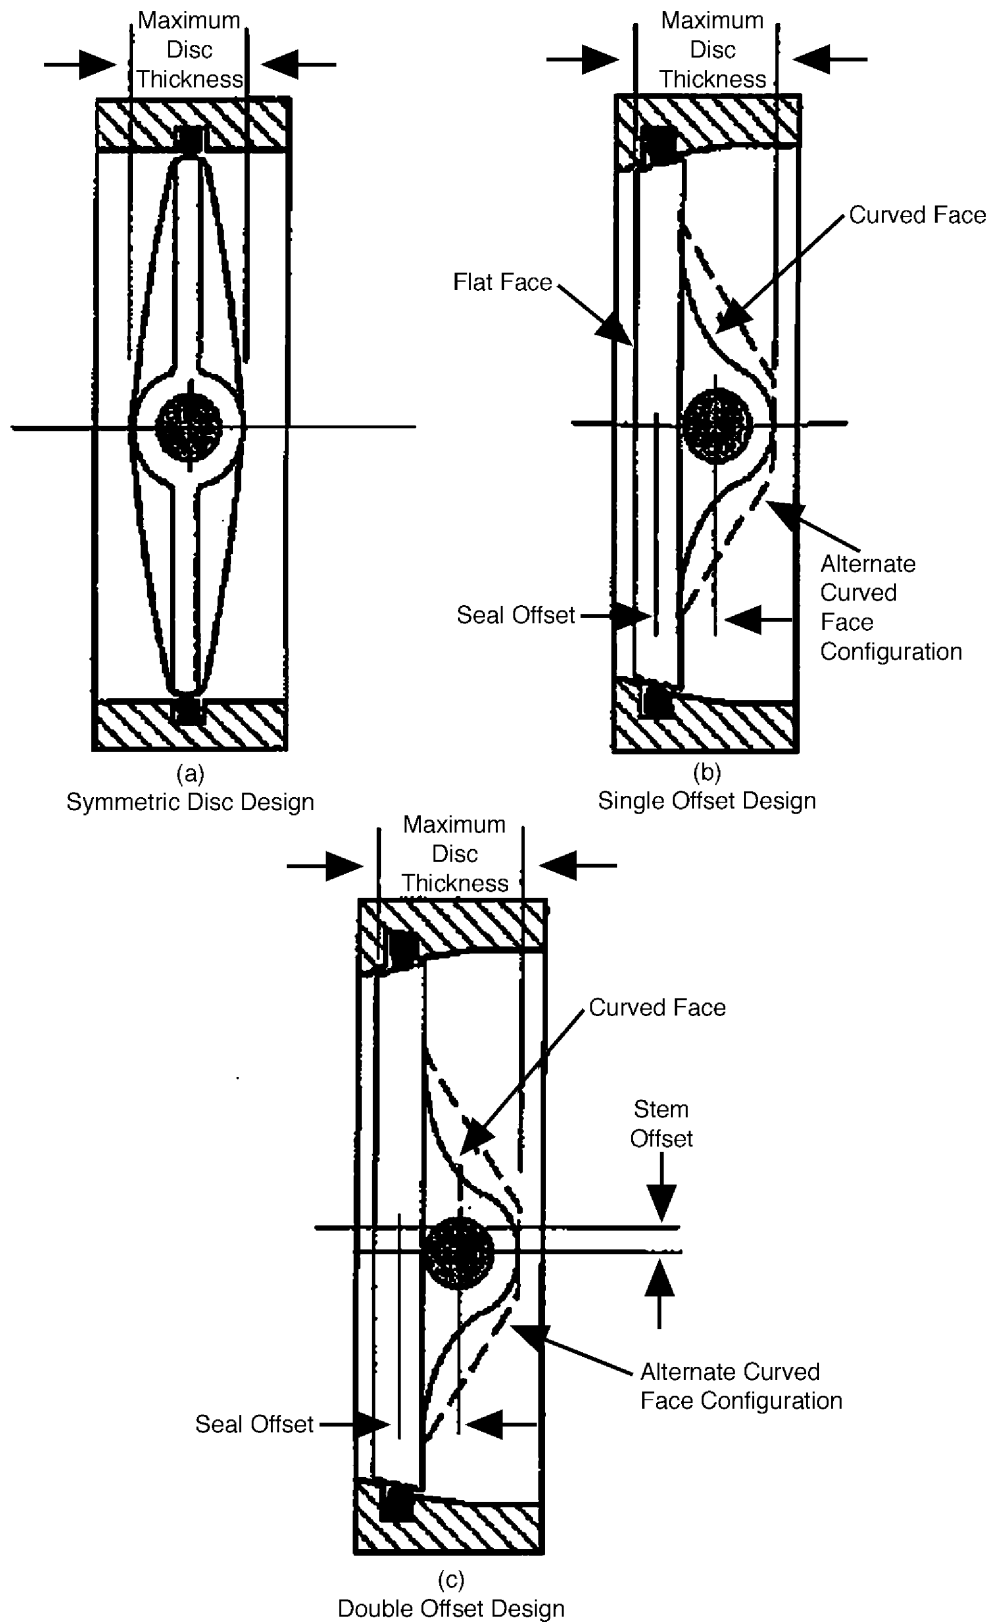
**Figure 2-2**  
**Typical Variations in Butterfly Designs**

In the symmetric design shown in Figure 2-2(a), valve seat leakage is prevented by using a sealing system between disc and body referred to as the liner. The liner also prevents the fluid from coming into contact with the body. This permits the use of carbon steel in most low-temperature fluid systems and helps keep the price of the valve low. The liner most commonly uses an elastomer such as ethylene propylene rubber (EPR). The liner material sets the temperature (limit  $\approx 350^{\circ}\text{F}/177^{\circ}\text{C}$ ) and operating fluid type (see Appendix B).

In both the ANSI and AWWA designs, the rubber liner is typically molded over the flange faces acting as a flange gasket, although some designs use an adhesive to bind an independent rubber liner inserted into the body flow port. It is important to realize that for these designs, normal gaskets are not to be used because leakage is highly likely at the flange joint. A liner is not normally used for high temperature service. Therefore, from a fluid compatibility perspective, the body material becomes an important design consideration (for example, using a 300 series stainless steel for both temperature and fluid.) Sealing also becomes metal-to-metal, usually along a tapered surface.

The symmetric disc type design shown in Figure 2-2(a) is generally referred to as the standard disc, conventional disc, or lenticular disc. Flow and total torque characteristics of a symmetric disc valve do not depend on the flow direction; thus, the valve can be installed either way without affecting performance. Symmetric disc designs are typically furnished with a rubber-lined body to provide a seal in the fully closed position, as shown in Figure 2-3. In this design, the shaft penetrates the rubber liner. An enlarged hub area around the shaft is provided with an interference fit with the rubber liner to prevent leakage around the shaft in the fully closed position. The disc hub area maintains a continuous contact against the body liner throughout the disc rotation. Normally, these valves are limited to low-pressure service (Class 300/PN 50). However, some manufacturers produce Class 600/PN 100 valves of this design.

The single offset non-symmetric disc design, Figure 2-2(b), appeared sometime in the early 1960s. Another term used is eccentric design. Because of the improved sealing characteristics over the symmetric design, it was possible to build offset valves capable of higher pressure ratings. This resulted from the fact that uniform 360° sealing of the disc/seat, as well as improved leak tightness, could take place because of the elastic deflections due to differential pressure across the disc and shaft. The first Class 600 (PN 100) valves began to appear commercially because of this change. In the 1970s, some manufacturers began to refer to the design as a high-performance butterfly valve—a term that survives to this day. *High Pressure-Offset Seat Butterfly Valves* [7] provides additional information about construction of these valves. As shown in Figure 2-2(b), the shaft centerline (and the center of disc rotation) is offset axially from the plane of the valve seat along the pipe centerline. The valve seat is a continuous cone shape (versus the cylindrical shape used for symmetric designs). Another variation is shown in Figure 2-4. This design is available in resilient as well as metal-to-metal seat. The disc face away from the shaft is typically flat or has a small curvature and is commonly referred to as the flat face. The other disc face is generally convex and contoured to accommodate the shaft. This face is generally referred to as the curved face or shaft side of the disc.

In this non-symmetric disc with double offset shaft design, the shaft has a seat offset (similar to the single offset design) and a relatively small lateral shaft offset as shown in Figure 2-2(c). The seat is also a cone shape. The magnitude of the shaft offset varies from 1/32 in. to 1/8 in. (0.8 mm to 3.2 mm). The additional offset provides less interference during seating, thus reducing seat wear. This design is available with resilient seats as well as metal seats. In the double offset design, the resultant force due to differential pressure across the disc in the closed position does not pass through the shaft centerline.

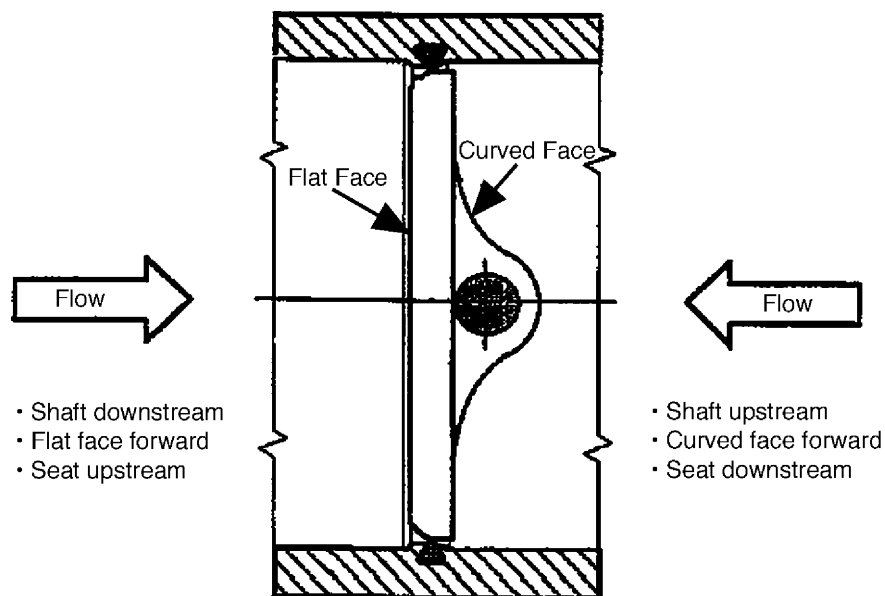
**Figure 2-5**  
**Valve Disc Flow Orientation Terminology**

Flow and torque characteristics of the valve depend on the flow direction with respect to the disc. When the shaft is on the downstream side (or the flat face of the disc is on the upstream side) of the flow direction, the installation is commonly referred to as shaft downstream or flat face forward (Figure 2-5). Similarly, when the shaft is on the upstream side (or the curved face of the disc faces the upstream side), the installation is referred to as shaft upstream or curved face forward.

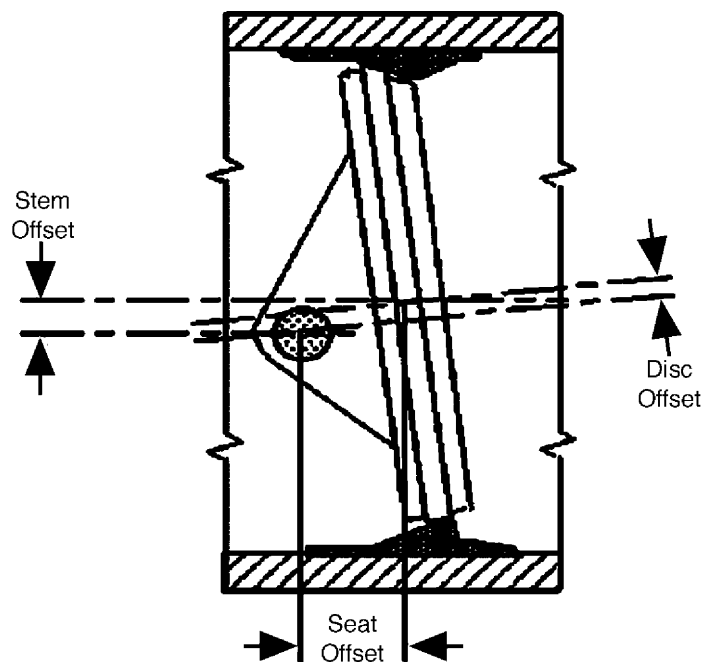
**Figure 2-6**  
**Triple Offset Butterfly Valve (Functional Depiction)**

Another variation in disc design that has been common for many years in European applications, but relatively uncommon in U.S. nuclear power plants until the 1990s, is the triple offset seat design shown in Figure 2-6. The main feature of this design is that, in addition to the seat and shaft offsets described above, the shaft has an additional (third) offset with respect to the disc centerline. This offset requires that the seating cone be rotated and an offset applied to the cone axis. This results in totally eliminating seat closing friction. It provides a tight seal due to the fact that the disc rotates into the seat as opposed to across the seat. (Note the similarity to a tilting disc check valve.) In other words, it is torque seated (in contrast to the other three disc designs shown in Figure 2-2, which are all position seated). This obviously has enormous benefits from a seat leakage perspective. With position seating, it is necessary to rely strictly on the seat seal design. Turning the shaft past the closed point simply opens the valve and increases leakage. With the triple offset, it is not possible to go through the seat. Additional force increases the sealing action. Although Figure 2-6 is correct as an illustration of how a triple offset works, most manufacturers do not have the seating (disc) plane at an angle. Rather they keep the disc plane normal, allowing the flow and machine of the seat and disc at an angle. This is shown in Figure 2-7.

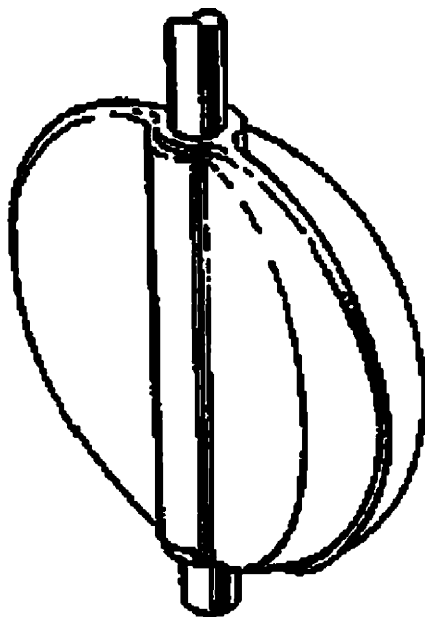
**Figure 2-8**  
**Fishtail Disc**

Butterfly valves with special disc designs are used primarily in throttling service or to decrease the torque required to actuate the valve. These special designs include fishtail discs (see Figure 2-8) for torque control and serrated edge or orifice discs (see Figure 2-9) for flow, noise, and cavitation control. In general, these valves are not required to give zero leakage in the fully closed position and are used primarily in a fully open or partially open position. In most cases, the shape of the disc makes the valve unidirectional.

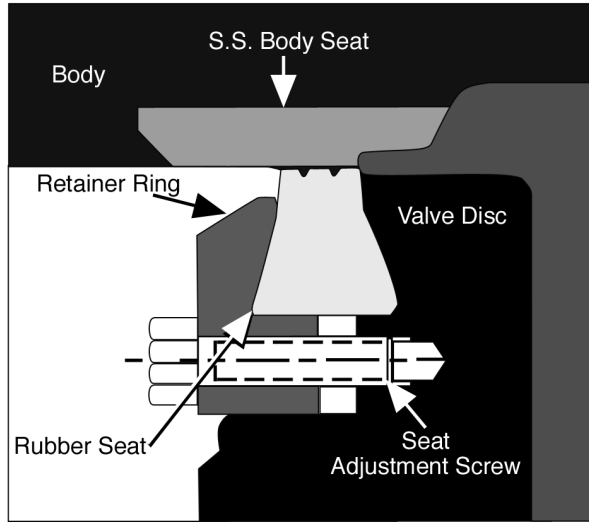
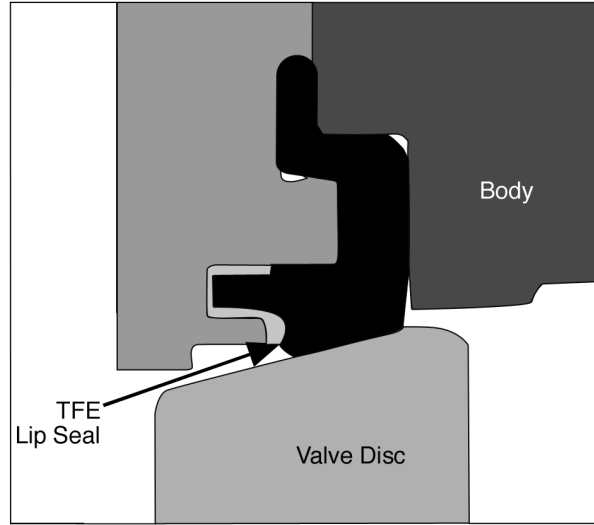
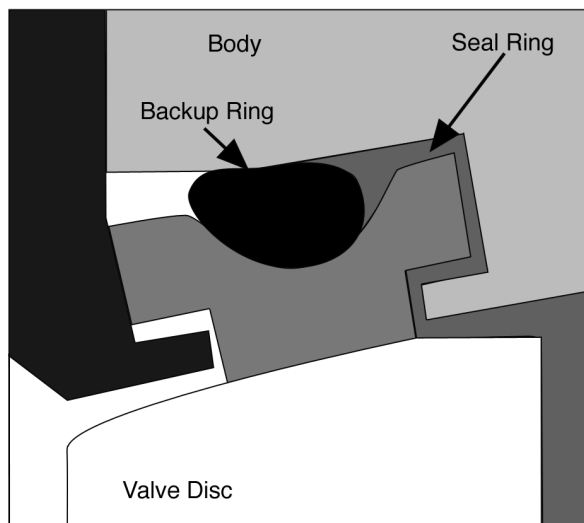
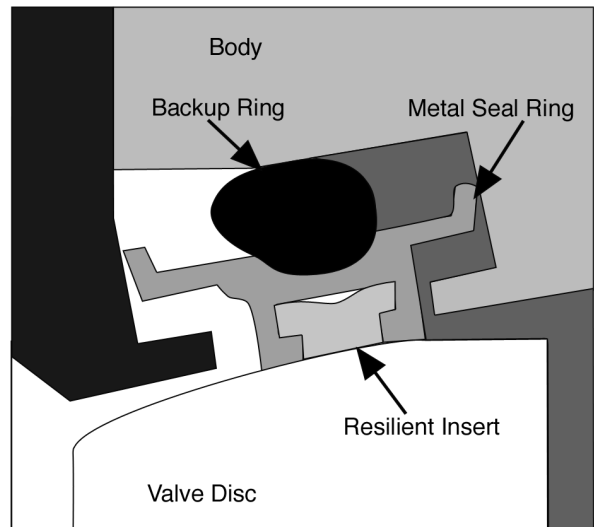
**Figure 2-10**  
**Typical Seat Designs**

A large number of combinations of valve seat designs and materials are available to meet the variety of applications and operating conditions. Figures 2-3, 2-4, and 2-10 show the variations most commonly found in nuclear power plant applications of butterfly valves. Based on seat leakage and seat torque requirements, valve seats can be divided into nominal leakage seats, low leakage seats, and tight shutoff seats. Except for externally pressurized elastomer seats of inflatable designs (Figure 2-11), which are not commonly used in nuclear power plants, tight shutoff seats require higher seating/unseating torque than the nominal leakage seat designs.

(a) Adjustable Type Interference Seat

(b) Lip Type Interference Seat

(c) Pressure Energized Seat

(d) Pressure Energized Fire-Safe Seat

The elastomeric seat can be disc mounted or body mounted. Disc-mounted replaceable seats depicted in Figure 2-10(a) are preferable from a maintenance perspective since they allow replacement without removing the valve from the piping. However, this may be irrelevant for larger sizes where the disc weight is considerable and the disc is difficult to remove from the valve in the field. Therefore, body-mounted replaceable seats would be satisfactory. (The AWWA standard [8] requires that rubber seats be replaceable at the installation site for valves 30 inches [DN 750] and larger.)

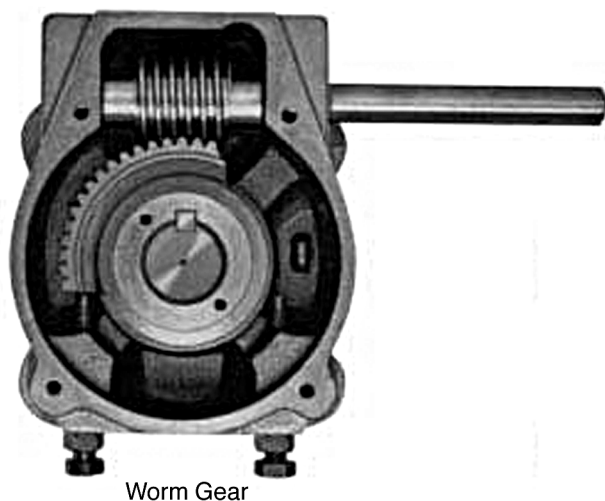
**Figure 2-12**  
**Worm Gear Manual Actuator**

A manual actuator can be as simple as a lever arm connected directly to the shaft. In larger valves, it can be a hand wheel connected to a worm gear (see Figure 2-12) or a traveling nut (see Figure 2-13) to produce the required torque.

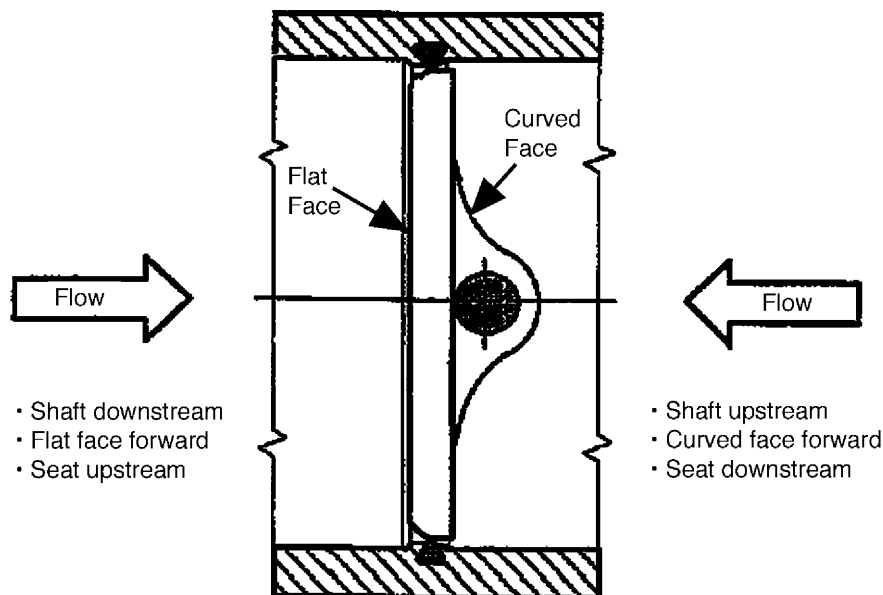
**Figure 3-1**  
**Valve Disc Flow Orientation Terminology**

As discussed in Section 2.4.4, flow and torque characteristics of the non-symmetric valve depend on the flow direction with respect to the disc. This difference and the reasons for it are discussed in Section 3.7.3.1 of EPRI's *Application Guide for Motor-Operated Valves in Nuclear Power Plants* [1]. This problem has also been identified to the industry through U. S. Nuclear Regulatory Commission (NRC) Information Notice 91-58 [12]. Since the valve can be installed either way, it is important to ensure the correct orientation before installing. When the shaft is on the downstream side of the installed flow direction, as shown in Figure 3-1, the peak dynamic torque can be significantly lower than when installed with the shaft facing upstream.

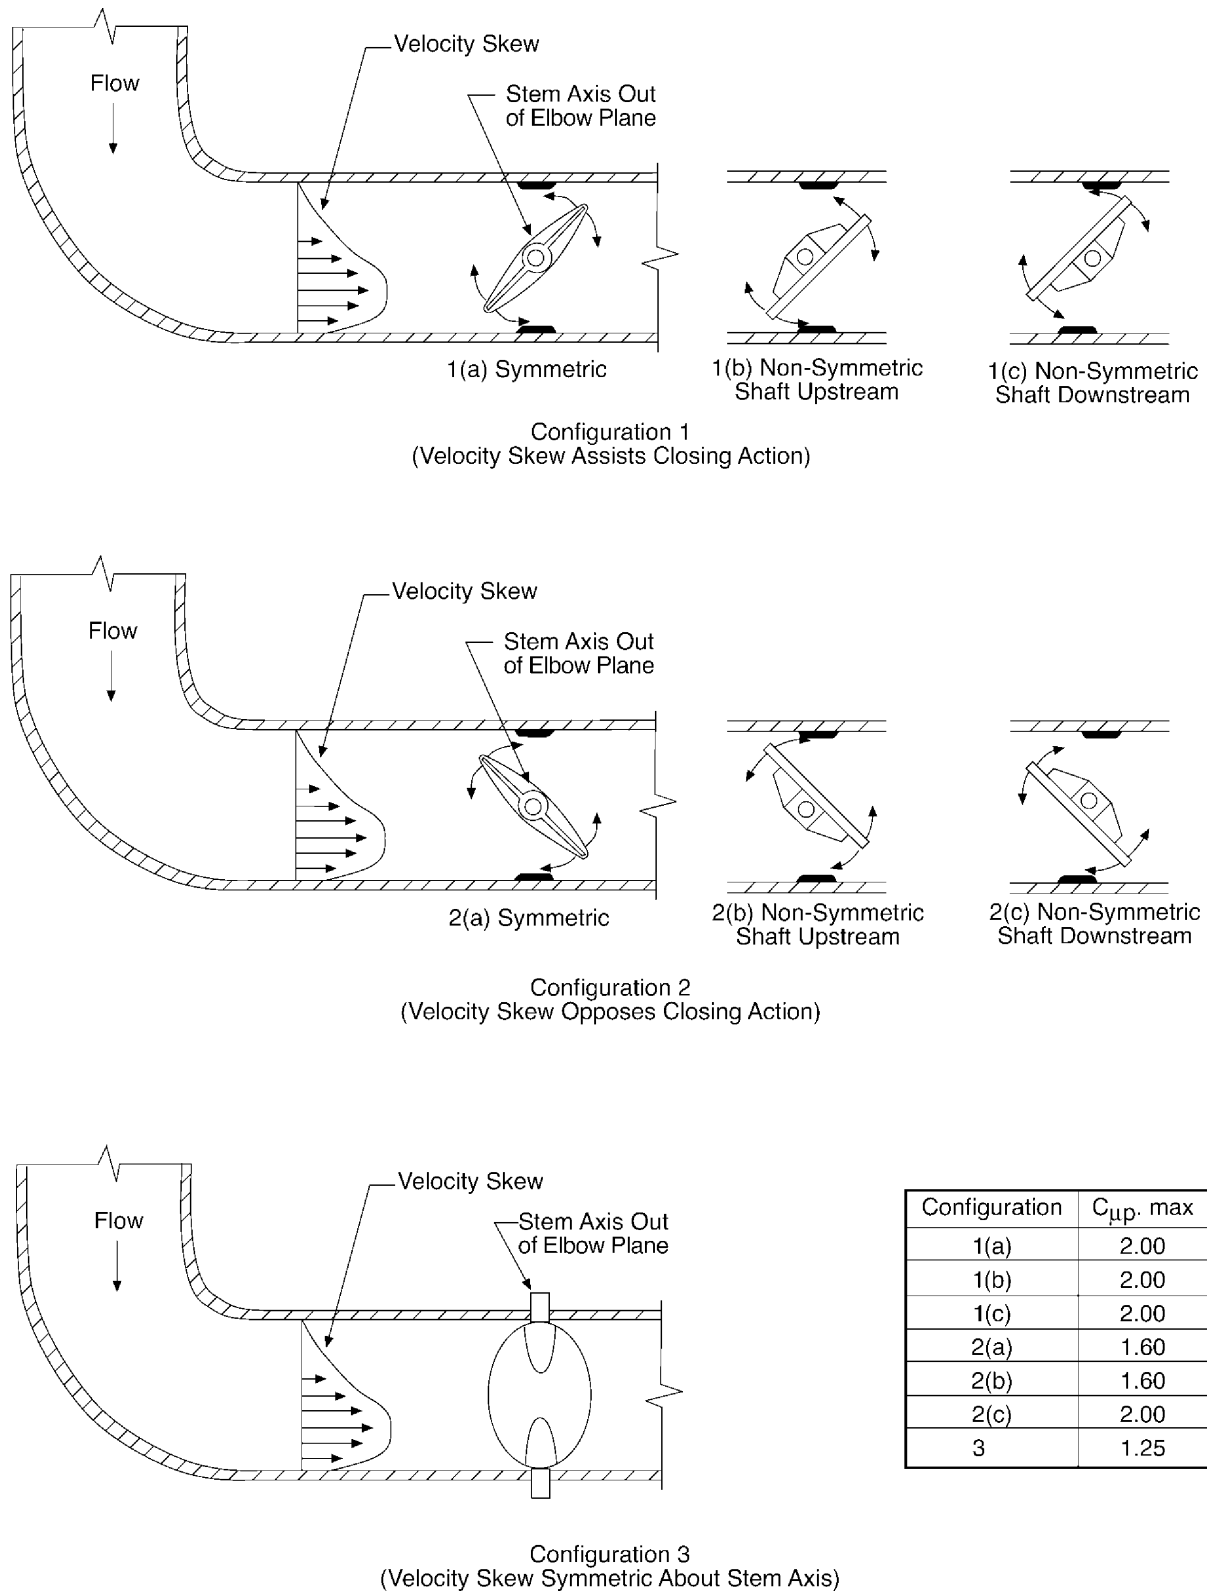
**Figure 3-2**  
Effects of Upstream Disturbance, Shaft Orientation, and Disc Opening Direction on Hydrodynamic Torque

Ideally, butterfly valves should be installed in straight pipe runs with a minimum of eight pipe diameters of straight upstream pipes. However, in typical applications, butterfly valves are installed within short distances of other piping components that can have a significant effect on valve performance, especially in high flow rate applications. Upstream elbows, tees, pumps, and other valves result in velocity skews and turbulence, which can significantly increase the required dynamic torque. Figure 3-2 shows three different valve orientations with respect to an upstream elbow.

In configuration 1, the velocity skew tends to assist valve closing. In configuration 2, the velocity skew tends to oppose valve closing. In configuration 3, the velocity skew has little effect on the valve because the flow is nearly symmetric around the disc. Configuration 3 (where the valve shaft and the elbow are in the same plane) is typically recommended because it has the least effect on the valve performance in both the closing and opening direction.

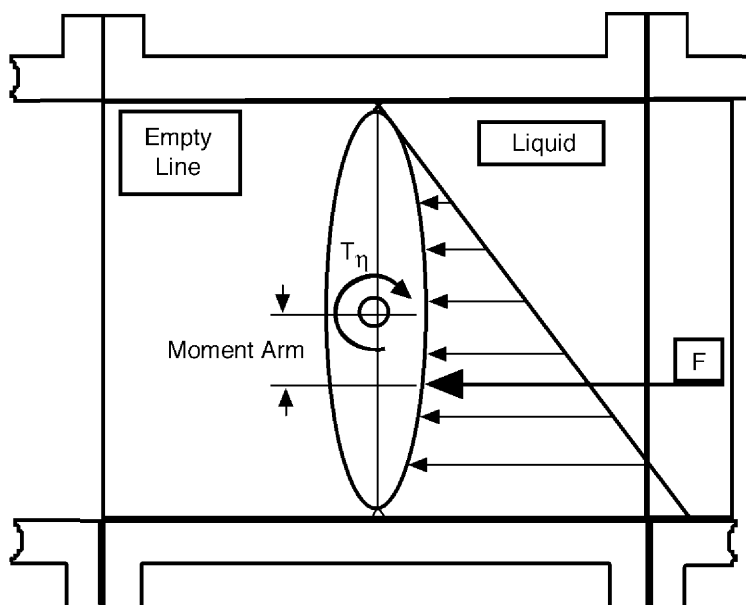
**Figure 3-3**  
**Hydrostatic Torque Component in a Horizontal Shaft Installation**

In offset valves, shaft upstream or downstream is important for seat leakage and torque requirements. On the other hand, vertical or horizontal orientation applies to both the symmetric and non-symmetric designs. The vertical shaft with actuator on top is the preferred orientation. In applications where the valve shaft is horizontal, the hydrostatic torque component results from the variation in the static head of the process fluid from the top to the bottom of the valve disc due to gravity, as shown in Figure 3-3. Depending upon the direction of the hydrostatic torque and the direction of shaft rotation to open or close the valve, this torque component can assist or oppose the actuator in the seating direction. In general, the hydrostatic torque can be neglected except for very large valves—30 inches (DN 750) and larger.

The hydrostatic torque becomes zero (or negligibly small) under any one of the following conditions:

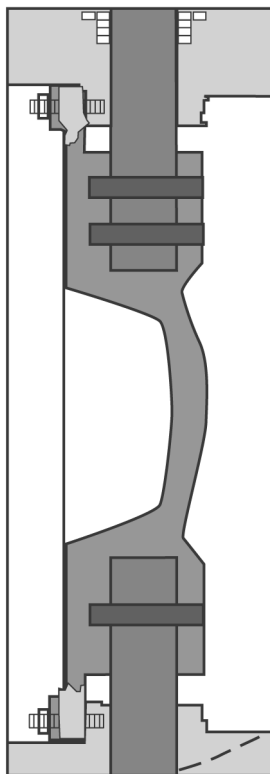
**Figure 3-4**  
**Dome Type Disc**

The most common method of reducing vibration is to turn the disc slightly into the flow stream (throttle), thus placing a preload on one side of the disc, which in turn resists the flow forces causing the vibration. However, if this problem involves a system that is operating close to its design limits, this strategy may not work. For example, if the circulating water system flow margin to maintain condenser vacuum at required levels is near zero (as may happen in summer), the small flow loss incurred by this throttling may not be acceptable. One plant reported that they had eliminated high velocity-induced vibration in their circulating water system by changing the valve to one that has a domed disc. An example is provided in Figure 3-4. A small amount of preloading was still required.

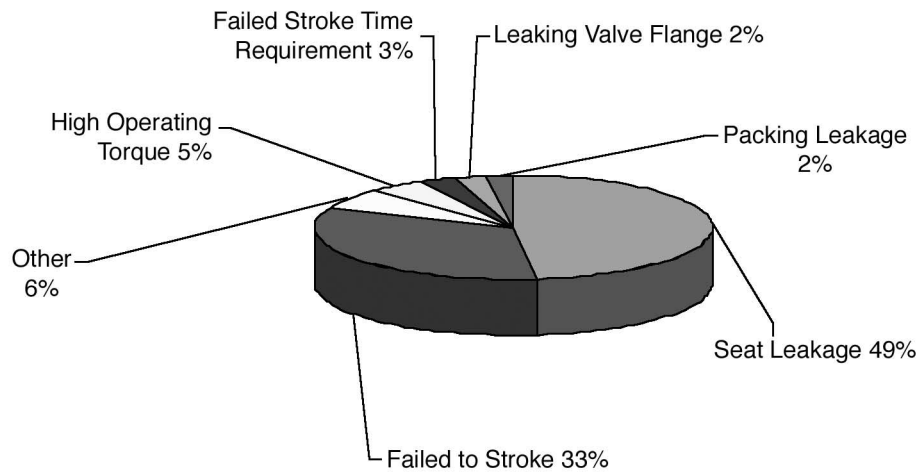
**Figure C-1  
Failure Modes**

The analysis provided in Appendix C identifies the following failure modes.

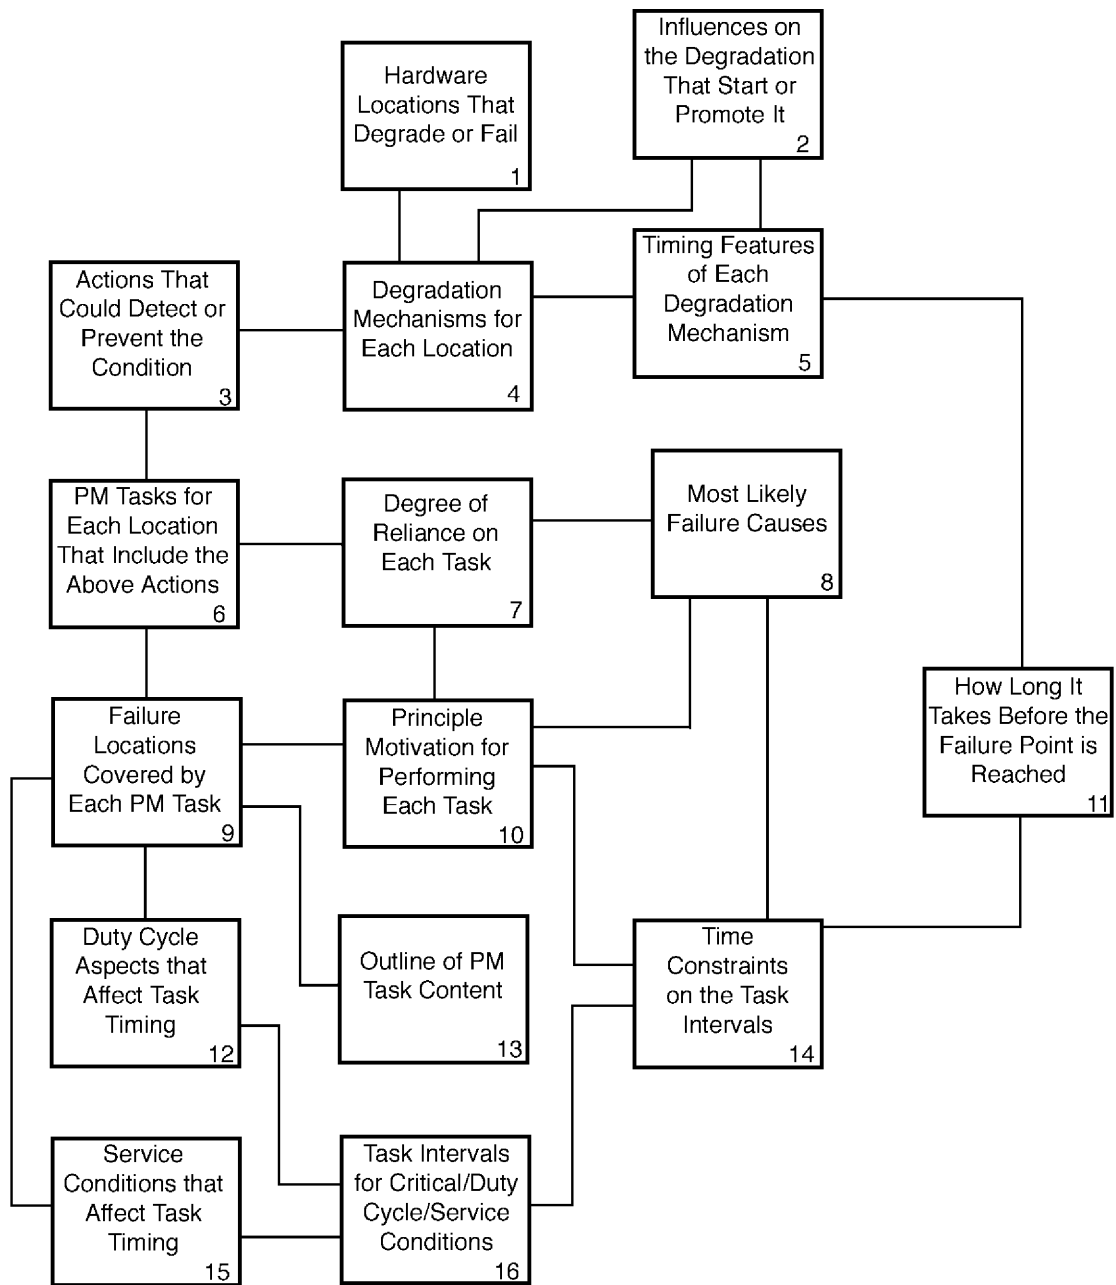
**Figure F-1**  
**Preventive Maintenance Development Process [17]**

The flowchart presented in this appendix presents a preventive maintenance development process.
