Mechanical Flange Leak Sealing

Design Modifications

1007926

Technical Update, December 2003

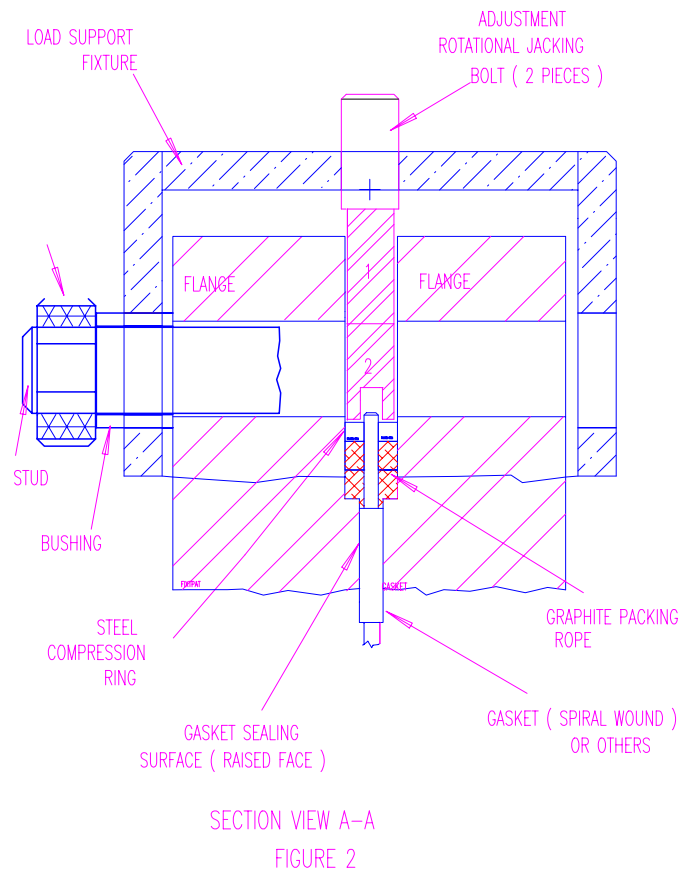
Figure 3-1
Cross-Section of Assembled Flange and Leak Sealing Fixture

Figure 3-1 illustrates the simplified configuration of the clamshell fixture. The three ‘sides’ of the fixture are joined together with a full penetration weld at the corners. Holes are positioned about the length of the fixture to accommodate several pieces of tooling. The top and bottom of the fixture have a series of large clearance holes spaced at 30 degree increments. This pattern allows for complete clearance of the flange studs and special hardened bushings, but does not allow the stud nuts to pass through.

Positioning bolts are located in between the larger stud holes. If the fixture is placed on a vertical run of pipe, the device will ‘lay’ on the outside surface of the flange. Since one of the keys to successful installation is ensuring that the device is properly centered, it was necessary to incorporate the positioning bolts into the fixture. By turning the bolts clockwise or counter clockwise, the fixture can be raised up or down, thus centering it over the flange and the gasket.

The web of the fixture contains a series of ‘viewing’ holes and tapped holes for impingement screws or jacking bolts. A typical quarter segment of the fixture will contain three or four locations for impingement bolts.

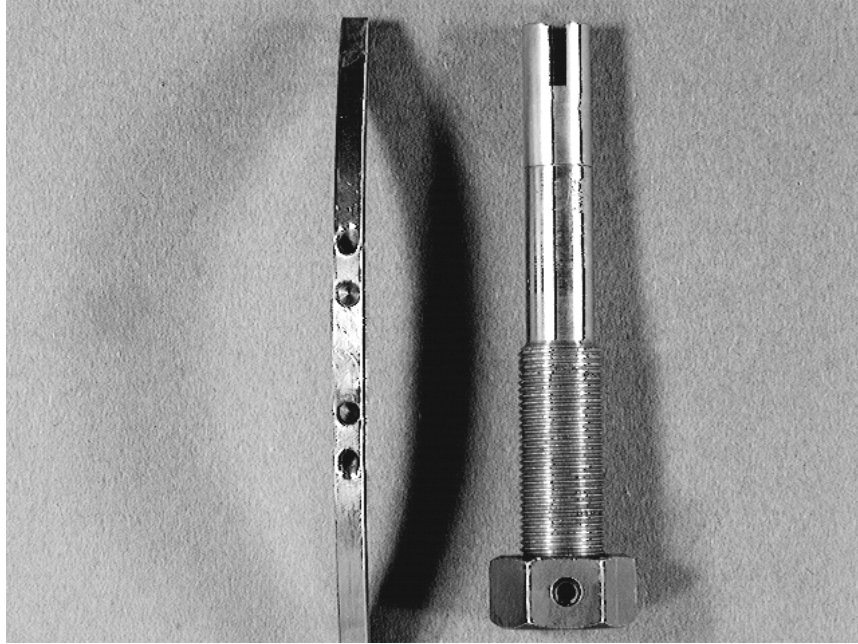
Figure 3-2
Impingement Bolt with Backing Bar Holes in Backing Bar Enable the User to “Direct” the Bar with a Rod

The impingement bolts are comprised of three parts. The working end of the bolt is split so that it can have intimate contact with the compression ring without touching the outer edge of the gasket. The main shaft of the bolt is loosely pinned at the junction of the shaft and the fork. This will accommodate any torsion stresses that may be generated when the bolt is tightened. The third component is a nut that has been pinned to the free end of the impingement bolt. This allows the operator the ability to use standard hand tools. In this case, the nut is 1-1/16-inch across the flats.

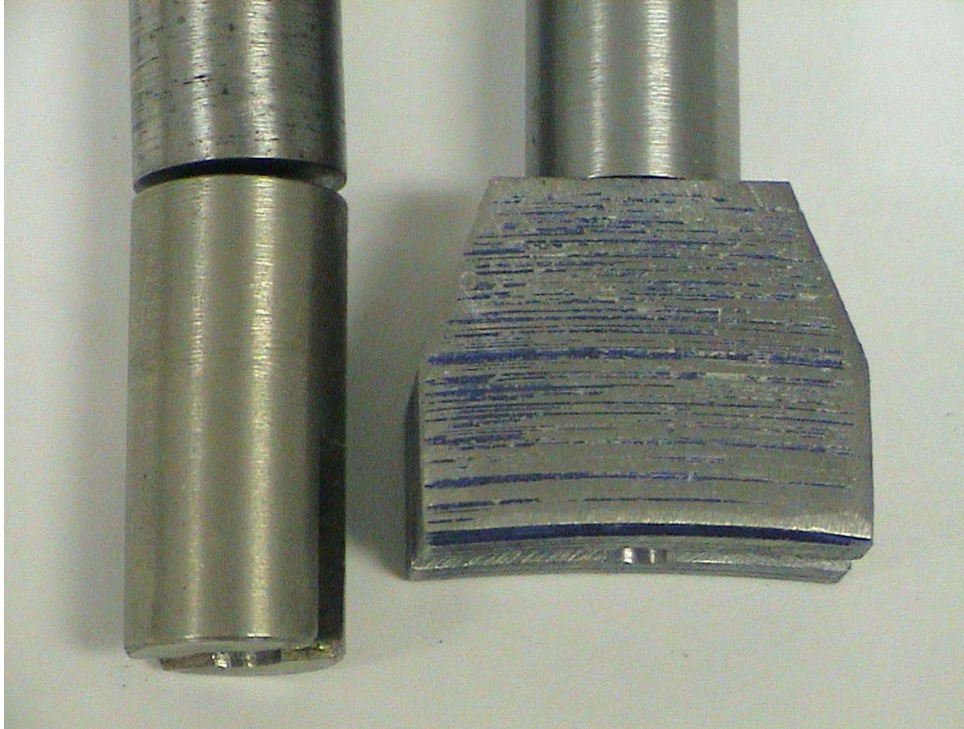
Figure xx – Original impingement bolt on left and modified bolt on right.

One of the key changes in the design centers around the end of the impingement bolt. The contact end has been broadened and radiused to conform the curvature of the backing bar as illustrated in Figure xx.

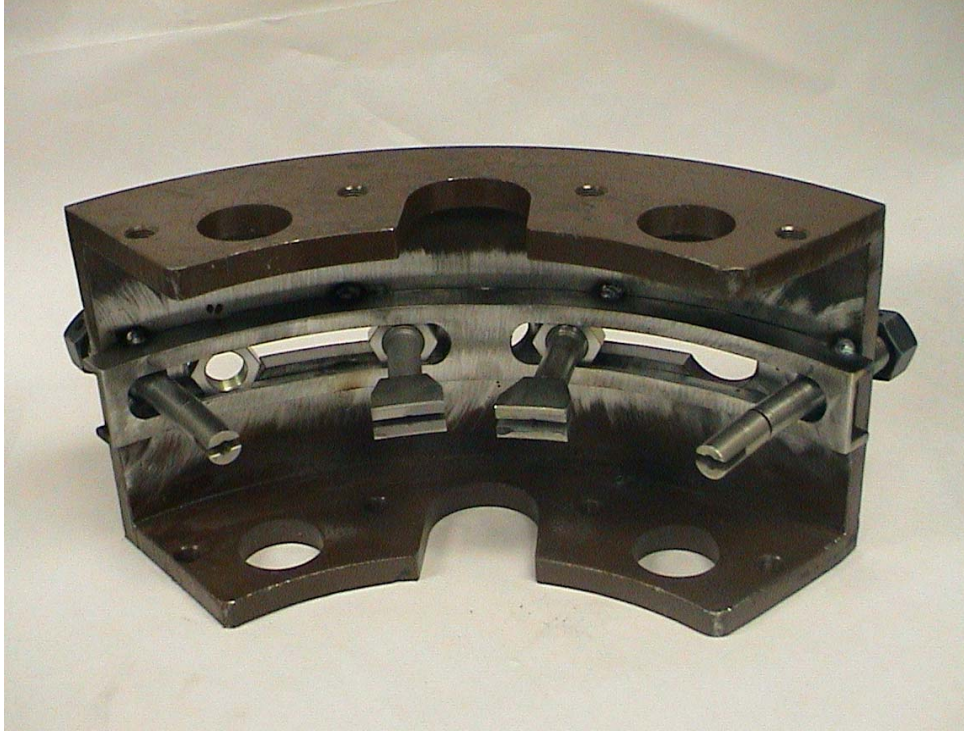
Figure xx – New slotted channel tack welded to fixture.

Additional design changes were made to accommodate greater freedom in placing the bolts in a position conducive to stopping the leak. To do this a large slot was machined into the face of the fixture. A corresponding slot was machined into a rolled channel. This component was rolled to a radius equal to that of the face of the main fixture.

The channel was tack welded to the inside surface of the fixture. With a nut placed in the channel the bolt now has the freedom of movement.

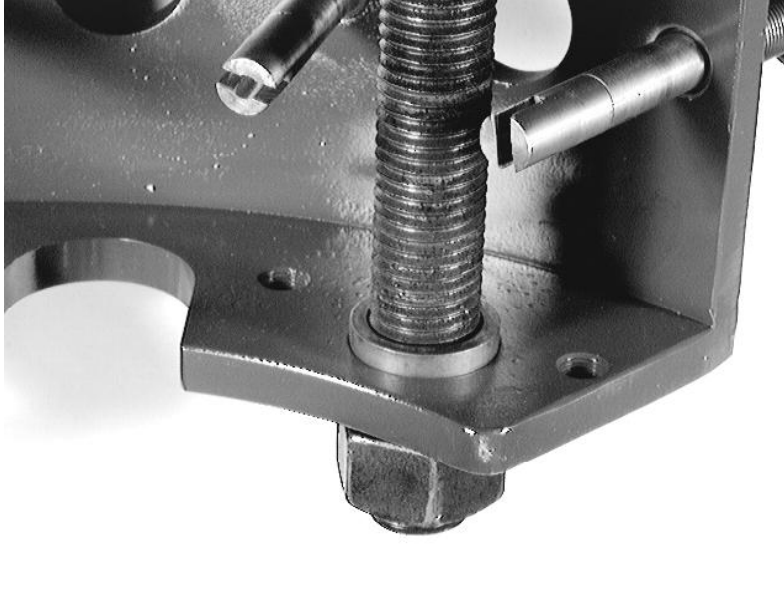
Figure 3-3
Clamshell with Stud and Hardened Bushing

To counter the shear, hardened bushings were placed between the studs and the clearance holes of the fixture. This served two functions. One, as the reaction loads are applied, the overall stress on the studs is reduced since the cross-sectional area of the bushings displaces the load over a larger area. Two, the bushing acts as a hinge in allowing the fixture to swivel once the fixture is attached with a single stud. See Figure 3-3.

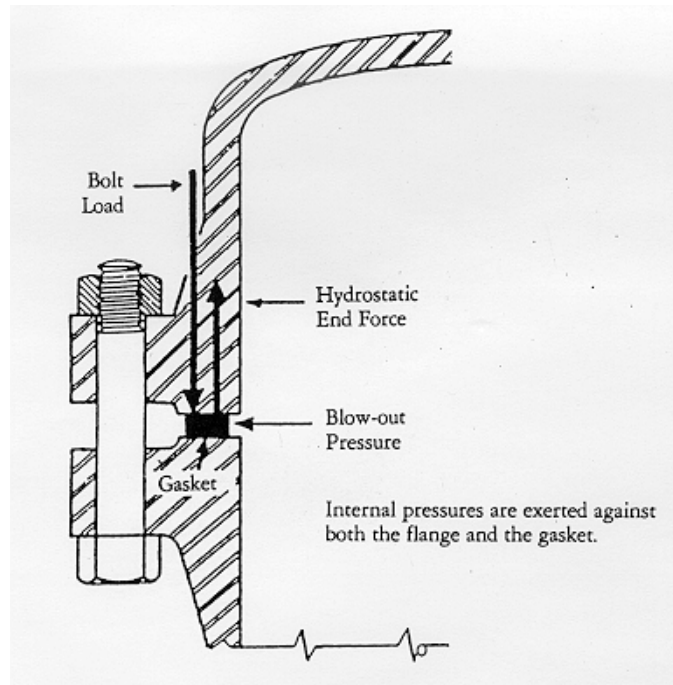
Figure 3-4
Schematic of Static and Dynamic Loads

Under normal operation, the flange will experience two loads: 1) the bolt load induced by the torque of the nuts against the studs, and 2) the hydrostatic force created by the flow of the water.

The addition of the leak sealing fixture creates a third loading condition. As the impingement bolts are tightened, they exert a force on the graphite packing, driving the packing material into the gasket/flange face region. The reaction loads cause a shearing strain on the studs.

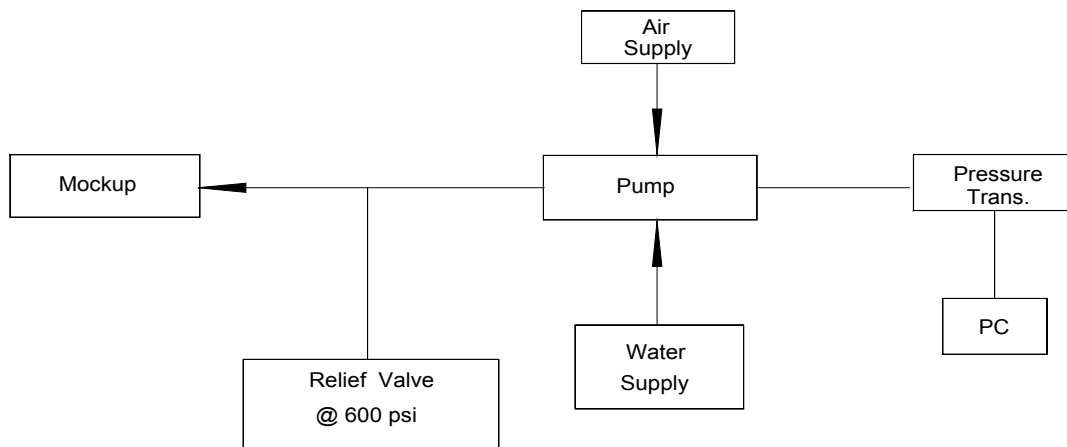
Figure 4-1
Test Setup

The following provides a detailed summary of the procedures used in testing the class 600 mechanical leak sealing fixture and the results of those tests. To date, four tests have been performed with various flawed gaskets. A schematic of the setup used in each test can be found in Figure 4-1.

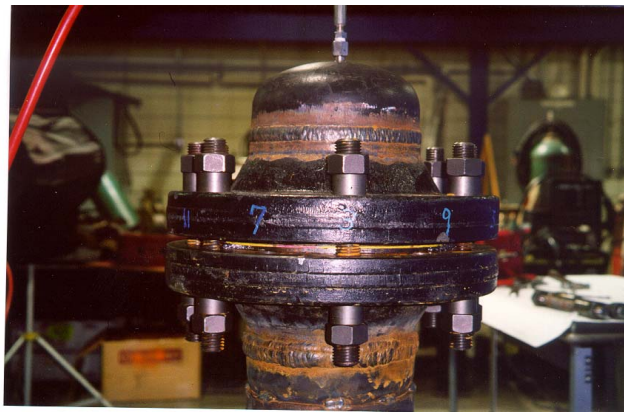
Figure 4-2

Assemble Flange with Two Studs Removed Prior to Installation of the Fixture

1. To begin the installation three adjacent threaded studs in the area of the leak were selected. The two outside studs were removed while the center stud was left intact as seen in Figure 4-2.

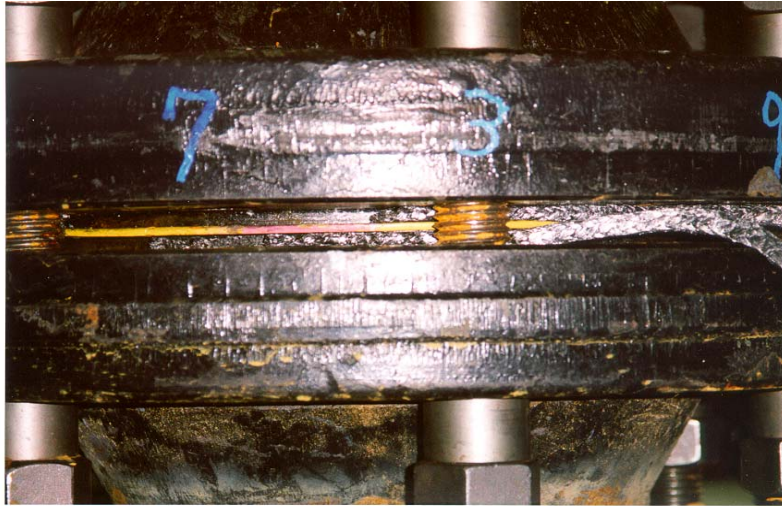
Figure 4-3

Insertion of Graphite Packing Material Above and Below the Gasket Centering Ring

2. Two strips of 1/4" graphite packing were then inserted into the gaps above and below the gasket within the radius of the bolts in the area of the leak as seen in Figure 4-3. During this process, care was taken to make sure that the packing material properly conformed to the boss radius of the flange.

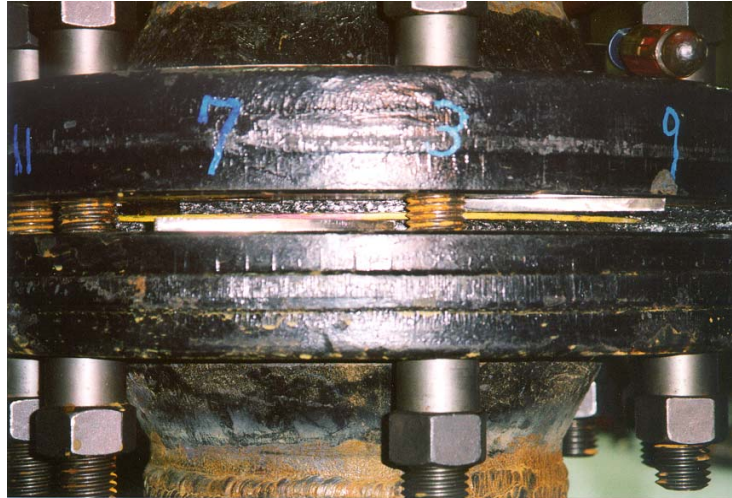
Figure 4-4
Backing Bars Being Placed Behind the Graphite Packing

3. Once the graphite packing was in place, packing rings were inserted into the gaps above and below the gasket within the radius of the bolts so that they conformed to the packing material and were in alignment with the fixture. This process can be seen in Figure 4-4. The packing rings consisted of four 1/4" × 7/16" circular sections. Two of the packing rings were used in the top gap and the other two were used in the lower gap.

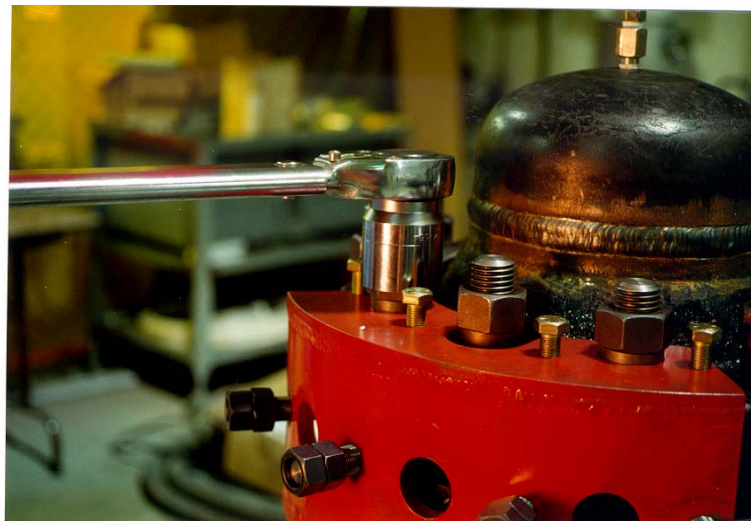
***Figure 4-5
Torque Wrench Applying Full Load on Studs But Not on Fixture***

4. Then one of the quarter sections of the fixture was mounted to the pipe flange as seen in Figure 4-5 using the two studs that were previously removed, in addition to the hardened bushings provided. The hardened bushing allowed the fixture to be independent of the flange, which allowed it to be moved in the vertical direction to facilitate alignment. Then each of the bolts was re-torqued to their proper specifications.

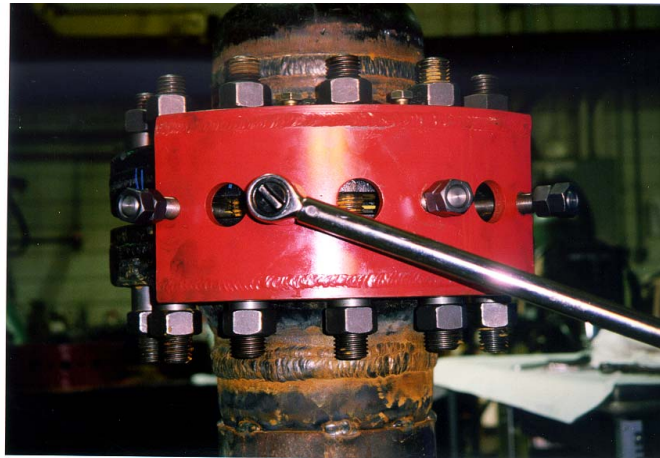
Figure 4-6
Impingement Bolts Driving Packing Material Inwards as the Bolts Are Turned

5. Four of the slotted jackscrews were inserted into the fixture. Then using the alignment bolts located on the top and bottom of the fixture, the jackscrews were centered so that they would slide over the centering ring of the gasket and make contact with the packing rings.
6. Once the impingement bolts were inserted and properly aligned, they were tightened in a clockwise manner to a torque value of 50 ft-lb as seen in Figure 4-6.

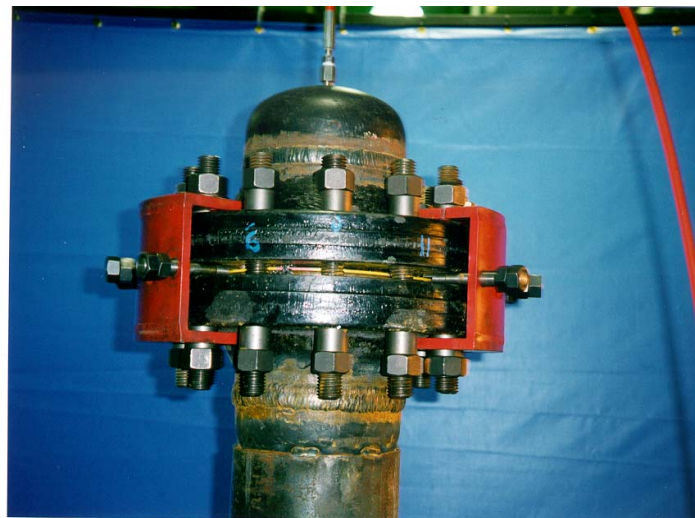
Figure 4-7
Fully Assembled Fixture After Stopping Leak

7. If necessary, additional quarter section leak sealing fixtures were installed in the same manner as seen in Figure 4-7.

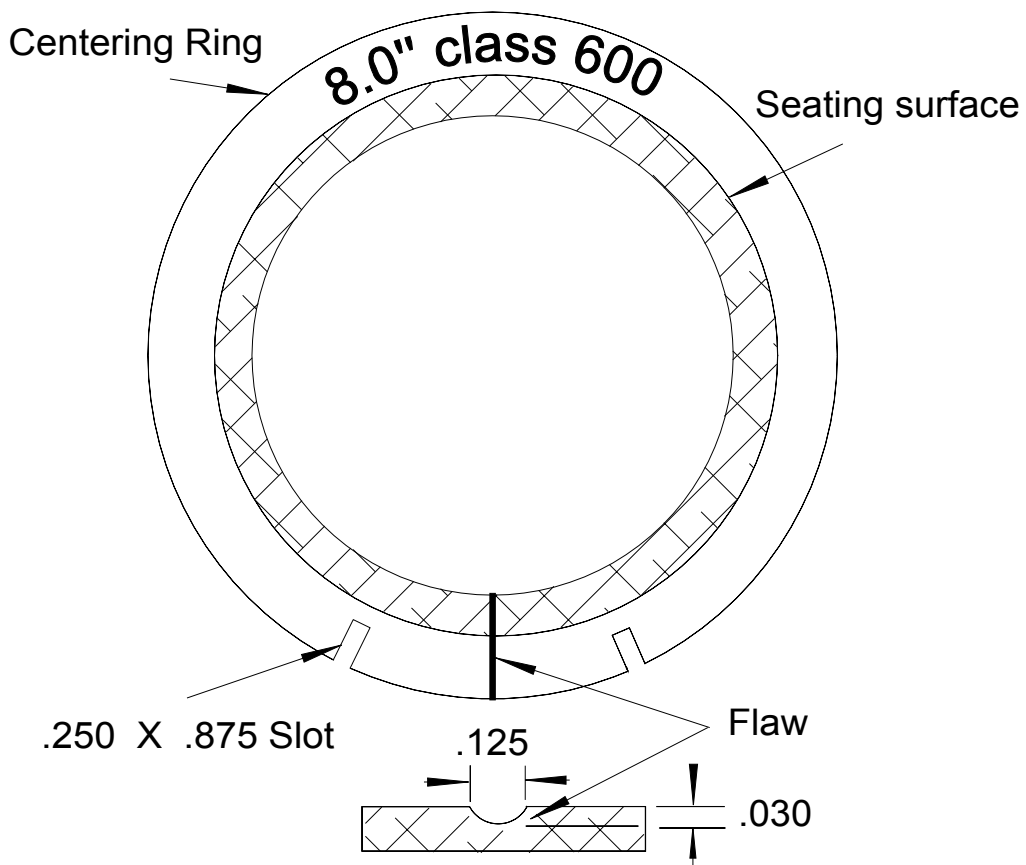
Figure 4-8
Flawed Gasket for First Test

In this test, one flaw with the dimensions shown above was inserted into a class 600 metallic gasket. The flawed gasket was then installed according to the procedures outlined above.

The flange was then pressurized and leaking began to occur at 400 psi. Visual inspection showed that the centering ring in the area of the leak was deflected downward. This prevented the installation of the graphite packing and packing rings. Attempts were made to manually correct the deflection of the centering ring; however, the centering ring was too ridged and we were unsuccessful. To solve this problem, a drill bushing (fixture) was developed and used to notch the carbon steel centering ring. This process relieved the stress on the ring and allowed it to flex. As a result, the packing and packing ring could then be installed. In this test, 1/4" graphite packing material was used. This packing was inserted into both the upper and lower gaps between the gasket and the flange.

Visual inspection showed that the leak was successfully stopped. The pressure was also monitored and found to hold constant at 600-605 psi.

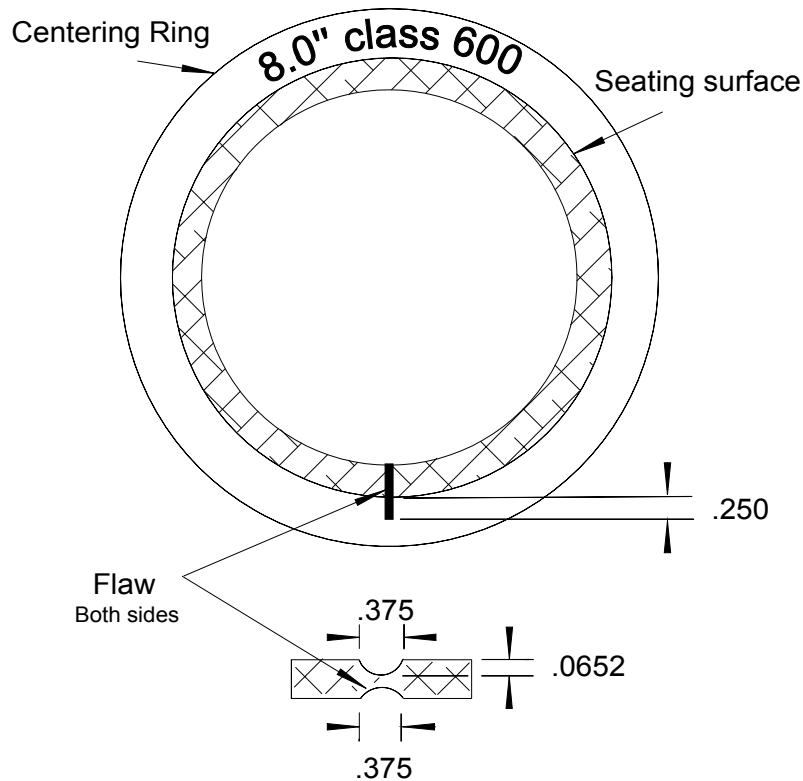
Figure 4-9
Flawed Gasket for Second Test

In this test one flaw with the dimensions shown above was inserted into a class 600 metallic gasket. The severity of the flaw caused substantial deformation in the seating surface of the gasket. This gasket was then installed following the procedure described above.

During the test substantial leaking occurred at 85 psi (water pressure). Following the installation procedures described earlier, the mechanical leak sealing fixture was then installed on the flange in the area of the leak. However, in this test $1/4" \times 7/16"$ packing rings were used in place of the $1/4" \times 1/4"$ used in test one. These larger packing rings were used because of their greater strength and rigidity, which allowed it to compress the packing more evenly without deforming the packing ring. As mentioned in the Test One description, four half-quarter sections packing rings were used rather than the two quarter sections. This allowed the packing rings to be installed easily without removing a third bolt from the flange.

Once the installation of the mechanical leak sealing fixture was completed, visual inspection showed that the leak was significantly slowed; however, it was not stopped. The damage to the gasket proved too great for this technique to be successful.

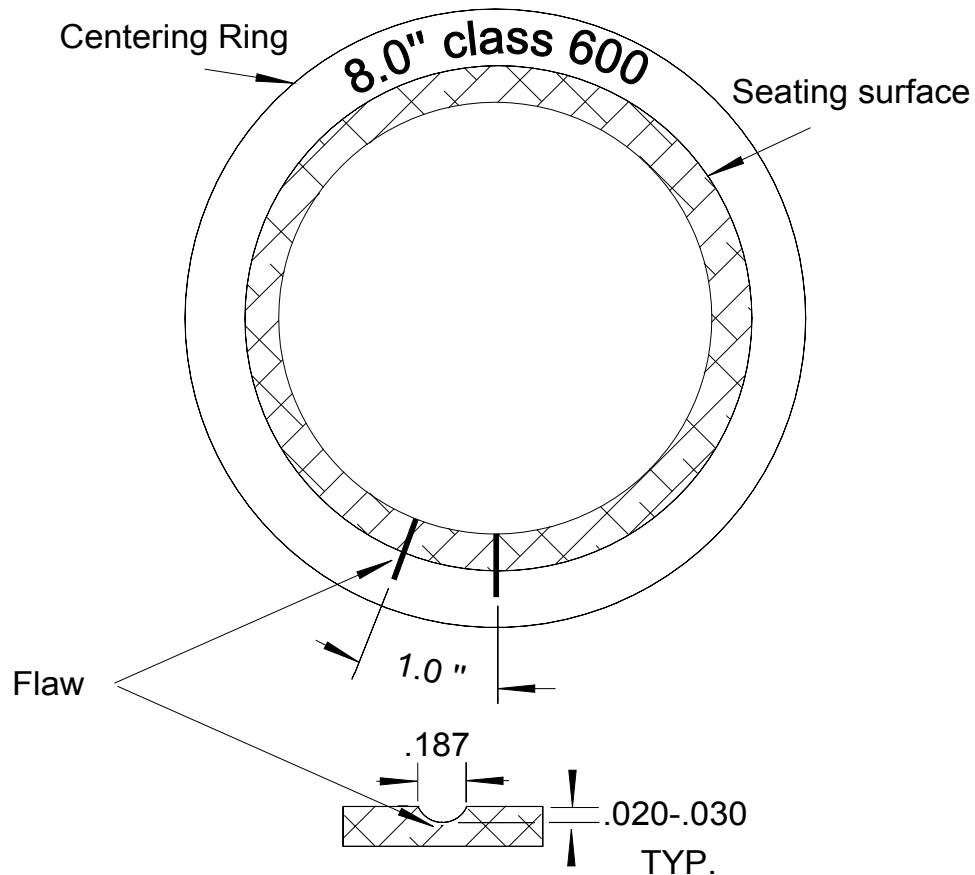
Figure 4-10
Flawed Gasket for Third Test

In this test, two flaws with the dimensions and orientation shown above were inserted into a class 600 metallic gasket. Initially, these flaws were only inserted into the seating surface of the gasket. However, they did not produce a leak and had to be extended into the centering ring portion of the gasket.

During the test, visual inspection showed that leaking occurred at both flaws at a pressure of 85 psi (water pressure). Due to the leaking, the maximum pressure that could be obtained with the

After the installation of the leak sealing fixture visual inspection showed that the leak was successfully stopped. The pressure was then monitored and found to hold at a constant pressure of 619-623 psi.

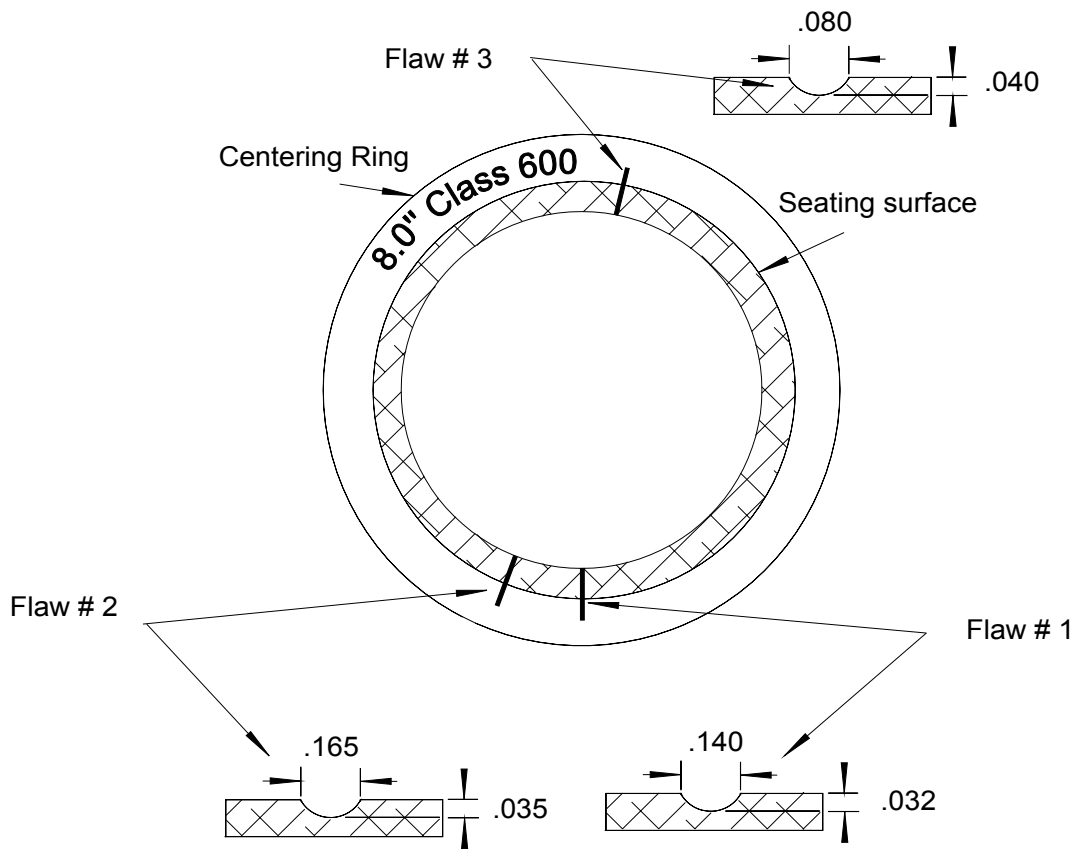
Figure 4-11
Flawed Gasket for Fourth Test

In this test, three flaws with the dimensions and orientation shown above were inserted into a class 600 metallic gasket. The flawed gasket was then installed following the procedure previously outlined.

During the pressurization of the flange, leaking occurred at 450 psi. Leaking occurred at each of the flaw locations and flaw #3 produced significant water spray. Due to the orientation of the leaks, two quarter-section leak-sealing fixtures were used. One fixture was used to seal the leaks produced by flaws #1 and #2 and a second fixture was used to seal the leak produced by flaw #3.

Once the mechanical leak sealing fixtures were installed, the flange was inspected. The inspection showed that all three leaks were stopped and the pressure could be maintained in the range of 640-655 psi.
