Testing of Stator Windings for Thermal Aging

Final Report

1009252

Final Report, December 2003

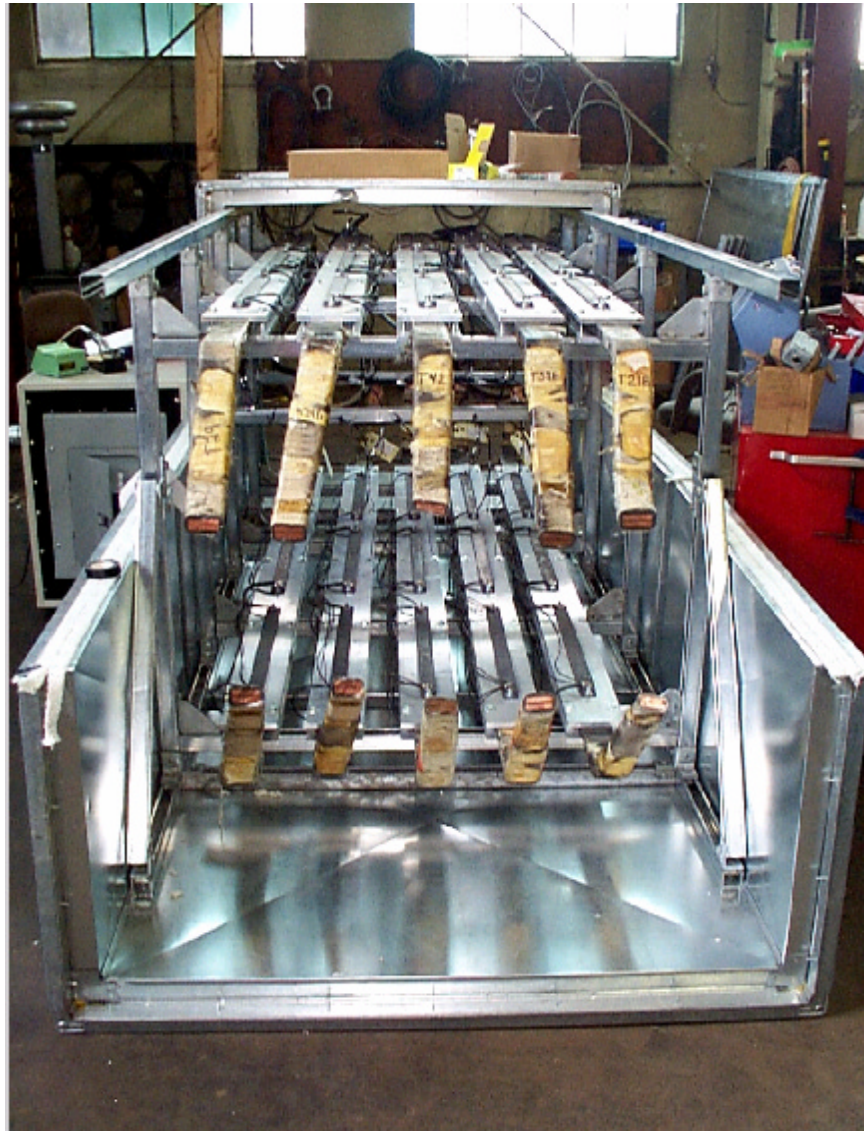
Figure 3-1
Bars loaded into aging cell

Following initial (conventional) characterization the stator bars were subjected to accelerated thermal aging, nominally to failure (as defined by the diagnostic tests), by the method described above. Figures 3-1 and 4-1 illustrate the configuration of the bars and the aging cell.

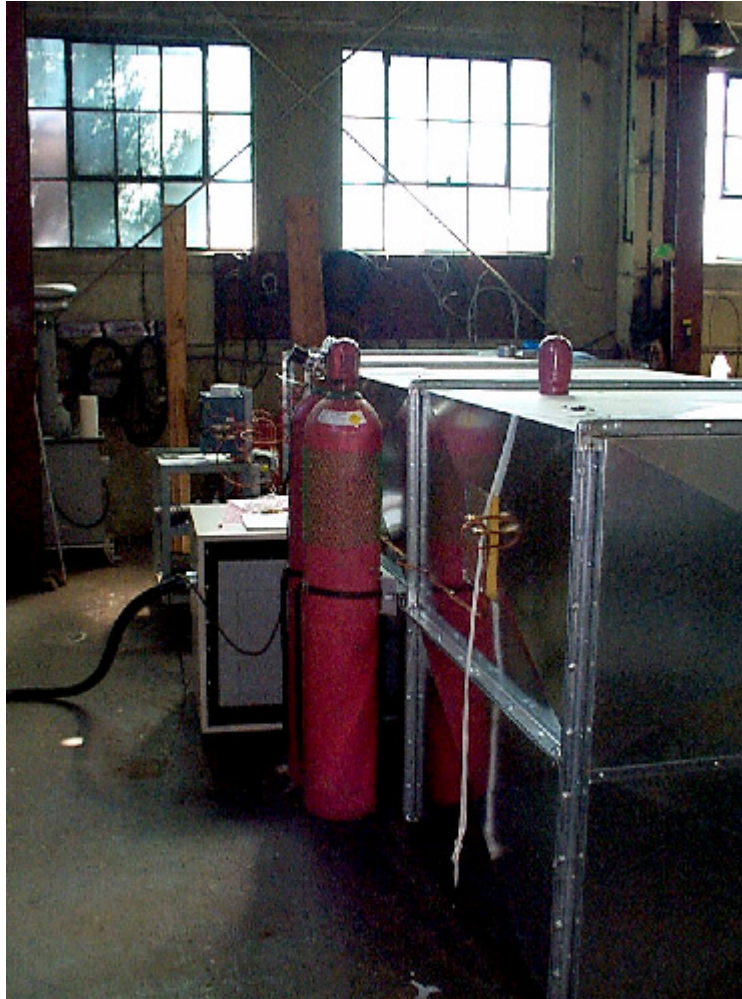
Figure 4-1
View of aging cell with gas handling and temperature control equipment

A specialized test facility has been designed to keep the bars under high temperatures while simultaneously exposing them to oxygen enriched air. Thermal aging results in the rapid consumption of oxygen in the air surrounding the bars; if care is not taken, oxygen depletion can be such that little thermal aging is taking place. Two steps are taken to ensure satisfactory oxygen availability during the aging experiment, the use of oxygen enriched air and the periodic measurement of oxygen concentration in the outflow from the specialized test cell. To control the aging atmosphere, the test cell was designed as an air-tight enclosure. Prior to commencing

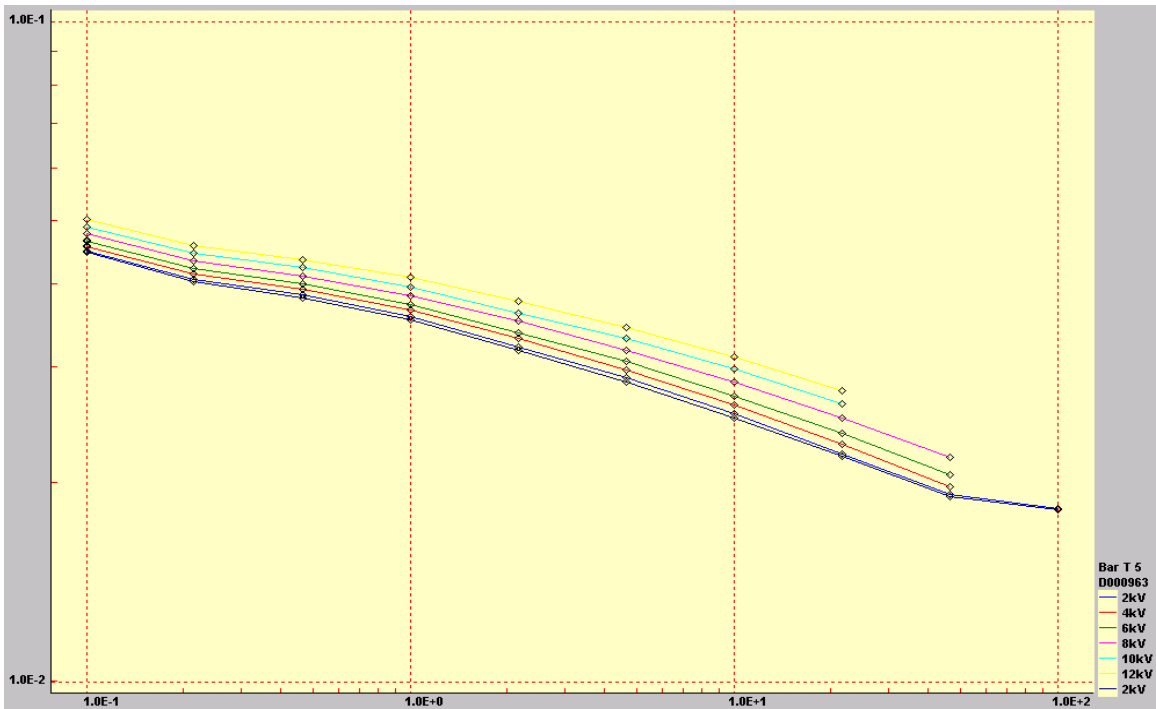
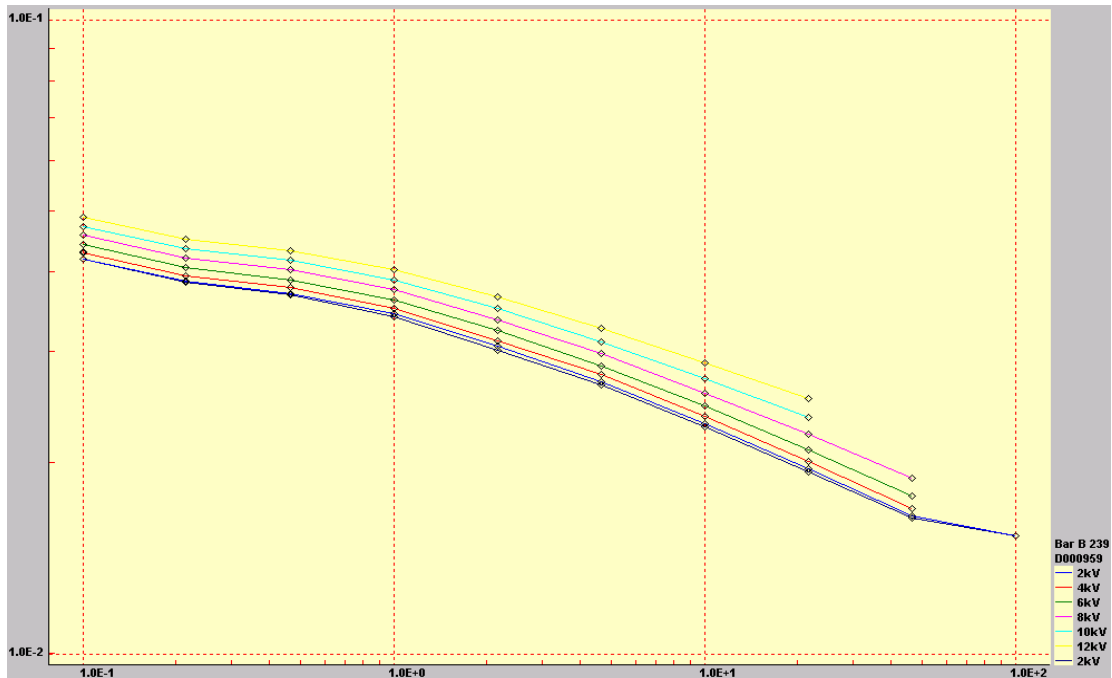
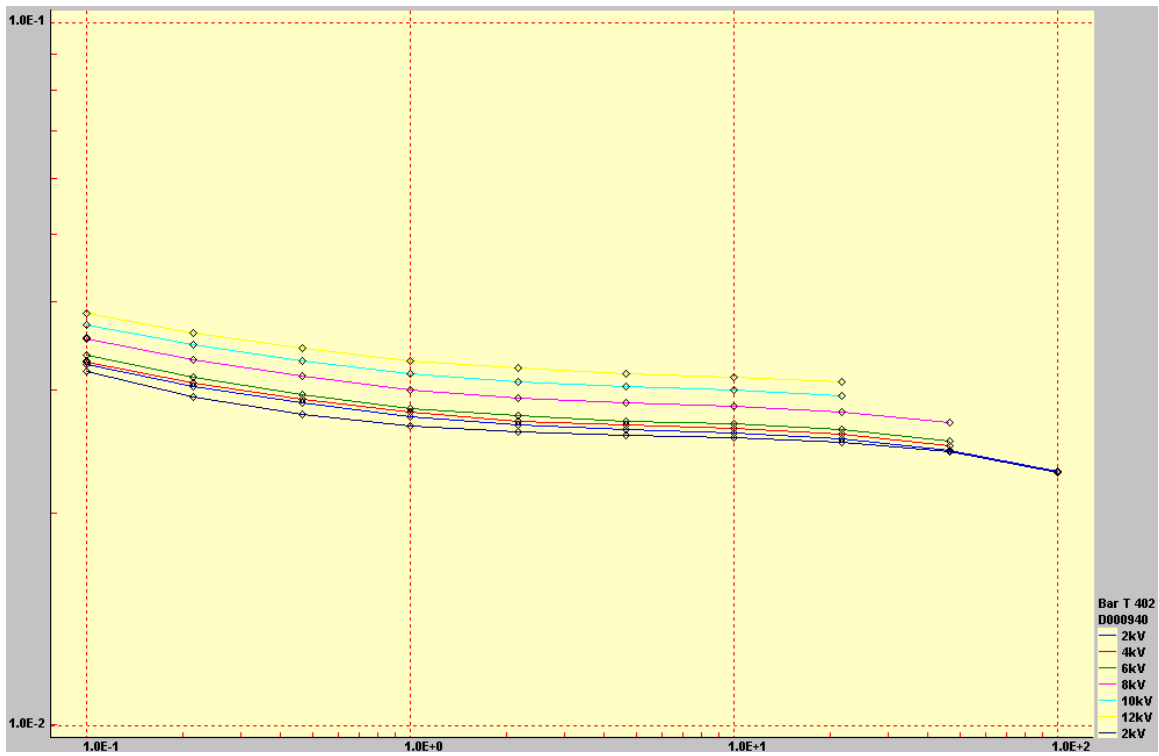
Figure 4-10
Dielectric response of bar T5, control bar

Figure 4-11
Dielectric response of bar T29, pre-aging

Figure 4-12
Dielectric response of bar T42, pre-aging

Figure 4-13
Dielectric response of bar T218, pre-aging

Figure 4-14
Dielectric response of bar T321, pre-aging

Figure 4-15
Dielectric response of bar B378, pre-aging

Figure 4-16
Dielectric response of bar T386, pre-aging

Figure 4-17
Dielectric response of bar B239, pre-aging

Figure 4-18
Dielectric response of bar B246, pre-aging

Figure 4-19
Dielectric response of bar T402, pre-aging

Figure 4-20
Dielectric response of bar B445, pre-aging

The results of DS testing for the stator bars prior to undergoing thermal aging are illustrated in Figures 4-10 through 4-20 in which $\tan\delta$ (dissipation factor) is plotted as a function of frequency. Initial inspection of these data show a number of common features.

1. The dielectric loss tends to increase as frequency decreases.
2. Losses increase as the applied voltage is increased. Note that at above 21 Hz, there are no data points for the higher voltages because of limitations in the high voltage amplifier used.
3. Similar to the power frequency diagnostic test results, differences between the low frequency behaviour of the stator bars also exist.
