Gimpel Trip and Throttle Valve Spindle Testing Project

Technical Update, December 2004

Project: Metallography of
PT Crack indication of
Valve Rod

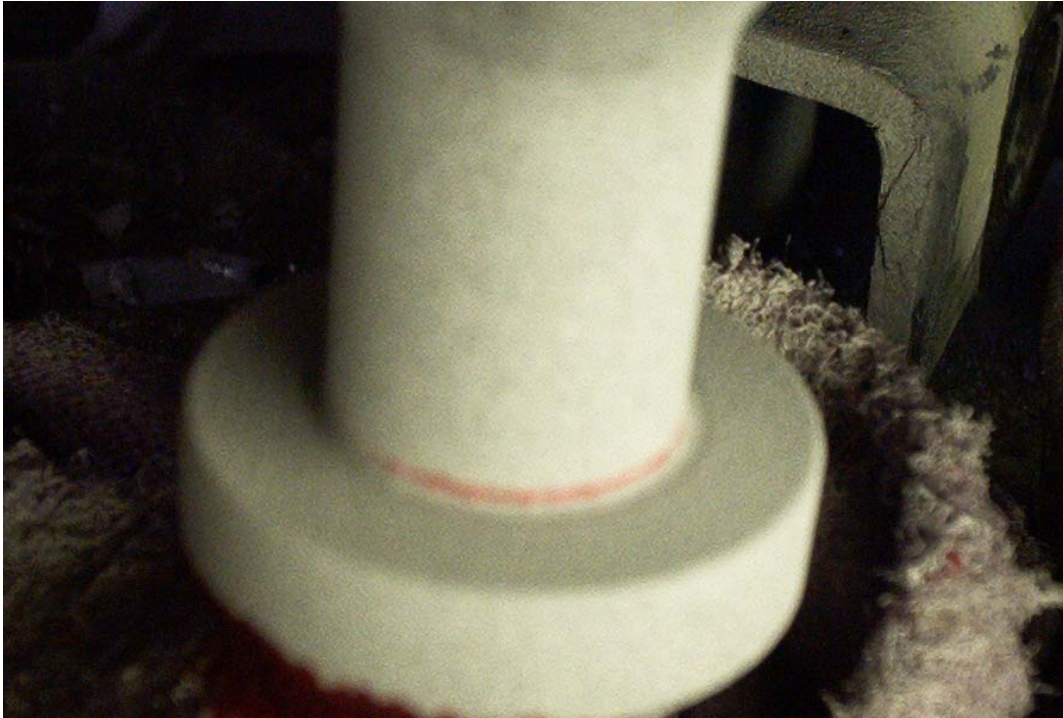
Photo of Indication in Spindle 1 at Completion of Test:

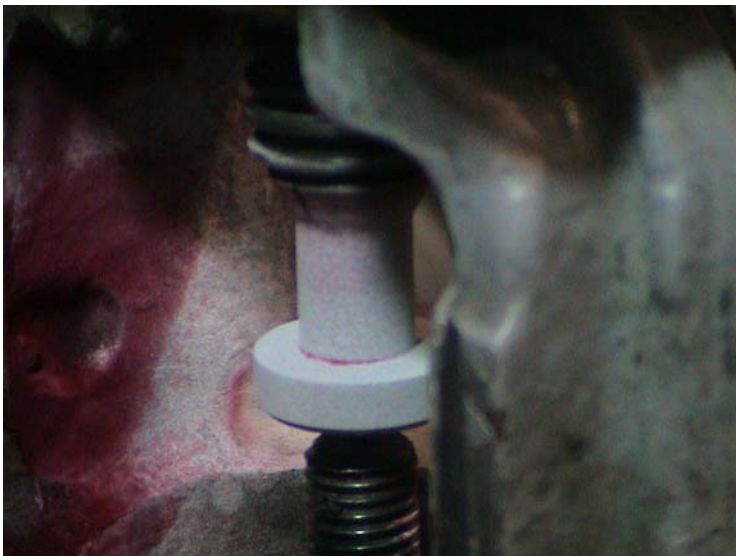
Photo of Spindle #3 after 3500 cycles Showing Indication
