# **EPRI Case History Study: High Pressure Feedwater Heater Replacement**

*A Success Story in Outage Management and Project Execution*

Technical Update, December 2005

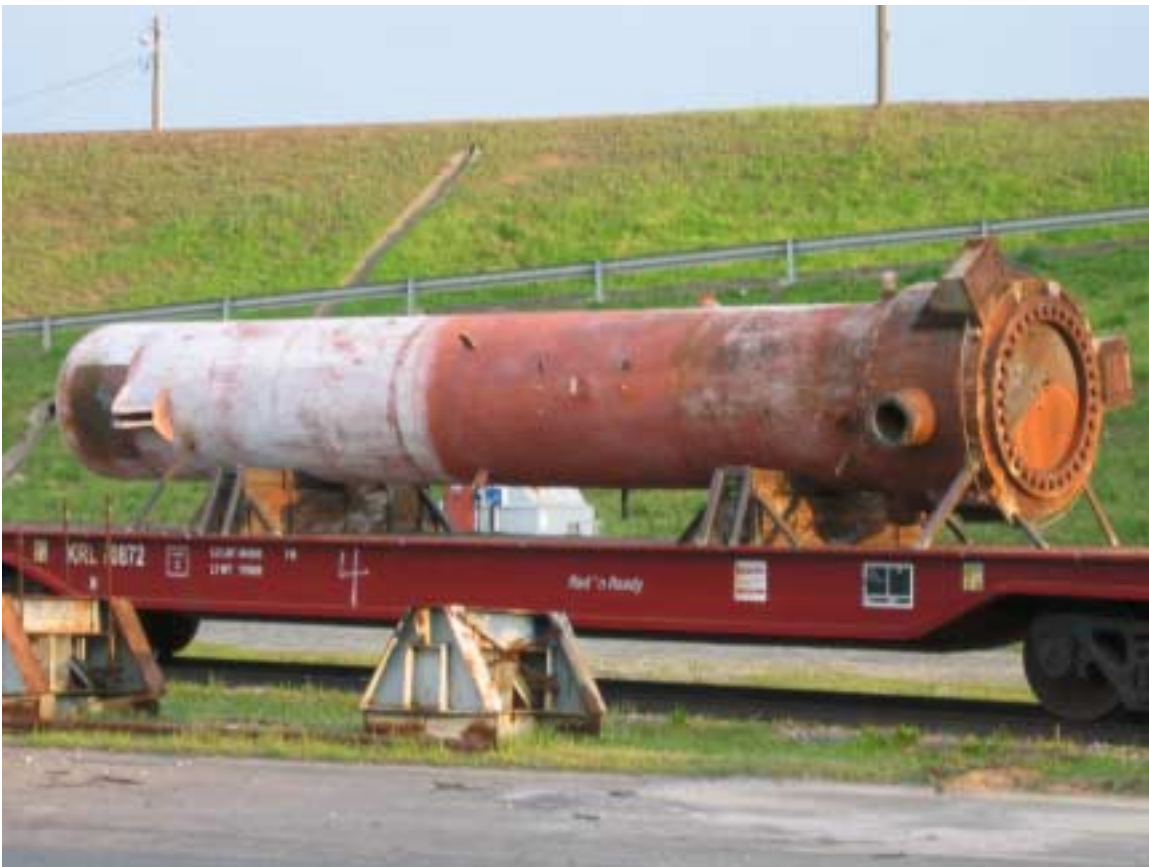
**Figure 1**  
**Old Feedwater Heater Ready for Disposal**

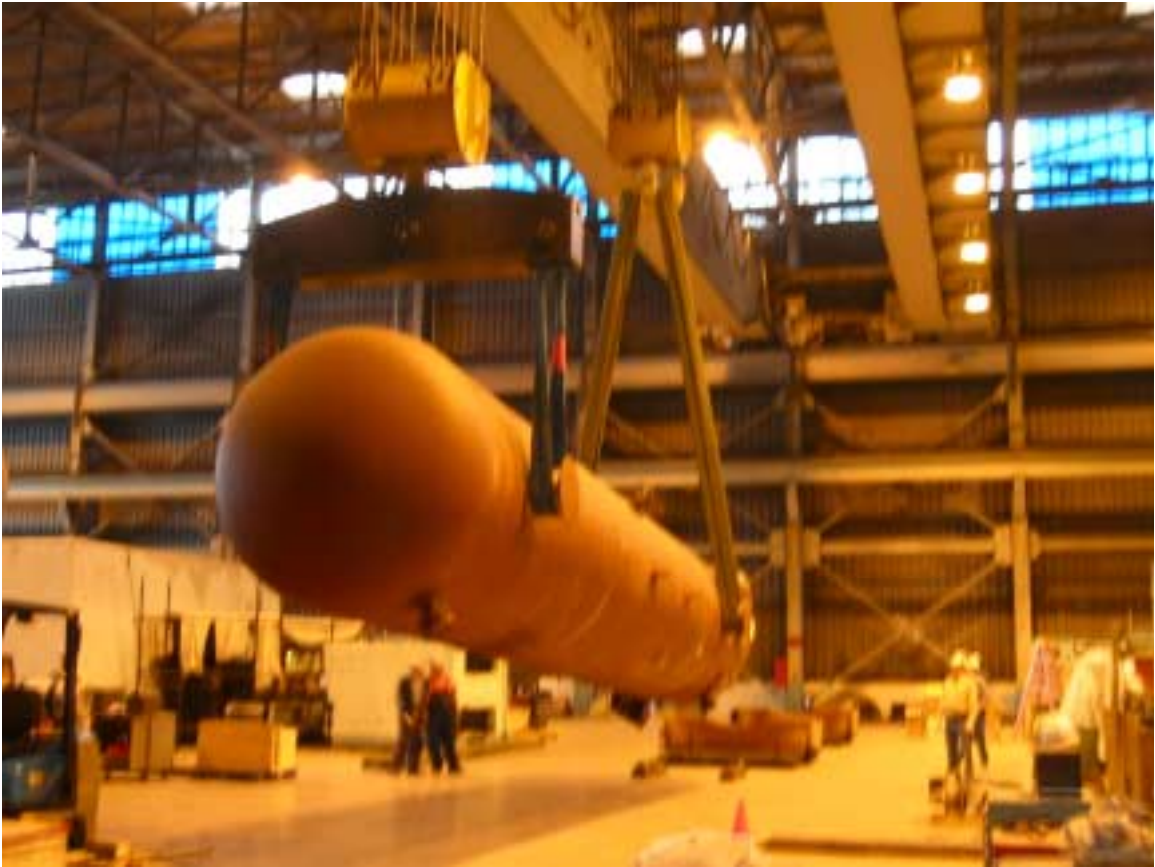
**Figure 2**  
**New Feedwater Heater Prior to Uprighting Over Heater Bay**

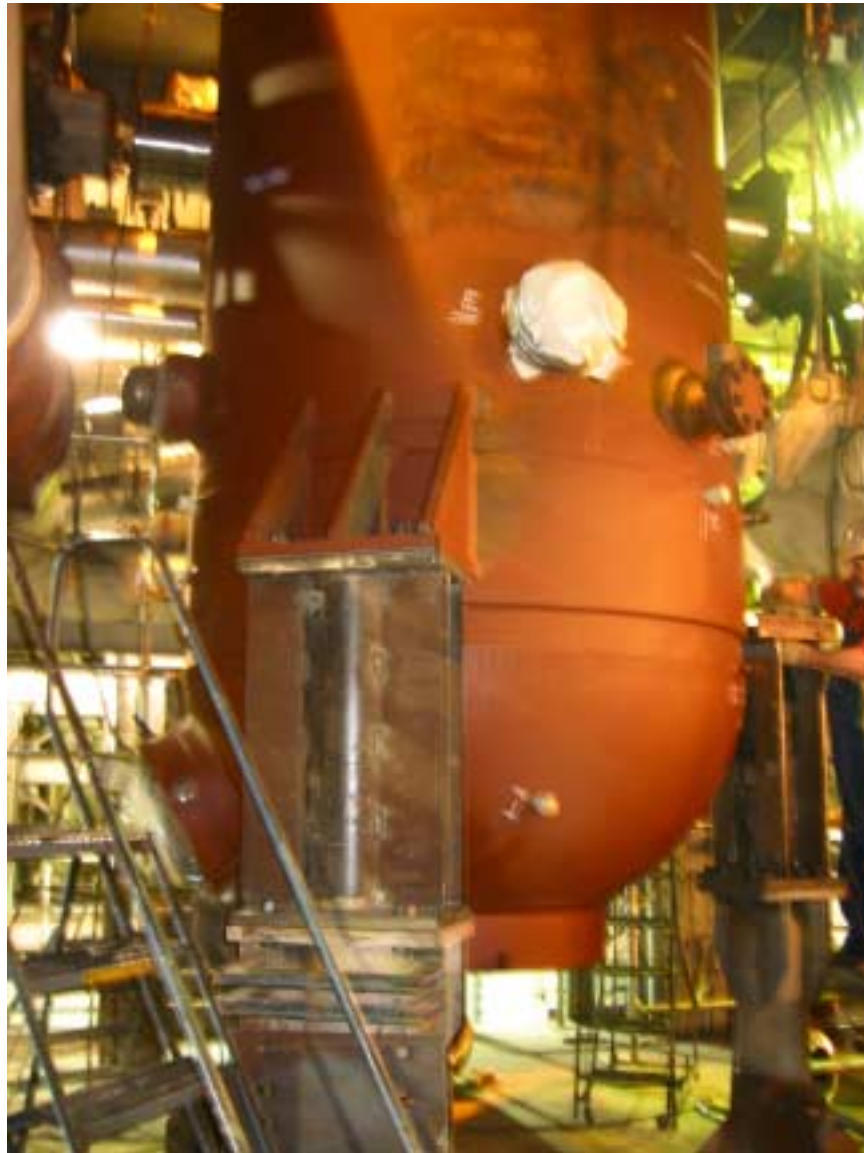
Figure 3 shows support leg extensions needed for the new feedwater heaters.

**Figure 3**  
**New Feedwater Heater Showing Support Leg Extensions**

Lifting the new longer, wider, and heavier heaters was the dominant installation concern, requiring a detailed lifting and rigging plan. Although the heaters were set on “feet” having the same footprint as the old heater, the larger shell diameter required that one of the three legs be shipped loose, and welded on in the field. The new heater had to stay on the crane hook until the third leg was welded on.

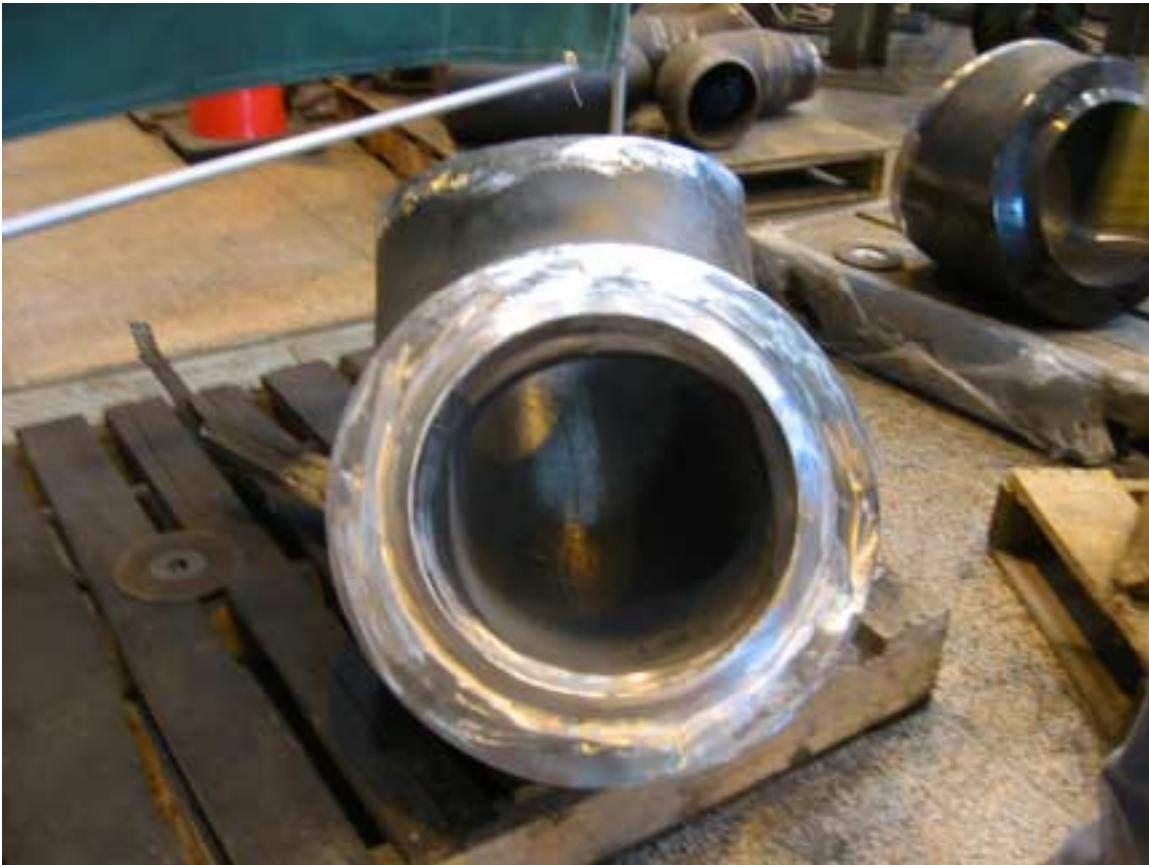
**Figure 4**  
**16-Inch Elbow for New Feedwater Line**

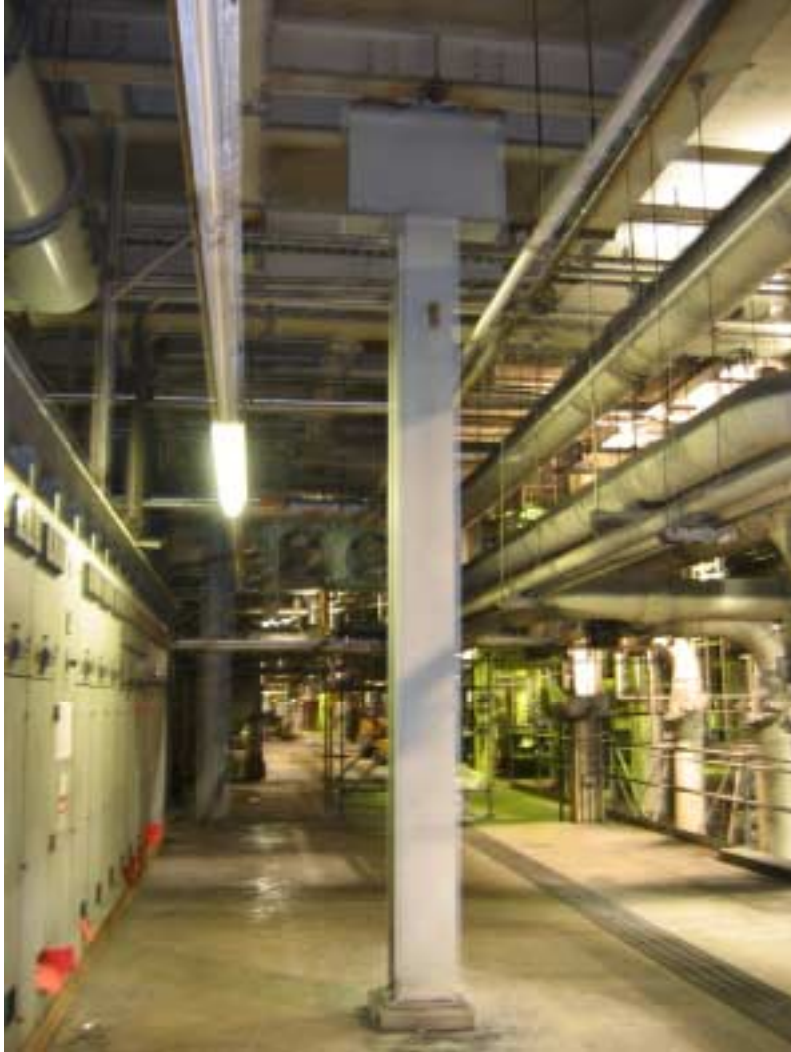
The first was adding new columns to the floor support steel below the heaters, between the mezzanine and basement floors. Figure 5 depicts these new supports. This work was handled pre-outage but still required careful planning because of the nearby 4160 volt bus duct shown to the upper left of the columns to the left of the light fixtures. Steel modification work was done in the fall of 2002.

**Figure 5**  
**New Support Columns**

Structurally, high loads from new heavier heaters had to be considered all the way from the rail spur entering the turbine building to the support steel around and under the heaters. The initial idea of reinforcing existing steel underneath the heaters was scrapped in favor of adding new

columns transferring the additional load down to the basement floor. This represented a savings in both schedule and construction scope.

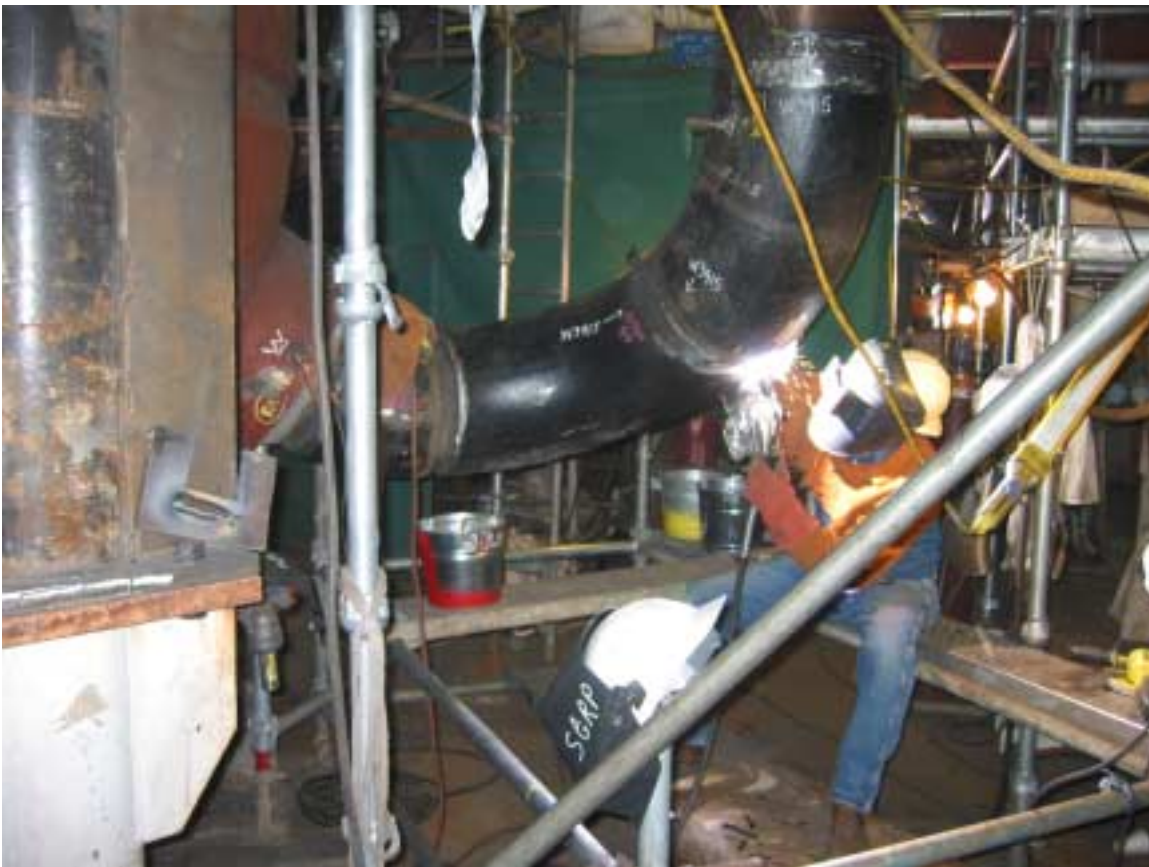
Figure 6 shows the installation work under way on the new feedwater line.

**Figure 6**  
**Feedwater Line Welding**

There are 40 connections on each heater, most of which are between the mezzanine floor and turbine room floor. Although several of these are maintenance drains that aren't connected to piping, the nozzles that are connected to permanent piping systems provide a view looking up from the mezzanine floor that can best be described as "spaghetti." Obviously this presents some installation issues for the pipe fitters. Pipe work including cutting, welding, NDE, hanger installation, and thermal insulation all had to be carefully coordinated. For these heaters, the largest line was 16" (feedwater) with a minimum wall thickness of 2.19 inches. All piping was carbon steel.

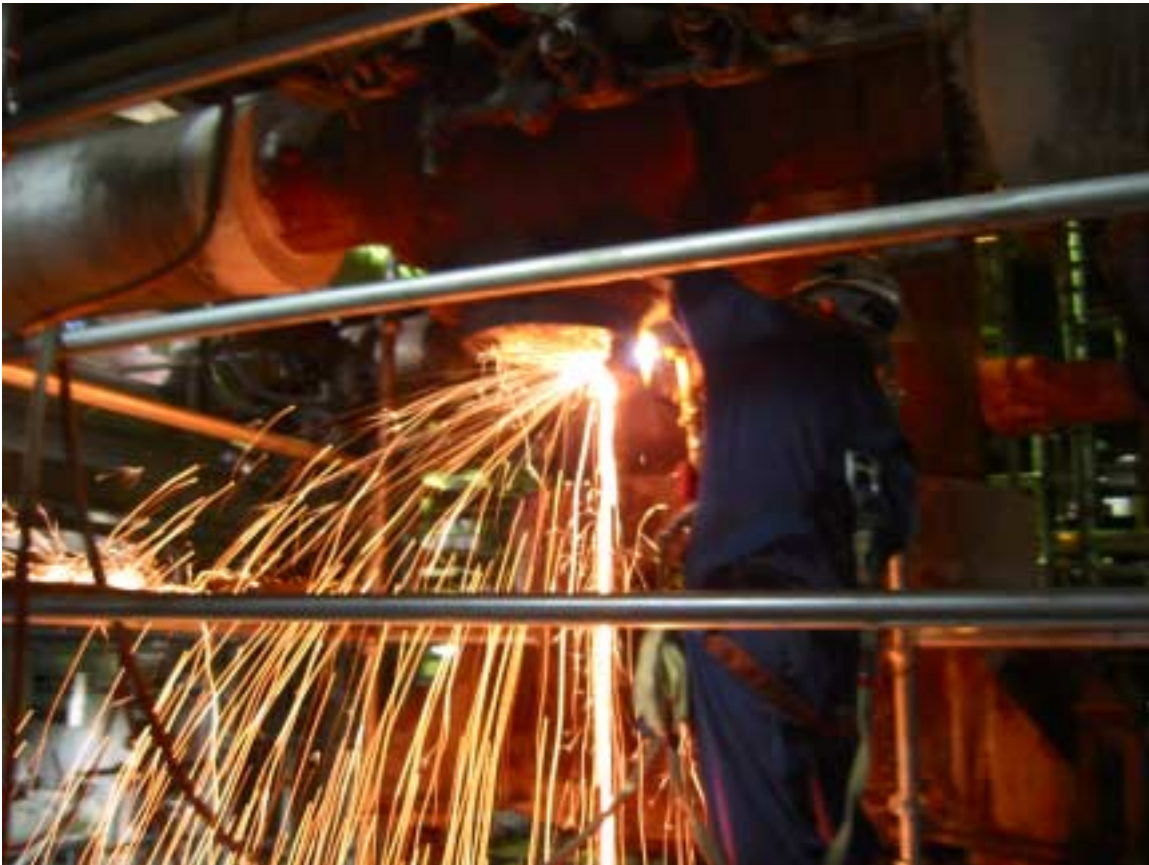
Weld preparation or repair work is shown in Figure 7.

**Figure 7**  
**Sparks Fly During Weld Prep/Repair**

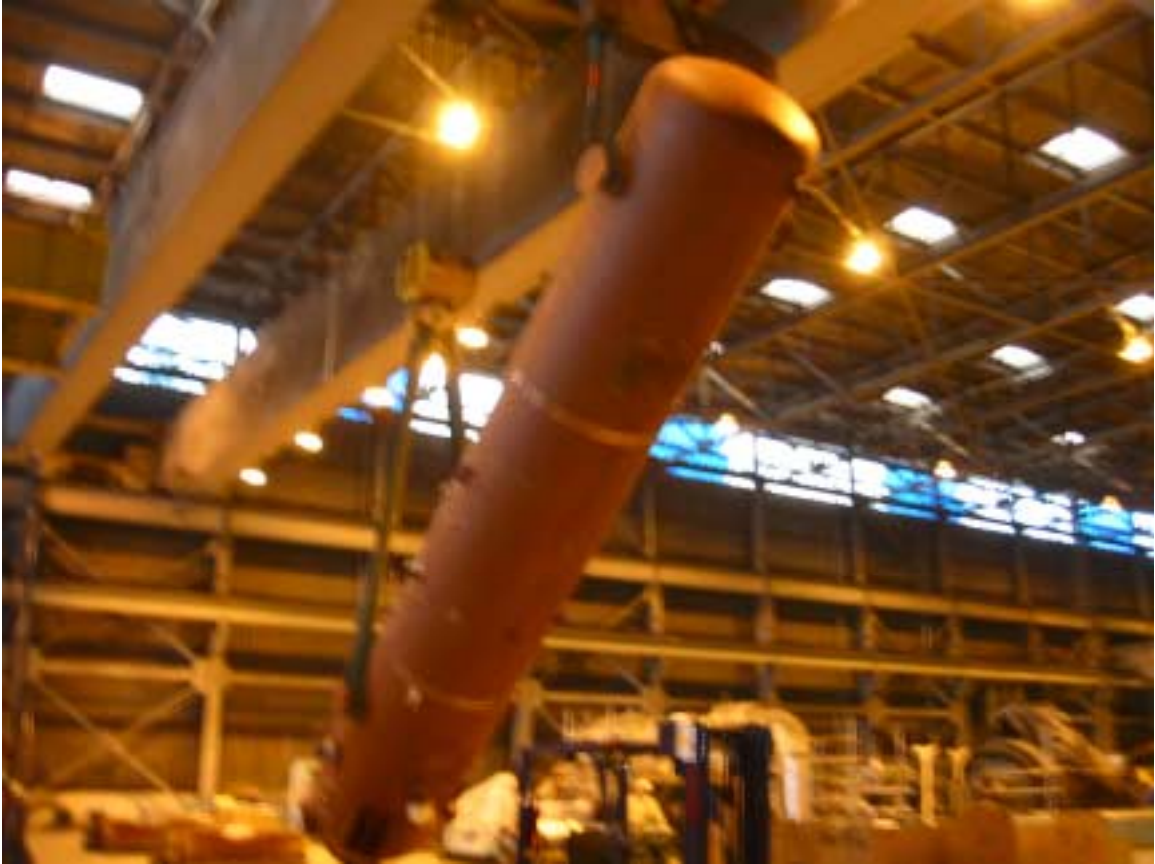
Kevlar slings were used around the trunnions to rig the heater to the crane. While the heater was vertical, supported only by the upper trunnions, a tear developed in the protective sleeve surrounding the sling. Although the structural integrity of the sling was intact, the visibility of the tear provided some anxiety for the rigging crew and crane operator. Figure 8 shows the feedwater heater being uprighted in the turbine building.

**Figure 8**  
**Uprighting Process**
